## Geotechnical Investigation Proposed Walkley Centre Development 1820-1846 Bank Street, Ottawa, Ontario

FINAL REPORT Revision 1

OTT-23002538-B0

October 3, 2024

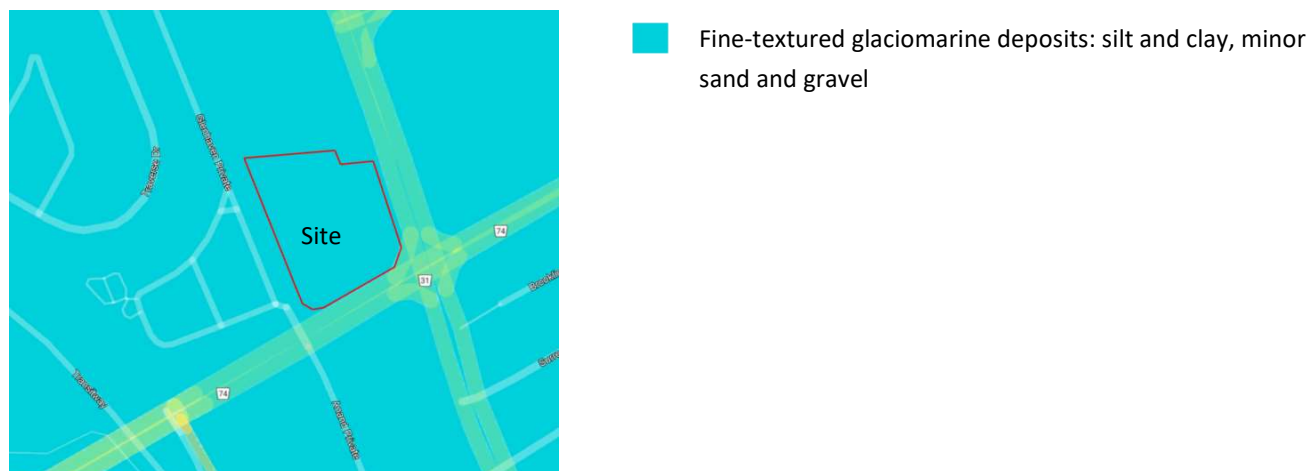
Image 1 – Surficial Geology

The surficial geology was reviewed via the Google Earth applications published by the Ontario Ministry of Energy, Northern Development and Mines available via [www.mndm.gov.on.ca/en/mines-and-minerals/applications/ogsearth/surficial-geology](http://www.mndm.gov.on.ca/en/mines-and-minerals/applications/ogsearth/surficial-geology) and was last modified on May 23, 2017. The map indicates the Site is underlain by fine-textured glaciomarine deposits consisting of silt and clay with minor sand and gravel. The surficial deposits are shown in Image 1 below.

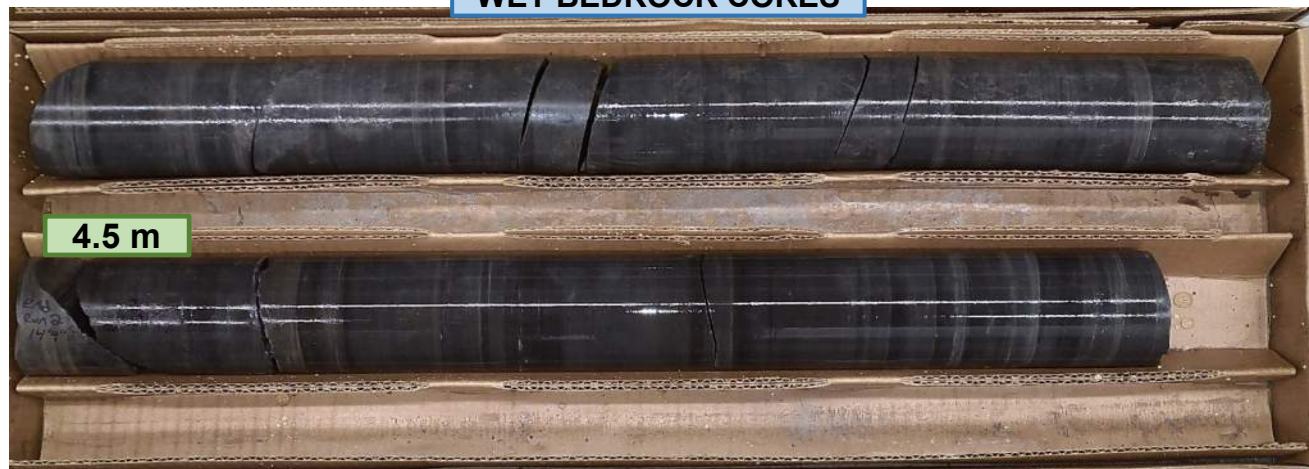
# WET BEDROCK CORES

The bedrock at the site is shale bedrock of the Carlsbad formation which is a type of shale that is prone to deterioration when exposed to the elements. It also heaves due to a complex mechanism caused in part from the bio-oxidation of the sulphides in the rock, which then react with calcite seams to form expanding gypsum. This occurs when oxygen is permitted to enter the rock, usually by exposure or lowering of the water table and is accelerated by the presence of heat.

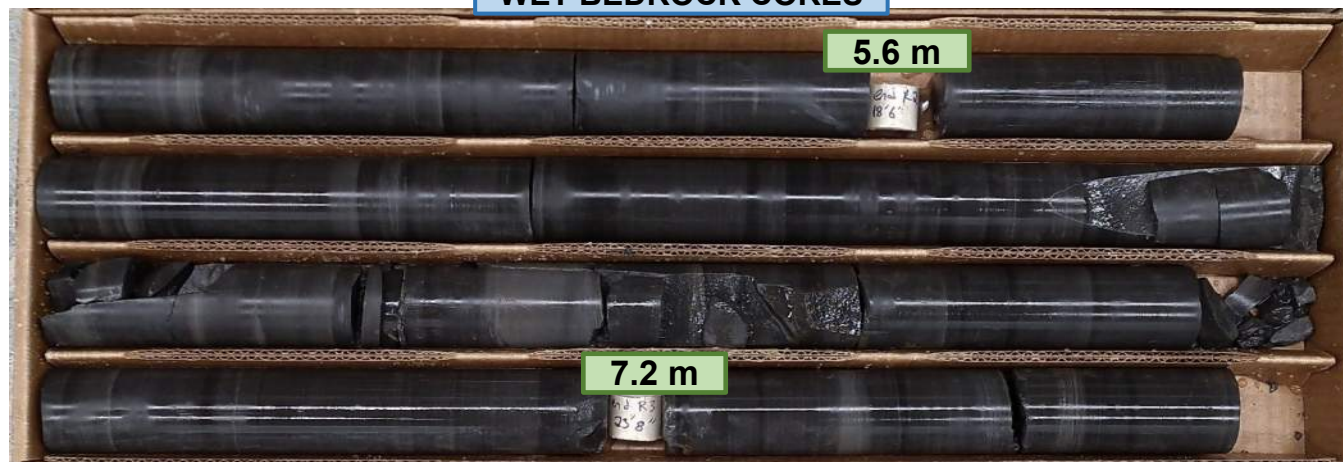
| Date Cored<br>10/30/2023 | | Rock Core Photographs | A-4 |

# DRY BEDROCK CORES

# WET BEDROCK CORES
