# **Geotechnical Investigation**

## **Proposed Residential Development**

3400 Woodroffe Avenue  
Ottawa, Ontario

Report PG7287-1 Rev. 1 dated April 20, 2026

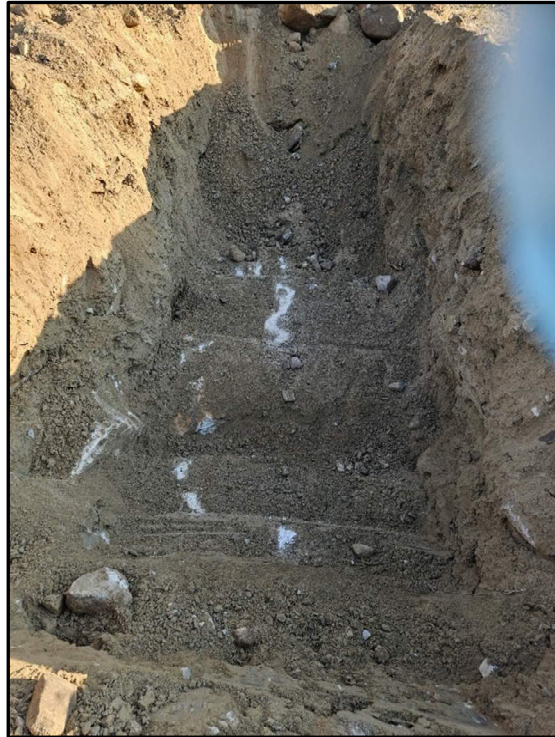
**Photo 1:** Photo of the test pit TP 1-24.

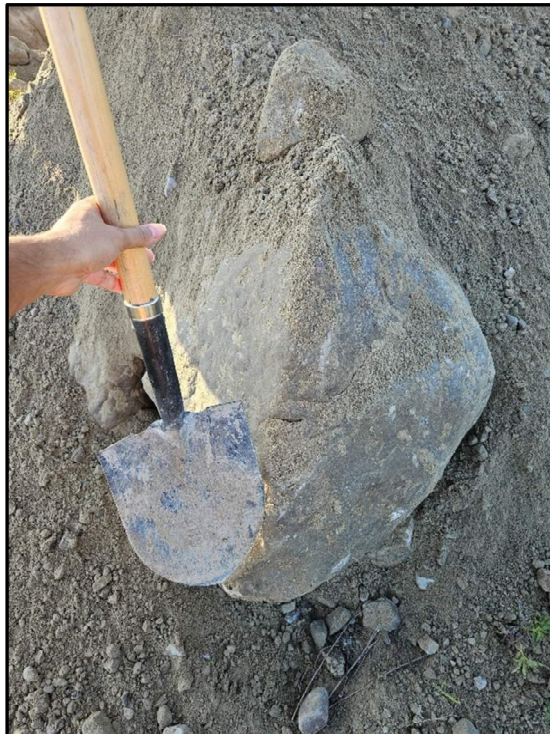
**Photo 2:** Photo illustrating the boulder excavated from the test pit TP 1-24.

The underlying glacial till was generally composed of compact to very dense, brown silty sand with gravel, cobbles and boulders. The amount of gravel, cobbles and boulders within the glacial till was noted to gradually increase with depth, varying approximately from 40 to 70 % of the total composition of the glacial till. The dimensions of the boulders observed within the test pits varied between about 300 to 1200 mm. Reference should be made to the test pit photos in Appendix 2 for a visual indication of the quantity and size of the gravel, cobbles, and boulders.

Significant cobbles and boulders should be expected during the servicing and building excavations at the subject site. A budget should be provided in the project tender for the removal of cobbles and boulders.

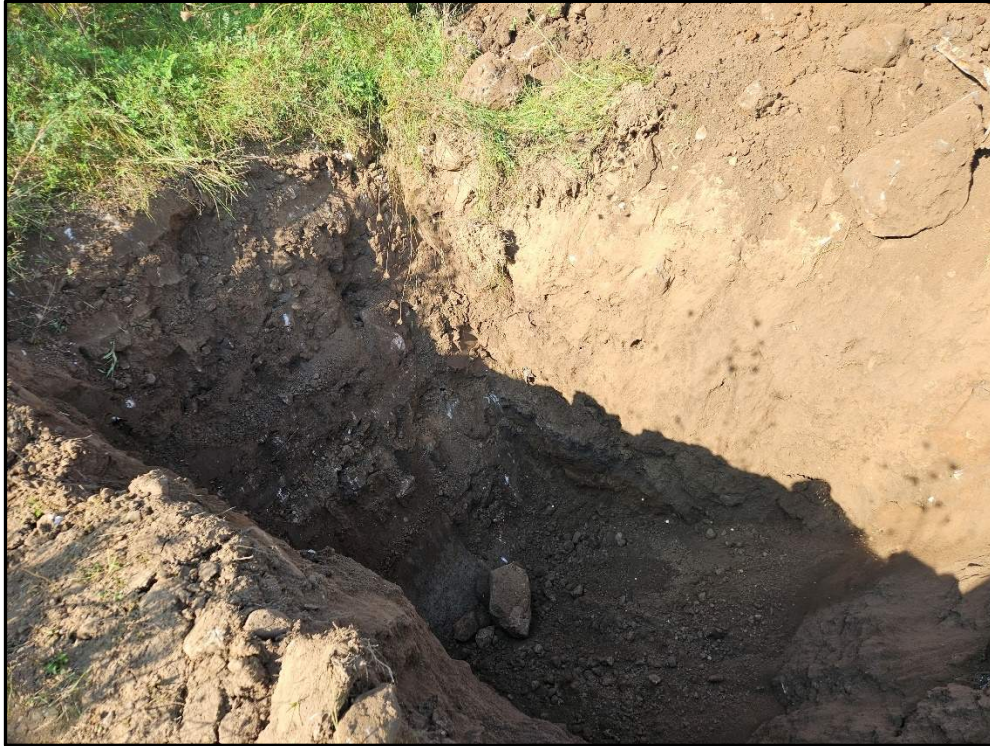
**Photo 3:** Photo of the test pit TP 2-24.

Generally, the subsurface profile at the test pit locations consists of a relatively thin layer of fill underlain by a glacial till deposit. The fill was generally observed to consist of silty sand with gravel and organics. Construction debris, such as crushed stone, bricks and concrete, were encountered within the upper approximate 0.3 and 2.4 m of the fill at test pits TP 2-24 and TP-3-24, respectively. It should also be noted that test pit TP 2-24 encountered refusal on a concrete slab at an approximate depth of 0.34m.

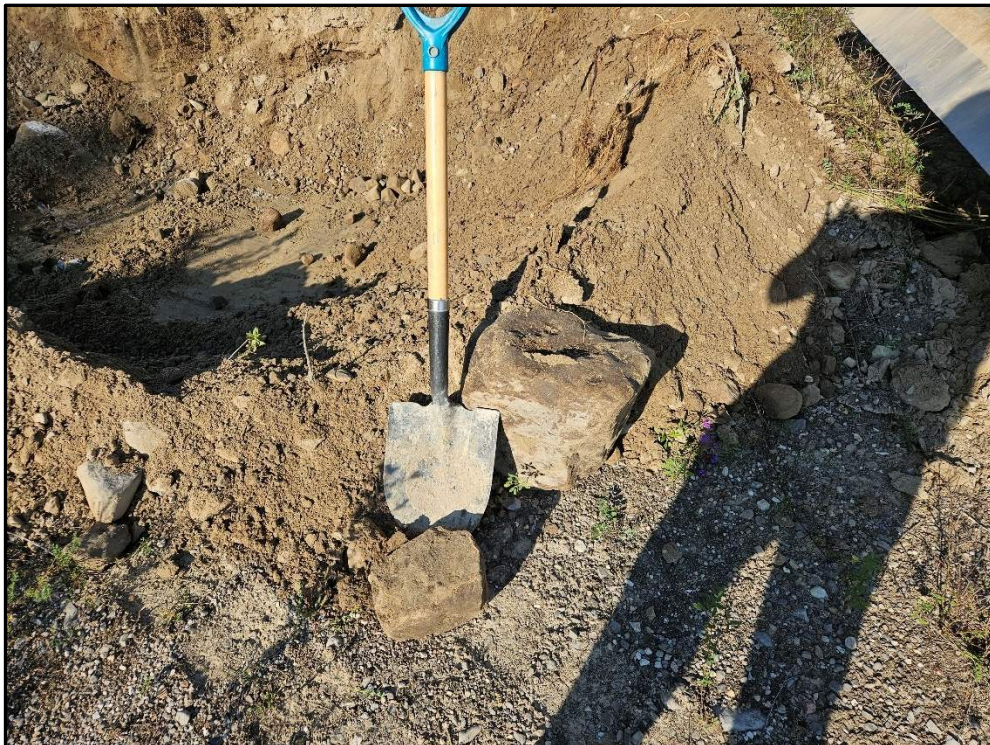
**Photo 4:** Photo illustrating the boulders from the test pit TP 2-24.

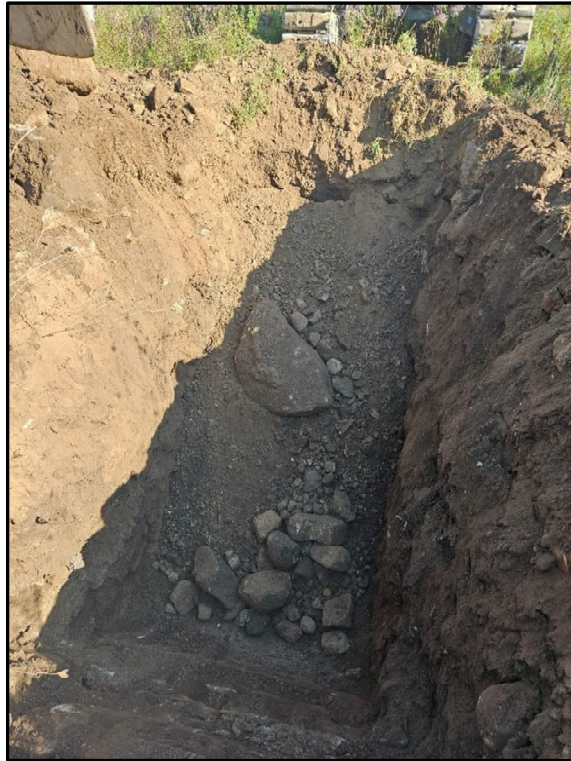
**Photo 5:** Photo of the test pit TP 3-24.

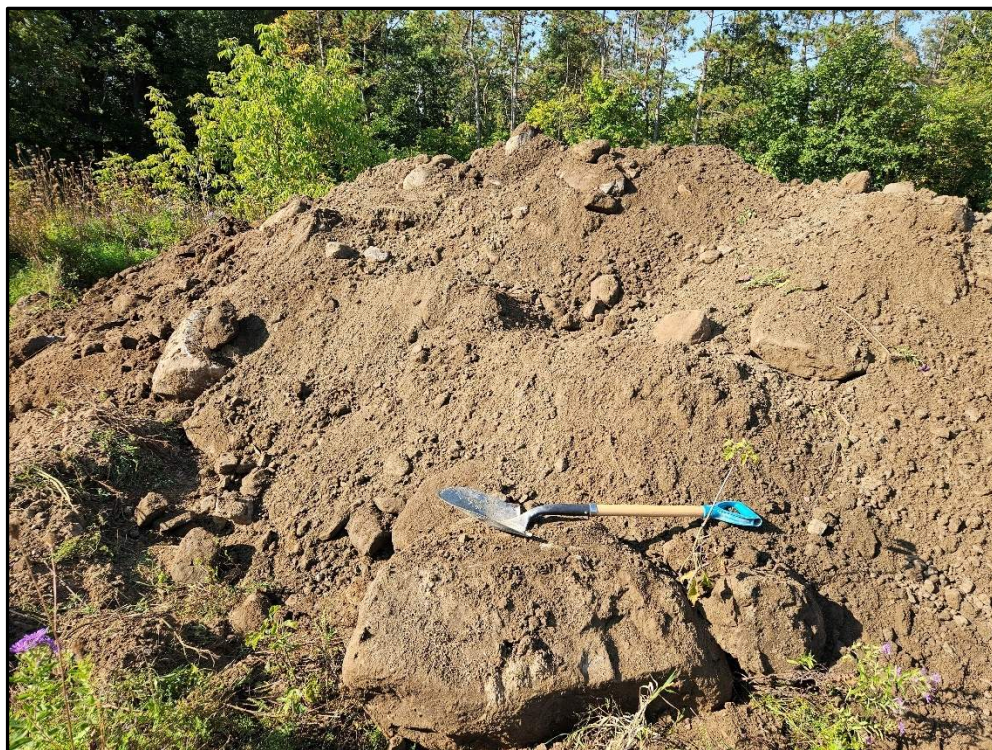
**Photo 6:** Photo illustrating the boulders excavated from the test pit TP 3-24.

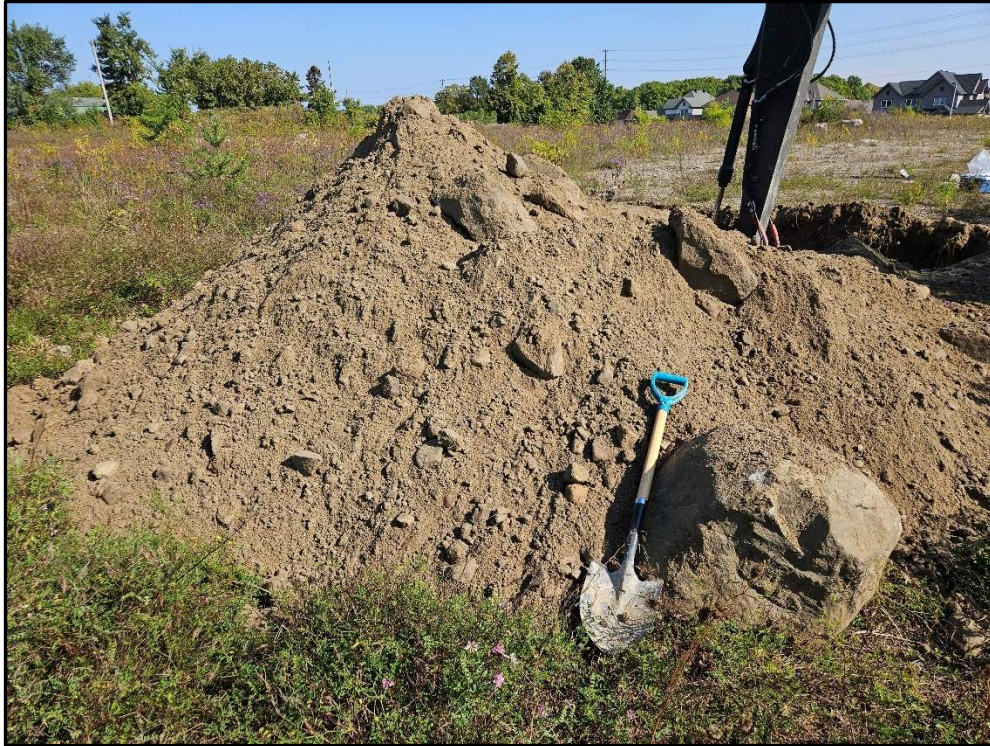
**Photo 7:** Photo illustrating the boulders excavated from the test pit TP 4-24.

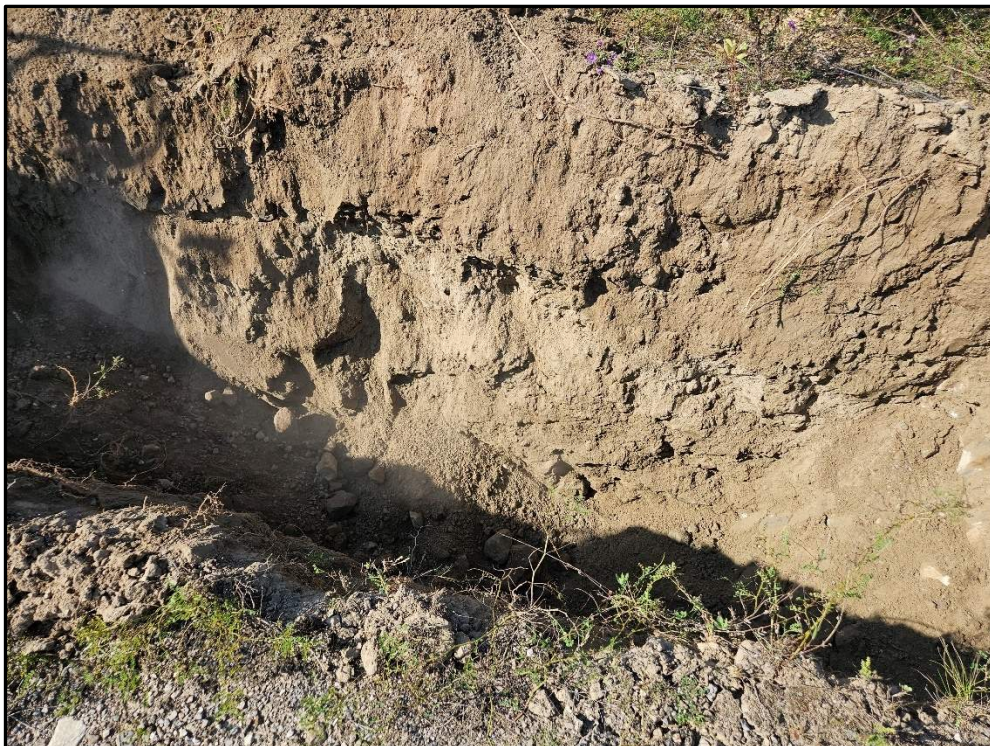
**Photo 8:** Photo of the test pit TP 4-24.

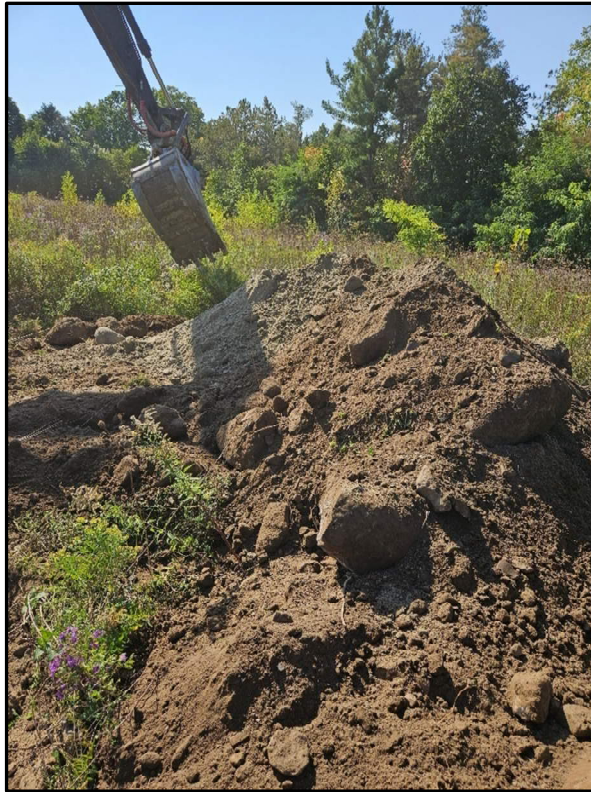
**Photo 9:** Photo illustrating the boulders excavated from the test pit TP 5-24.

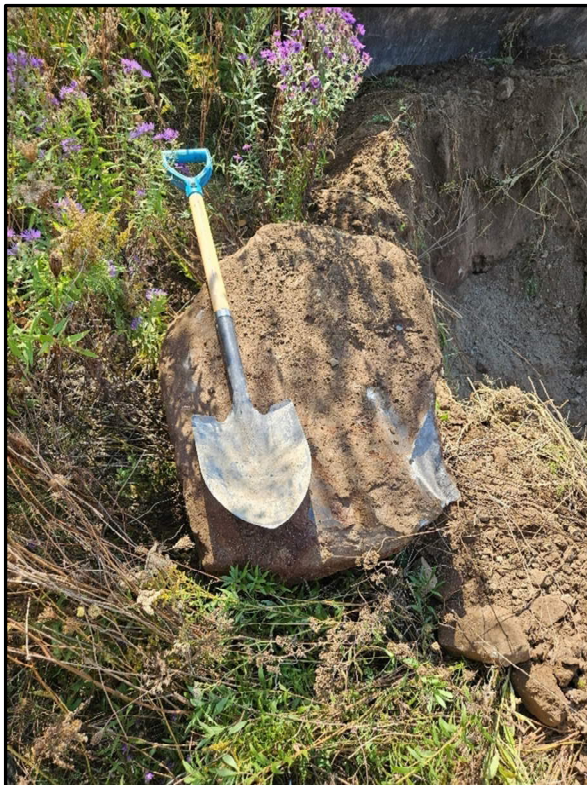
**Photo 10:** Photo illustrating the boulders excavated from the test pit TP 5-24.

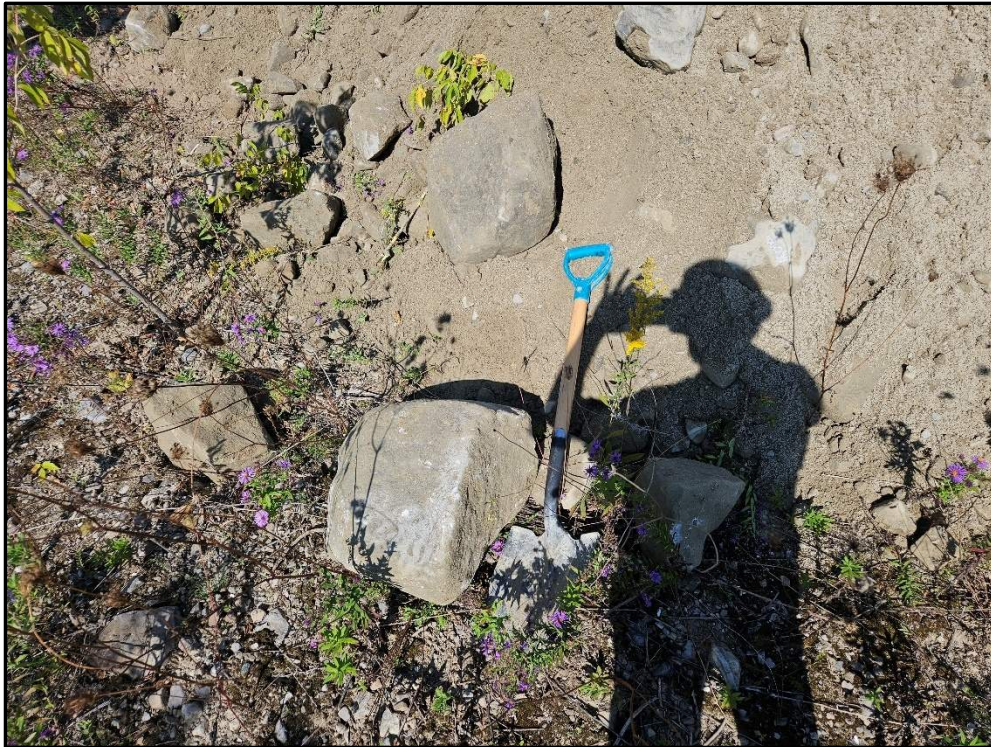
**Photo 11:** Photo illustrating the boulders excavated from the test pit TP 7-24.

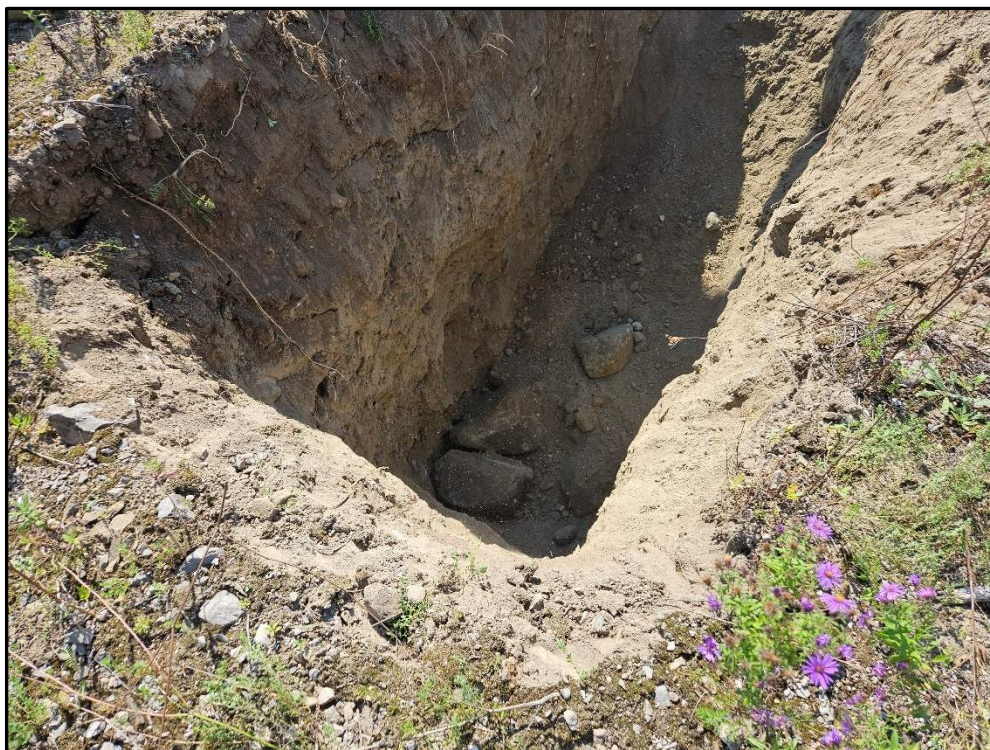
**Photo 12:** Photo of the test pit TP 7-24.

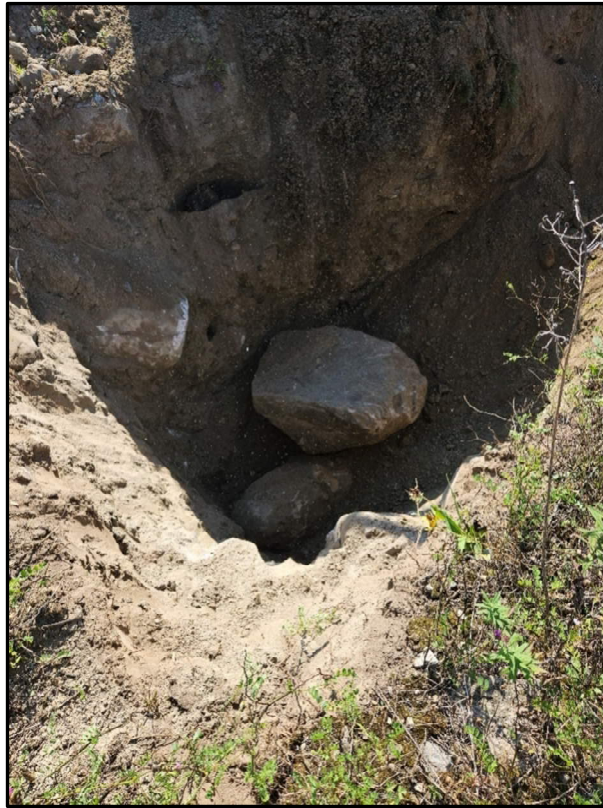
**Photo 13:** Photo of the test pit TP 8-24.

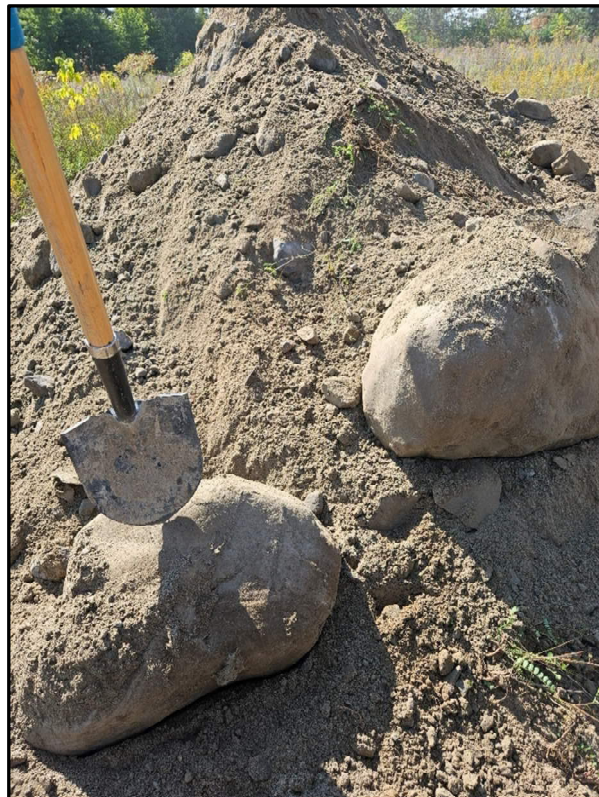
**Photo 14:** Photo illustrating the boulders excavated from the test pit TP 8-24.

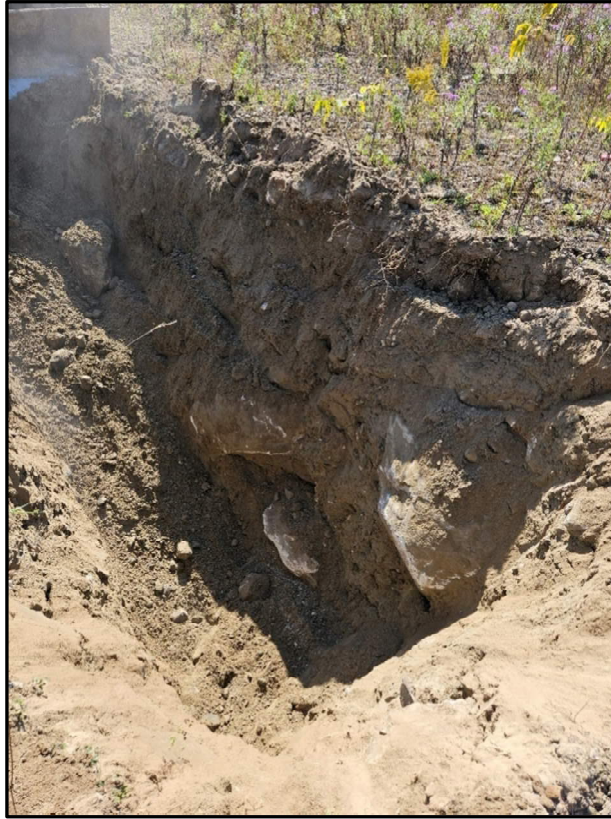
**Photo 15:** Photo of the test pit TP 9-24.
