# **Phase I Environmental Site Assessment**

260 MacLaren Street  
Ottawa, Ontario

Prepared for Claridge Homes

Report: PE7414-1  
May 29, 2026

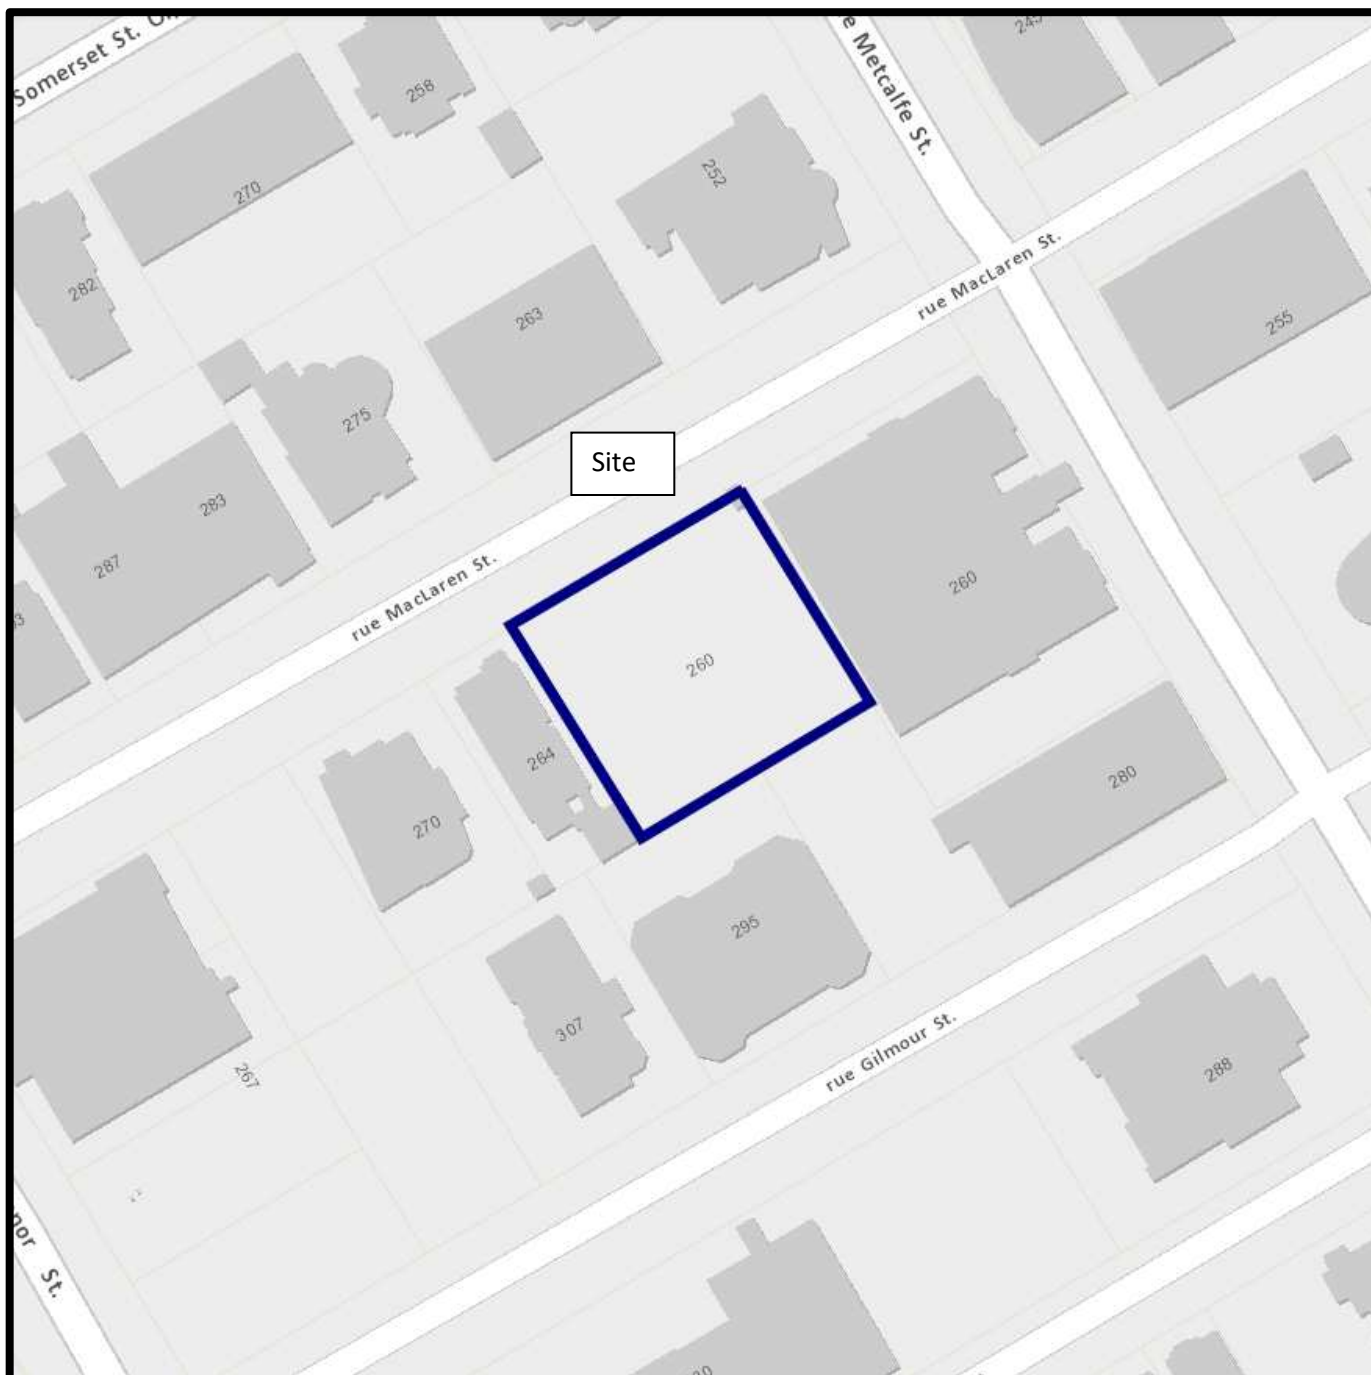
FIGURE 1  
KEY PLAN

Location: The Phase I Property is located on the south side of MacLaren Street, approximately 40 m west of the MacLaren Street and Metcalfe Street intersection, in the City of Ottawa, Ontario. Refer to Figure 1 - Key Plan in the Figures section following the text.

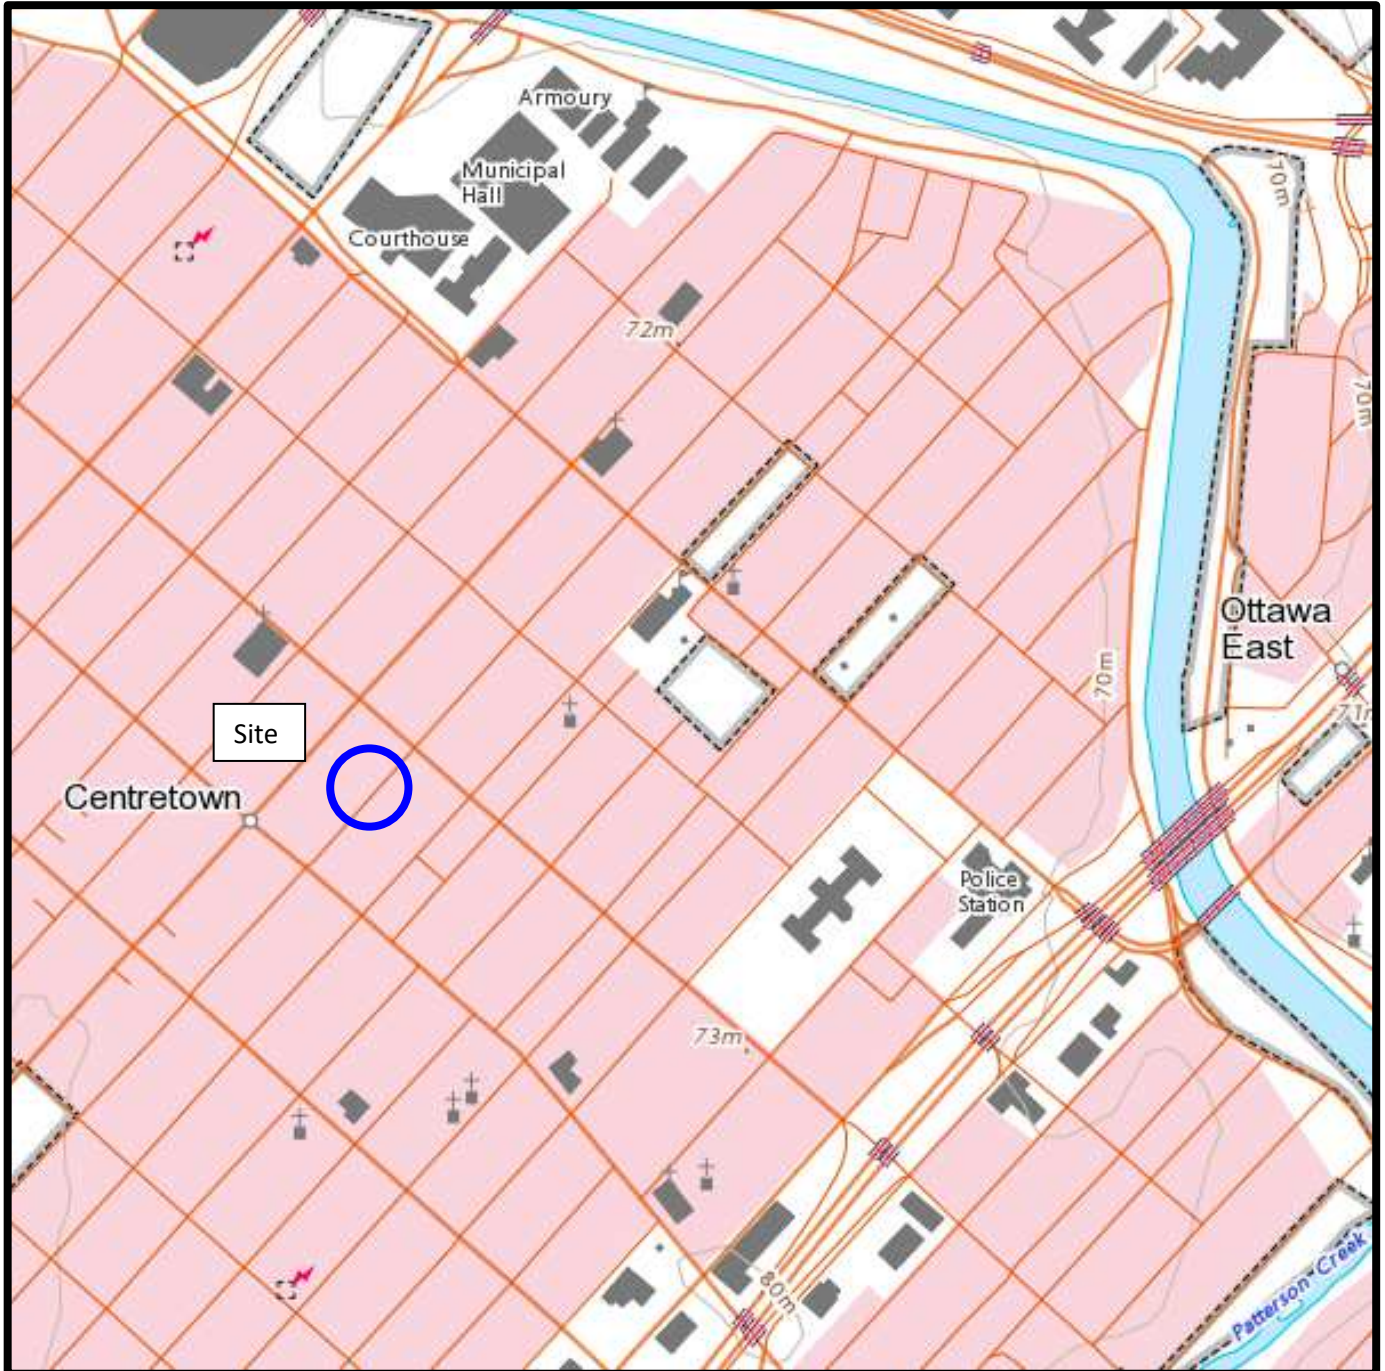
FIGURE 2  
TOPOGRAPHIC MAP

Topographic maps were obtained from Natural Resources Canada – The Atlas of Canada website and from the City of Ottawa website. The topographic maps indicate that the regional topography in the general area of the site slopes down in an easterly direction towards the Rideau Canal. An illustration of the referenced topographic map is presented on Figure 2 – Topographic Map, appended to this report.

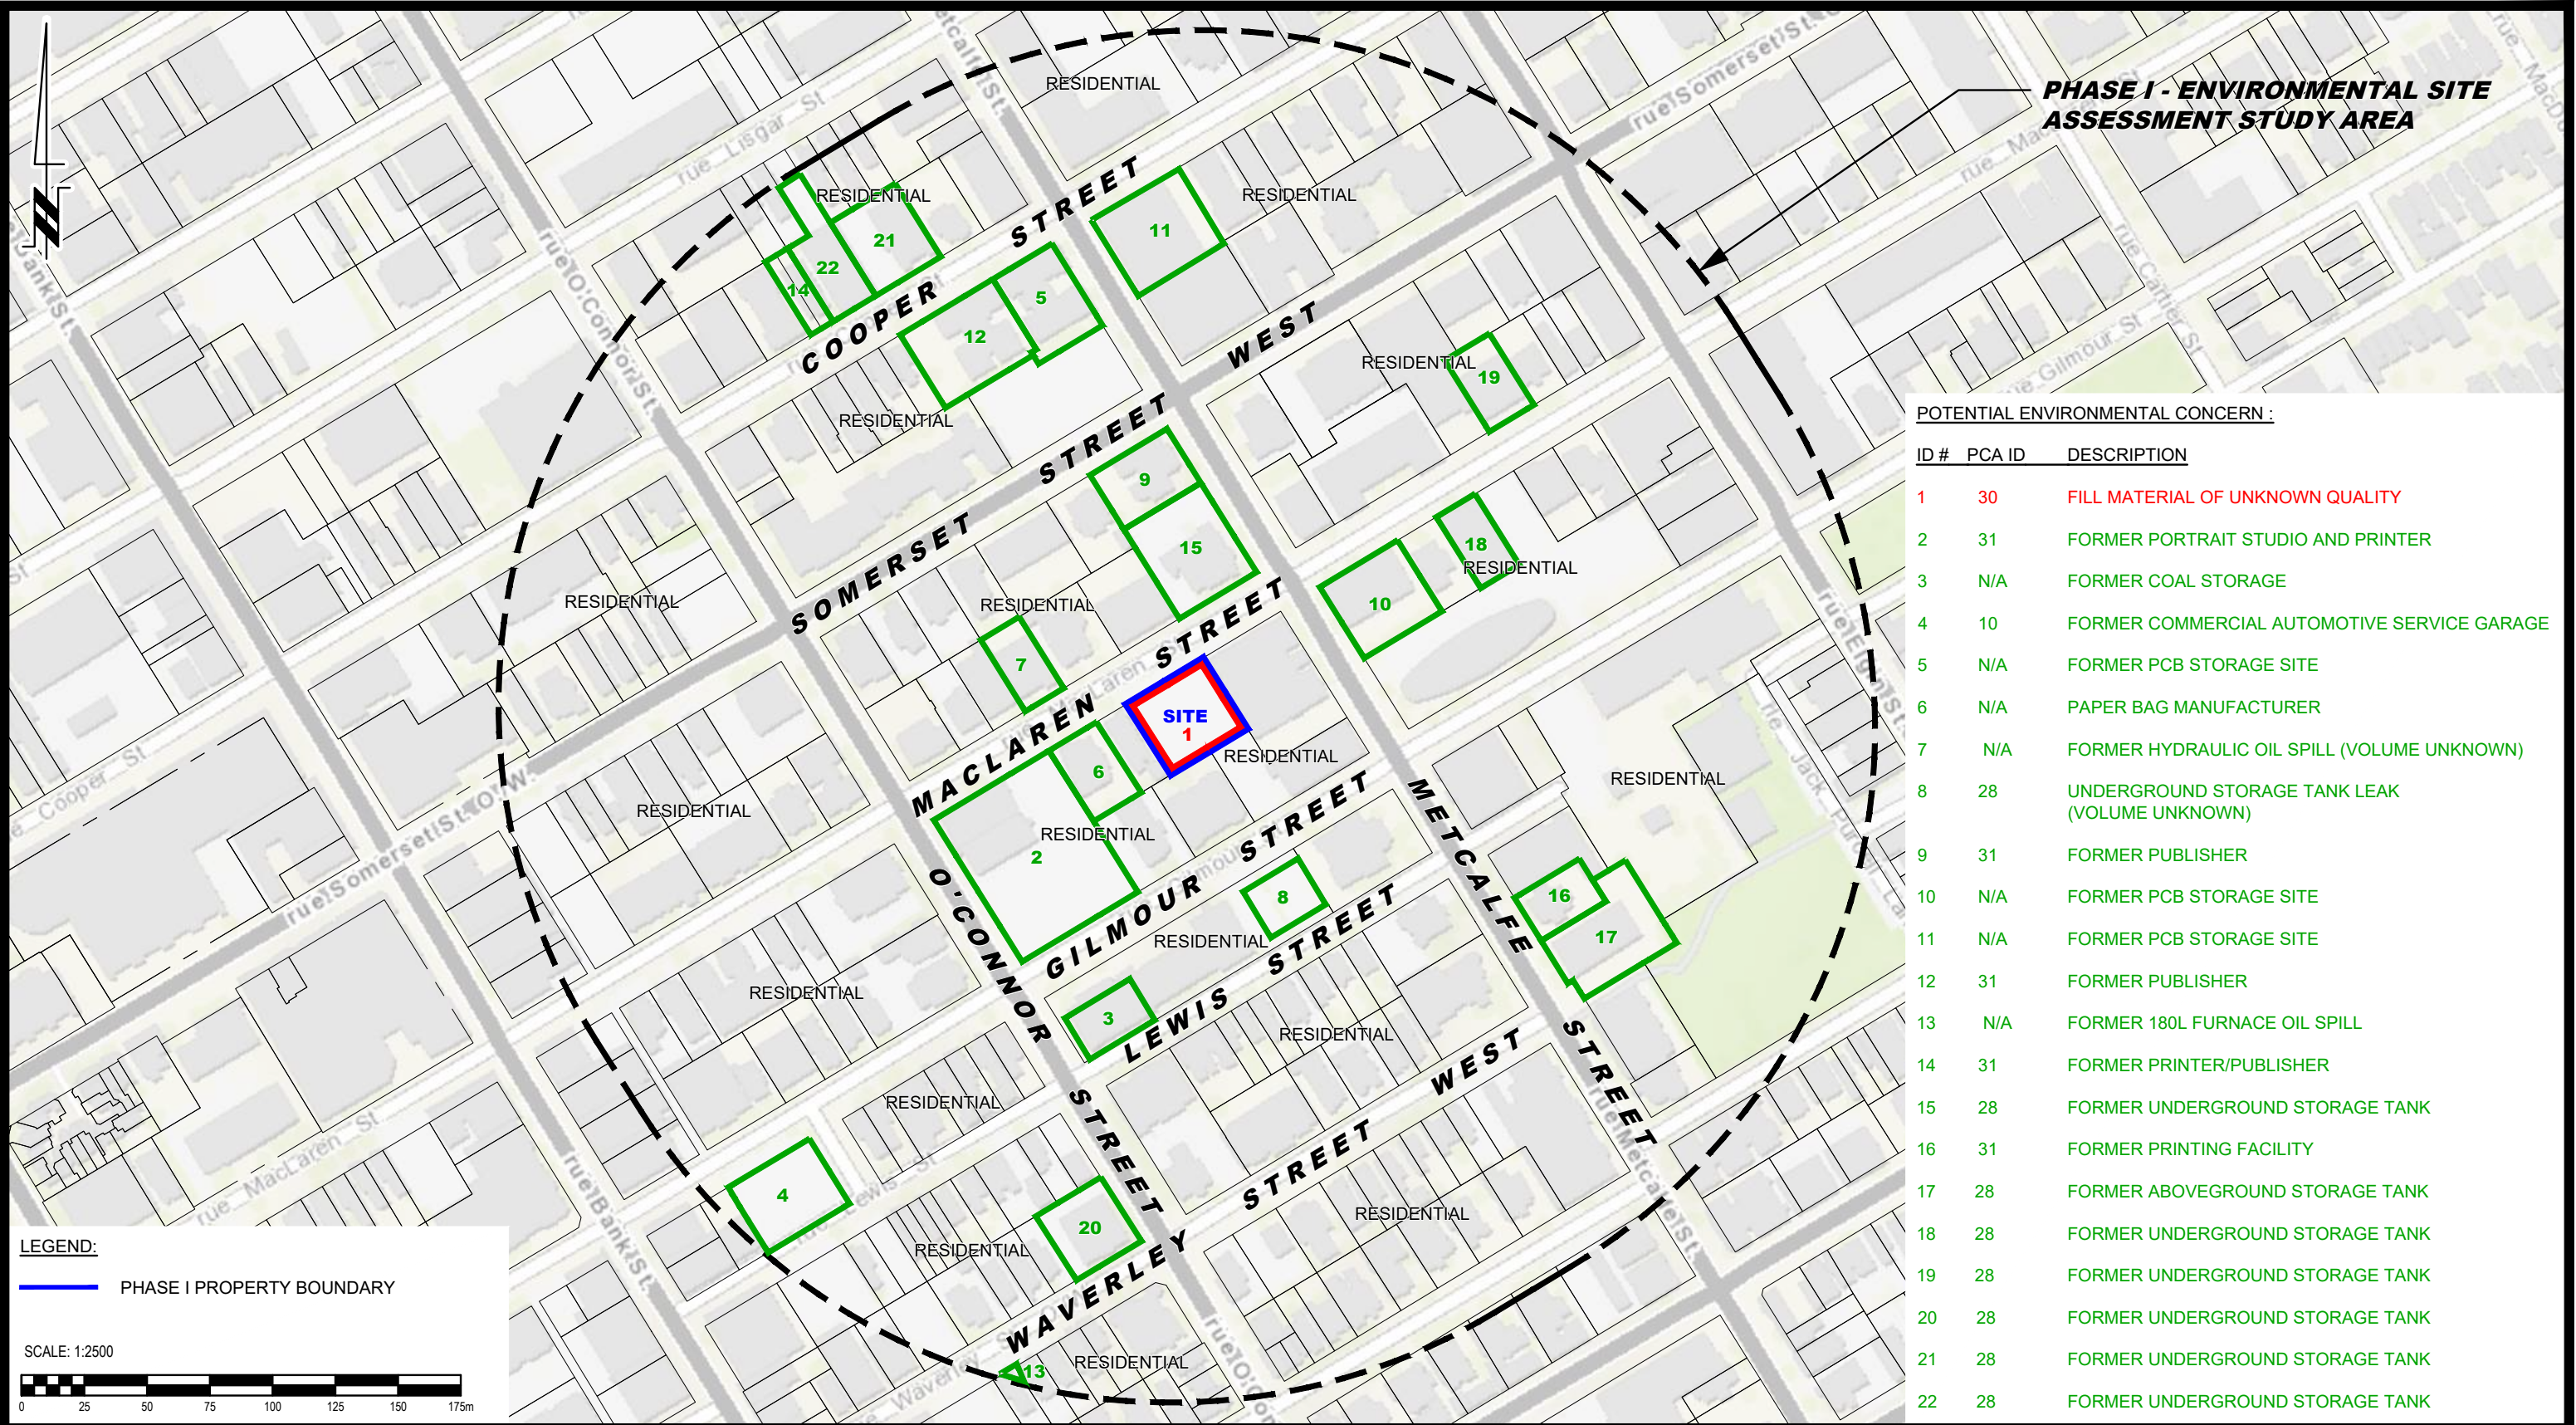
**PHASE I - ENVIRONMENTAL SITE ASSESSMENT STUDY AREA**

**POTENTIAL ENVIRONMENTAL CONCERN :**

| ID # | PCA ID | DESCRIPTION |
|---|---|---|
| 8 | 28 | UNDERGROUND STORAGE TANK LEAK (VOLUME UNKNOWN) |

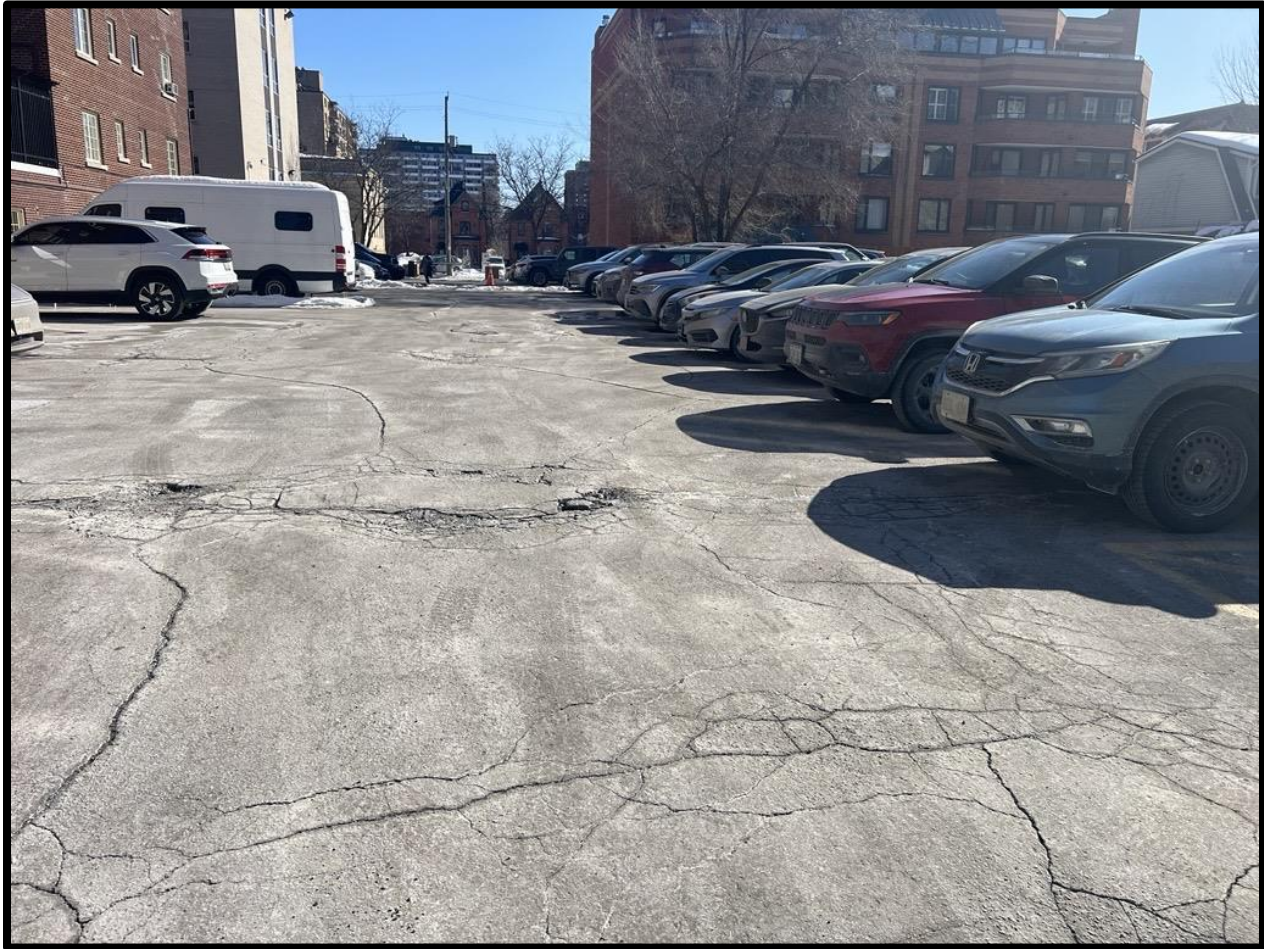
Photograph 1: View of the Phase I Property, facing south.
