Phase II – Environmental Site Assessment

2006, 2020, & 2026 Scott Street and
314 & 318 Athlone Avenue
Ottawa, Ontario

Morley Hoppner Group

Report: PE5303-2R

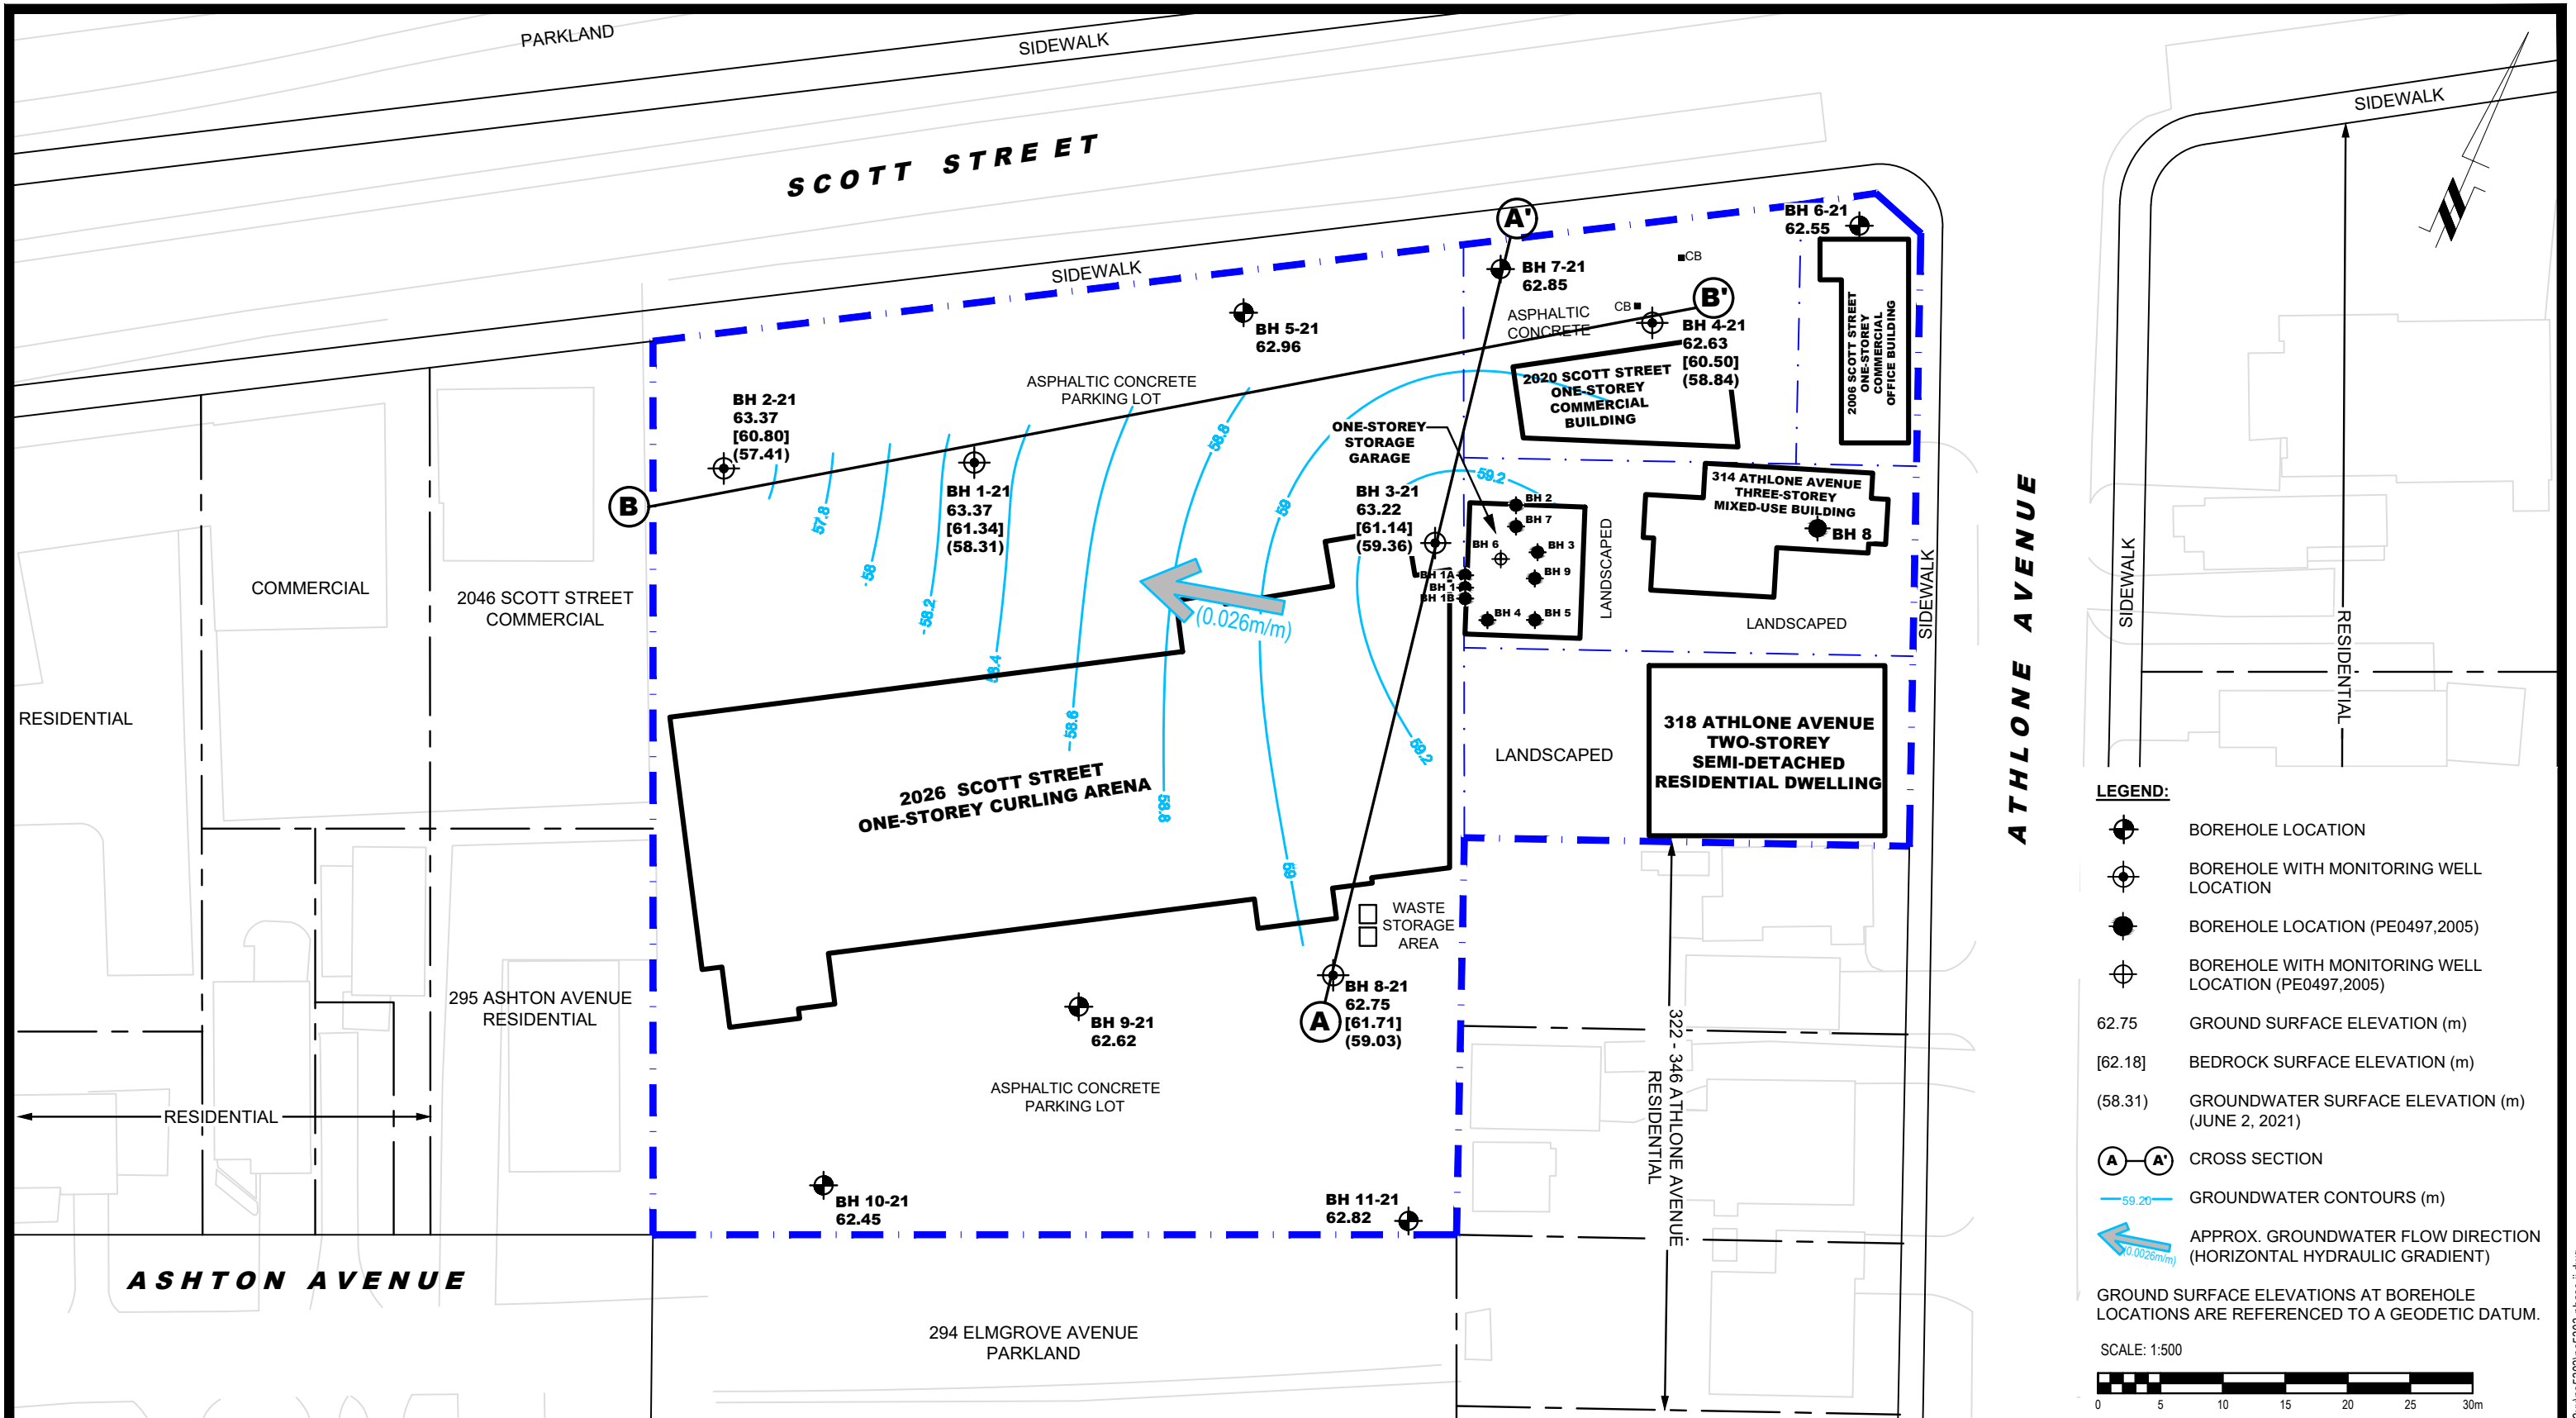
Drawing PE5303-3 – Test Hole Location Plan

Scale:	1:500	Date:	07/2021
Drawn by:	JM	Report No.:	PE5303-2
Checked by:	NS	Dwg No.:	PE5303-3
Approved by:	MSD	Revision No.:

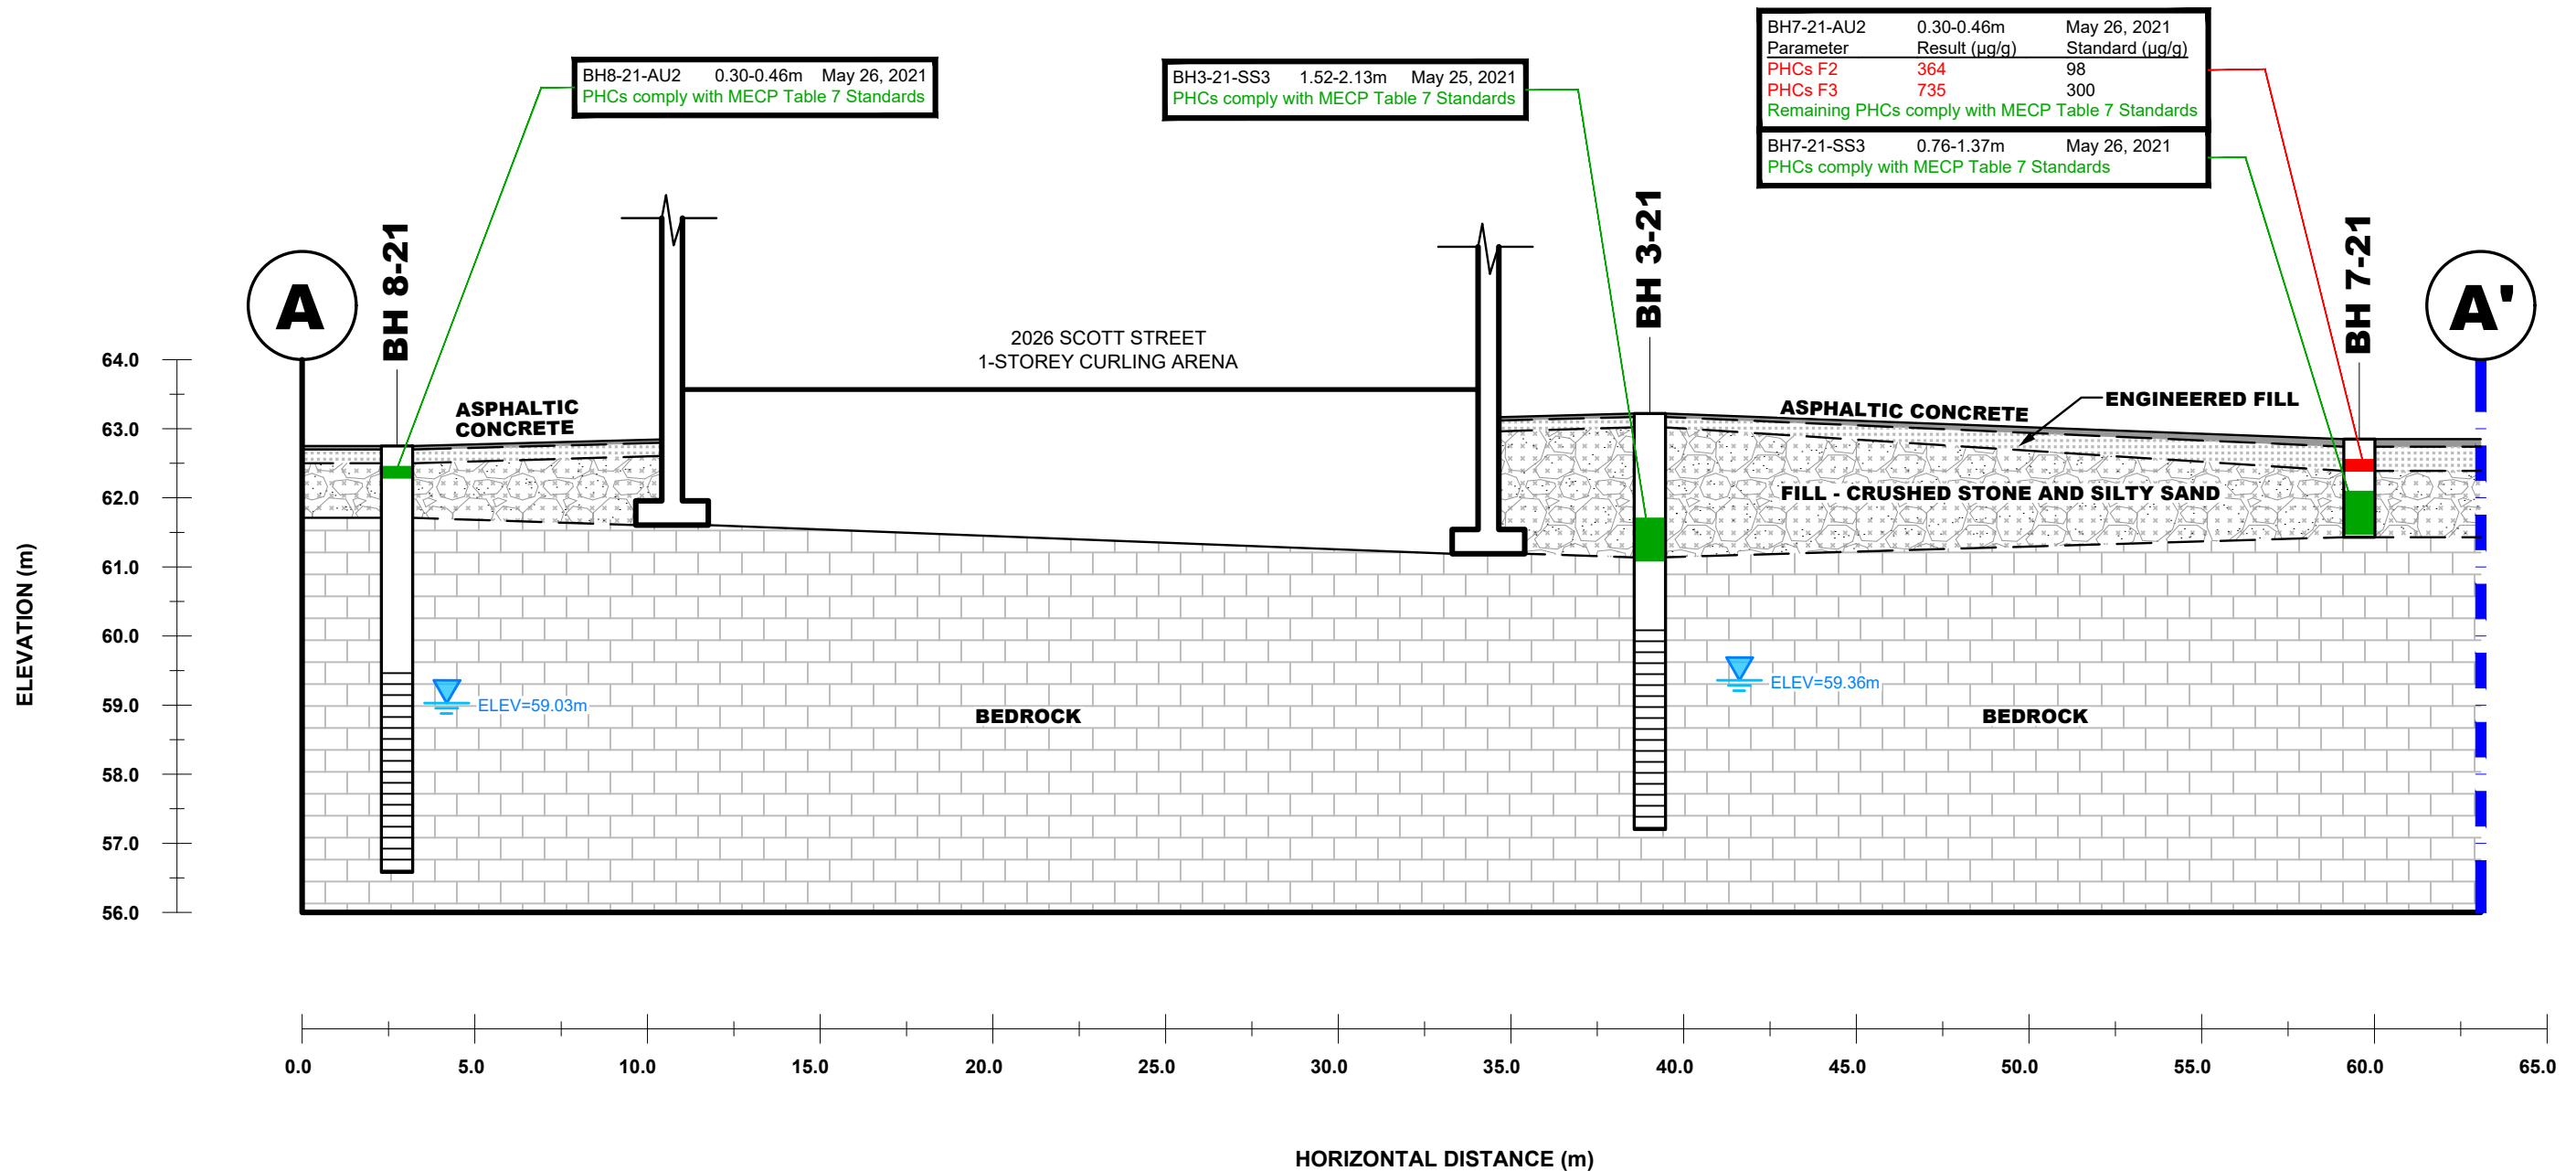
Drawing PE5303-4A – Cross Section A-A' – Soil (PHCs)

MORLEY HOPPNER GROUP
PHASE II - ENVIRONMENTAL SITE ASSESSMENT
2006, 2020 & 2026 SCOTT STREET
314 & 318 ATHLONE AVENUE
ONTARIO
CROSS SECTION A-A' - SOIL (PHCs)

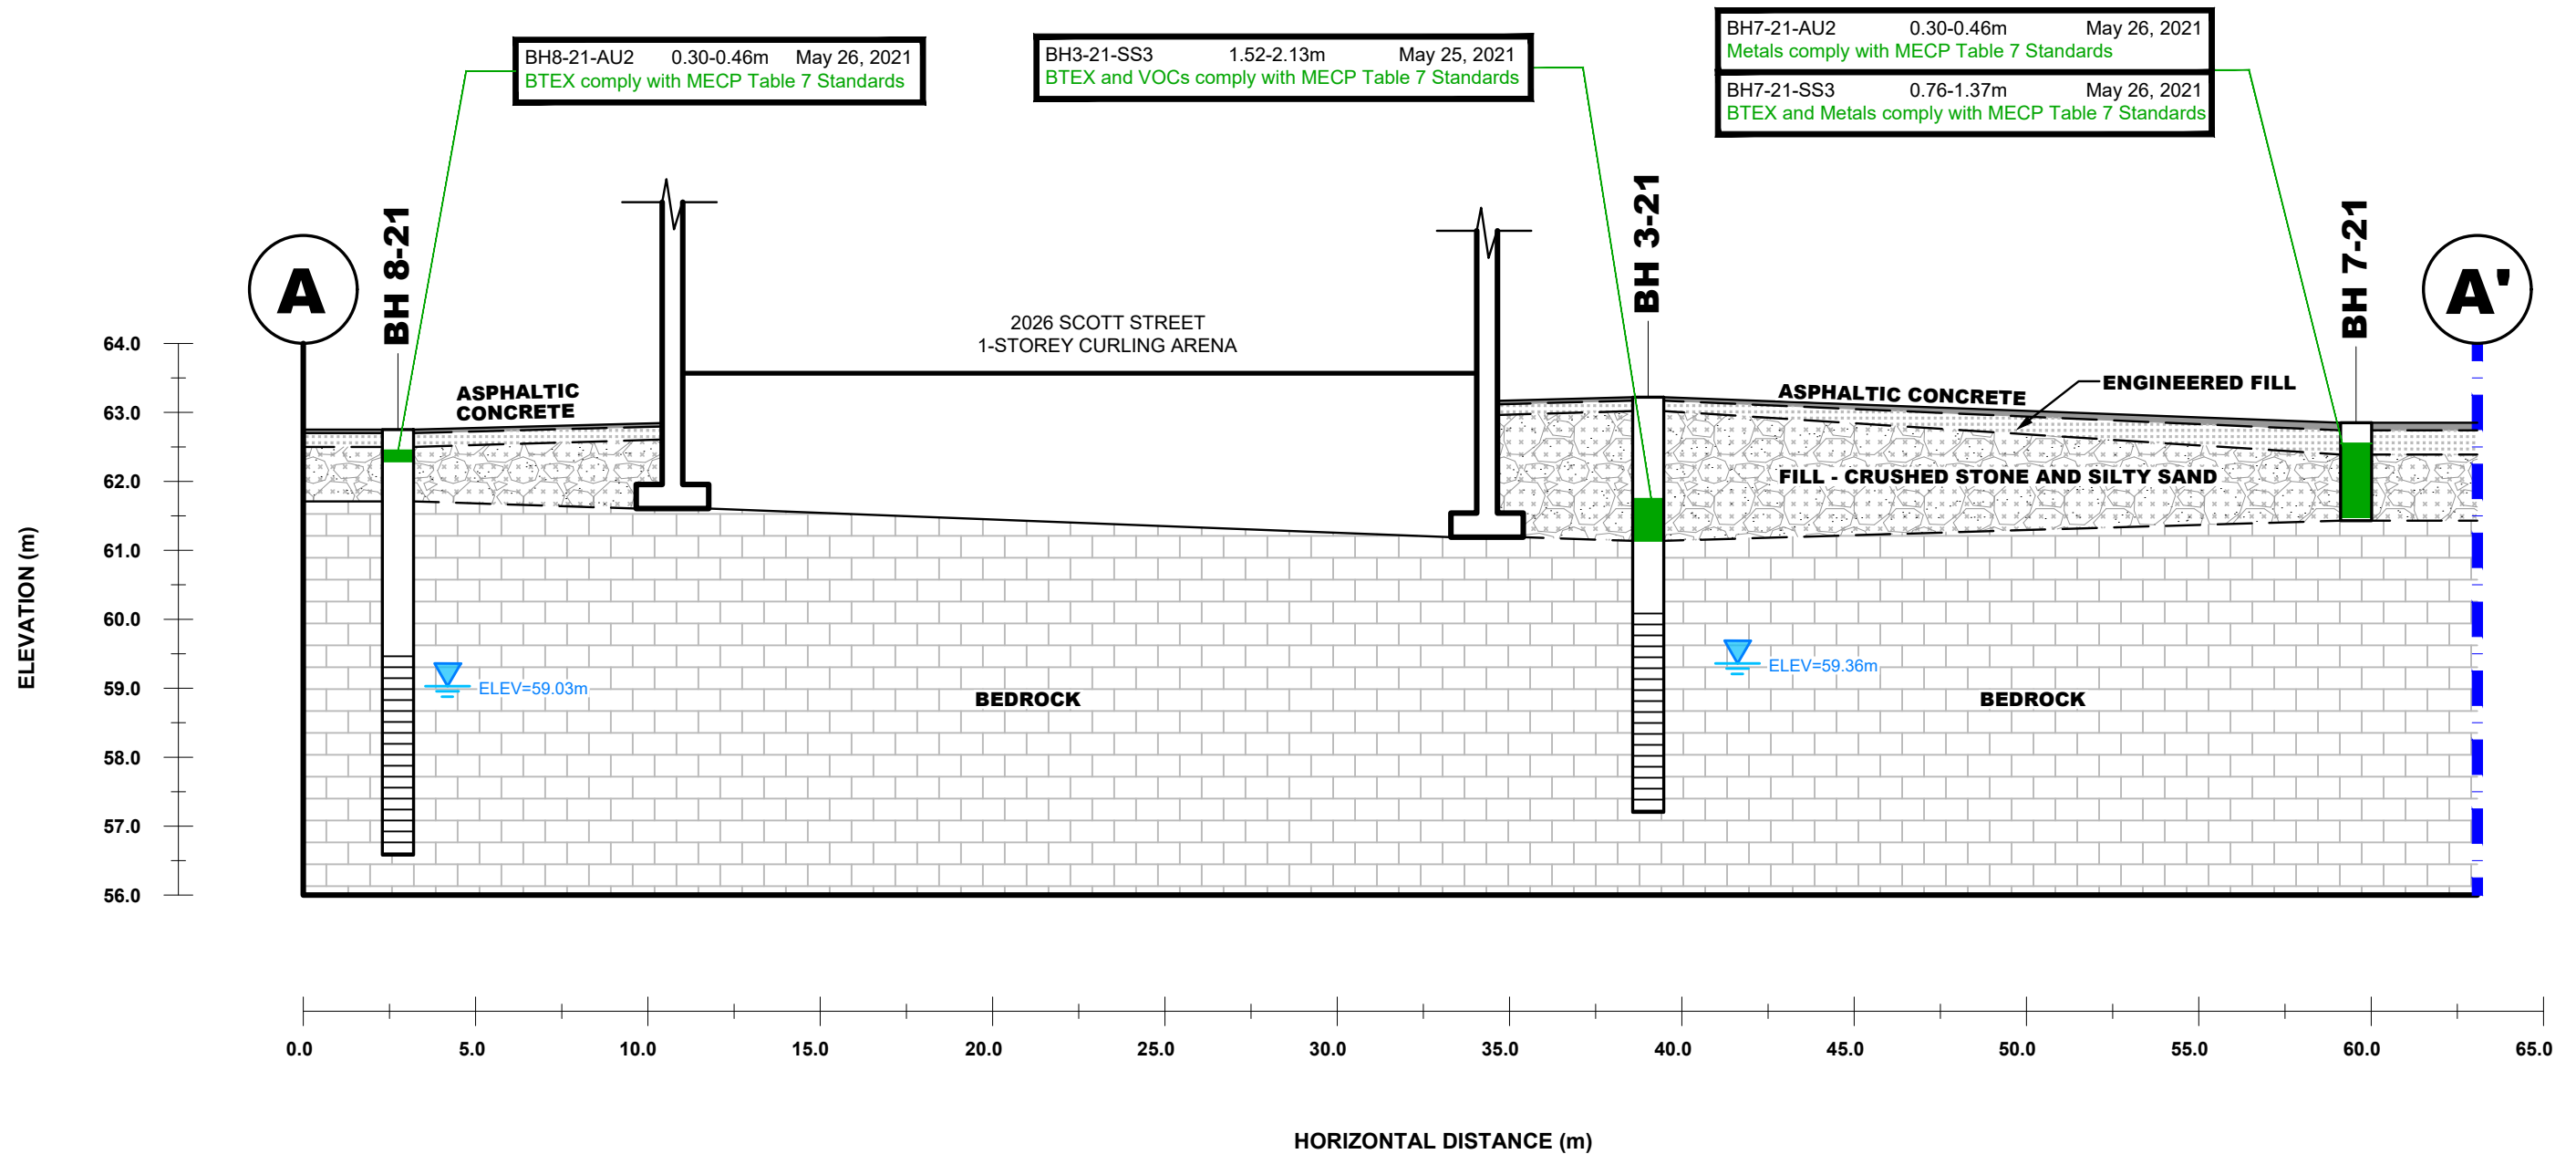
Drawing PE5303-5A – Cross Section A-A' – Soil (BTEX, VOCs, Metals)

Title:
CROSS SECTION A-A' - SOIL (BTEX, VOCs, METALS)

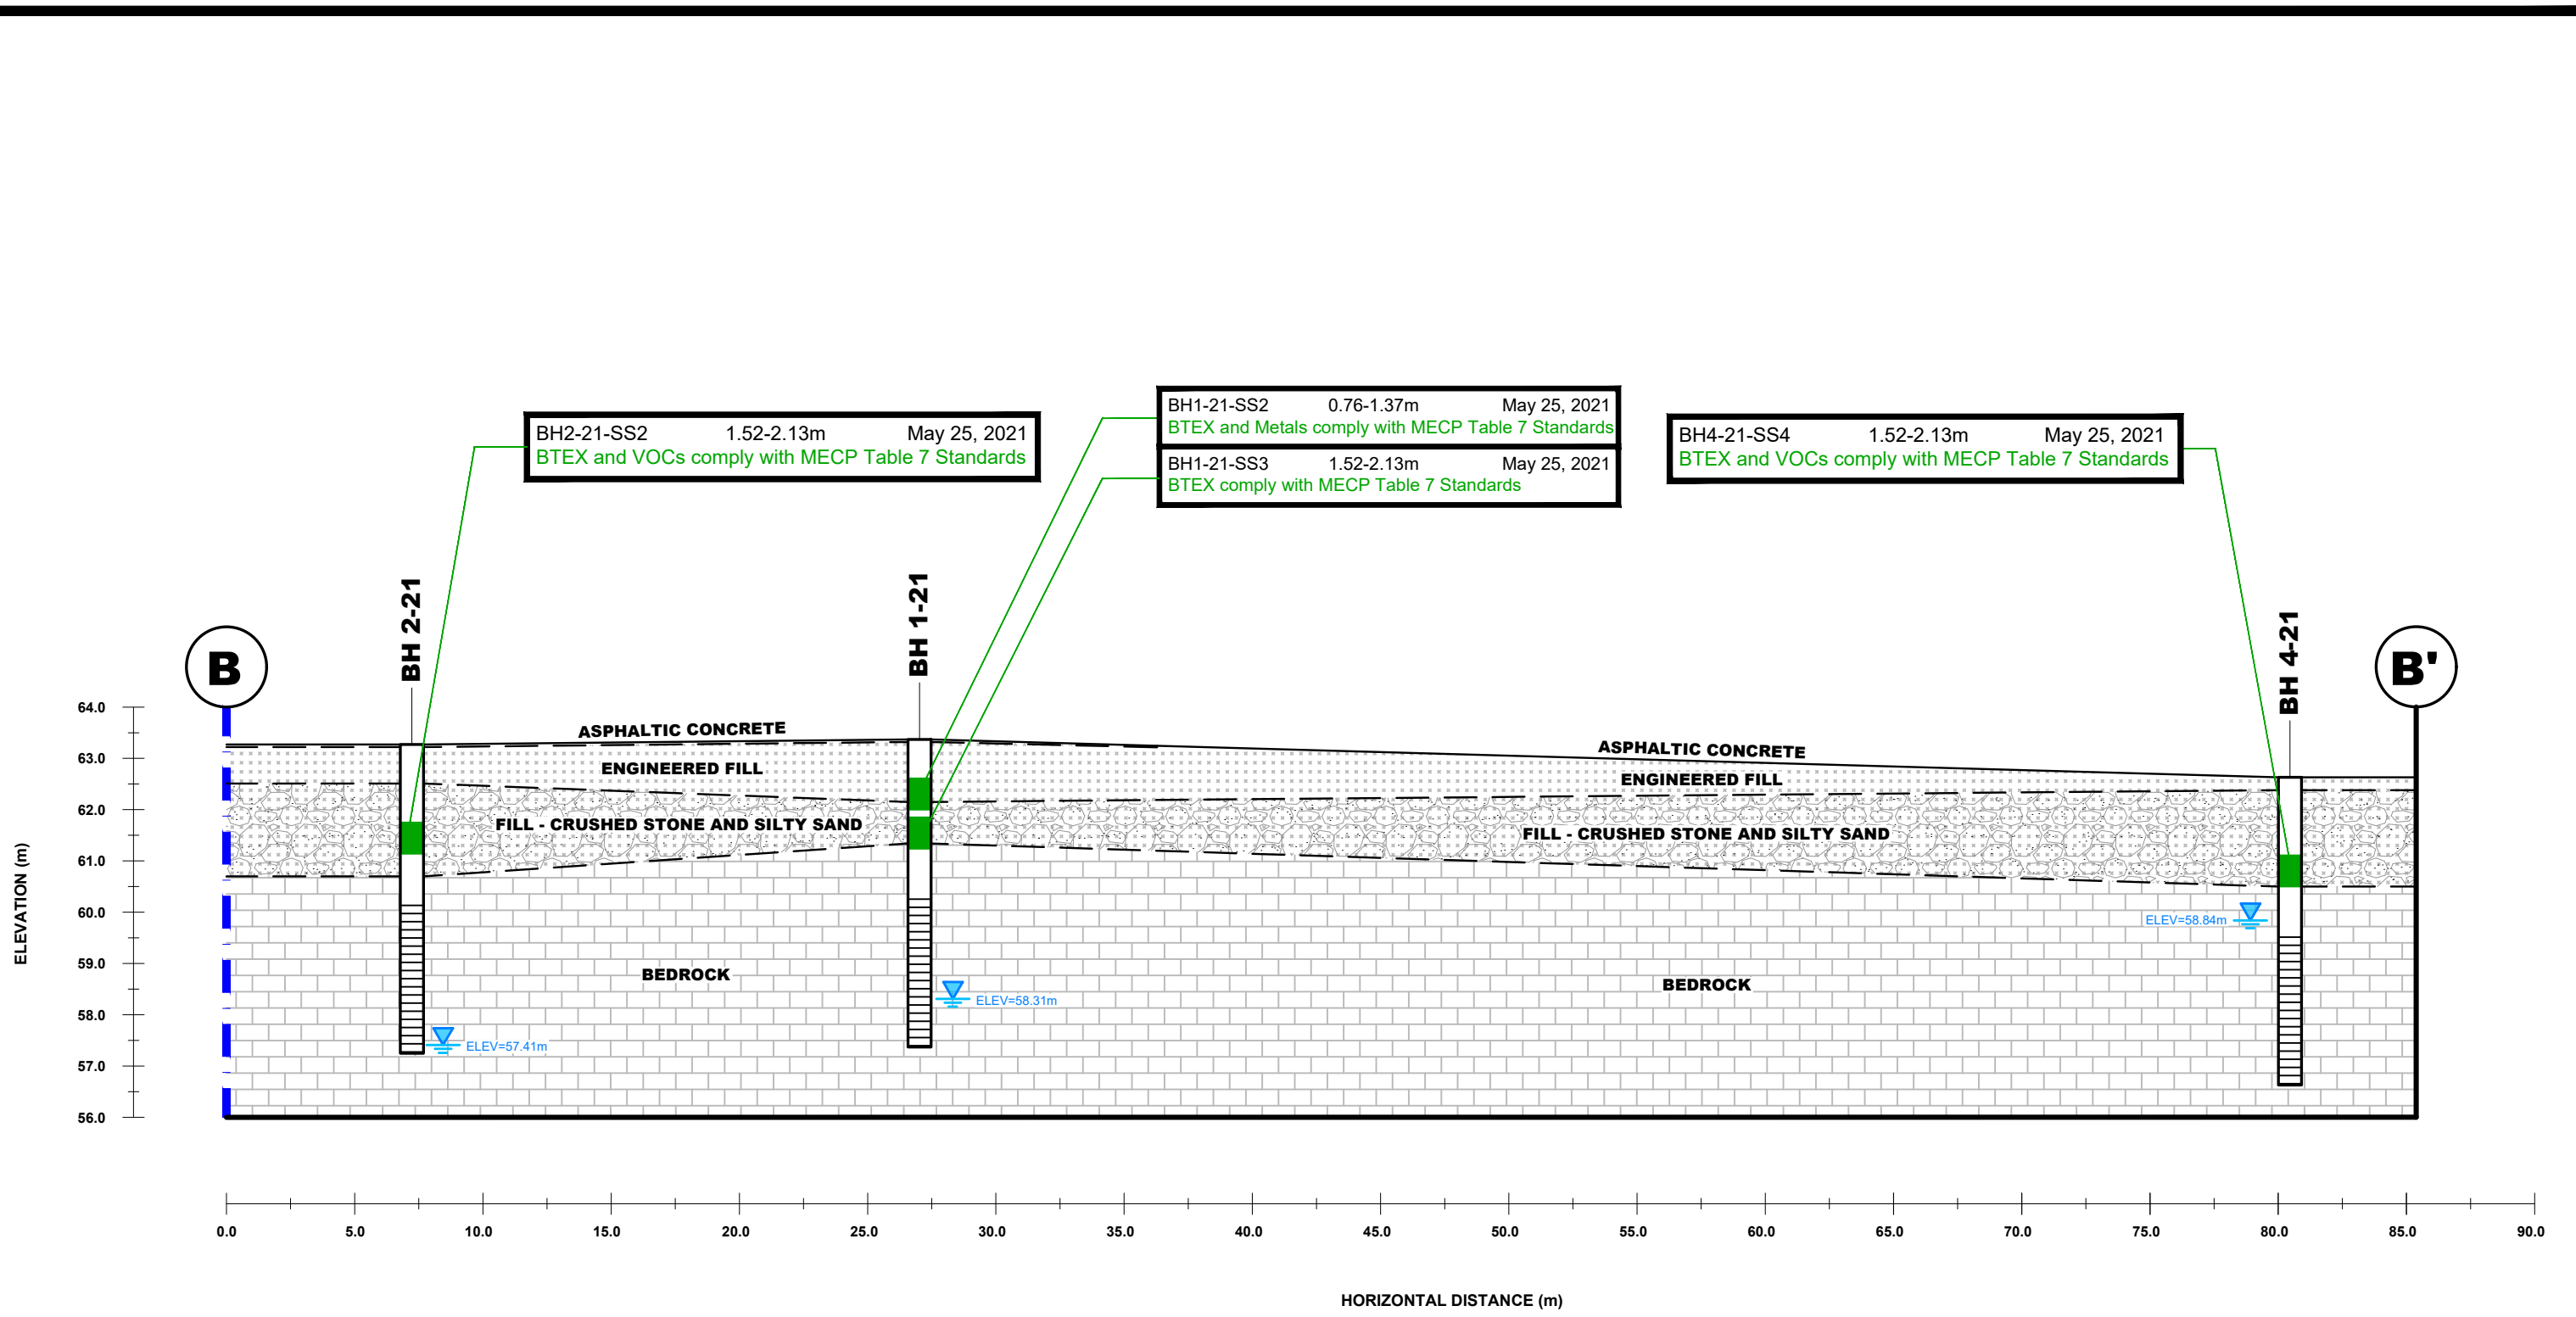
Drawing PE5303-5B – Cross Section B-B' – Soil (BTEX, VOCs, Metals)

MORLEY HOPPNER GROUP
PHASE II - ENVIRONMENTAL SITE ASSESSMENT
 2006, 2020 & 2026 SCOTT STREET
 314 & 318 ATHLONE AVENUE
 OTTAWA, ONTARIO
CROSS SECTION B-B' - SOIL (BTEX, VOCs, METALS)

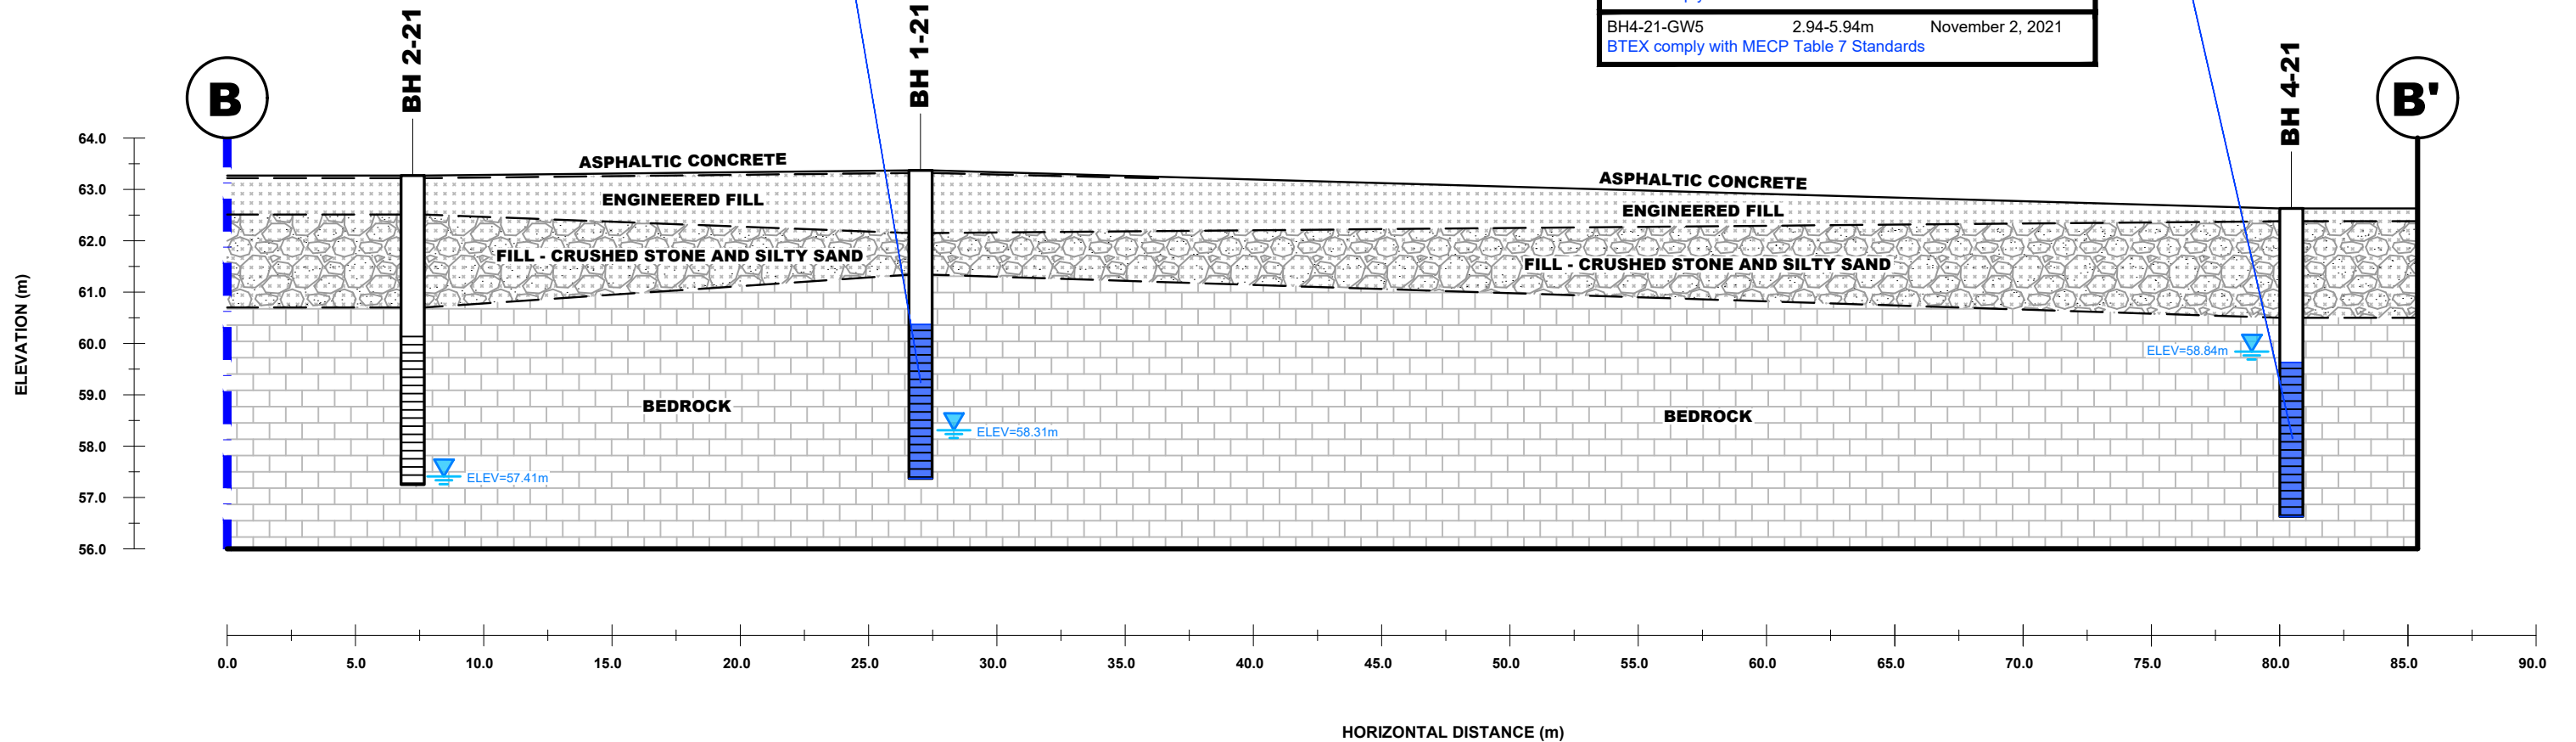
Drawing PE5303-6B – Cross Section B-B' – Groundwater (BTEX & VOCs)

MORLEY HOPNER GROUP
PHASE II - ENVIRONMENTAL SITE ASSESSMENT
2006, 2020 & 2026 SCOTT STREET
314 & 318 ATHLONE AVENUE
OTTAWA, ONTARIO
Title: **CROSS SECTION B-B' - GROUNDWATER (BTEX, VOCs)**

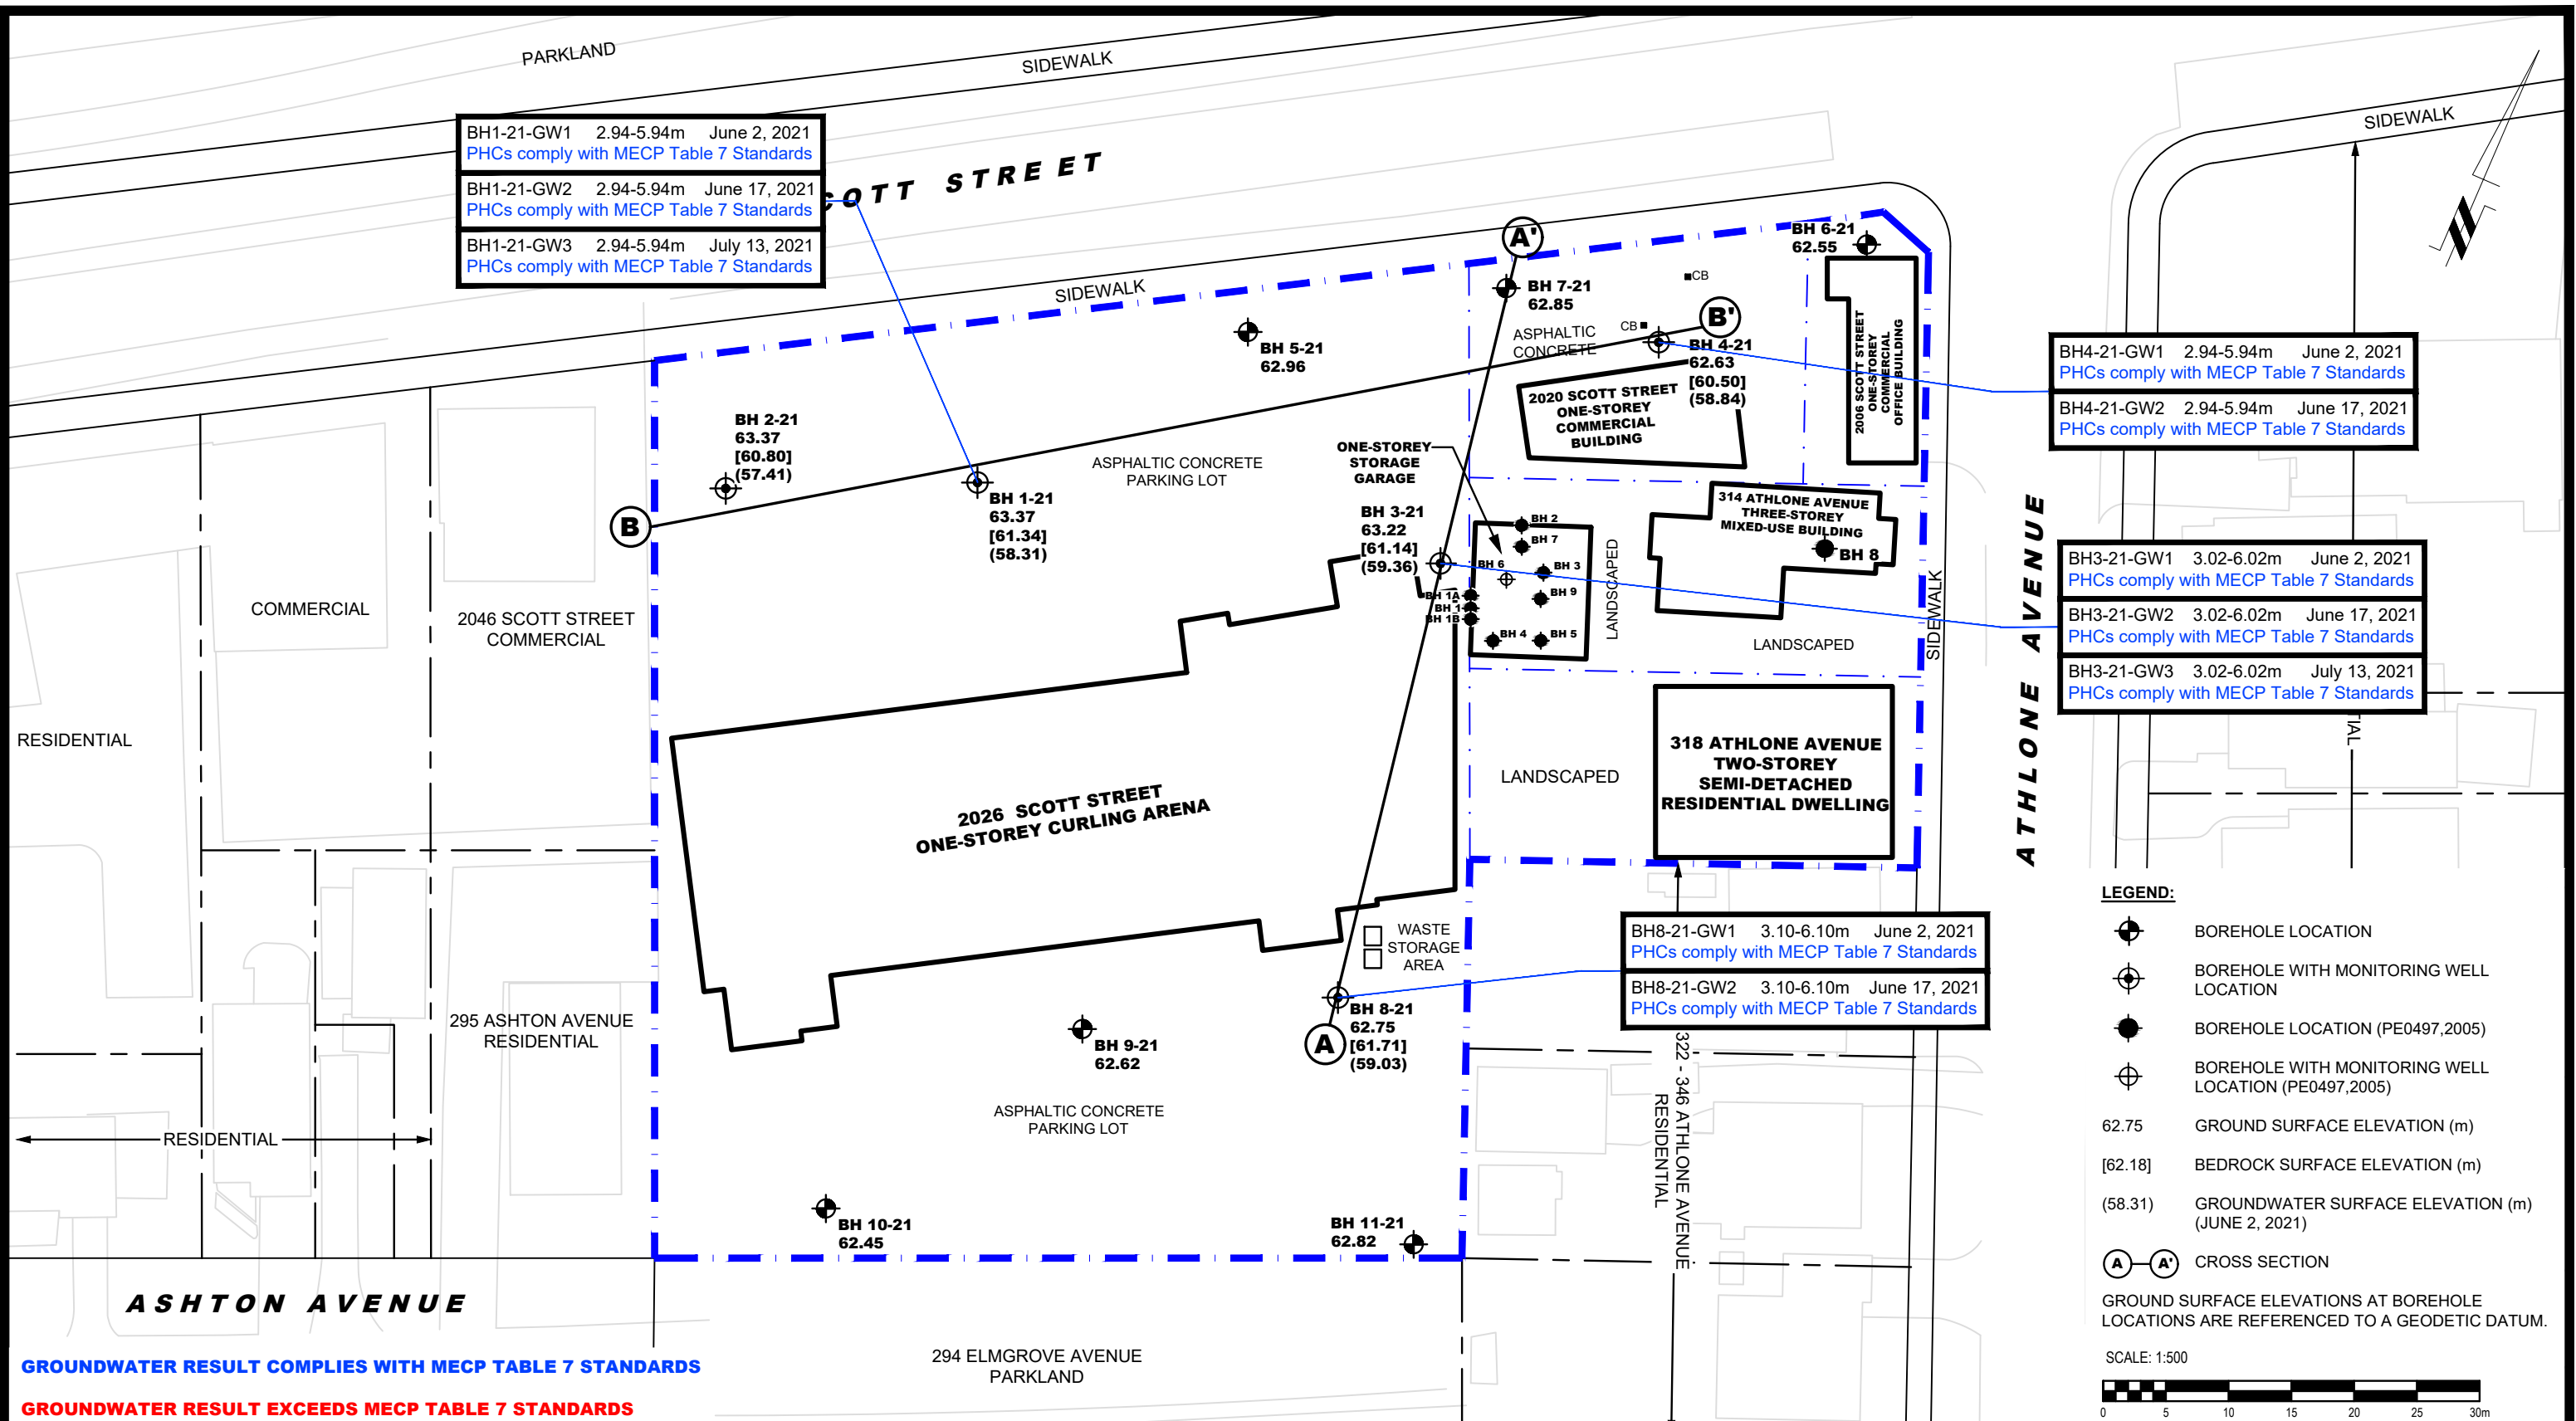
Drawing PE5303-7 – Analytical Testing Plan – Groundwater (PHCs)

BH1-21-GW1 2.94-5.94m June 2, 2021
 PHCs comply with MECP Table 7 Standards

BH1-21-GW2 2.94-5.94m June 17, 2021
 PHCs comply with MECP Table 7 Standards
