## **Phase I-Environmental Site Assessment**

1740, 1746 and 1754 Carling Avenue, 828 Boyd Avenue  
and 1755 Kerr Avenue  
Ottawa, Ontario

**Report: PE4425-1**

**July 16, 2025**

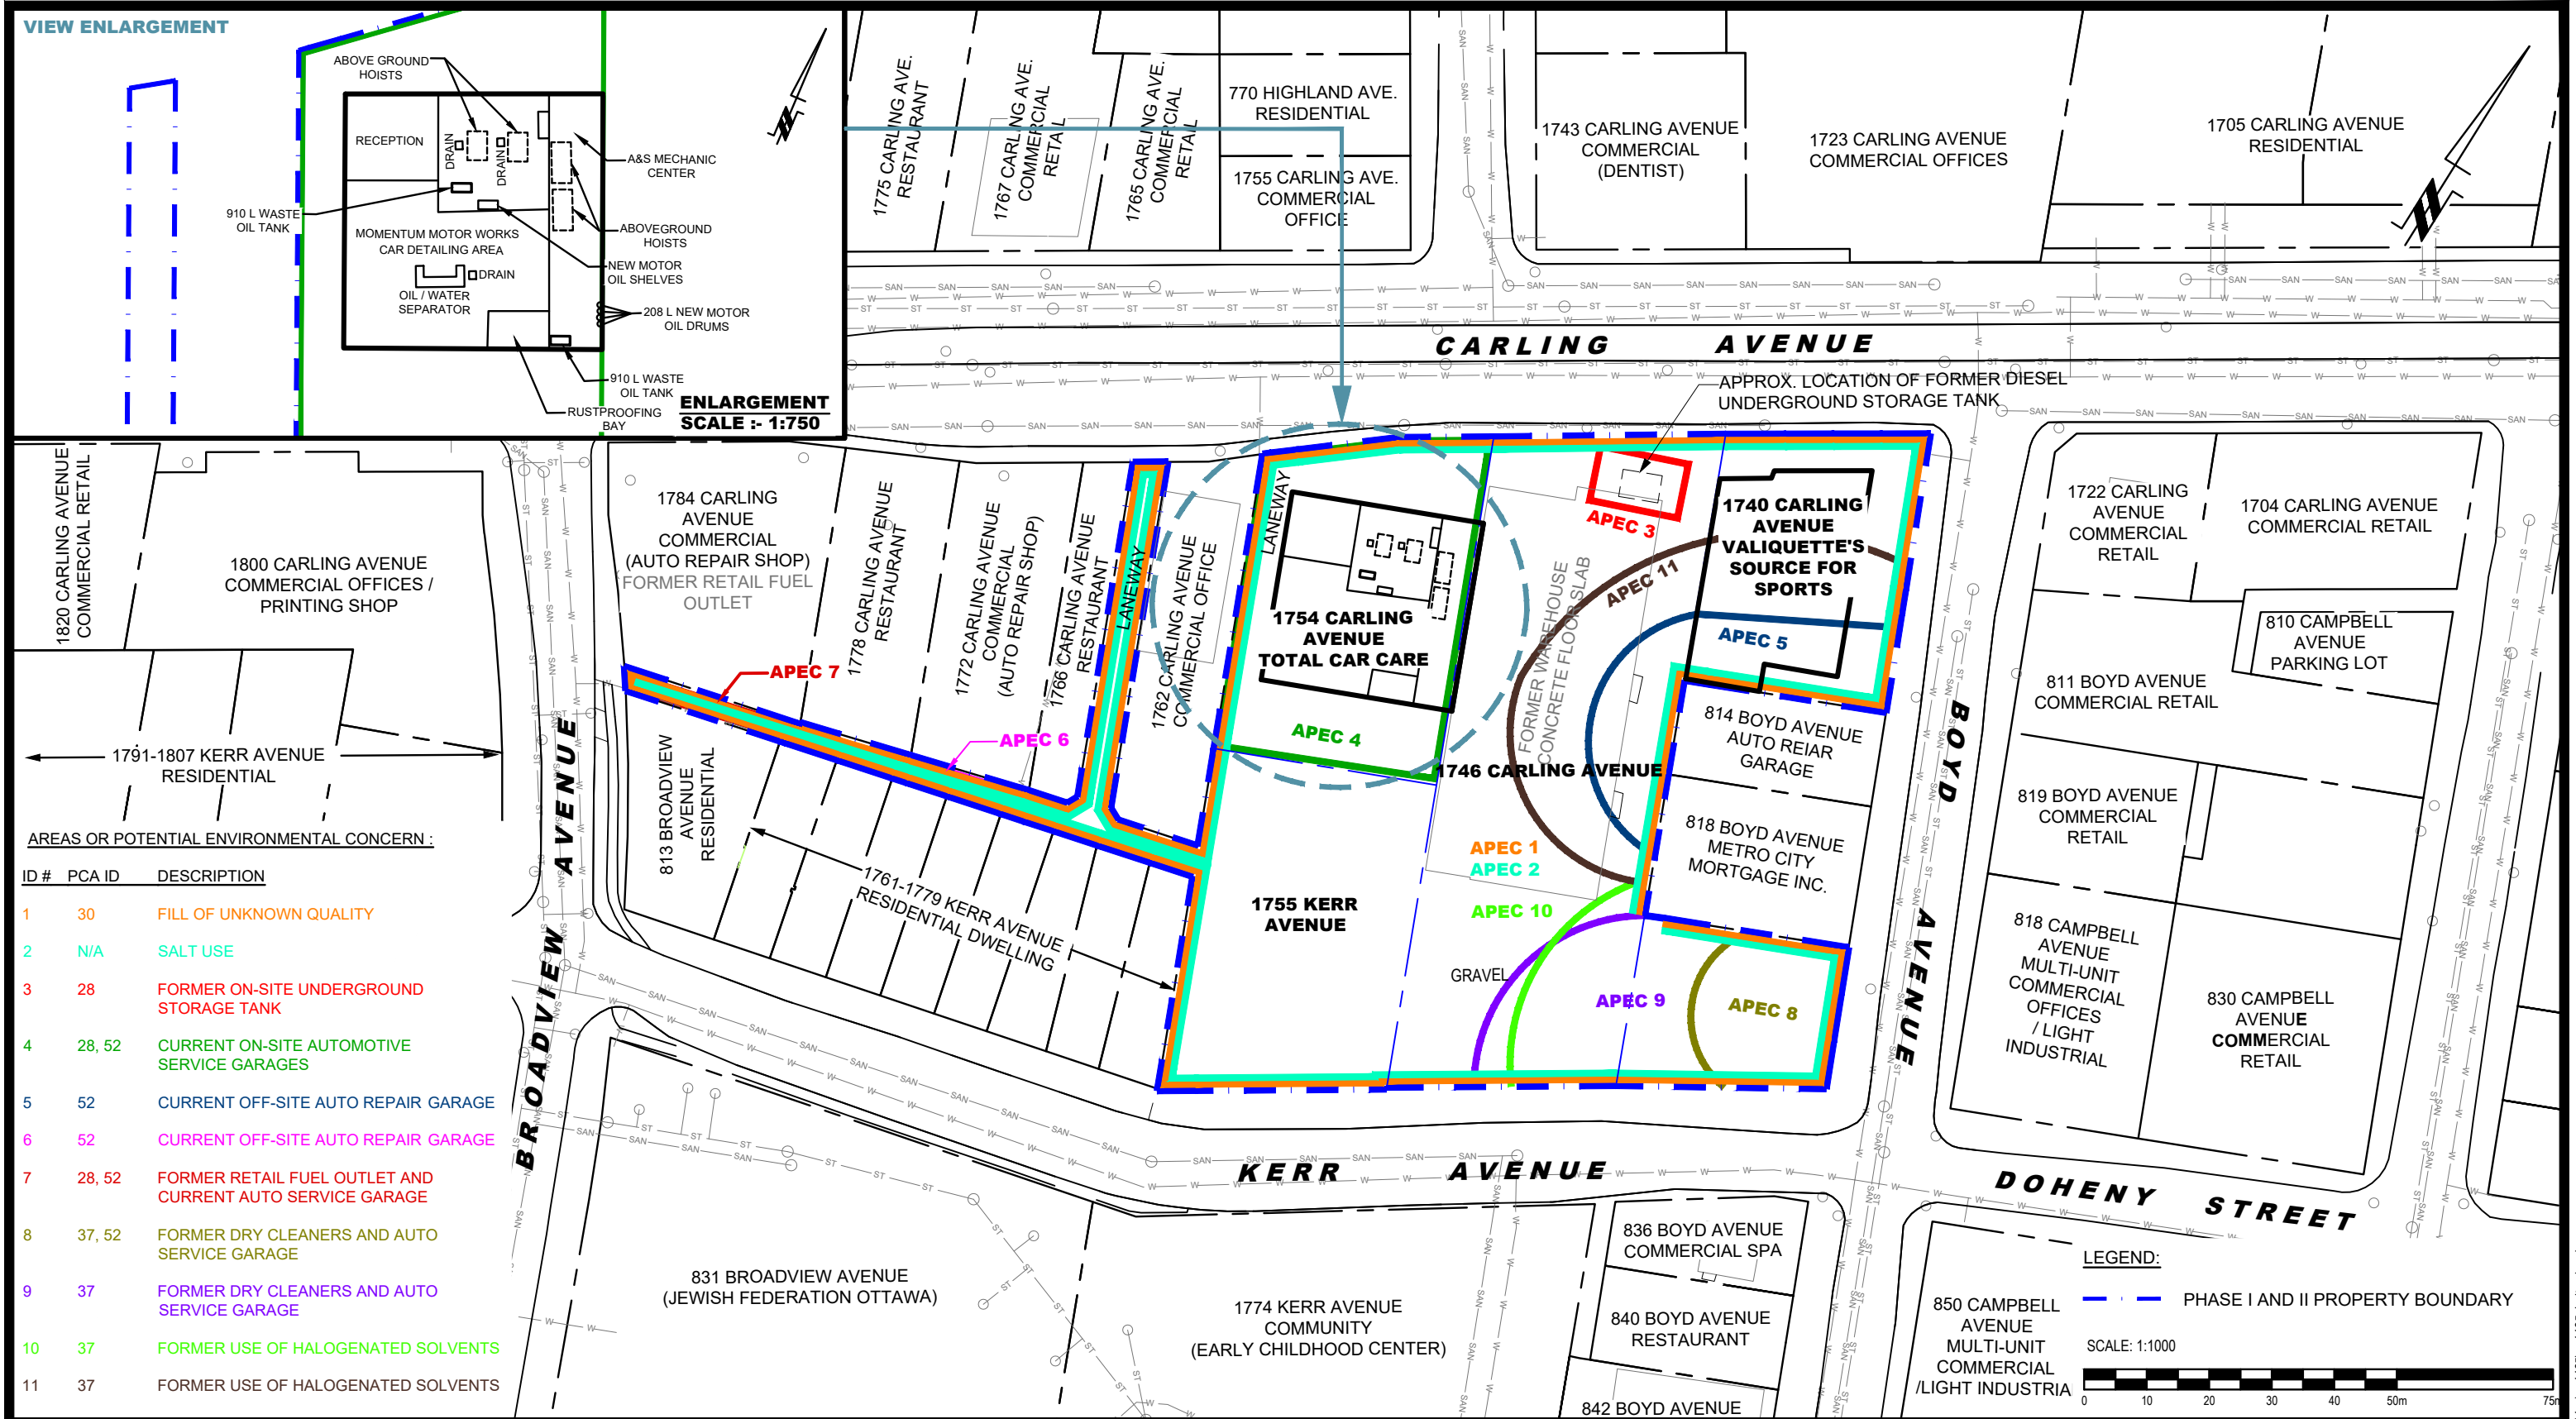
**DRAWING PE4425-1 – SITE PLAN**

No potential sources of PCBs were identified on the exterior of the Phase I Property at the time of the site inspection. No signs of stressed vegetation, surficial staining or evidence of fill material were noted on the Phase I Property. A depiction of the Phase I Property is illustrated on Drawing PE4425-1 – Site Plan, in the Figures section of this report.

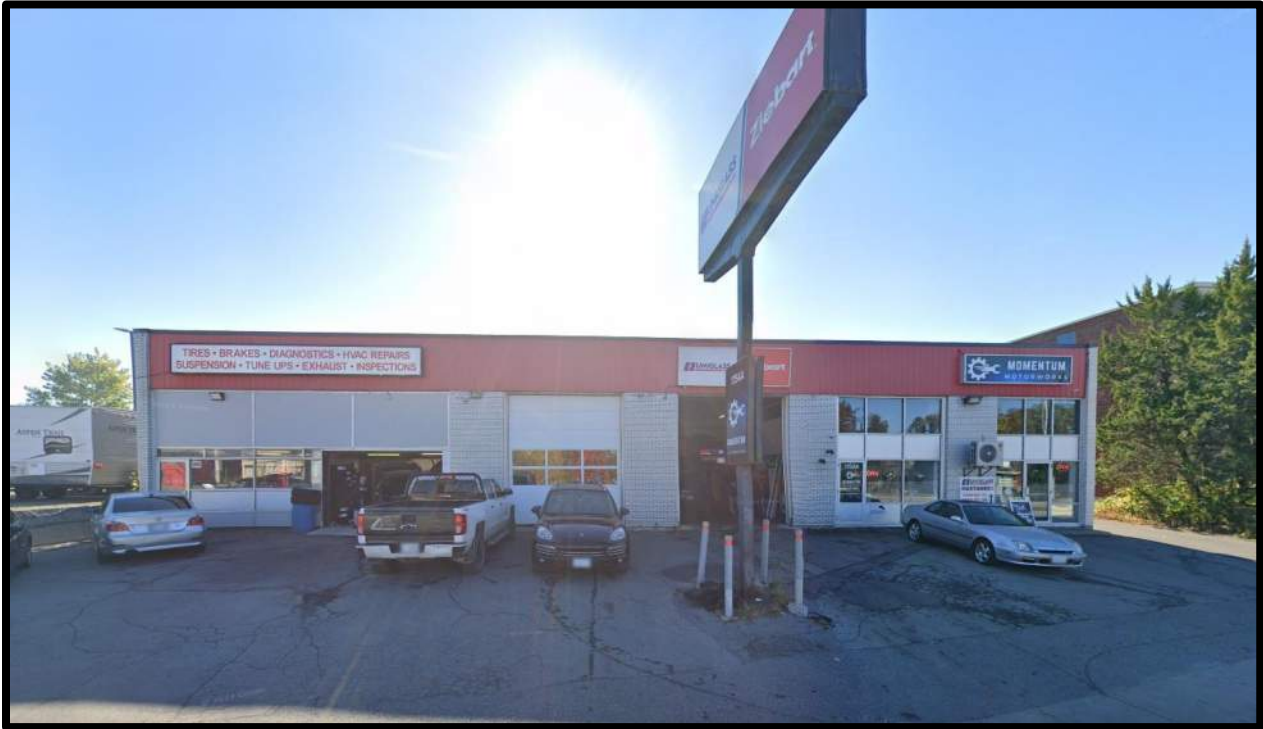
The commercial building addressed 1740 Carling Avenue fronts onto Boyd Avenue and occupies the northeastern portion of the Phase I Property. The remainder of the site is covered with an asphaltic concrete parking lot. A waste bin used to store domestic, non-hazardous waste and recycling is present at the front of the property.

Photograph 1: View of the front side of 1740 Carling Avenue, facing south.

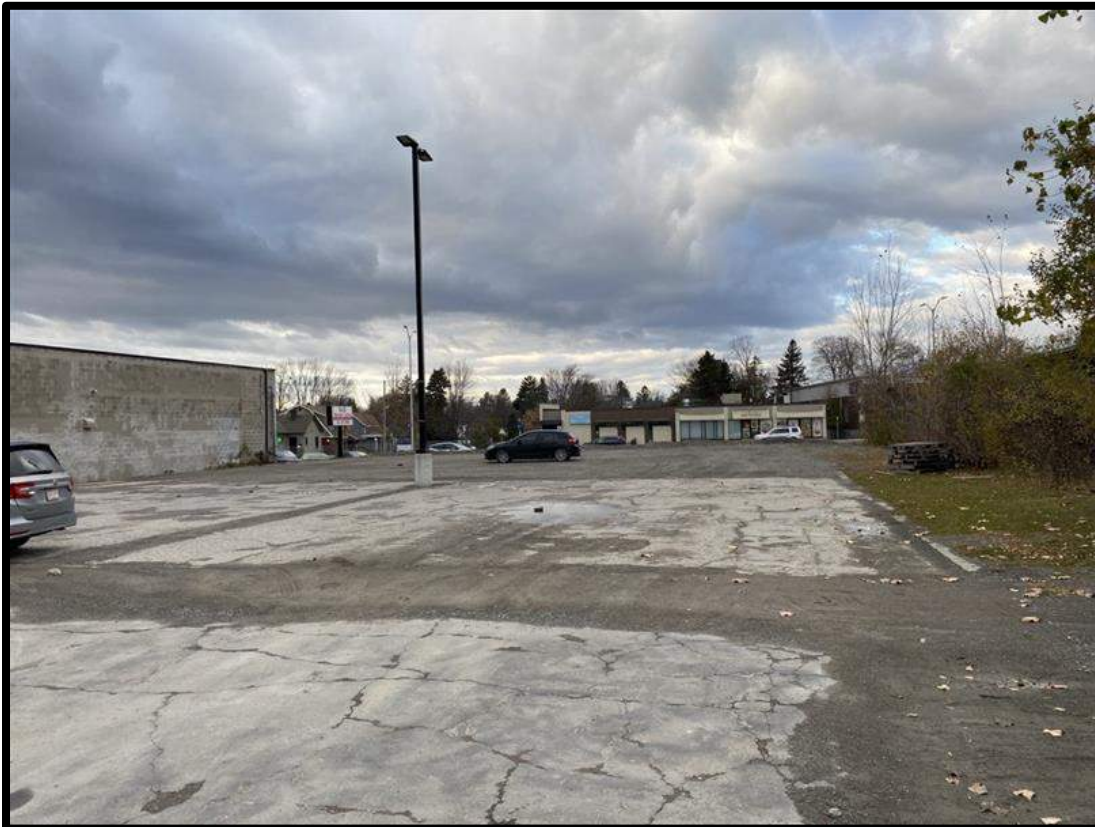
Photograph 2: View of 1746 Carling Avenue, facing north.

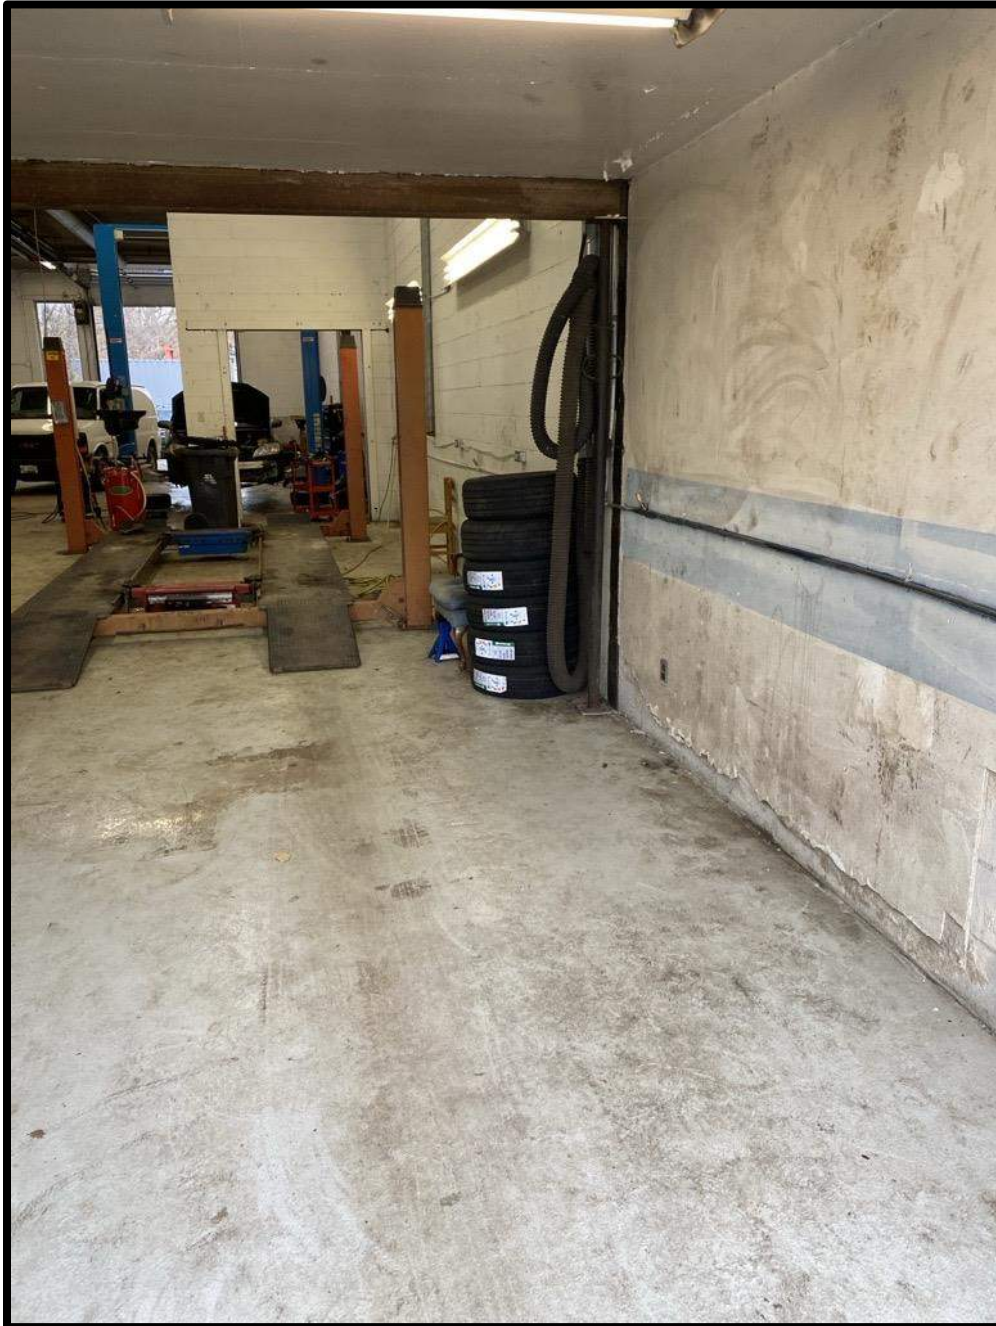
The building addressed 1754 Carling Avenue is occupied by two auto service garages and one auto detailing and glass replacement shop. A general description of the interior building finishes are as follows:

Heating is provided by a natural gas-fired suspended furnace. The auto service garage that's occupying the western portion of the property has two aboveground electrical hoists. Two floor drains leading to an oil-water separator were observed in the garage. The drains were observed to contain cloudy water at the time of the site visit.

One 910L aboveground waste oil storage tank was observed inside this unit. Three (3) 208L drums containing new motor oil were observed inside the garage, in addition to multiple containers (less than 10L) of motor oil, windshield waster fluid, brake fluid and transmission fluid in sealed containers were properly stored on shelves. No areas of staining were observed on the concrete floor throughout the garage. The concrete floor was in good condition at the time of the site assessment.

The auto service garage that's occupying the central-south portion of the property has two aboveground electrical hoists. One floor drain leading to an oil-water separator was observed in the garage. The drain was observed to be dry at the time of the site visit.

One 910L aboveground waste oil storage tank was observed inside this unit. Multiple containers (less than 10L) of motor oil, windshield fluid, brake fluid and transmission fluid in sealed containers properly stored on shelves. Small areas of staining were observed on the concrete floor throughout this unit. The concrete floor was in good condition at the time of the site assessment.

Photograph 3: View of inside the unit at 1754 Carling Avenue, facing south.

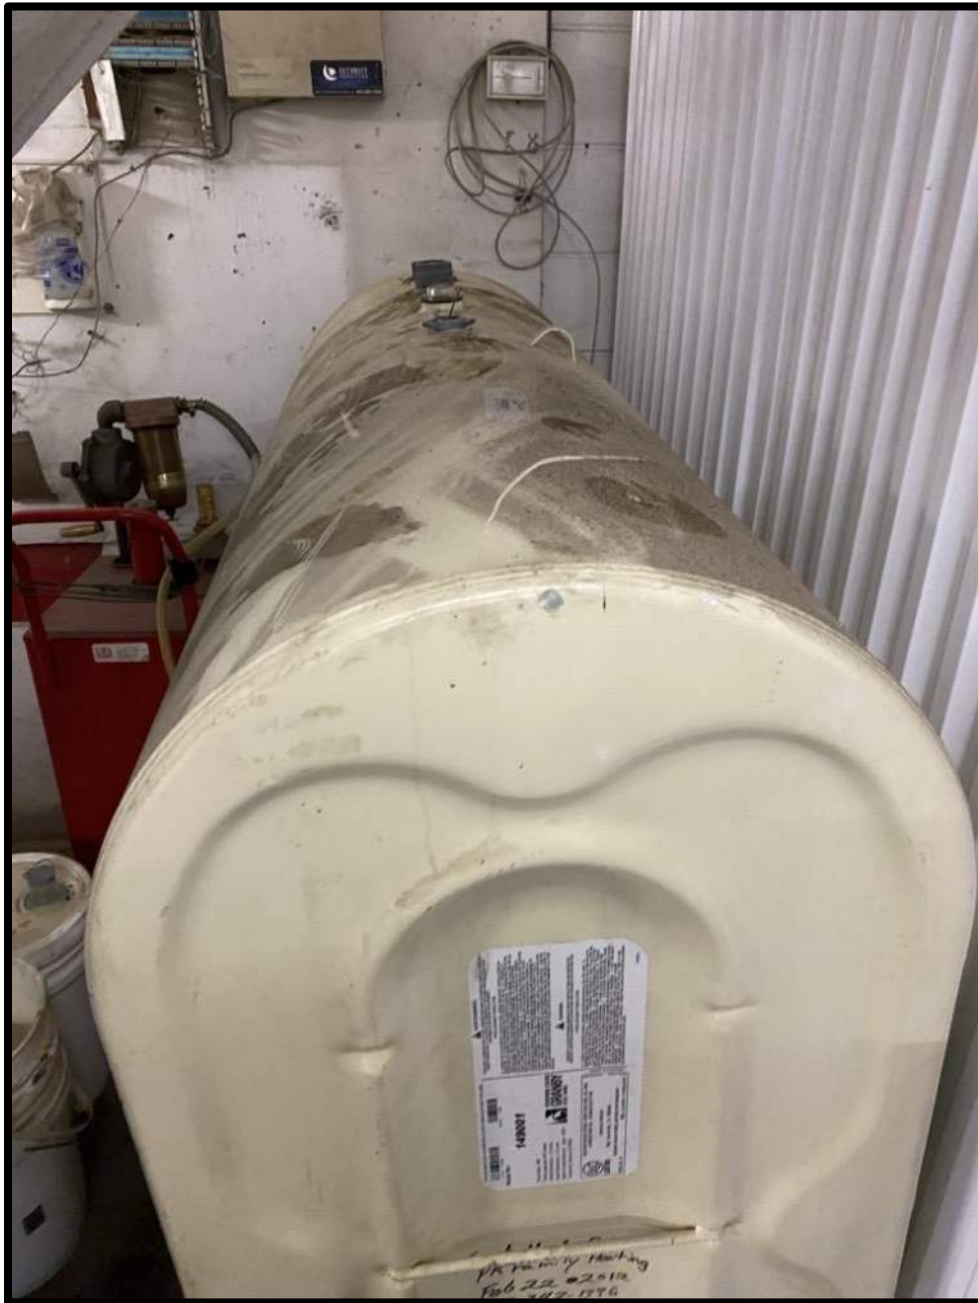
The subject buildings are heated with natural gas-fired equipment. Two 910L aboveground waste oil storage tanks were observed inside 1754 Carling Avenue at the time of the site visit. No obvious signs of staining were observed around the waste oil storage area.

Photograph 4: View of one of the 910L waste oil tanks inside 1754 Carling Avenue.
