Geotechnical Investigation

Proposed Lot Severance
2940 Mer Bleue Road
Navan, Ontario
Revision 1

LRL File No.: 230311

August 2023; *Revised: October 2024*

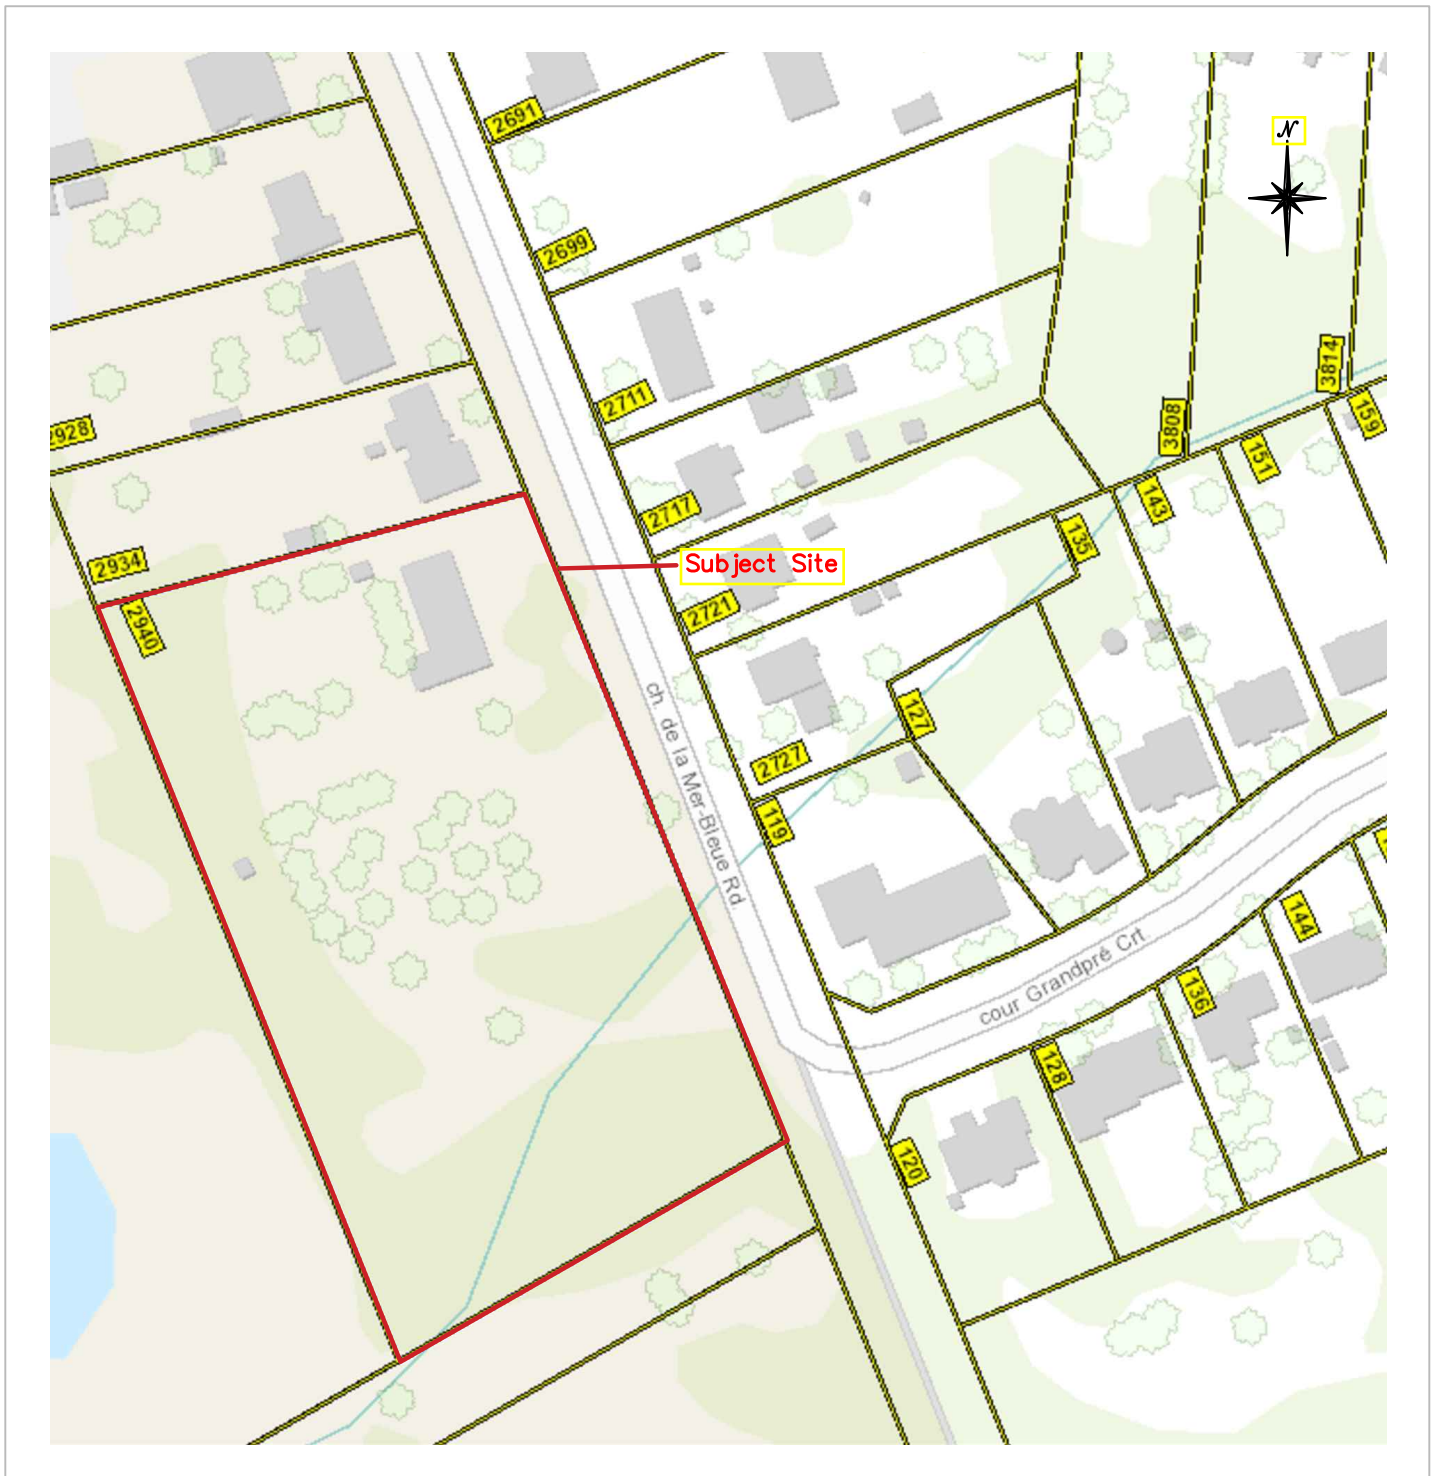
FIGURE 1

The property is situated at 2940 Mer Bleue Road, Navan, Ontario. It is legally described as Part of Lot 1 Concession 4 within the City of Ottawa. It is located directly west of Mer Bleue Road and 250 m south of Navan Road. The location of the site is shown in **Figure 1**. The site's dimensions are 150.6 m in width by 95.4 m in depth. The site's total surface area is approximately 15,500 m² (1.55 ha). The property is presently developed with an existing single-family residence along with additional outbuildings on the north side of the site. The topography is slightly inclined in the north direction, but can generally be considered relatively flat; with the exception of the slopes located near the property lines at the south and southwest portions of the site.
