## **Phase II – Environmental Site Assessment**

1200 Baseline Road  
Ottawa, Ontario

Prepared for Zena Investment Corporation

**Report: PE6468-2**

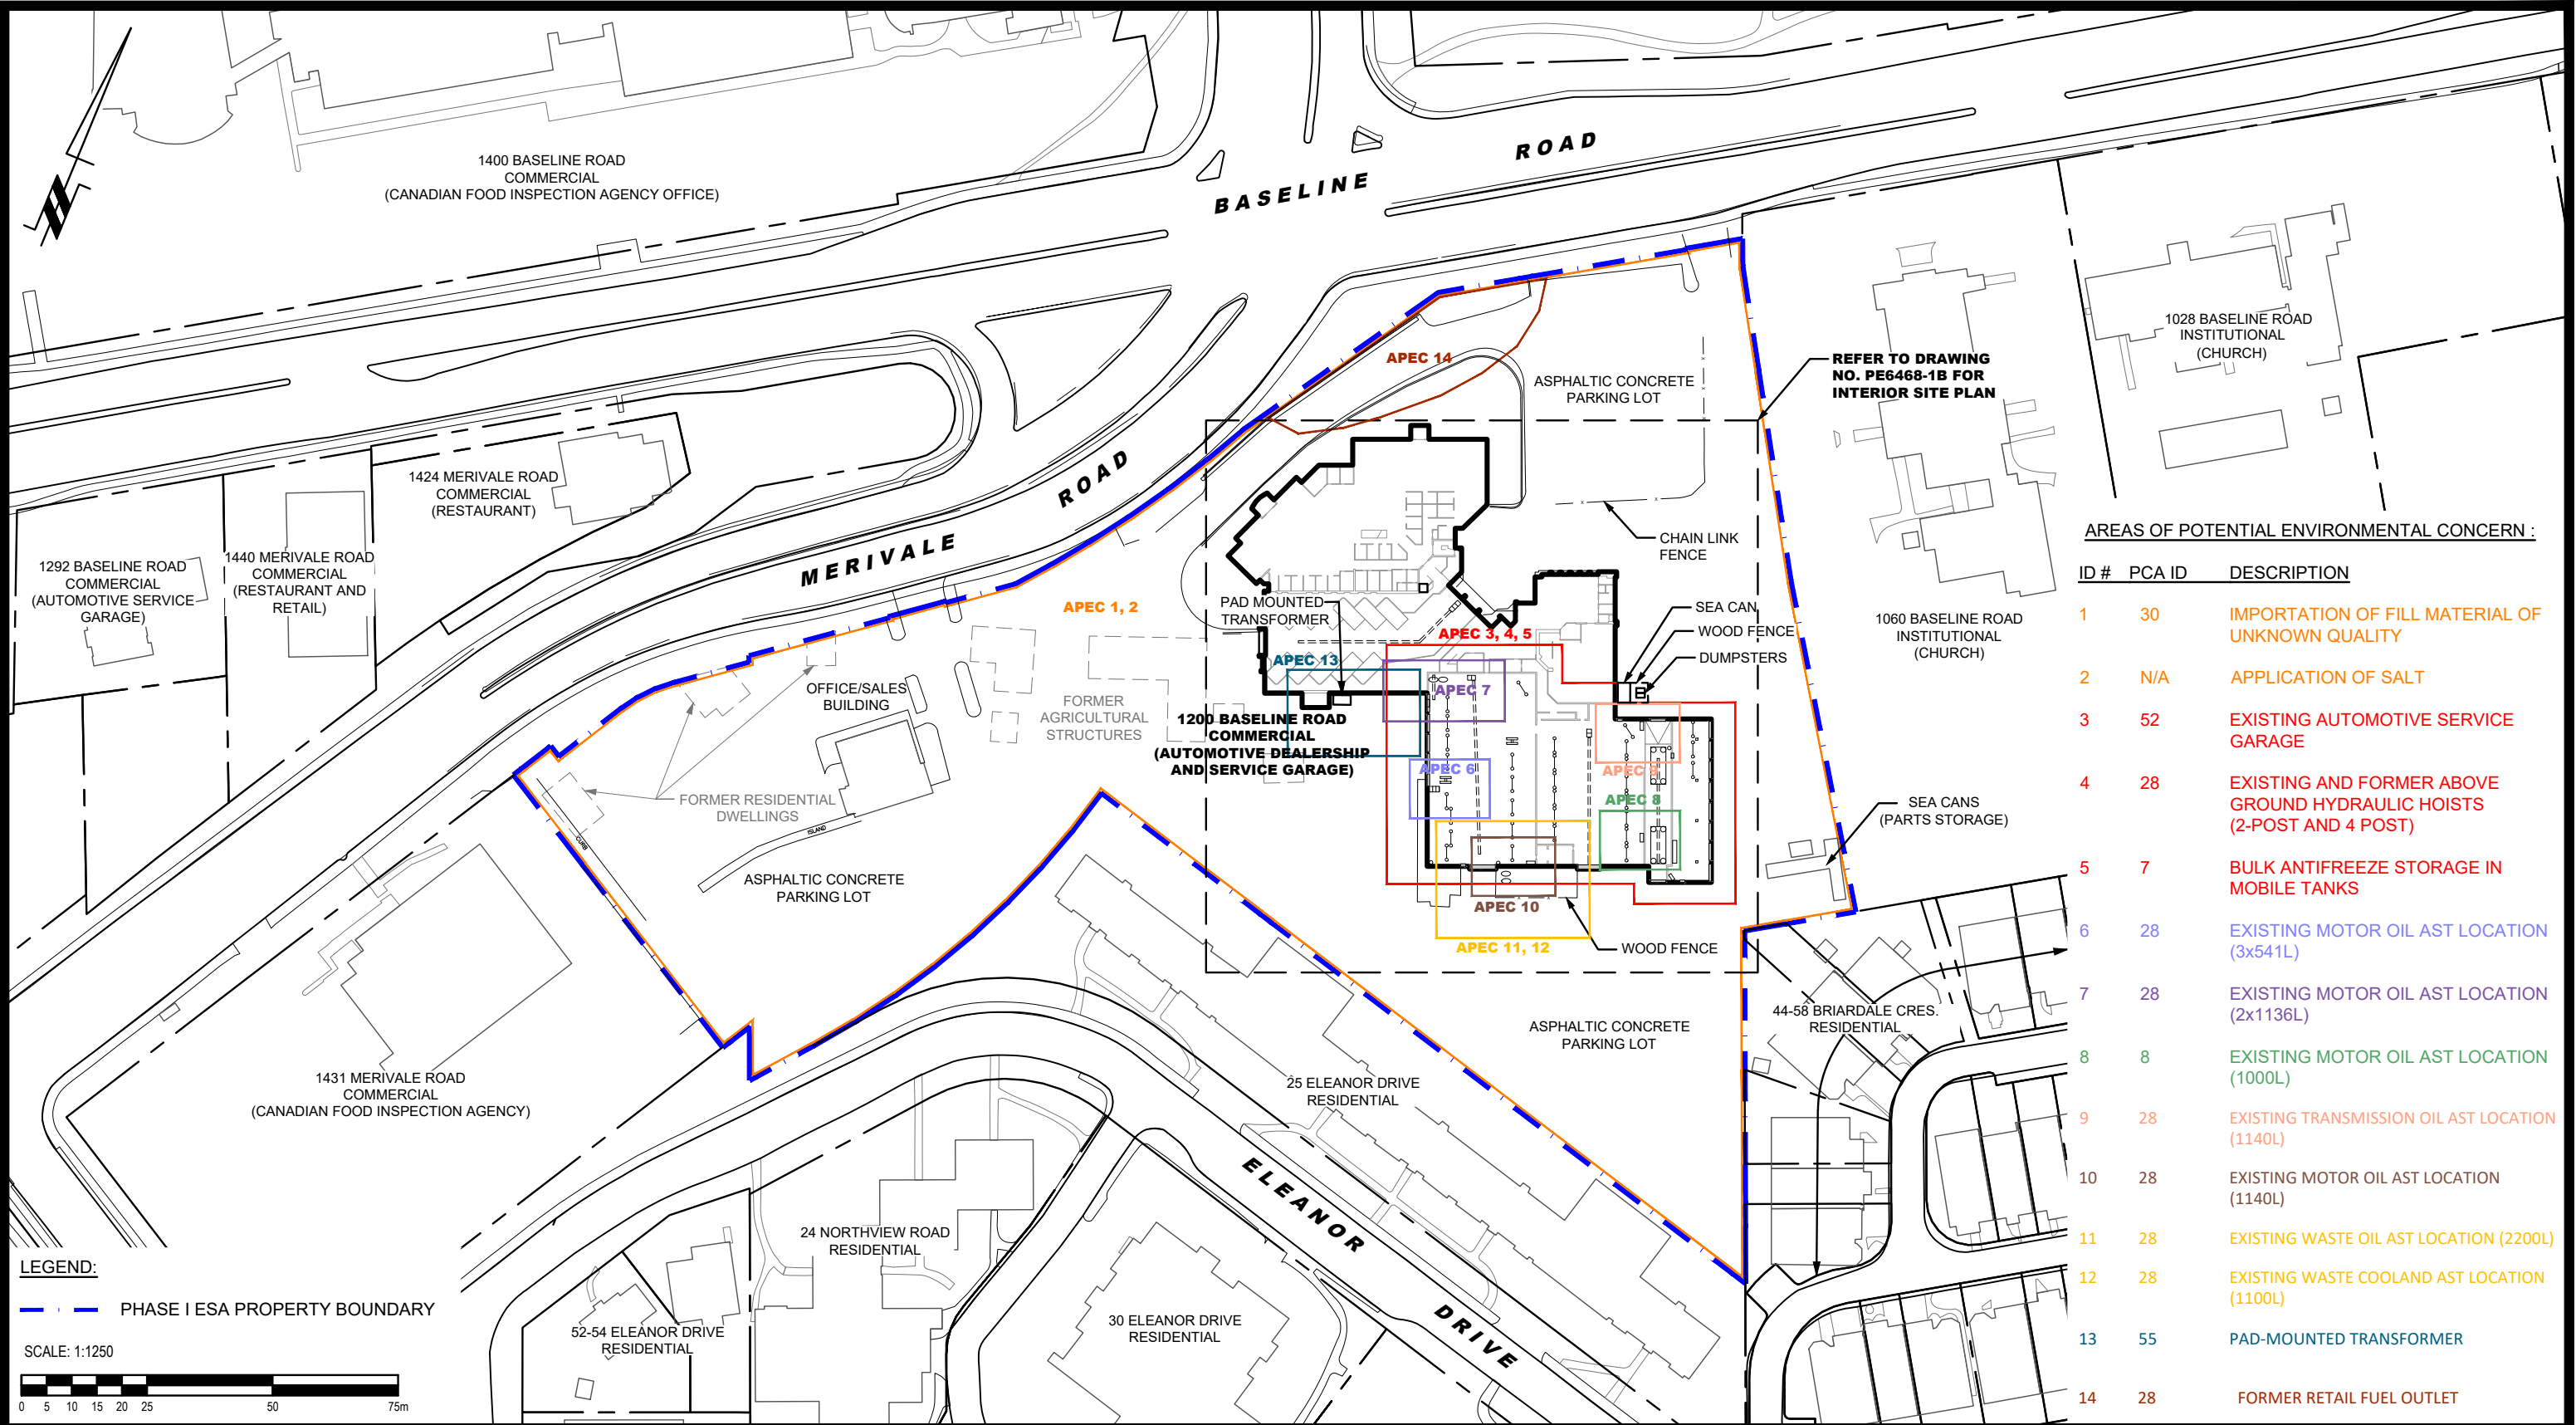
Dwg. No.: PE6468-1

AREAS OF POTENTIAL ENVIRONMENTAL CONCERN :

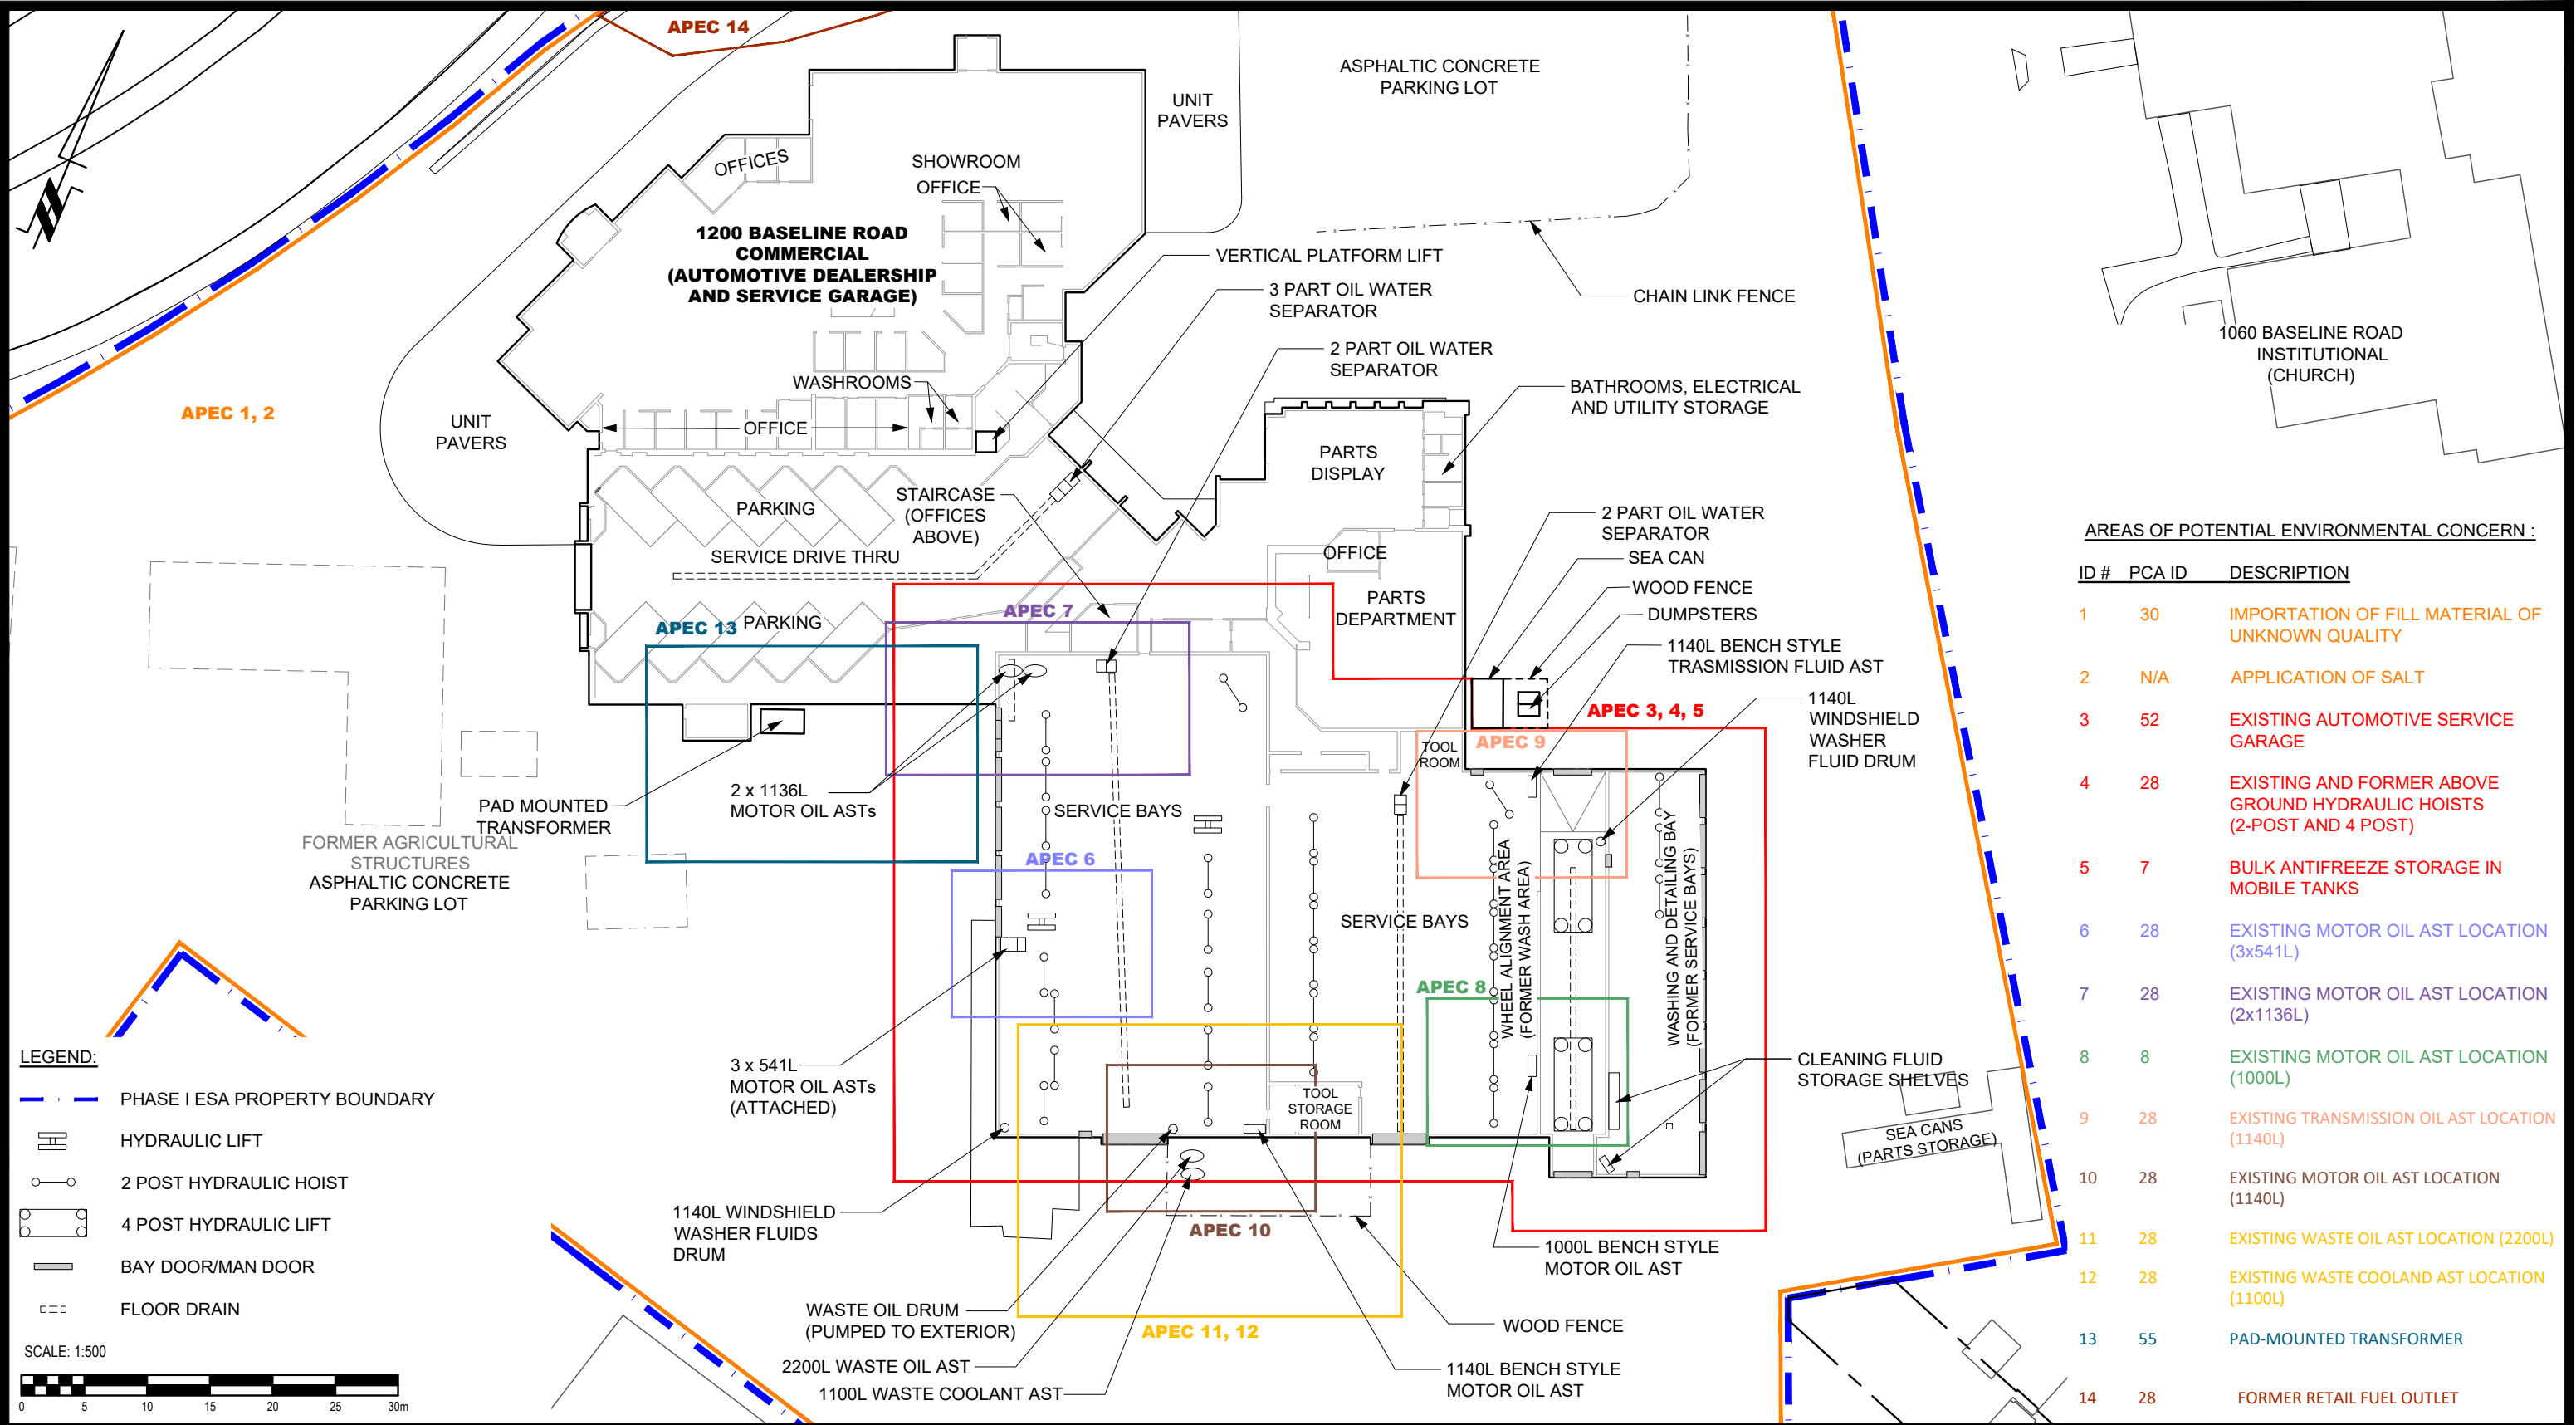
| Checked by: | JA | Dwg. No.: | <b>PE6468-1B</b> |

AREAS OF POTENTIAL ENVIRONMENTAL CONCERN :

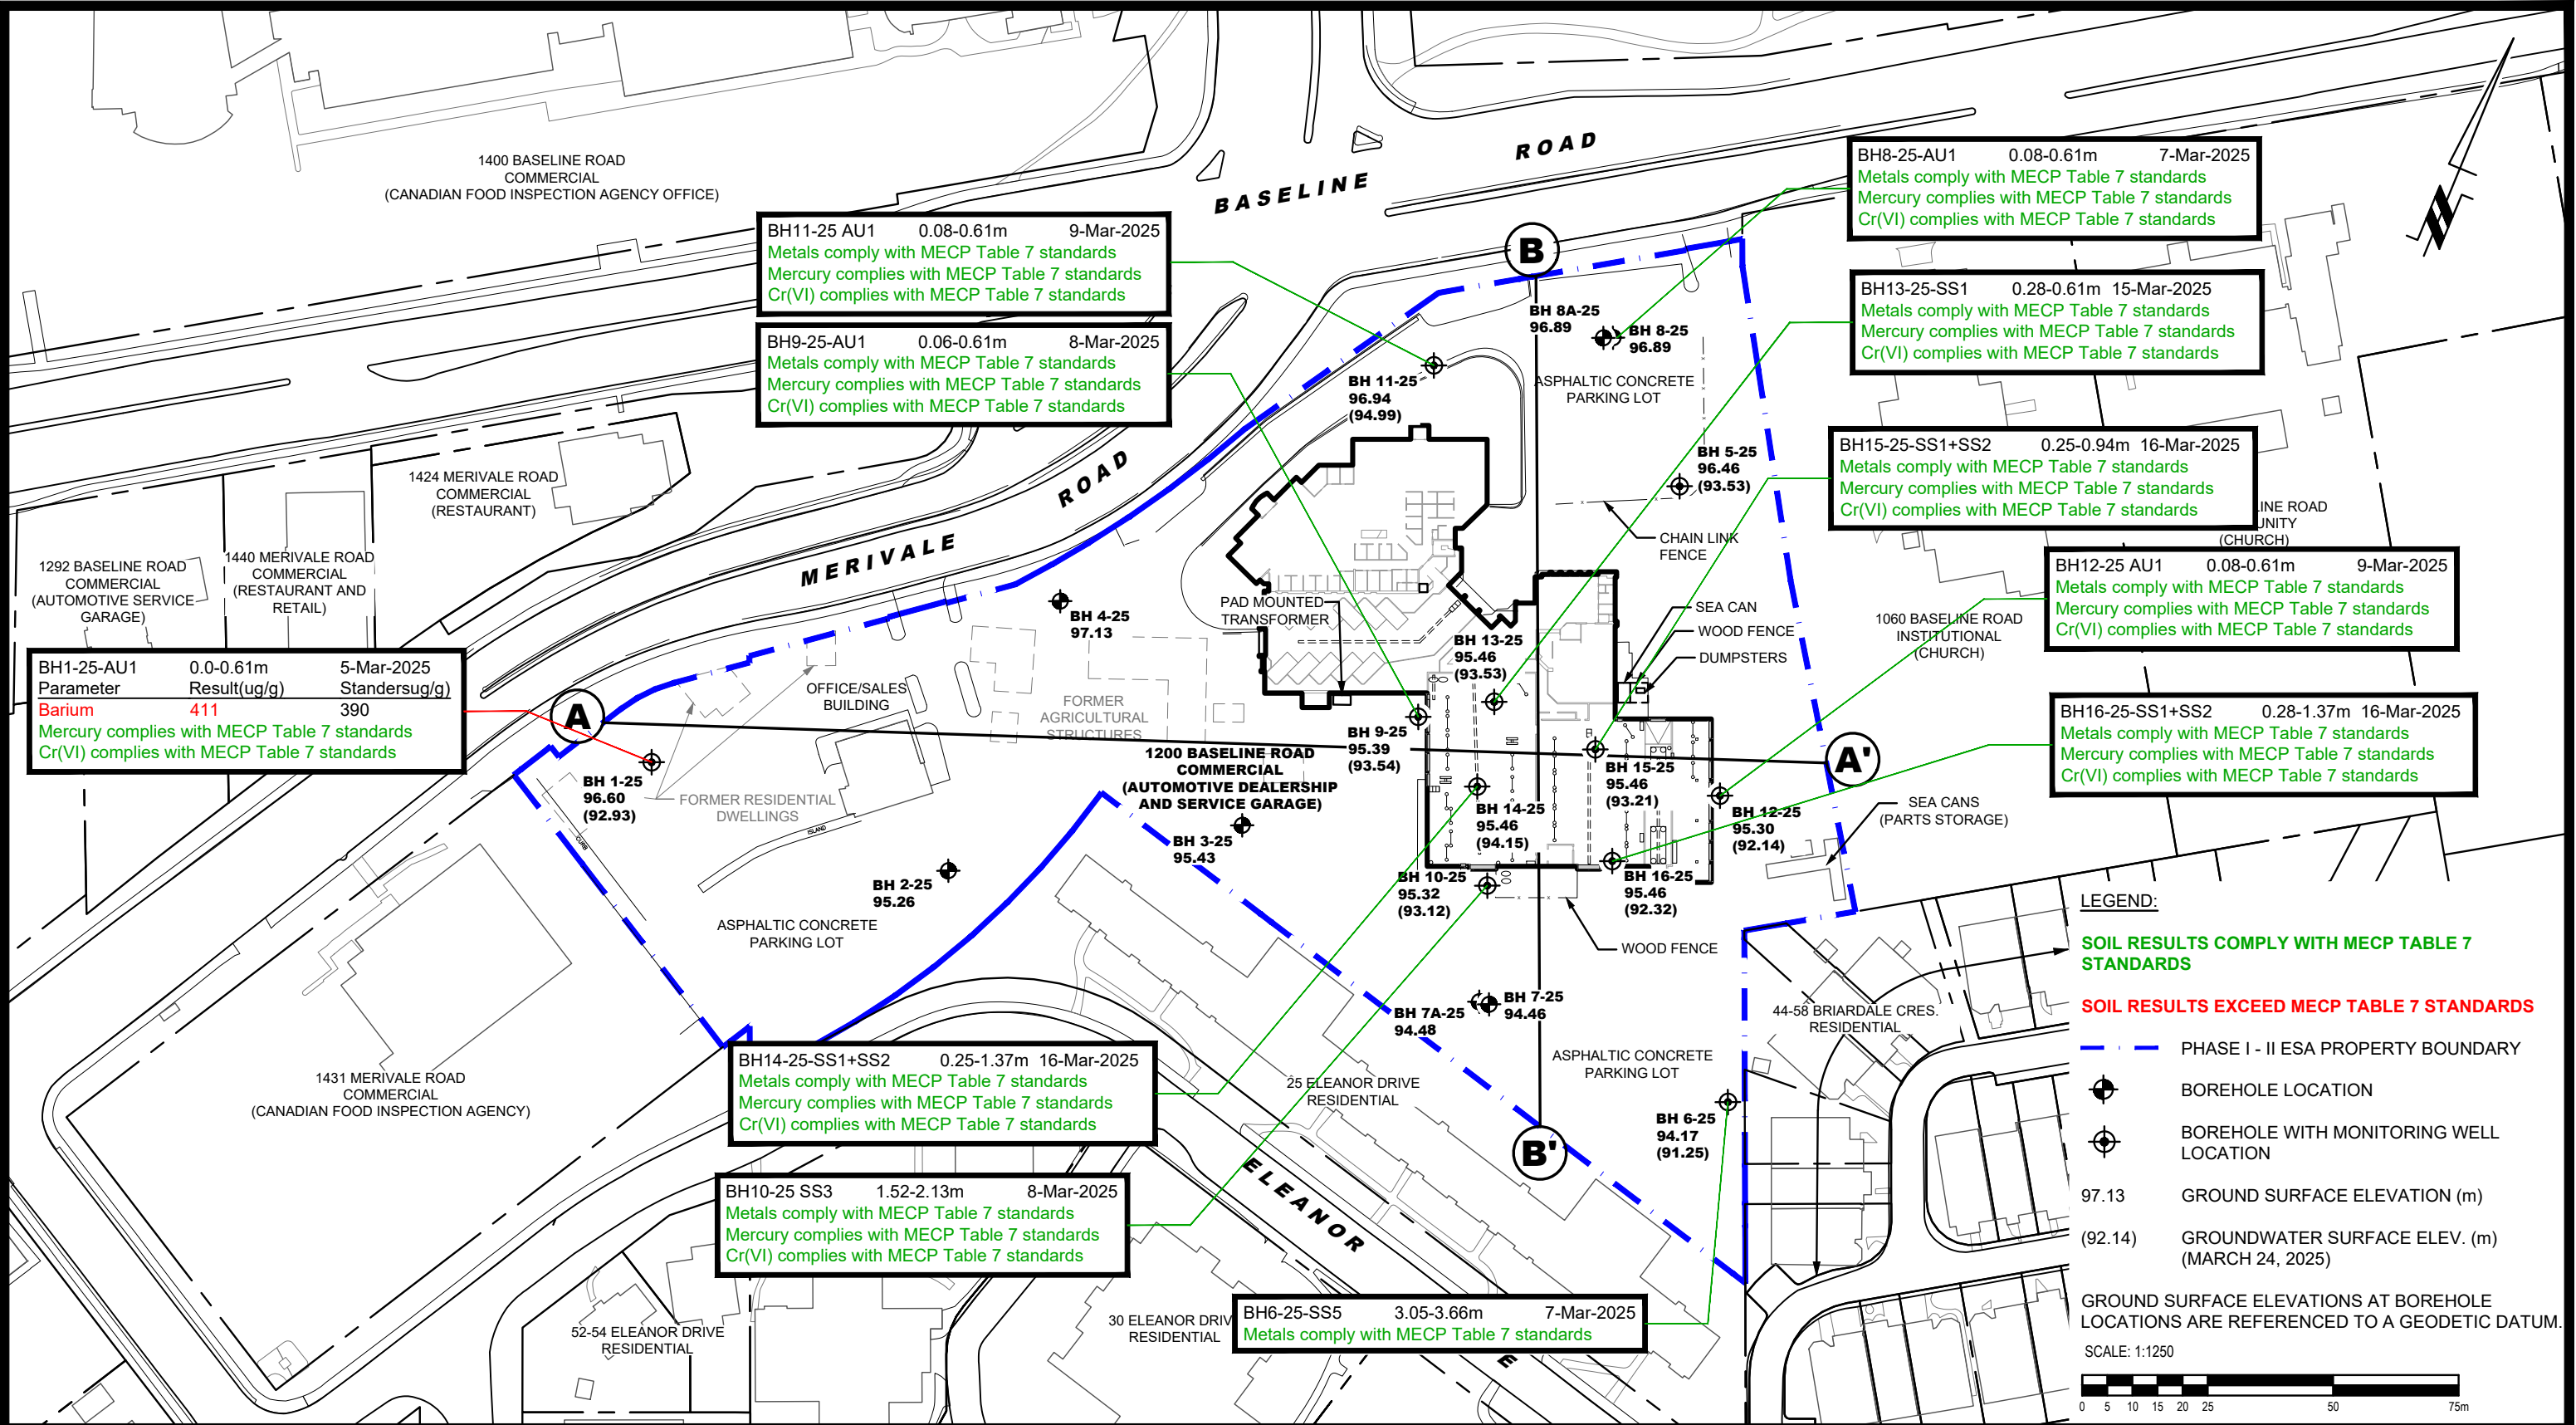
**SOIL RESULTS COMPLY WITH MECP TABLE 7 STANDARDS**

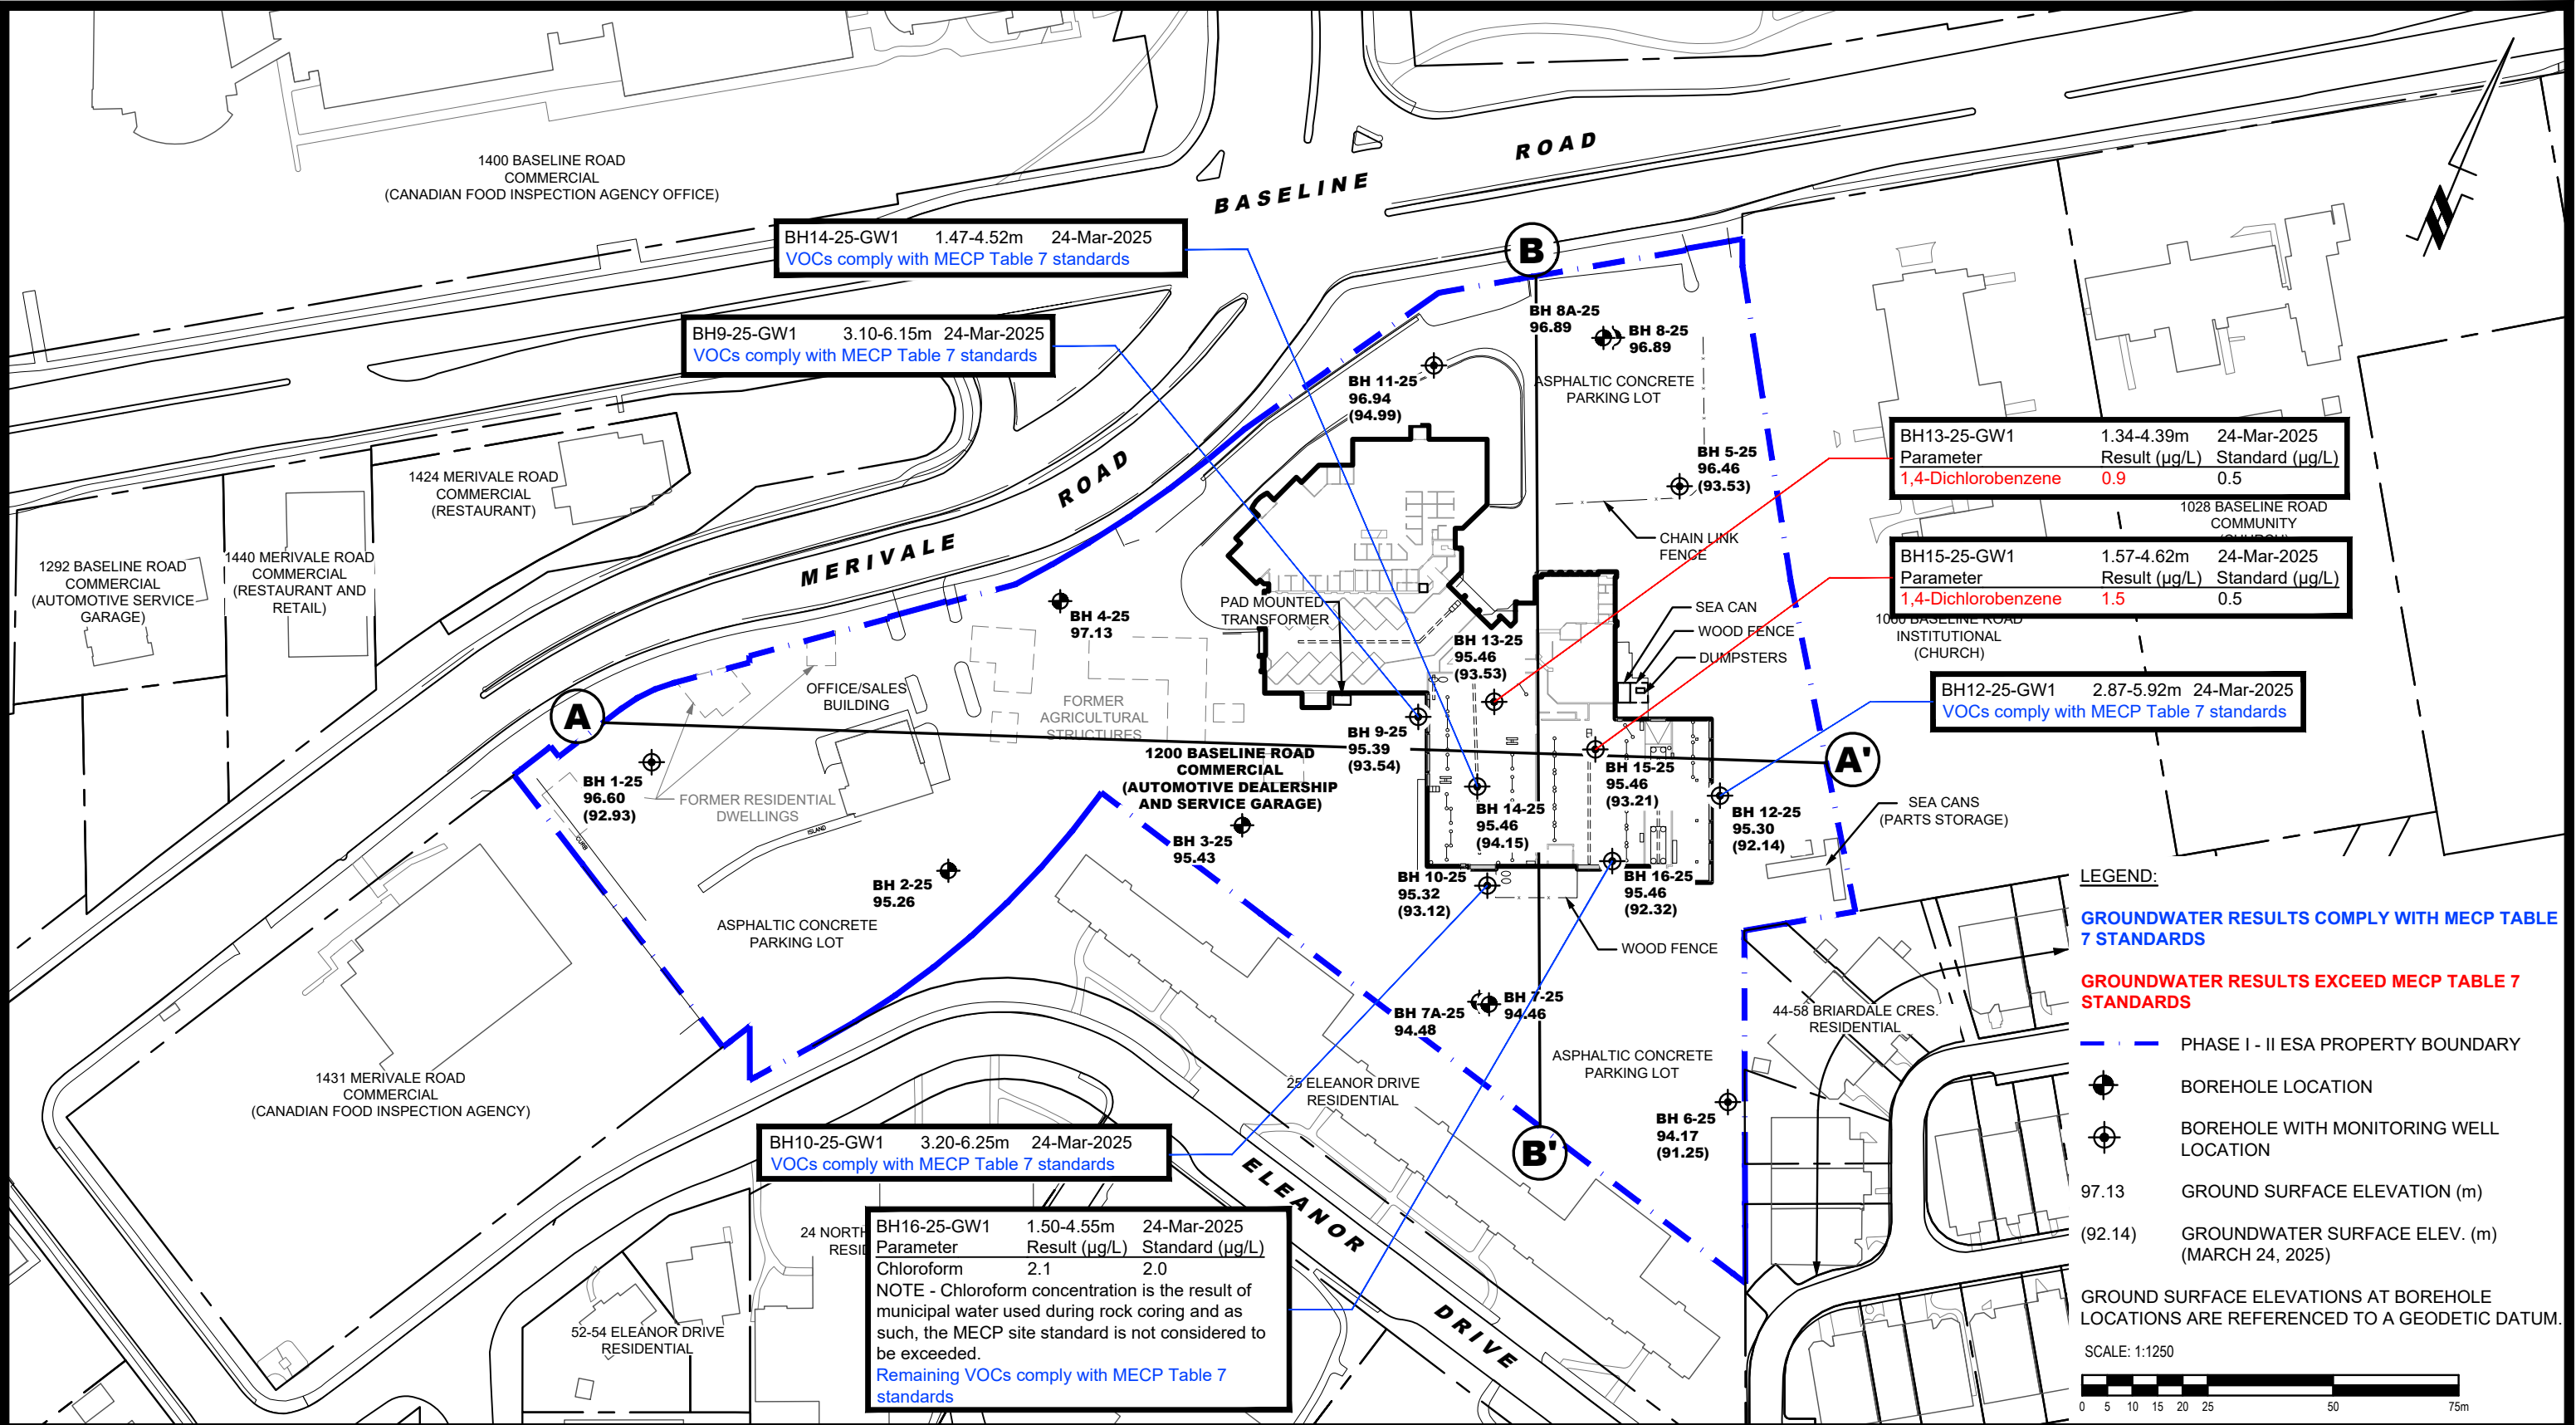
| | | | | Title: ANALYTICAL TESTING PLAN - GROUNDWATER (VOCs) | | | | |

Groundwater present beneath the northern portion of the service bay area in the automotive service garage building on the Phase II Property is contaminated with VOCs (1,4-dichlorobenzene) above the MECP Table 7 Residential standards. The origin of these contaminants is unknown but may be the result of cleaning or deodorizing chemicals used historically during vehicle servicing, or from on-site janitorial supplies that may have been introduced to the groundwater via leaky floor drains, conduits and/or oil water separators.

Groundwater impacted with BTEX, VOCs and PHCs was identified on the Phase II Property and is suspected to be the result of on-site commercial activities resulting in the identified APECs on the RSC Property. Prior to the redevelopment of the Phase II Property, it is recommended that impacted groundwater be further assessed. Monitoring wells with impacted groundwater are recommended to be resampled to confirm the presence and concentrations of these contaminants. If the presence of impacted groundwater is confirmed, the extent of these impacts should be further delineated.

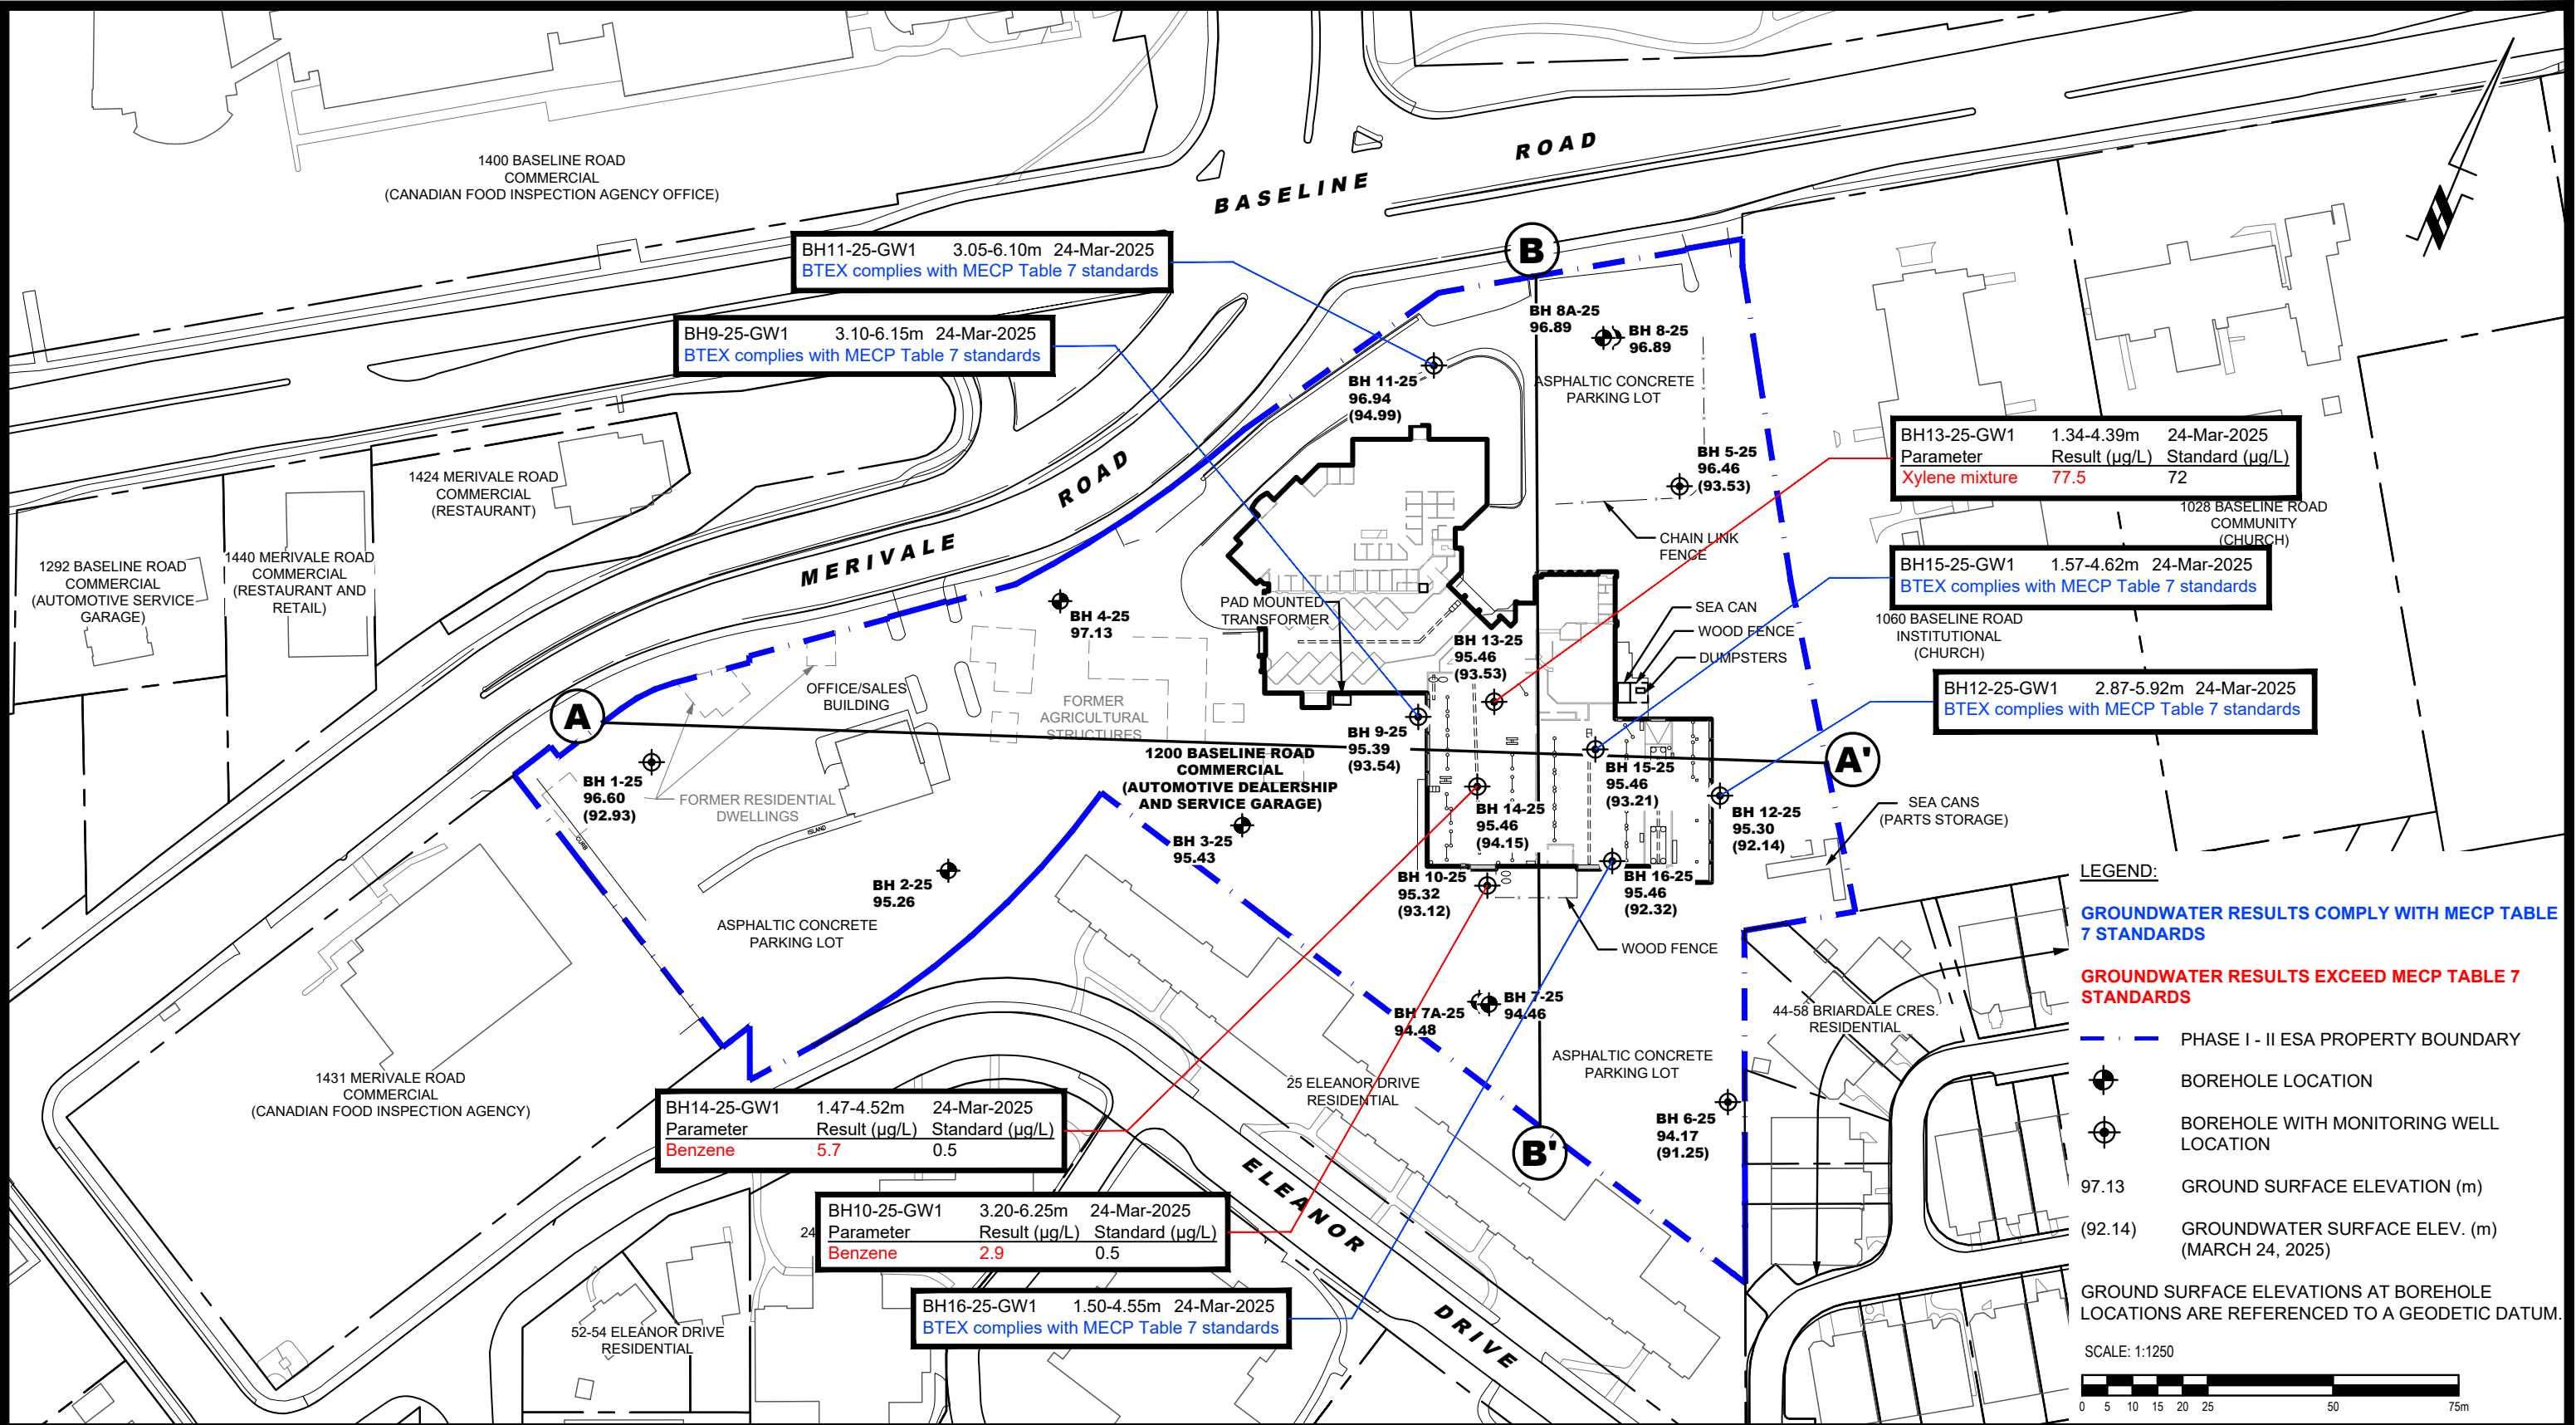
It is unknown where BTEX, VOC and PHC contamination in groundwater encountered within or immediately adjacent to the service bay area of the automotive service garage originated, but it could be the result of spills related to on site petroleum-derived product storage tanks in these areas, and from on-site janitorial supplies that may have been introduced to the groundwater via leaky floor drains, conduits and/or oil water separators.

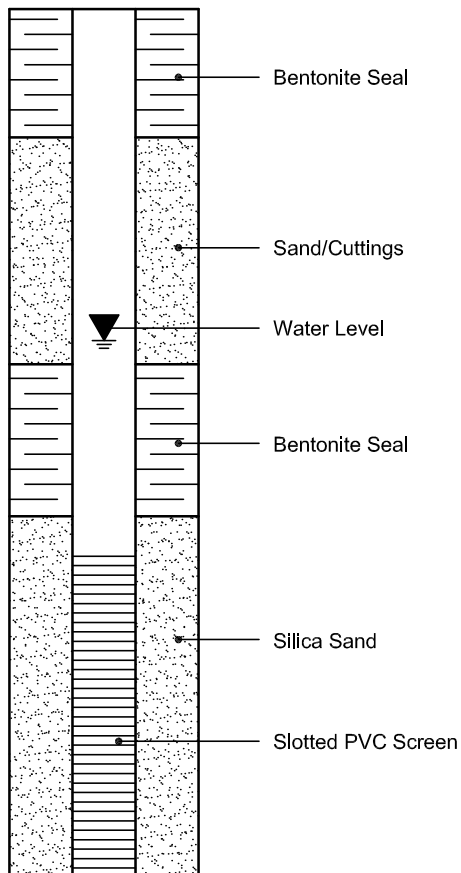
#### MONITORING WELL CONSTRUCTION

Upon installation, the groundwater monitoring wells were developed using a dedicated inertial lift pump, with a minimum of three well volumes being removed from the wells. The wells were developed until the appearance of the water was noted to have stabilized. In addition, the ground surface elevations of each borehole were subsequently surveyed with respect to a known geodetic elevation using GPS equipment.
