# PHASE ONE ENVIRONMENTAL SITE ASSESSMENT UPDATE

## LANSDOWNE PARK – PROPOSED EVENT CENTRE LANDS

JANUARY 14, 2025

PROJECT NO.: CA0037195.1094

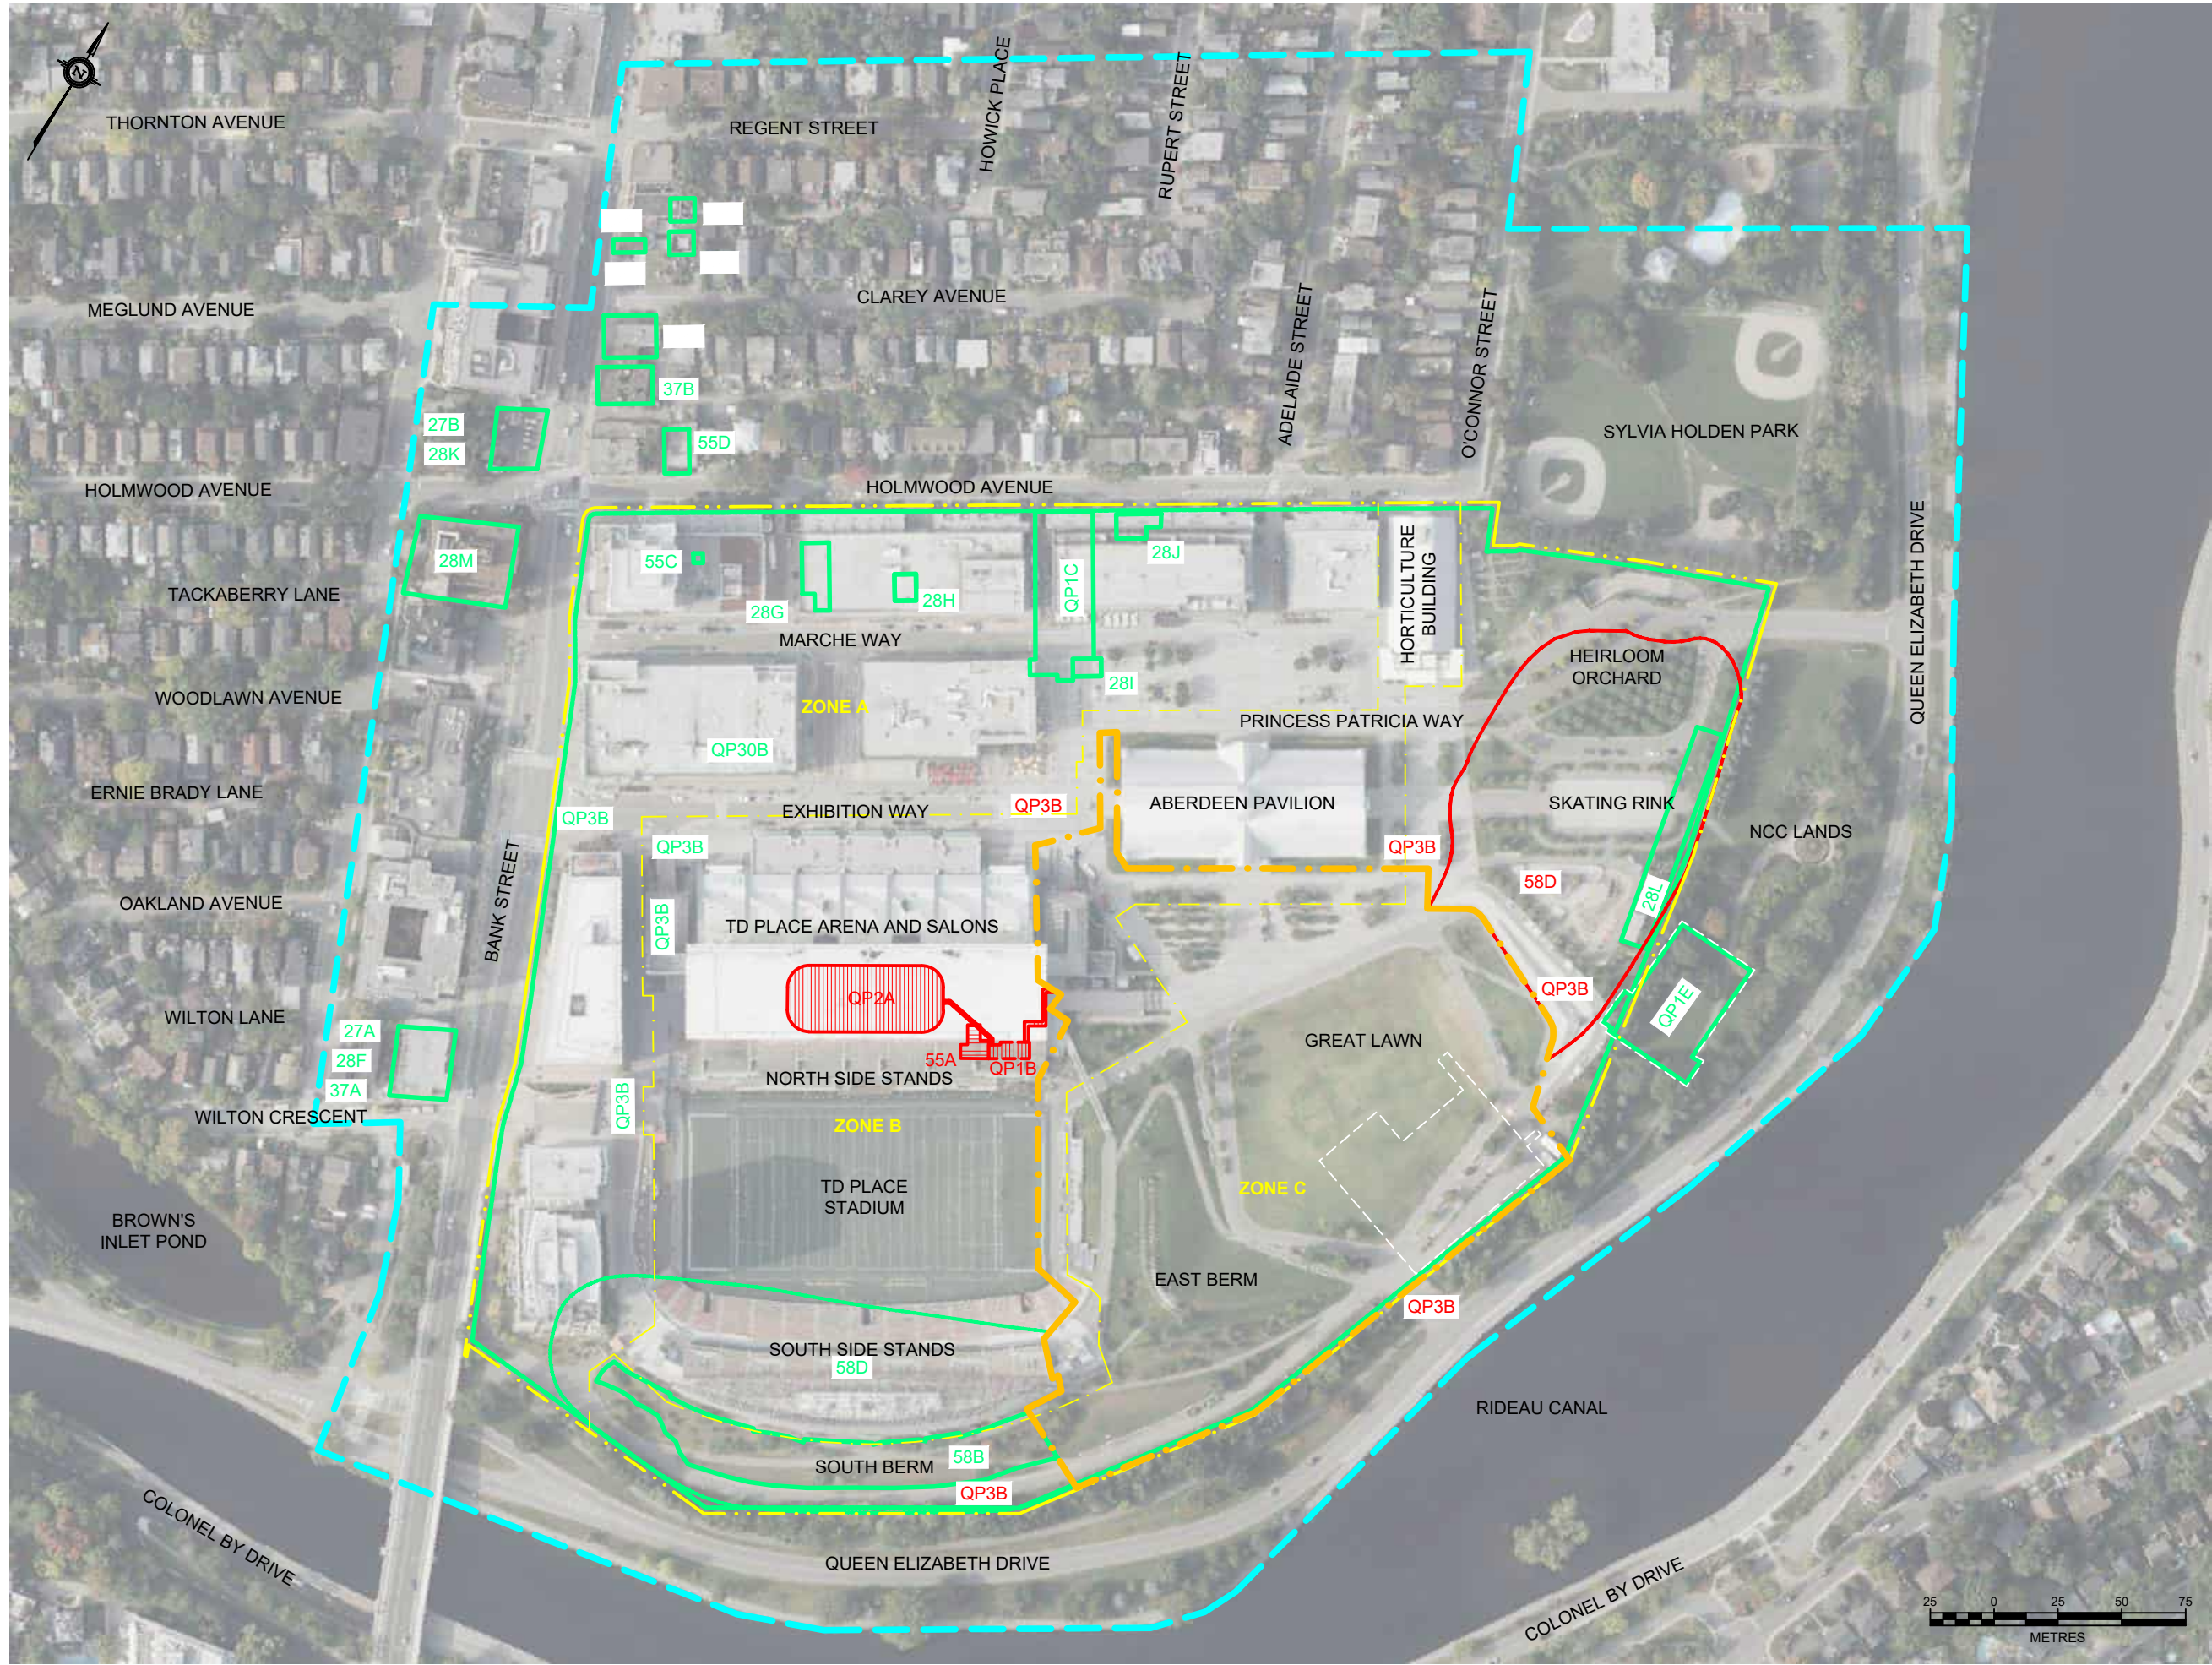
| HISTORIC LANDFILL FEATURE | The historic landfills identified within the HLUI are referenced from the City's Old Landfill Management Strategy report (OLMS, 2004). Contact the City's Environmental Remediation Unit (ERU-UAE@ottawa.ca) if you would like more information about the old landfill sites identified in the OLMS report. |
|---|---|
| ADJACENT_LANDUSE | residential and parkland; the zoning is EW (waterway corridor) in the general area of the site. |
| ADJACENT_INDUSTRY | none based on information reviewed |

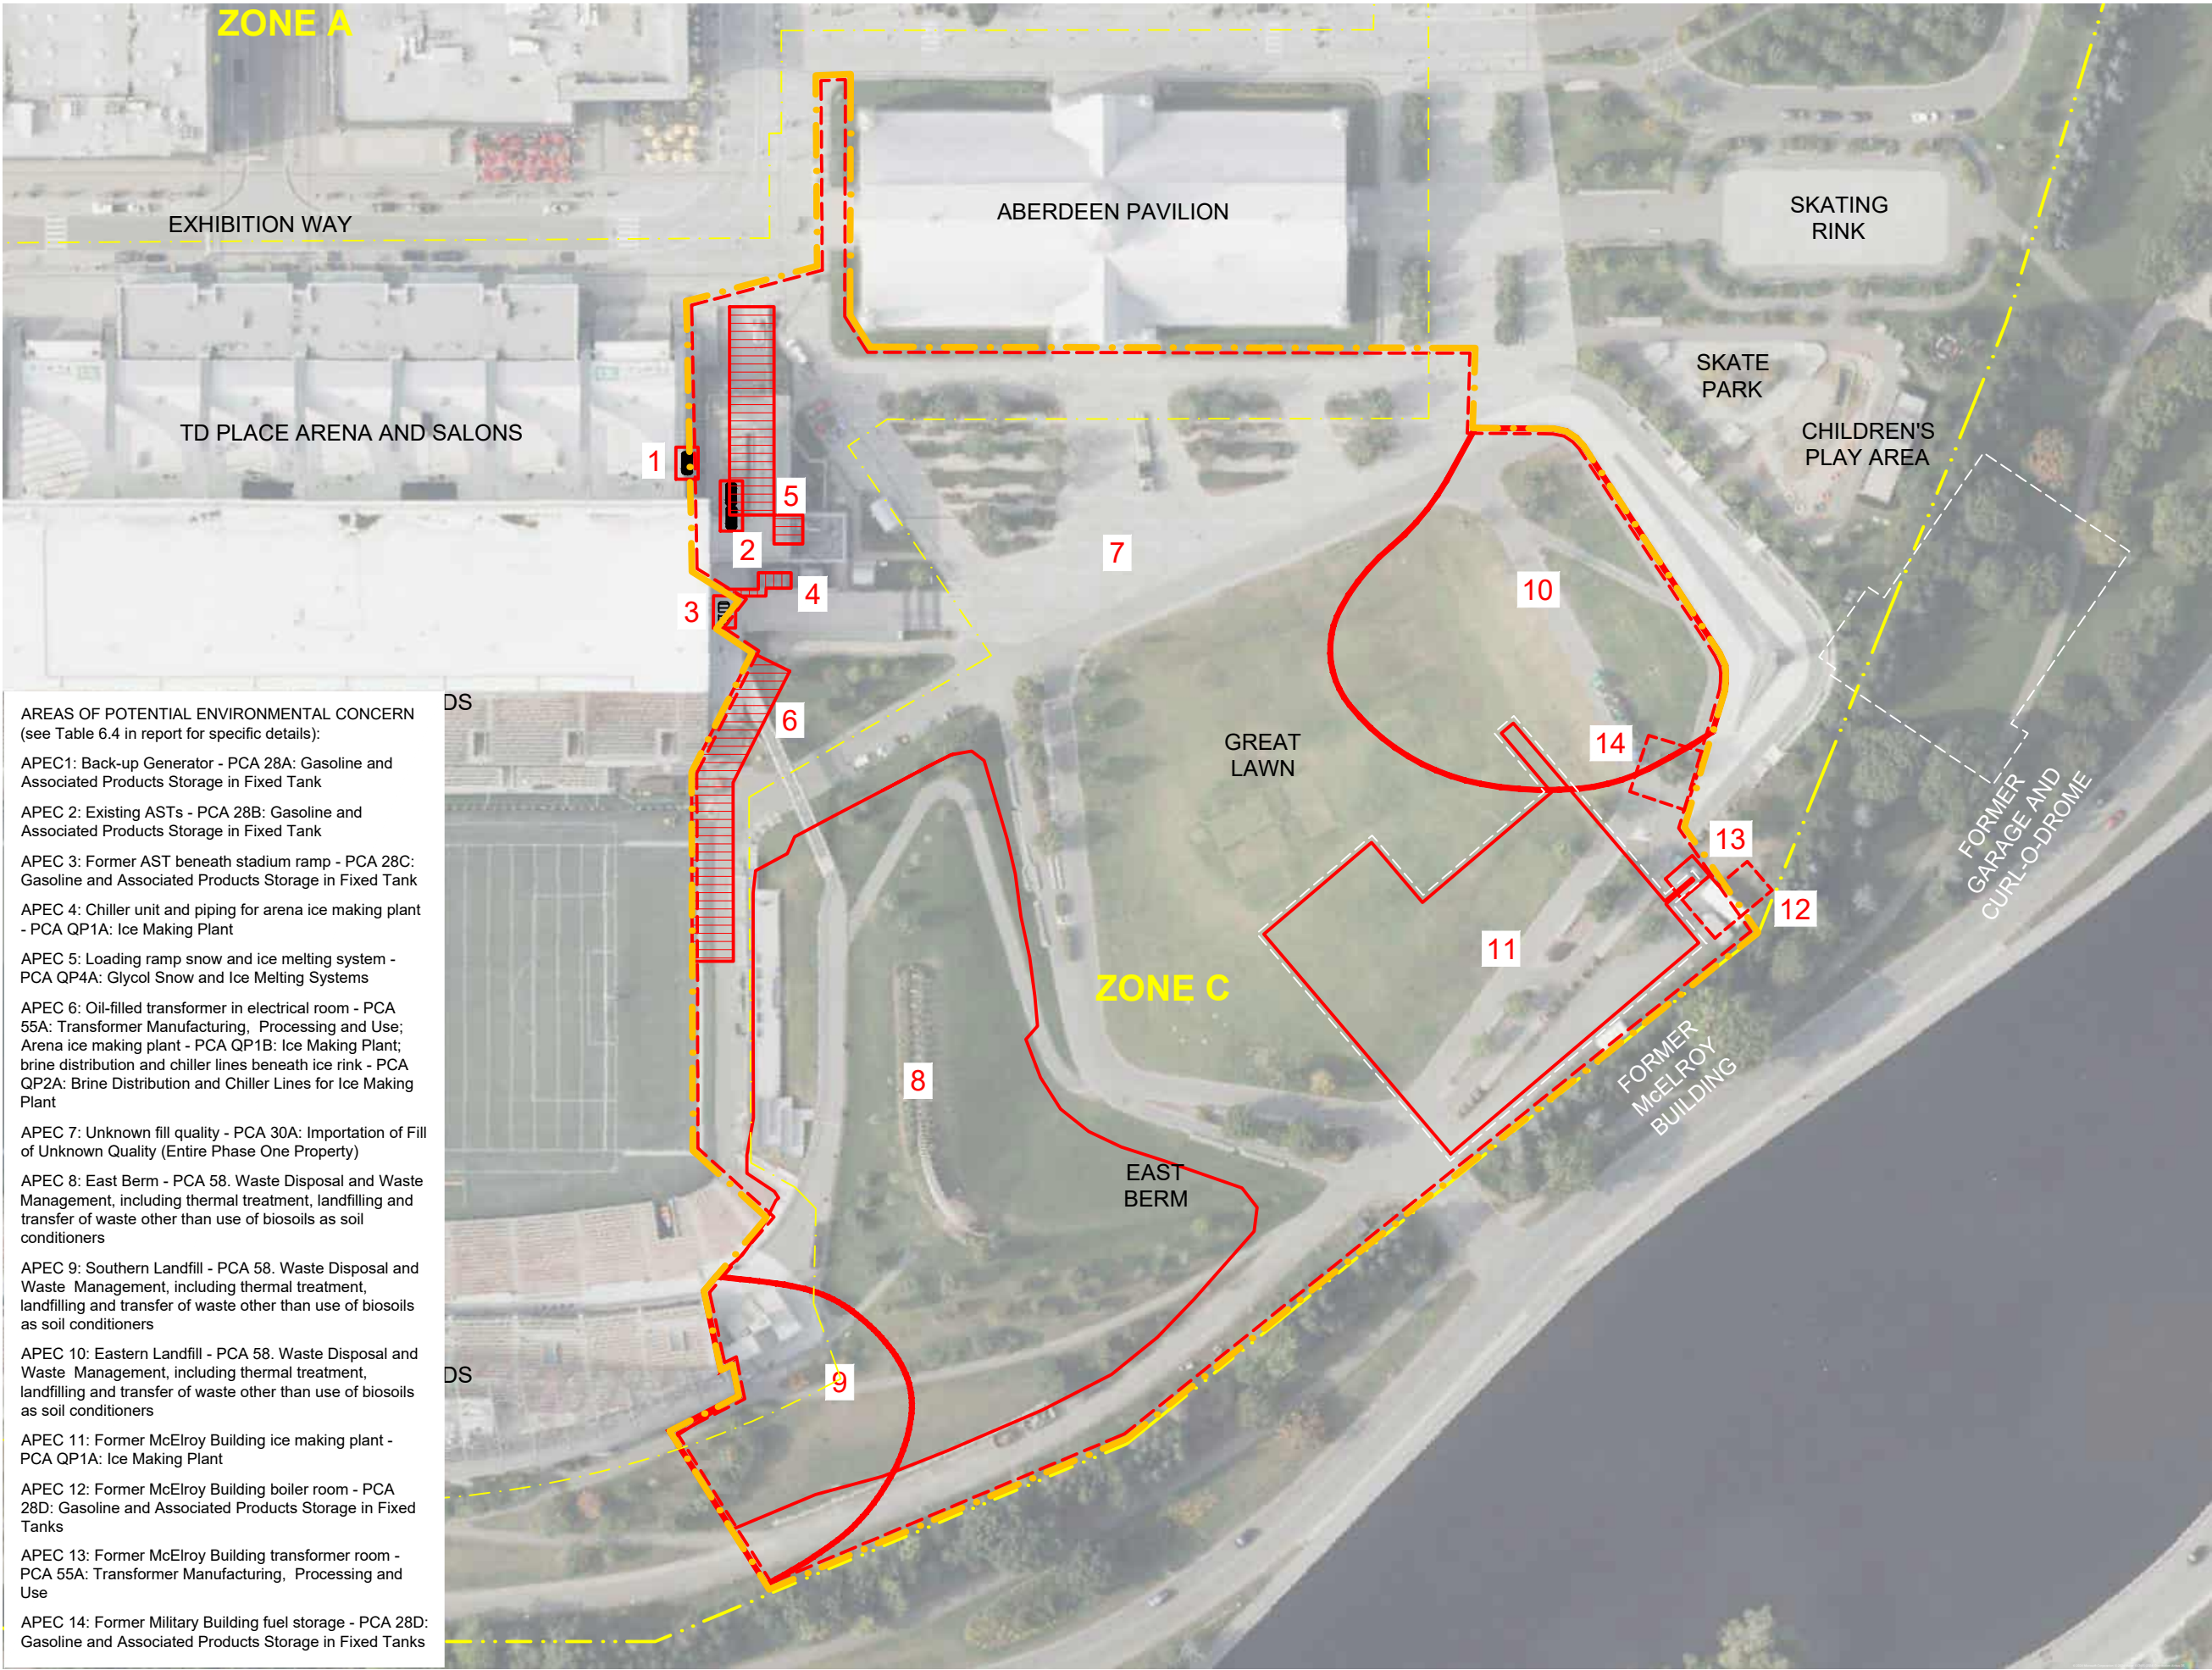
| HISTORIC LANDFILL FEATURE | The historic landfills identified within the HLUI are referenced from the City's Old Landfill Management Strategy report (OLMS, 2004). Contact the City's Environmental Remediation Unit (ERU-UAE@ottawa.ca) if you would like more information about the old landfill sites identified in the OLMS report. |
|---|---|
| ROAD_TYPE | <null> |
| ROAD_NAME | <null> |

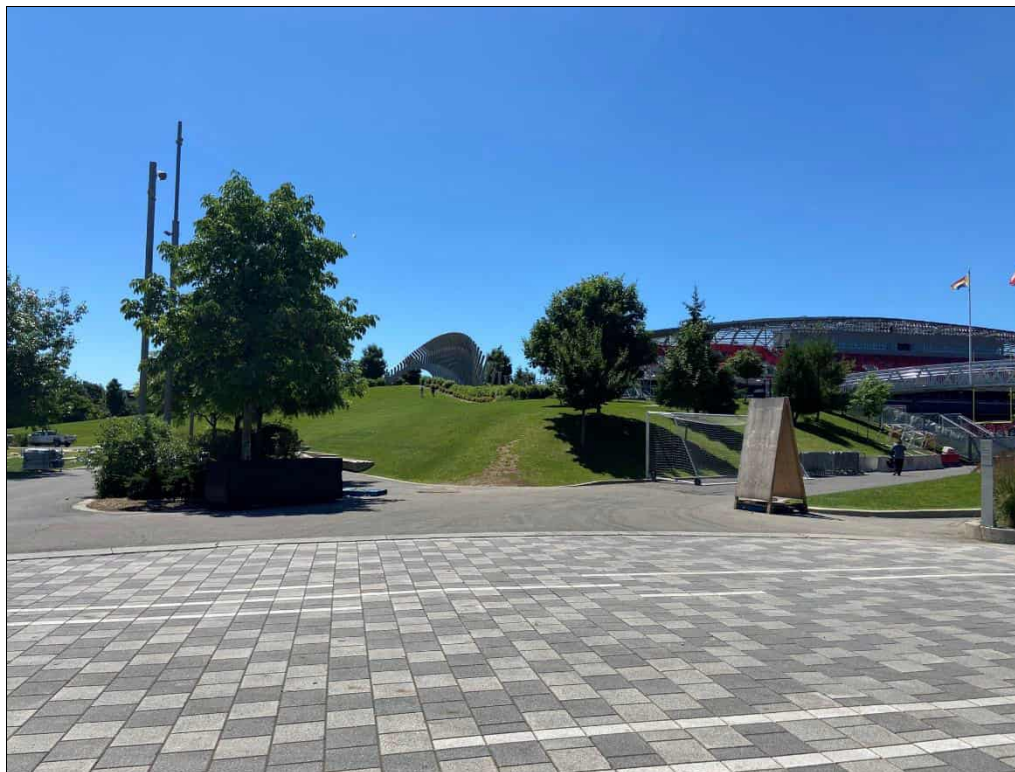
**Photo 6:**

General view of the northern elevation of the East Berm.

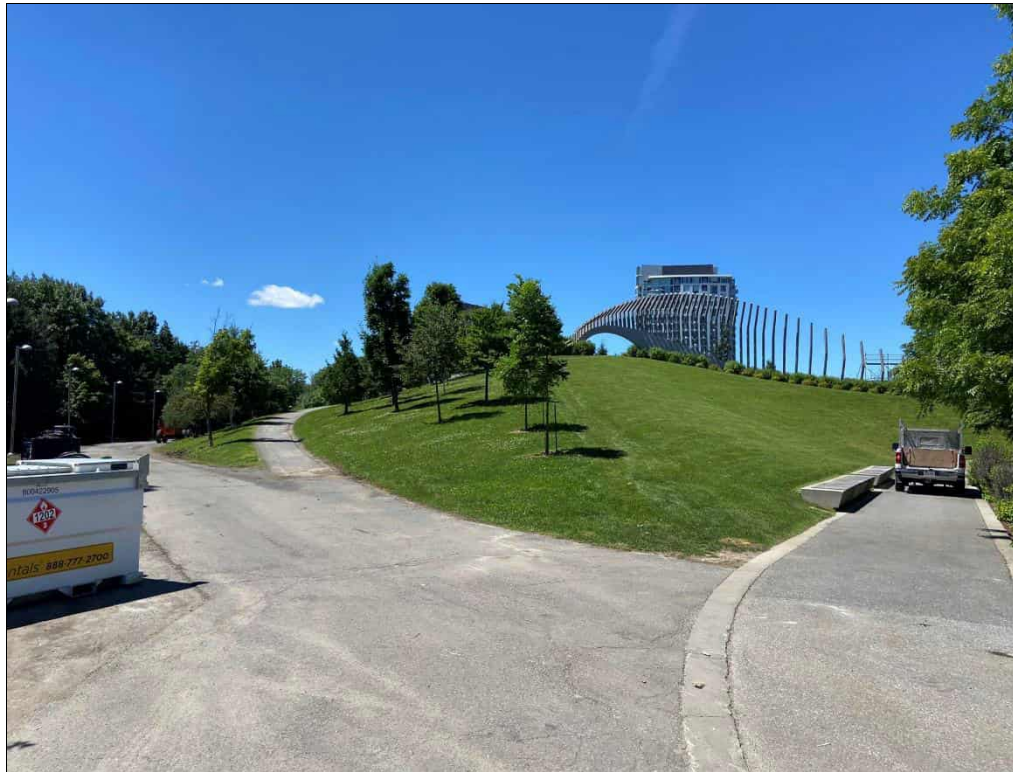
**Photo 7:**

General view of the southern elevation of the East Berm.

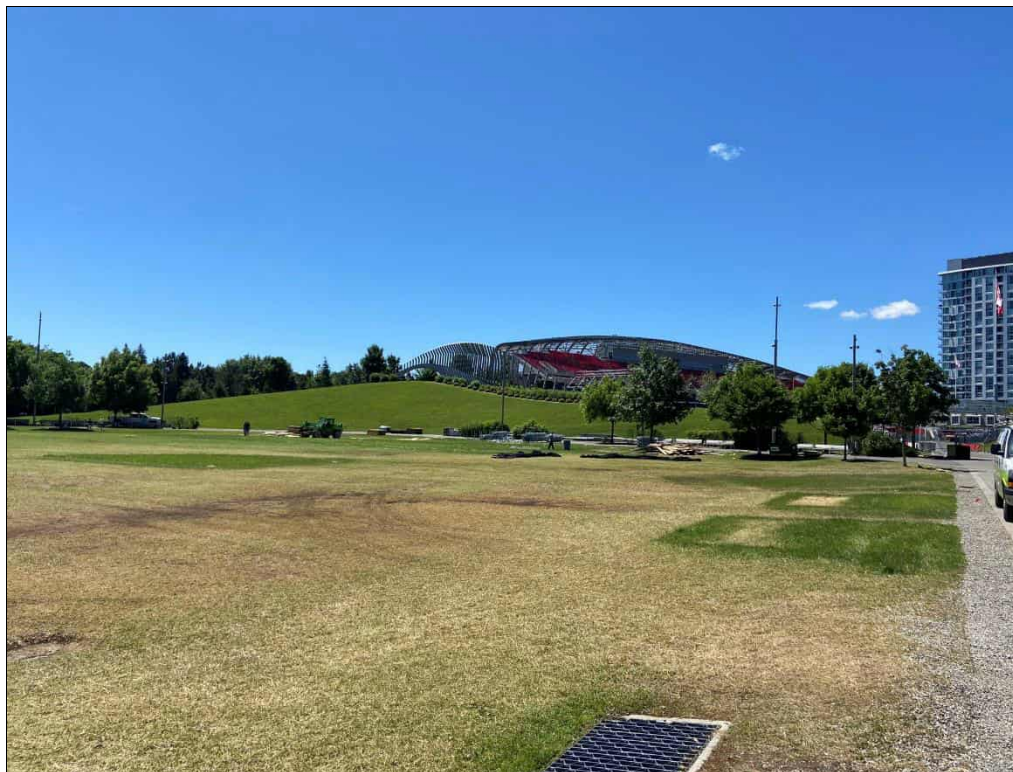
**Photo 8:**

General view of the eastern elevation of the East Berm.

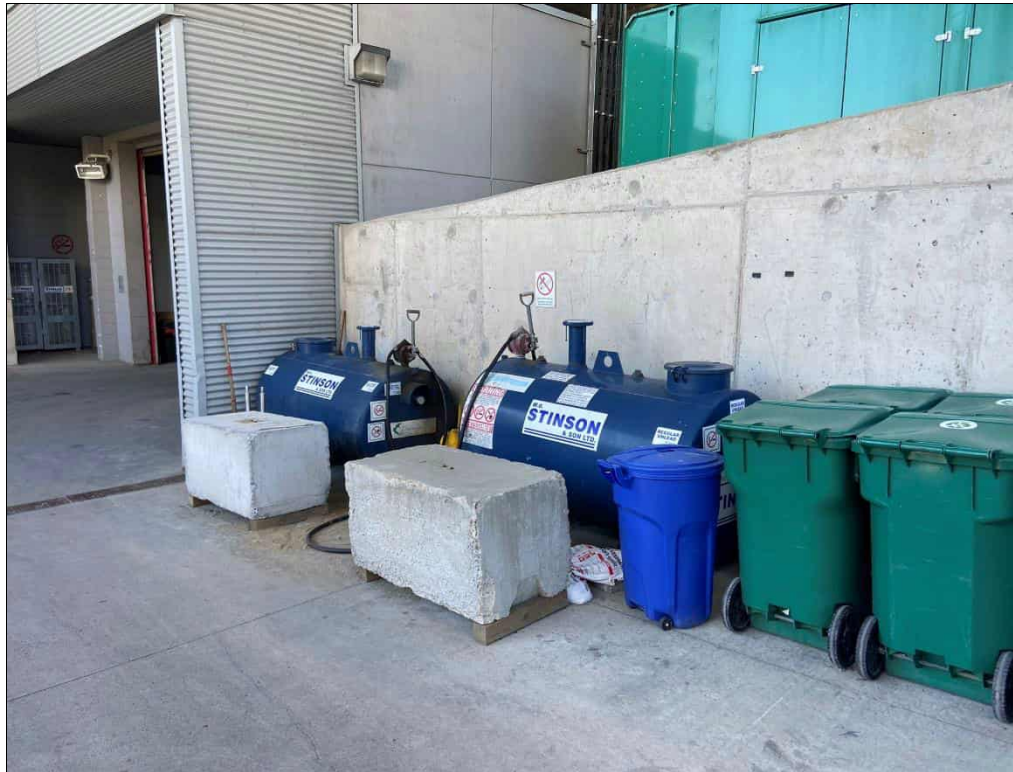
| <b>Photo 11:</b> |

| 500 L capacity coloured diesel and gasoline above ground storage tanks located on the ramp outside the loading dock area. Note: fuel spills would flow down the ramp to the grate floor drain. |

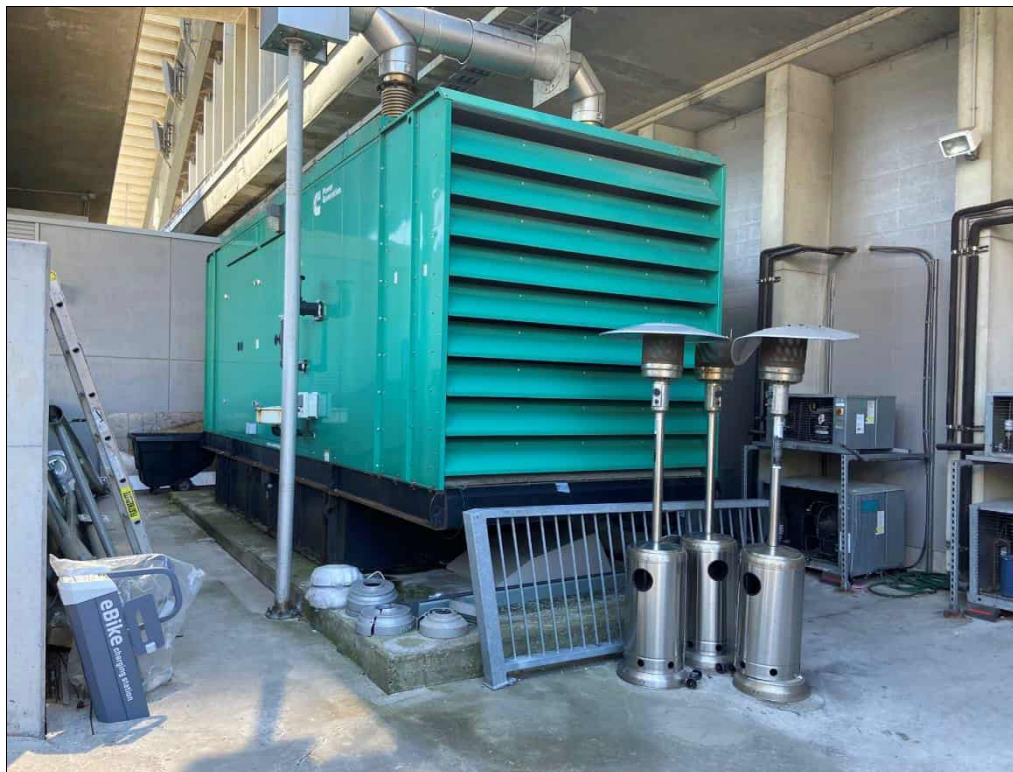
| <b>Photo 12:</b> |

| Back-up generator located outside the loading dock area on the east side of TD Place Stadium. Fitted with a 5,791 L capacity diesel storage tank. |
