Geotechnical Investigation Report – Proposed New Warehouse Structure

1309 Carling Avenue, Ottawa, Ontario

Project Number TR1363B

May 12, 2025

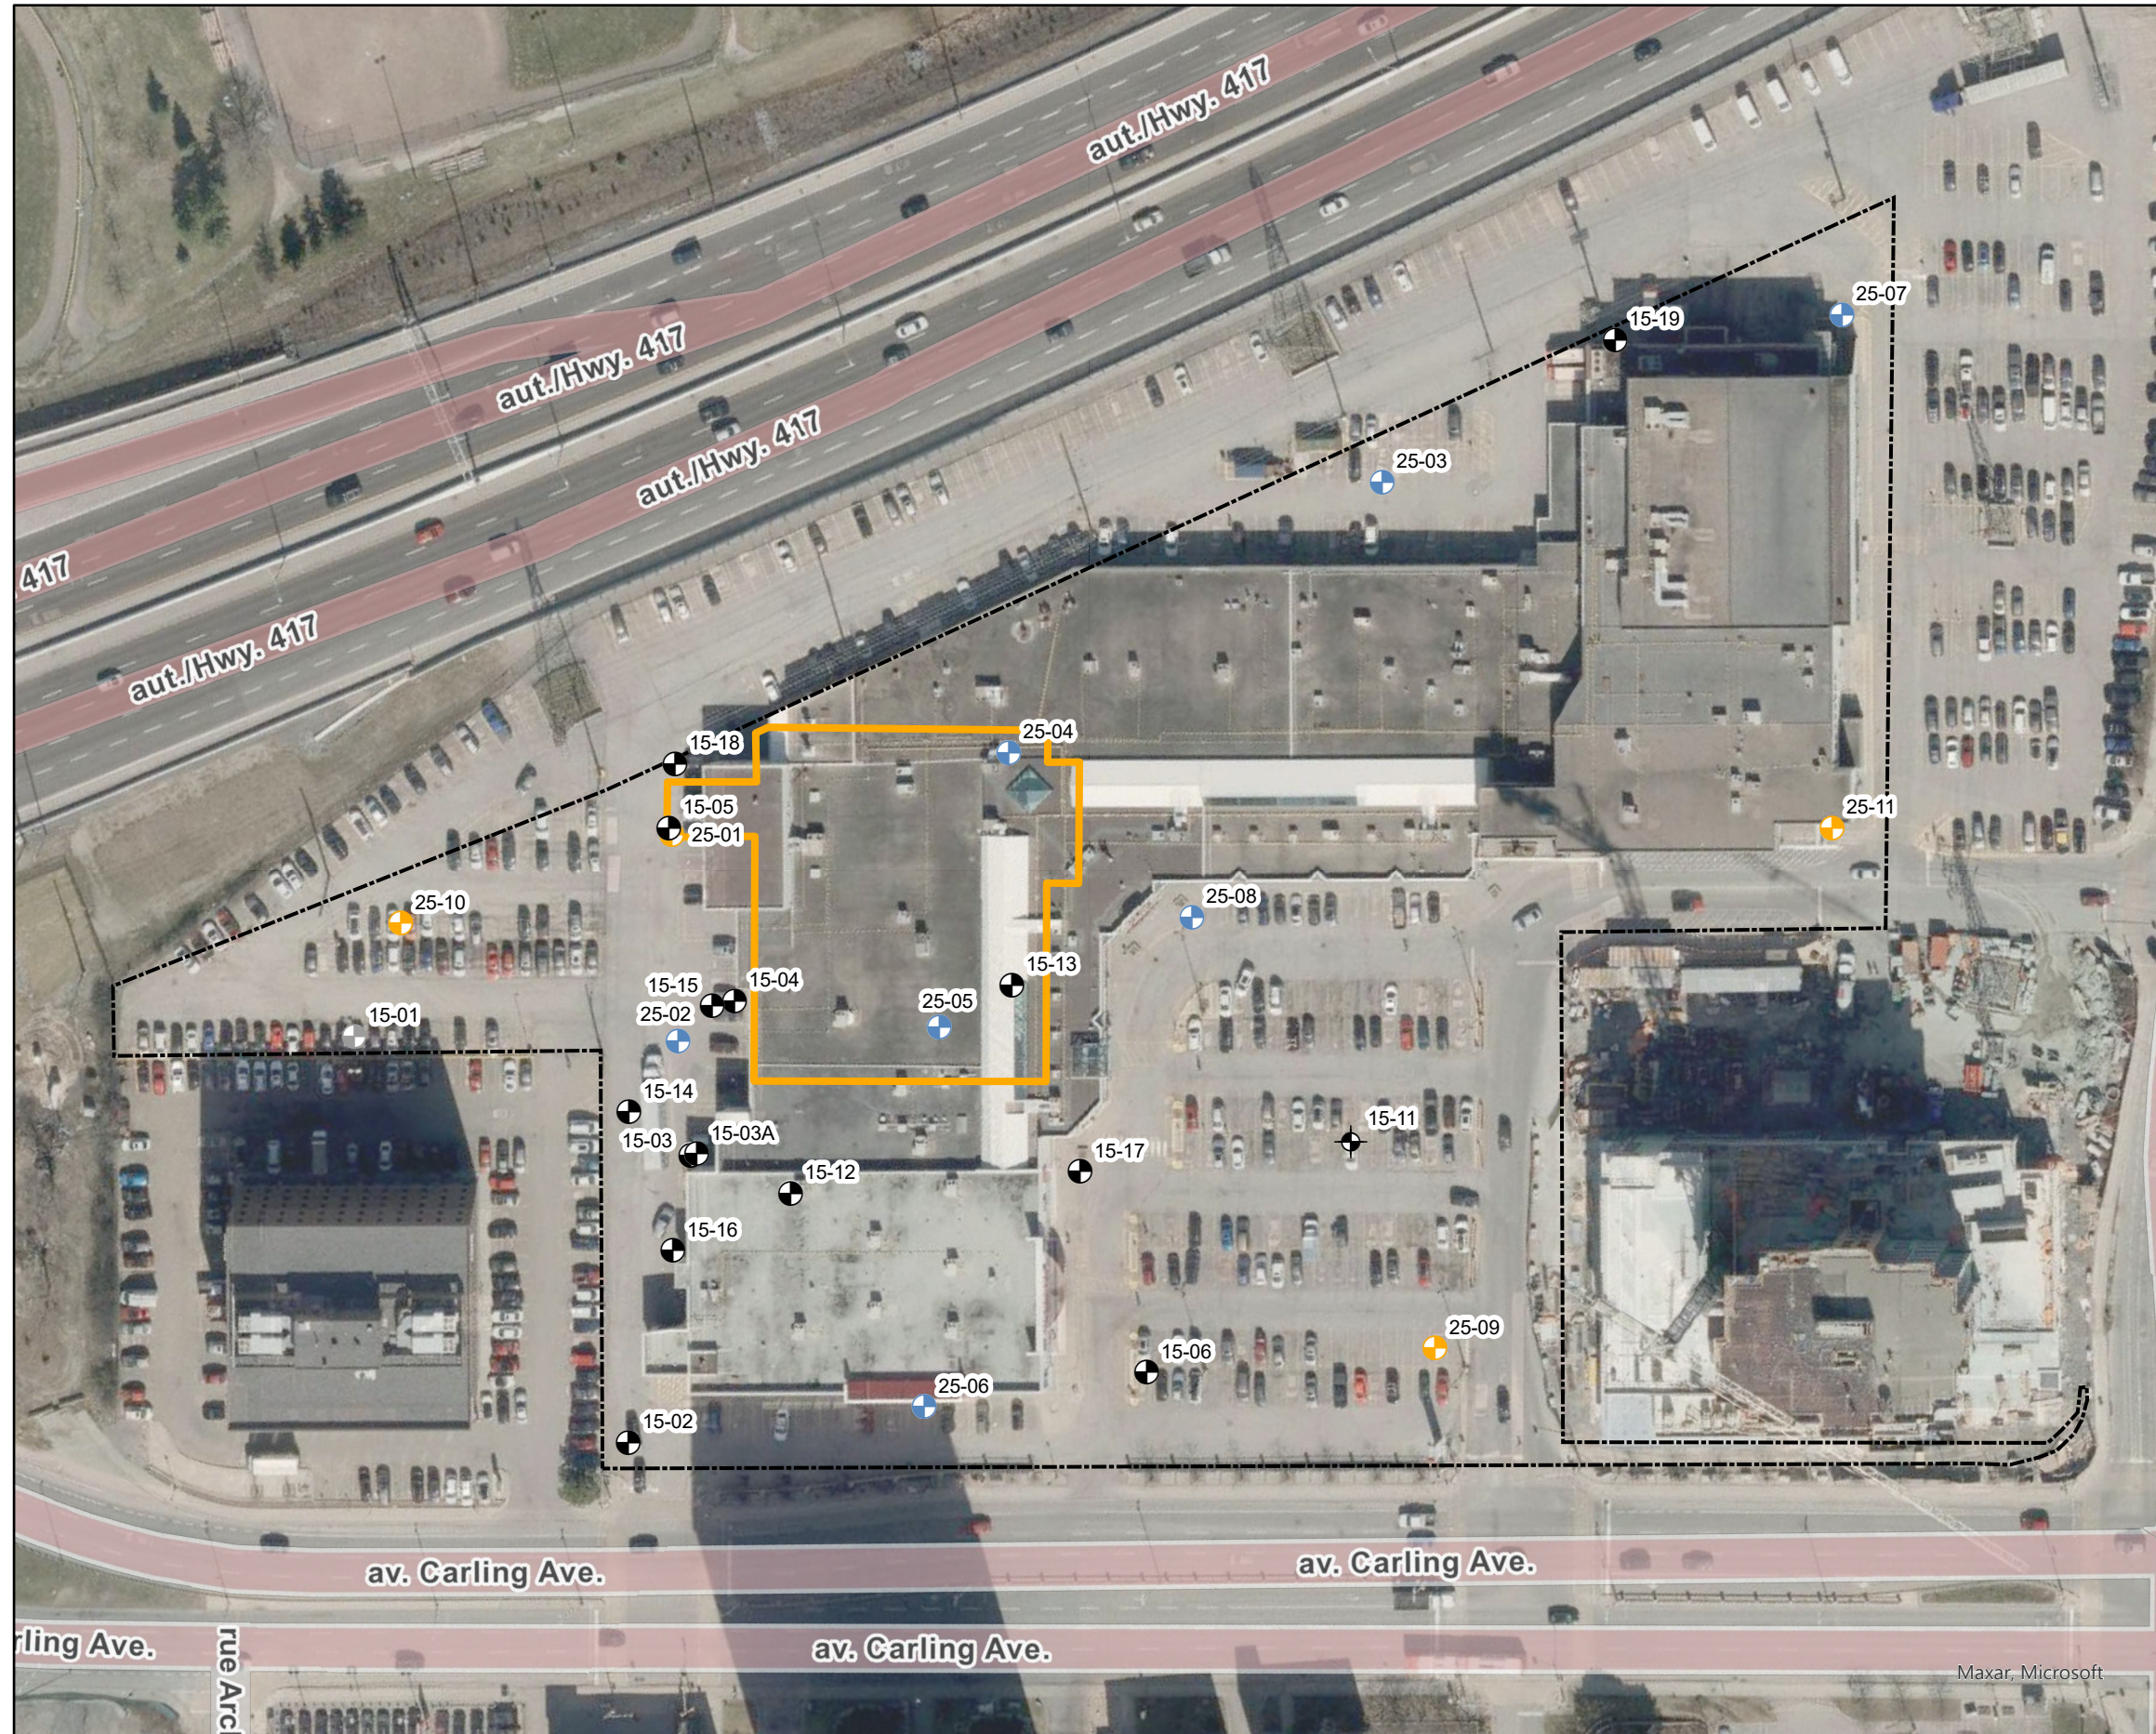
- Legend:**
- Borehole (Geosyntec)
 - Monitoring Well (Geosyntec)
 - Previous Borehole (Golder)
 - Previous Monitoring Well (Golder)
 - Unlocatable Previous Monitoring Well (Golder)
 - Phase Two Property Boundary
 - Building Footprint (approximate)

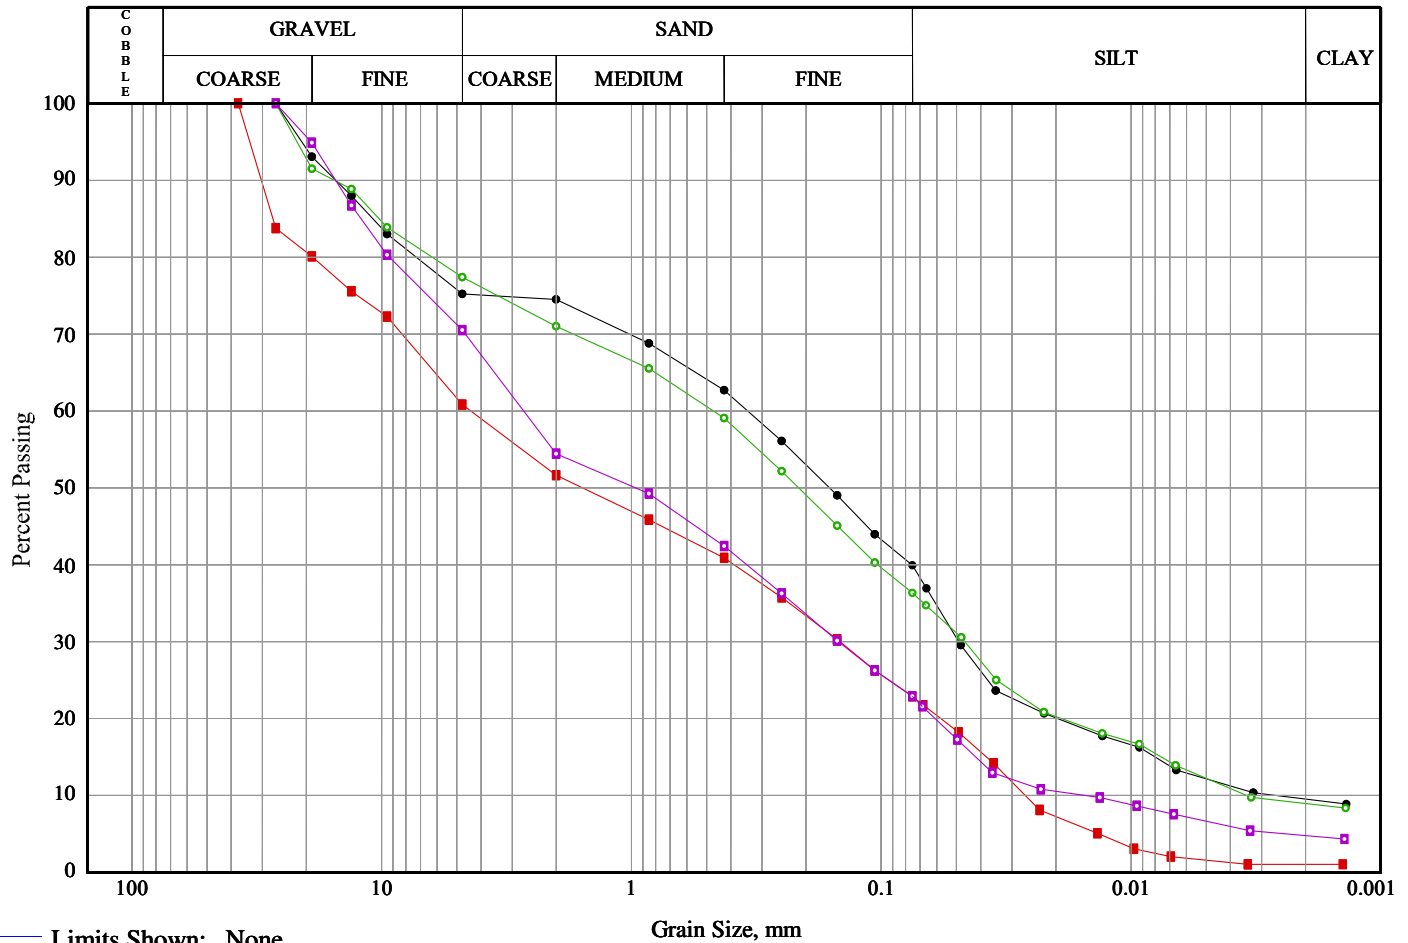
Line Symbol	Sample	Borehole/ Test Pit	Sample Number	Depth	% Cob.+ Gravel	% Sand	% Silt	% Clay
—●—		25-01	SS09	6.86-7.47	24.8	35.3	30.4	9.5
—■—		25-02	SS12	8.84-9.45	39.2	38.0	21.8	1.0
—○—		25-08	SS11	9.14-9.75	22.6	41.1	27.4	8.9
—□—		25-08	SS13	13.71-14.32	29.5	47.6	18.1	4.8

Line Symbol	CanFEM Classification	USCS Symbol	D ₁₀	D ₁₅	D ₃₀	D ₅₀	D ₆₀	D ₈₅	% 5-75µm
—●—	Gravelly silty sand , trace clay	N/A	0.003	0.008	0.05	0.16	0.34	10.85	30.4
—■—	Silty gravel and sand , trace clay	N/A	0.027	0.038	0.15	1.57	4.40	27.21	21.8
—○—	Gravelly silty sand , trace clay	N/A	0.003	0.008	0.05	0.21	0.47	10.24	27.4
—□—	Gravelly sand , some silt , trace clay	N/A	0.016	0.042	0.15	0.96	2.70	12.09	18.1

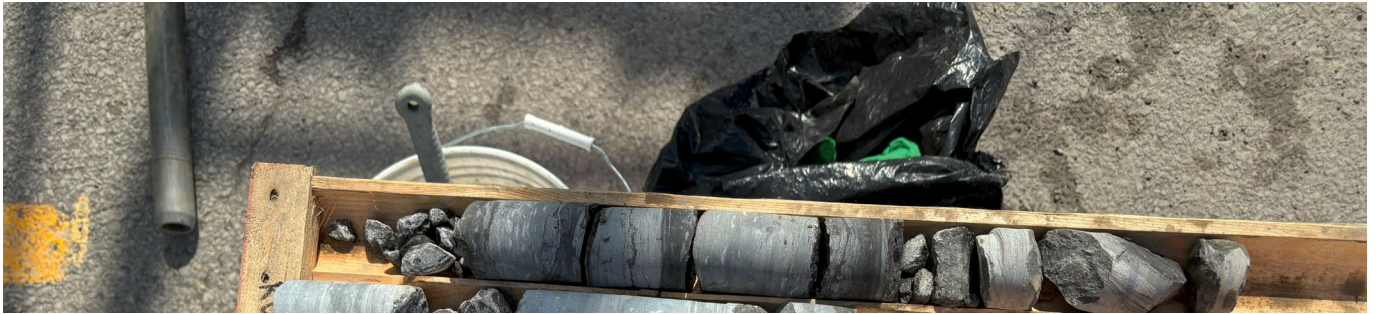
Borehole 25-01

Depth: 12.4 m – 13.2 m

Bedrock, Run1, RQD 0%

It is identified as a grey limestone with black shale interbeds. The upper 0.5 to 1.5 m of bedrock was found to be highly weathered and fractured in boreholes 25-01 and 25-08 with Rock Quality Designation (RQD) of zero; however, this highly weathered zone was absent at borehole 25-02 location. At borehole 25-02 a fractured and very poor quality zone was observed between the approximate depths of 11.8 m bgs and 12.5 m bgs. The rock quality improved with depth within the investigated bedrock zone, with RQD varying between 80% and 95%, indicating good to excellent quality.

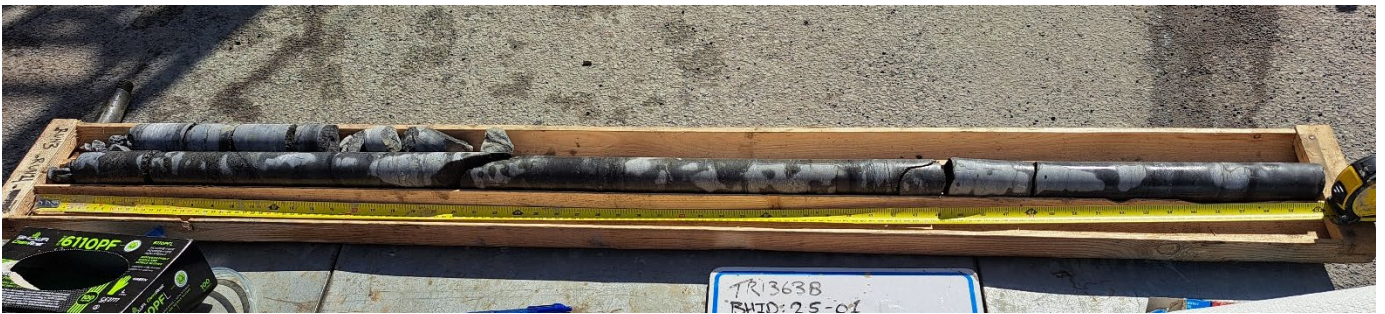
Borehole 25-01

Depth: 13.2 m – 14.6 m

Bedrock, Run2, RQD 95%

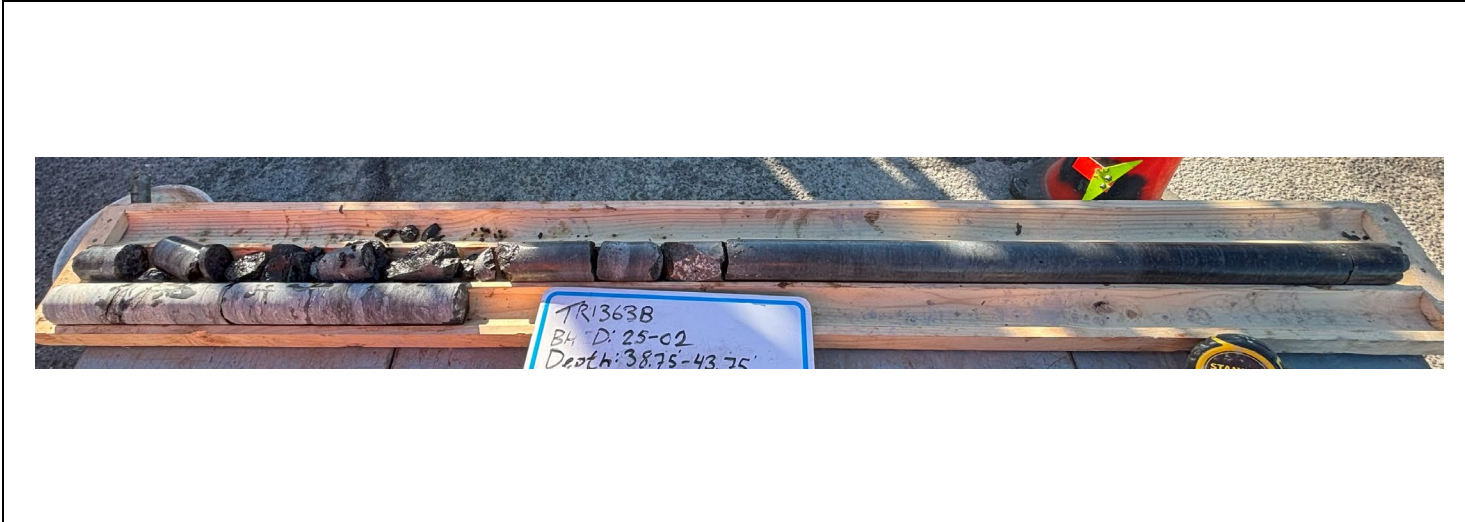
Borehole 25-02	Depth: 11.8 m – 13.3 m	Bedrock, Run2, RQD 52%
----------------	------------------------	------------------------

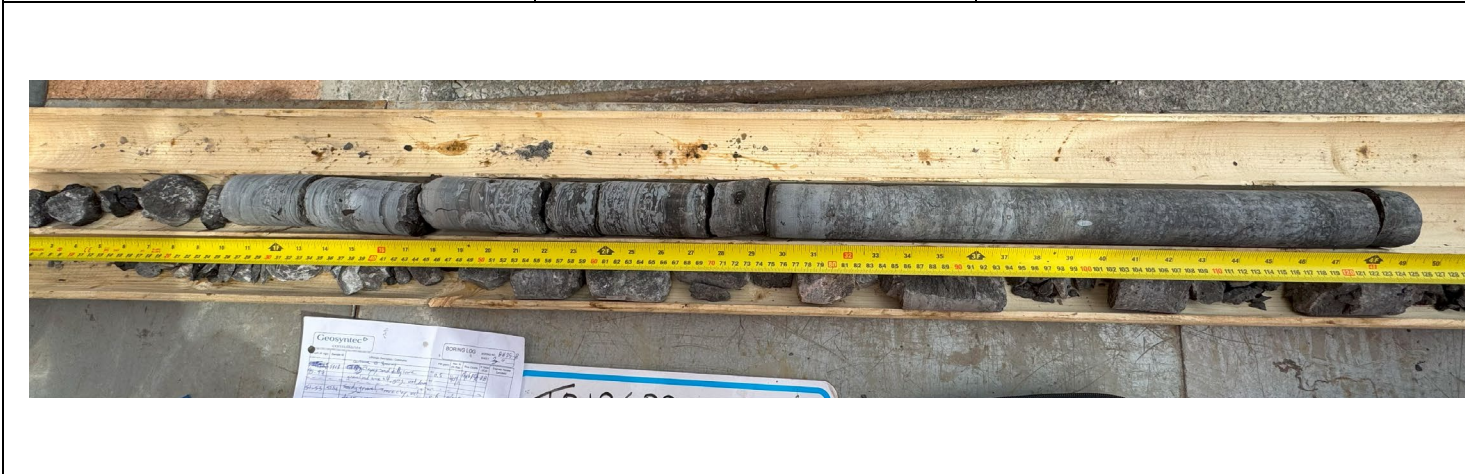
Borehole 25-08	Depth: 19.4 m – 20.6 m	Bedrock, Run2, RQD 80%
----------------	------------------------	------------------------
