re: Retaining Wall Global Stability Analysis
Proposed Retaining Walls
1009 Trim Road – Ottawa, Ontario

file: PG5336-MEMO.07 Revision 1

- Figures 1 to 6 – Global Stability Analysis Under Static & Seismic Condition
- Markup Site Plan

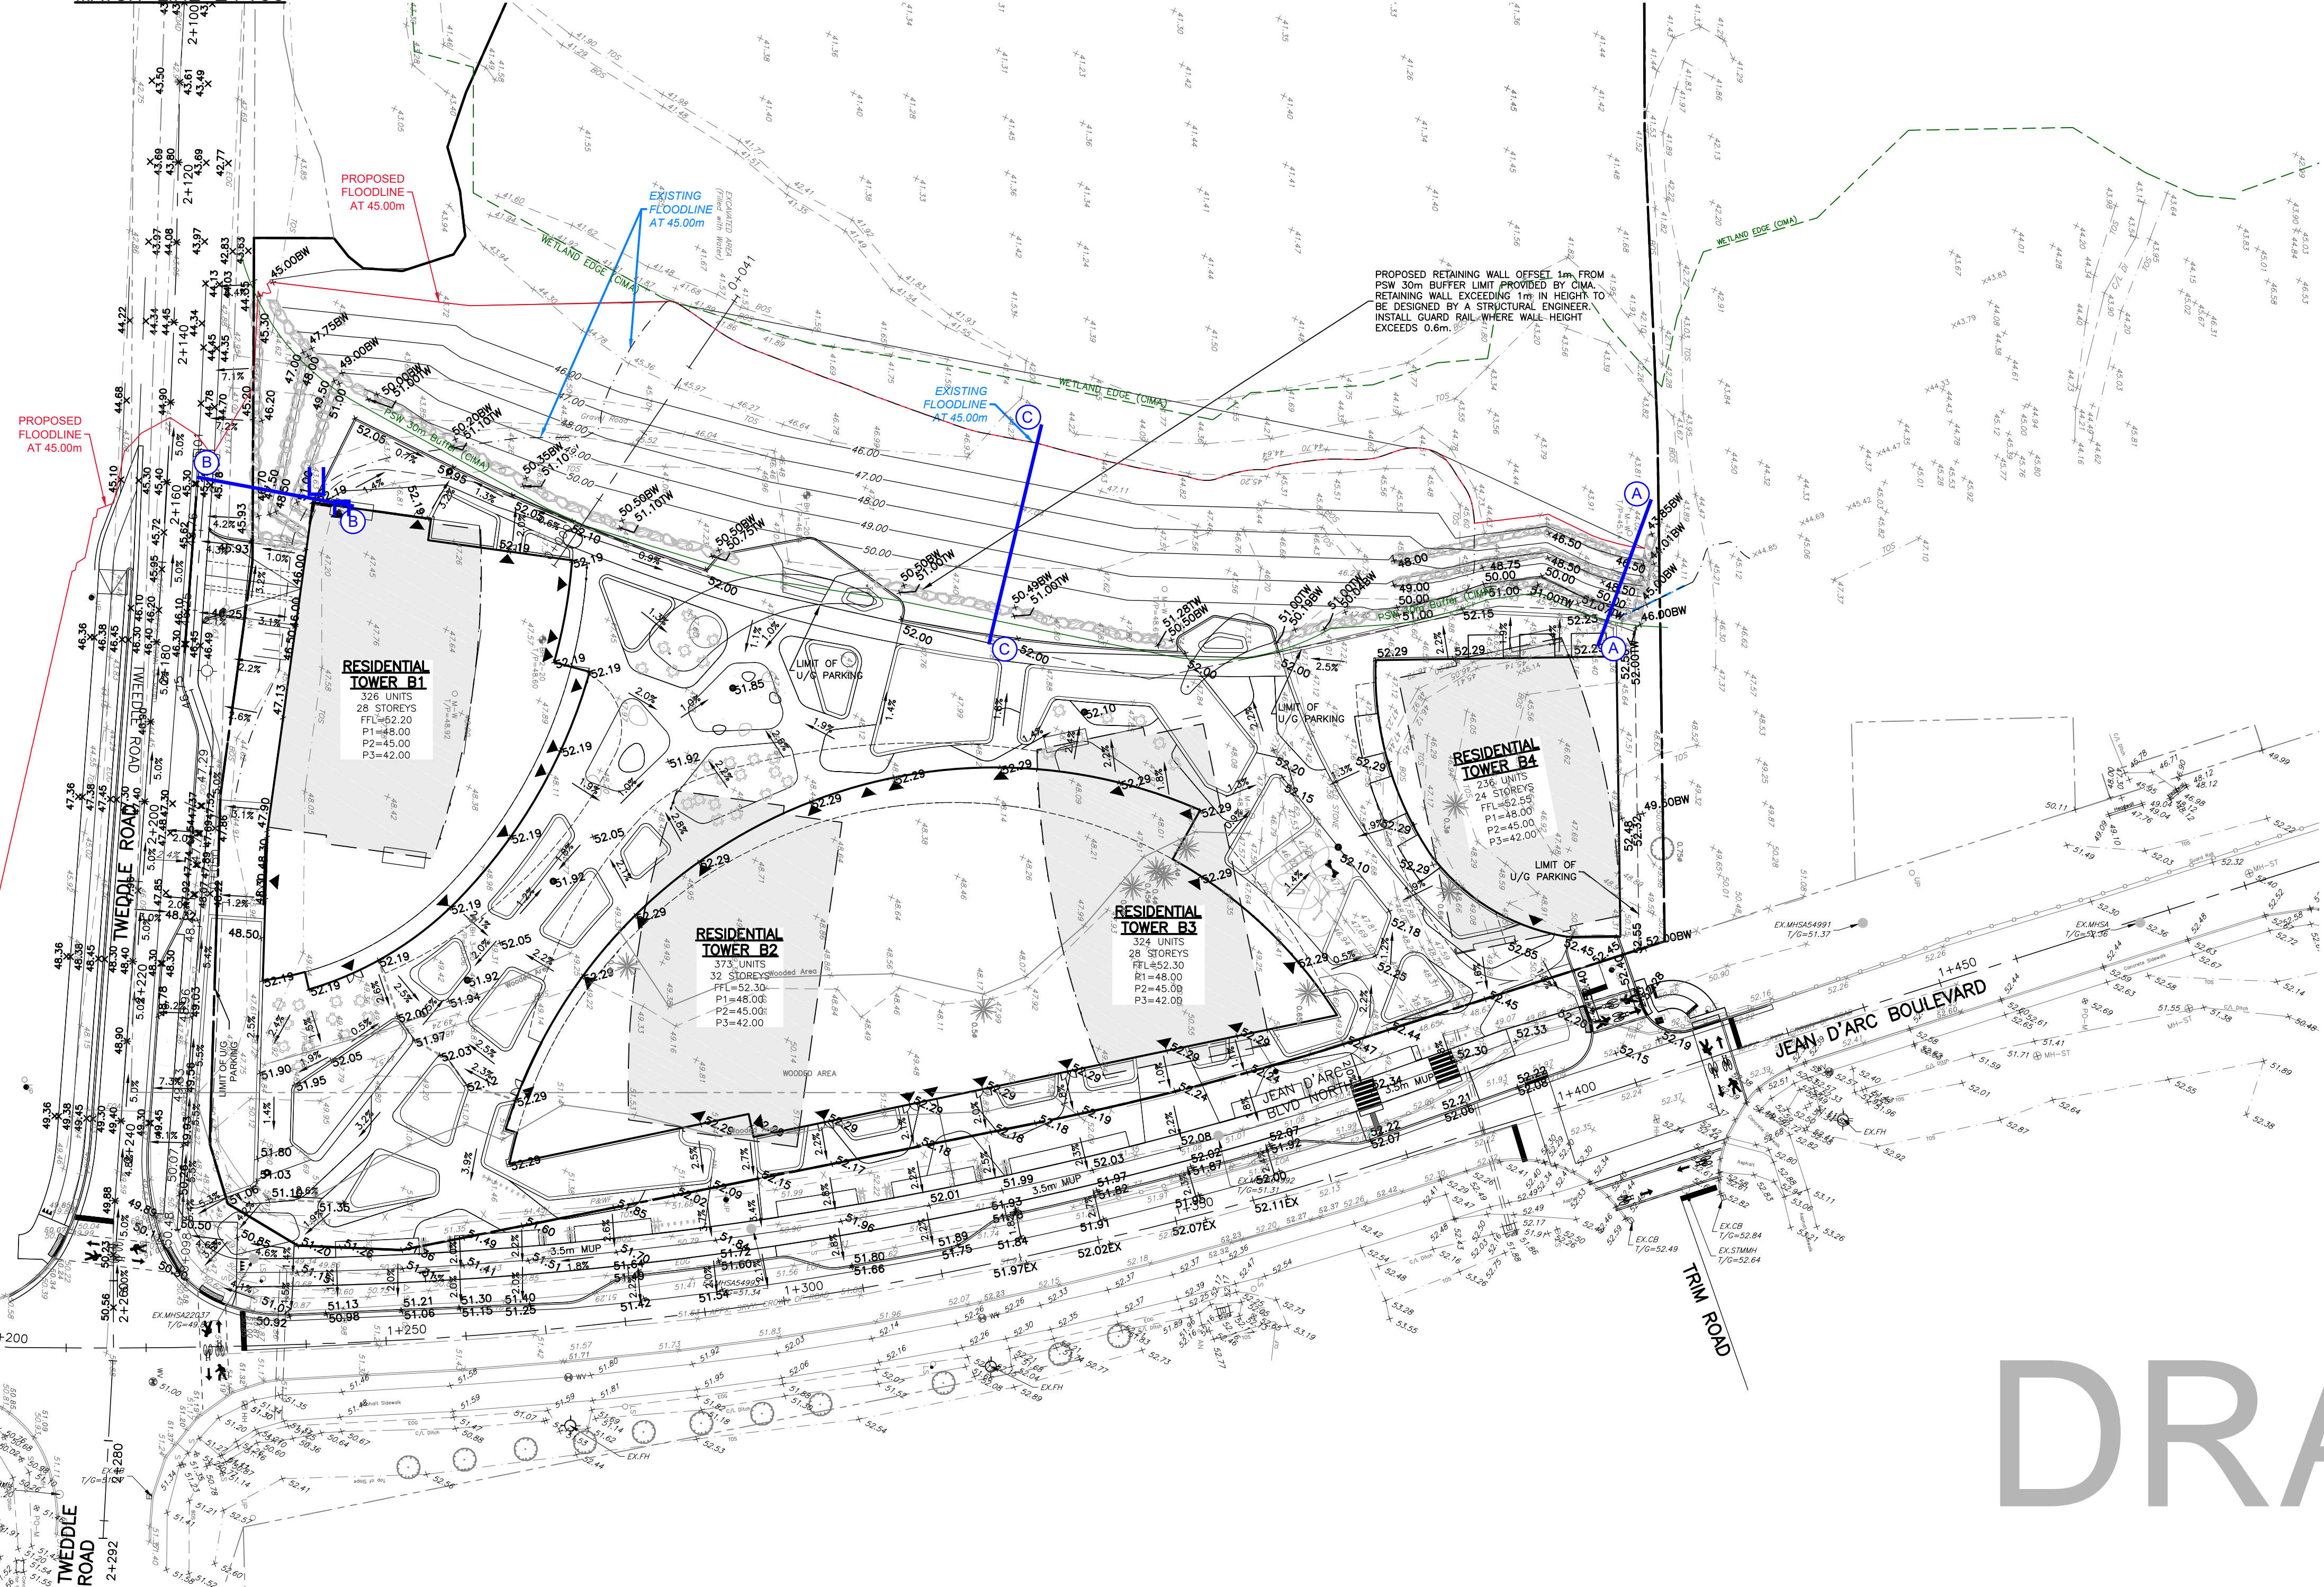
BASEPLAN	PROJECT
SAB	1015 TWEDDLE ROAD DEVELOPMENT
JLF	1015 TWEDDLE ROAD
JLF	OTTAWA, ONTARIO.
SAB	SITE GRADING PLAN
BMT	
BMT

Three (3) cross-sections, considered as the “worst case” scenario, has been analyzed for global stability, where the proposed slope and/or retaining walls have more than 2m height. The location of the cross-section is shown on the attached drawing.

- Drawing C200 – Site Grading Plan, Revision 2, dated March 25, 2024, prepared by EXP.
