**PH4991-LET.02.REV.02**

Subject: **Hydrogeological Assessment and  
Terrain Analysis**  
Proposed Commercial Development  
**541 Somme Street, Ottawa, Ontario**

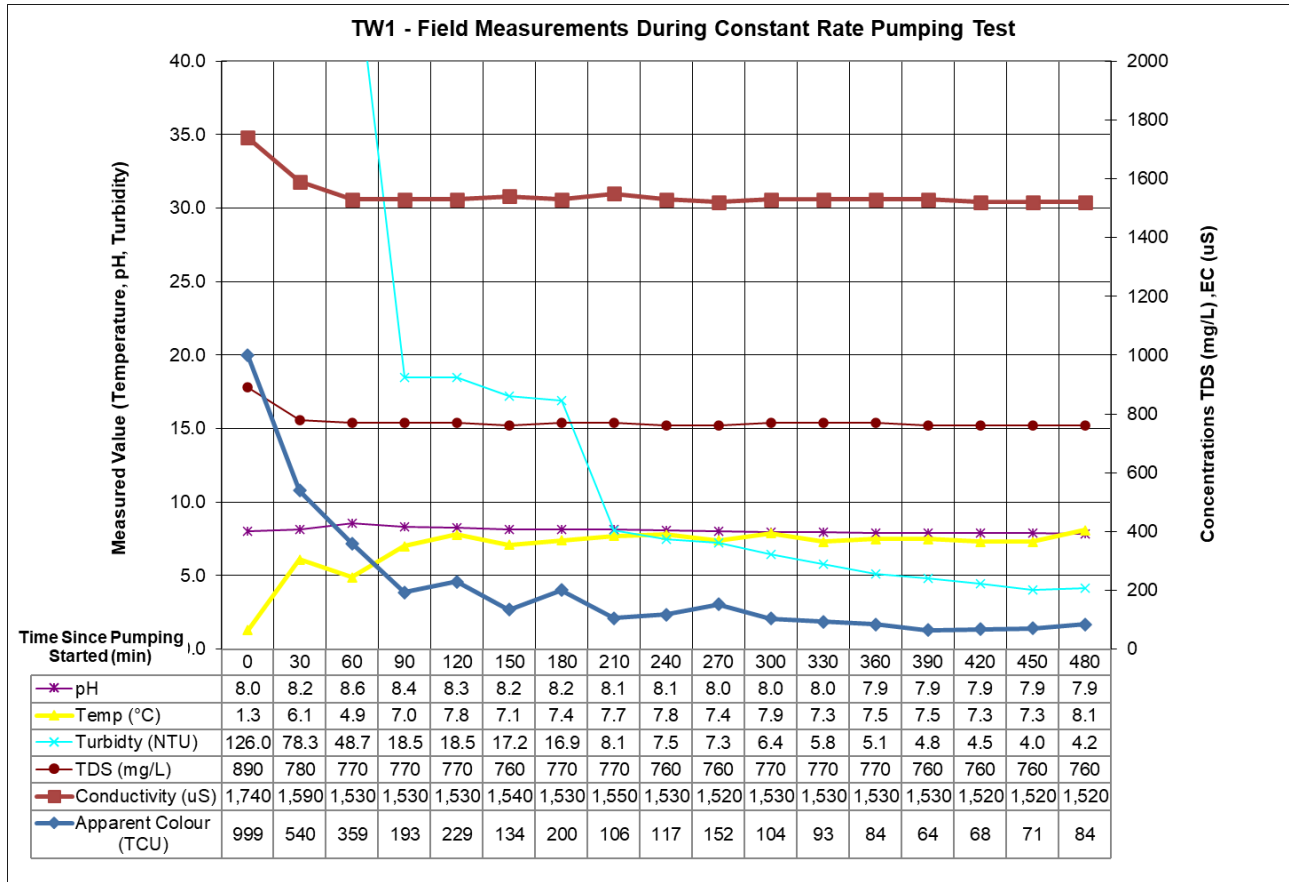
Figure 1: Field Measurements

Turbidity, electrical conductivity, total dissolved solids (TDS), pH, apparent color and temperature were measured at the wellhead during the pumping test. The measurements and time intervals for each of these parameters are summarized on the graphical representation (Figure 1) below. In addition, a HACH Pocket Colorimeter II chlorine reader was used to measure the free chlorine residual level. No chlorine residual was detected in the discharge water prior to the collection of the water samples.

Hydrogen sulfide was detected olfactorily during the pumping test. Hydrogen sulfide was measured using the HACH Hydrogen Sulfide Test Kit, Model HS-C, (# 2537800) when it was detected. Hydrogen sulfide was measured in the range of 0-0.1 mg/L at each point.

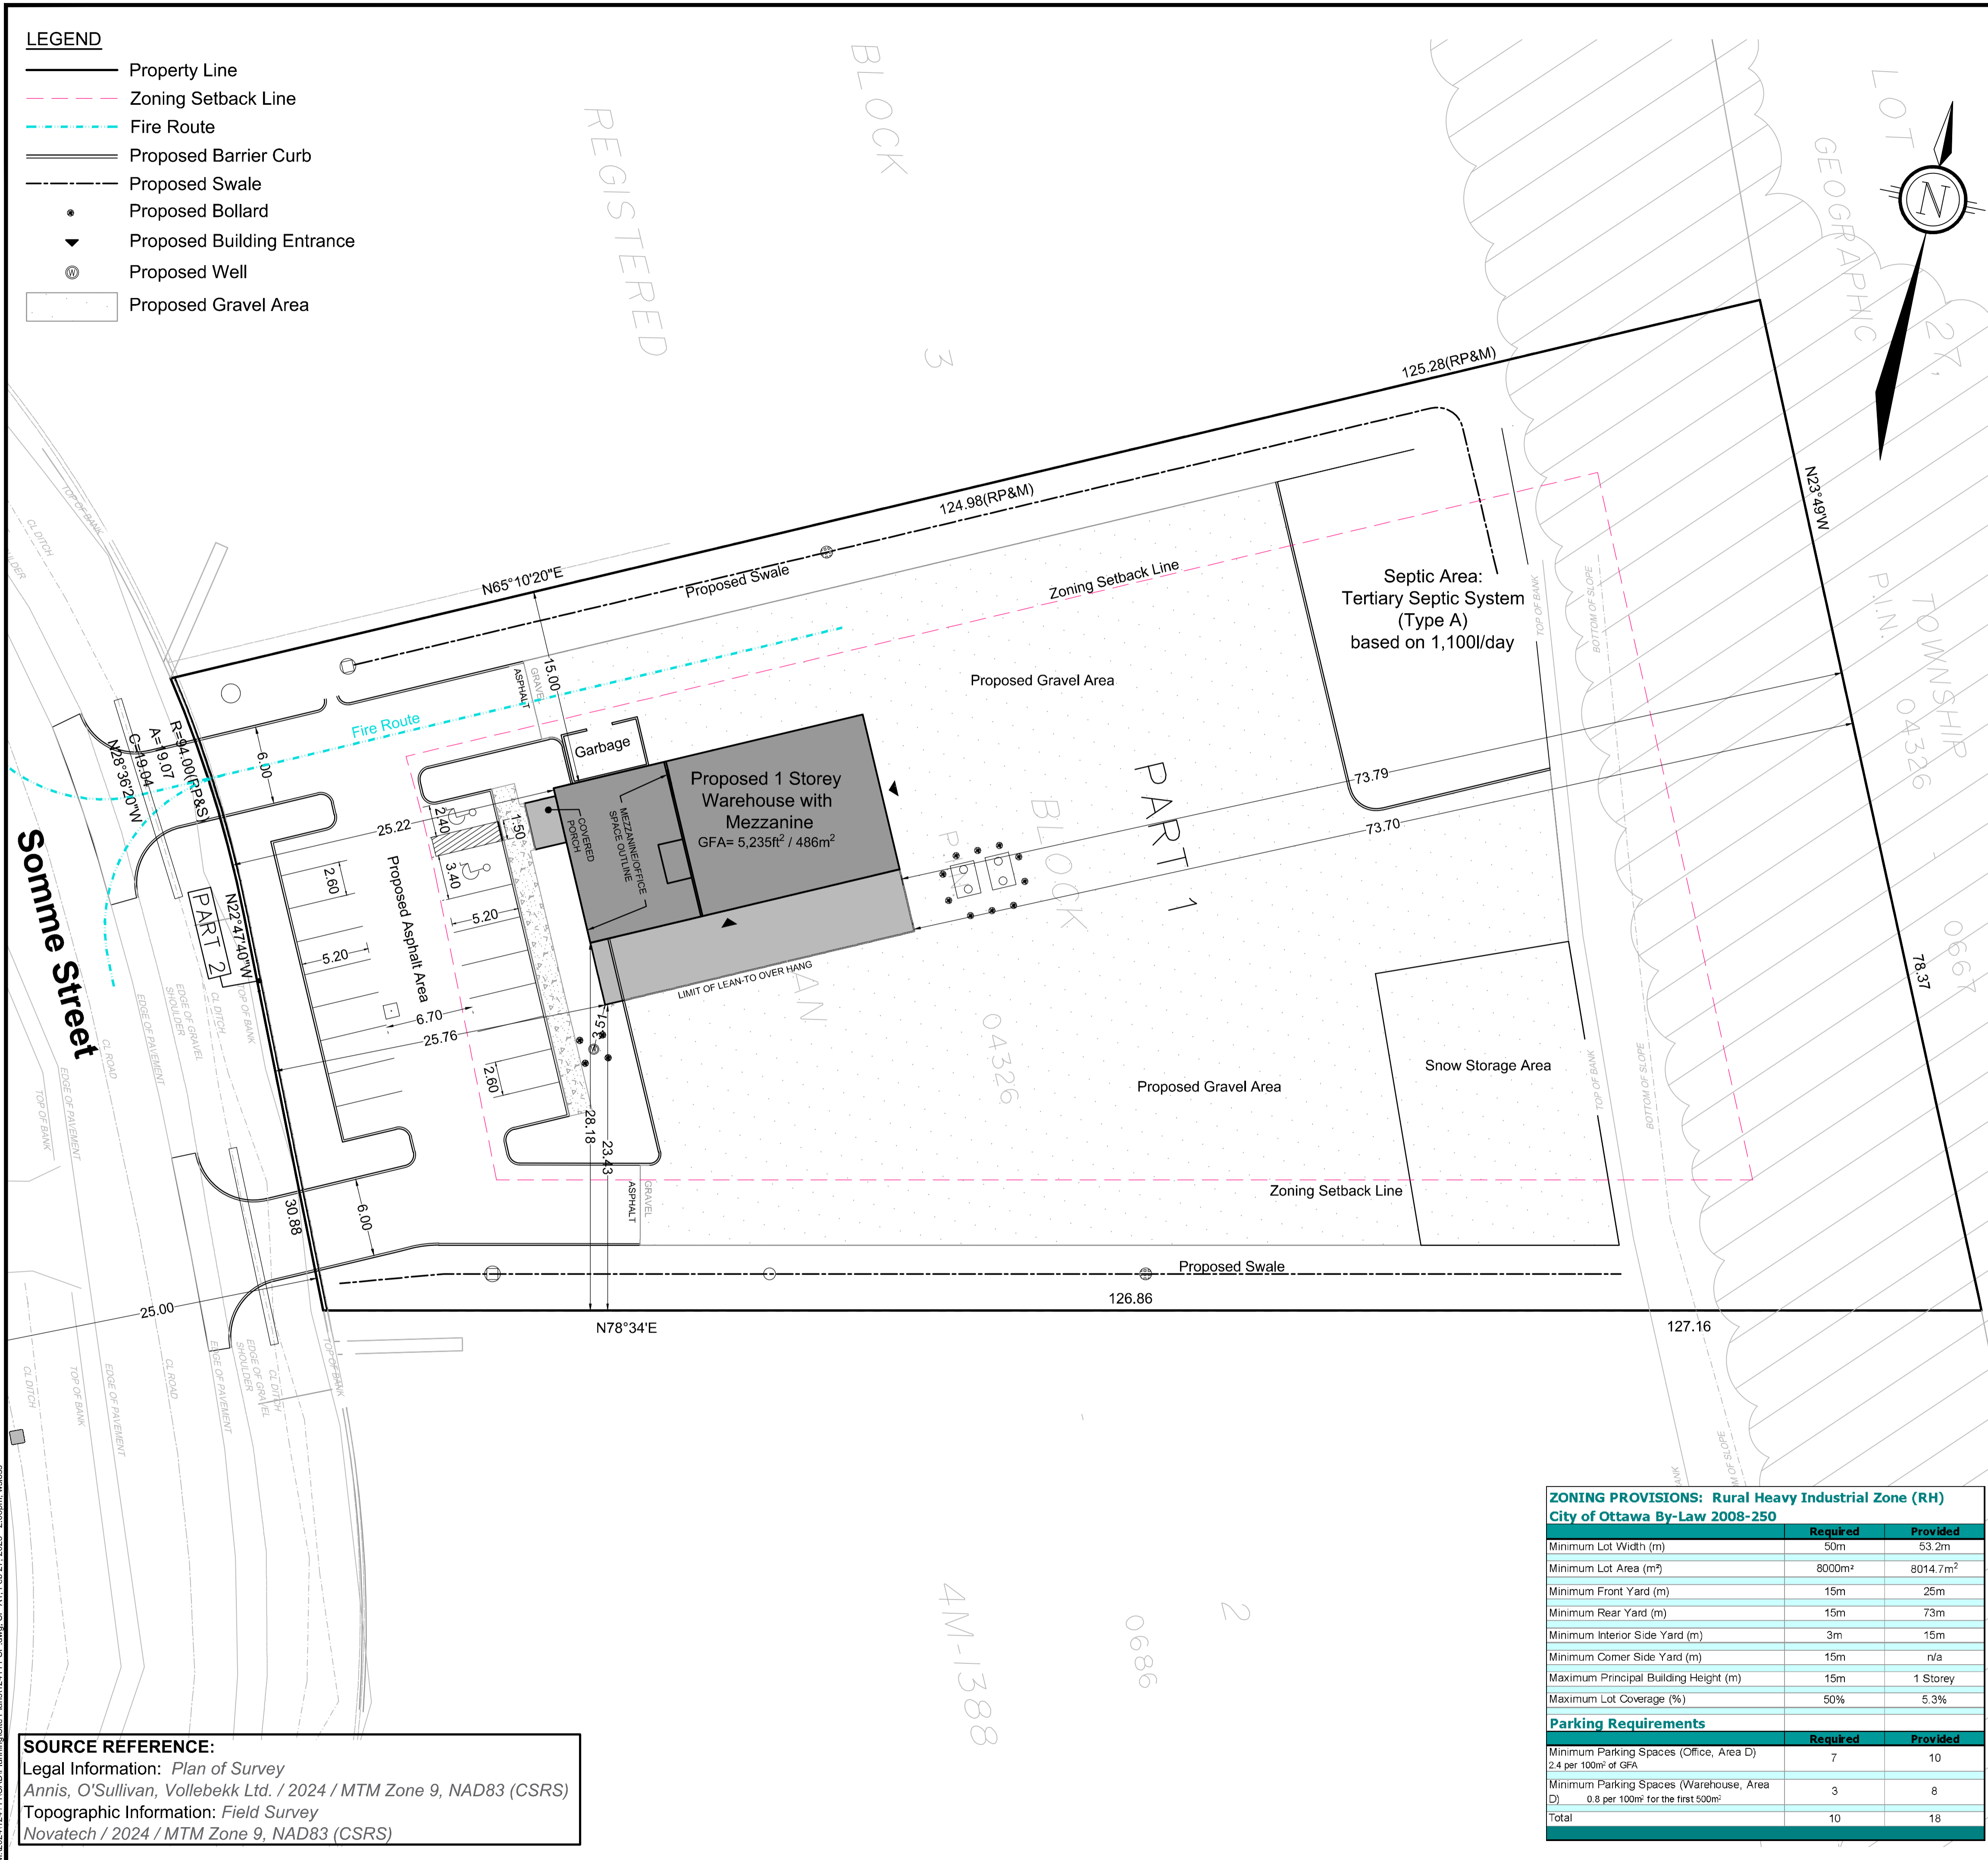
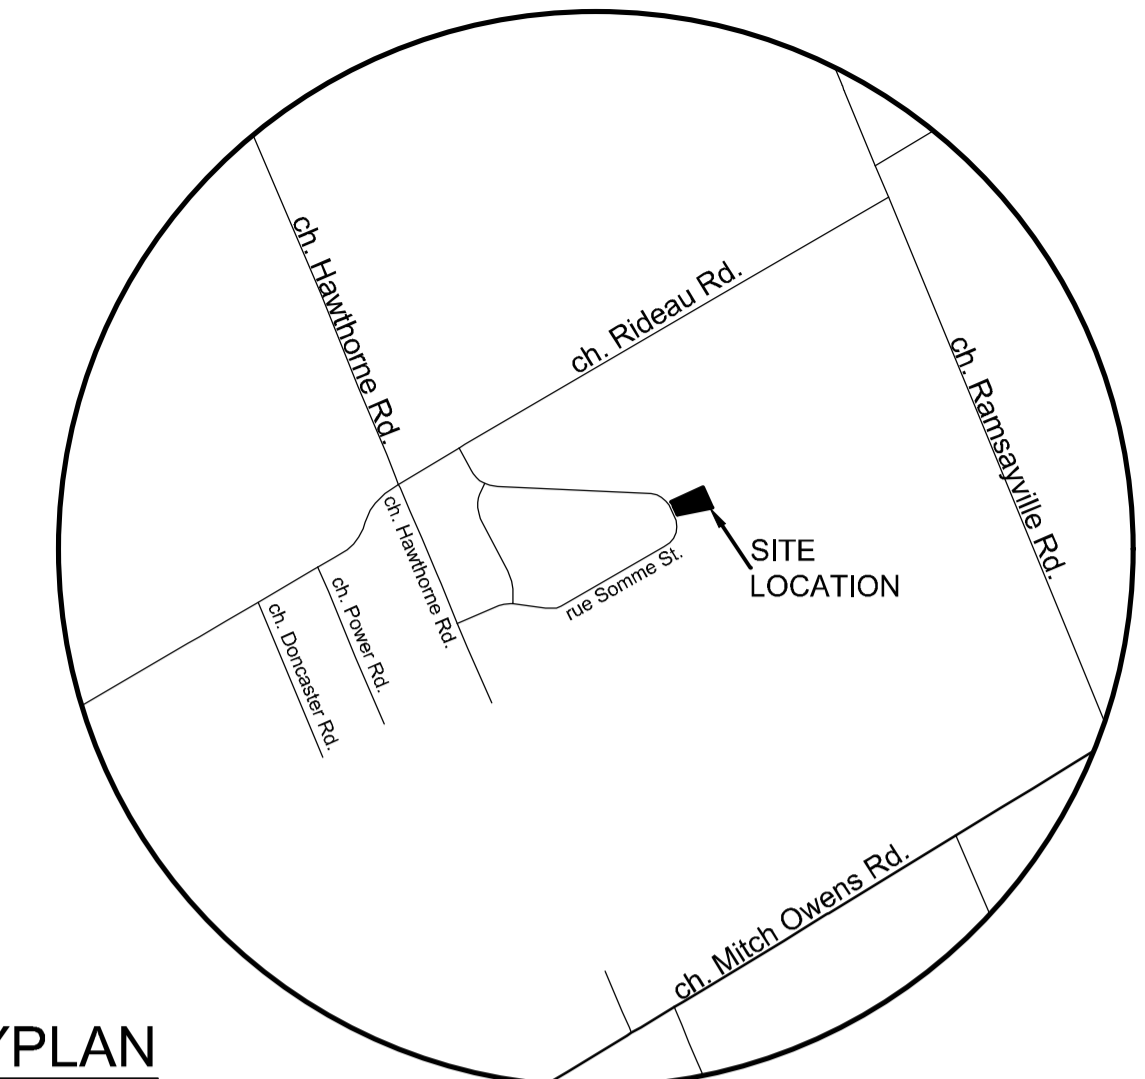
# SITE PLAN

A one-storey warehouse with a mezzanine and an office along with associated parking and infrastructure is proposed to be constructed onsite. The location of the proposed structure can be found on the attached Novatech Drawing 124111-SP, Site Plan dated February, 2025. The proposed private sewage servicing and site grading design is provided by Novatech.

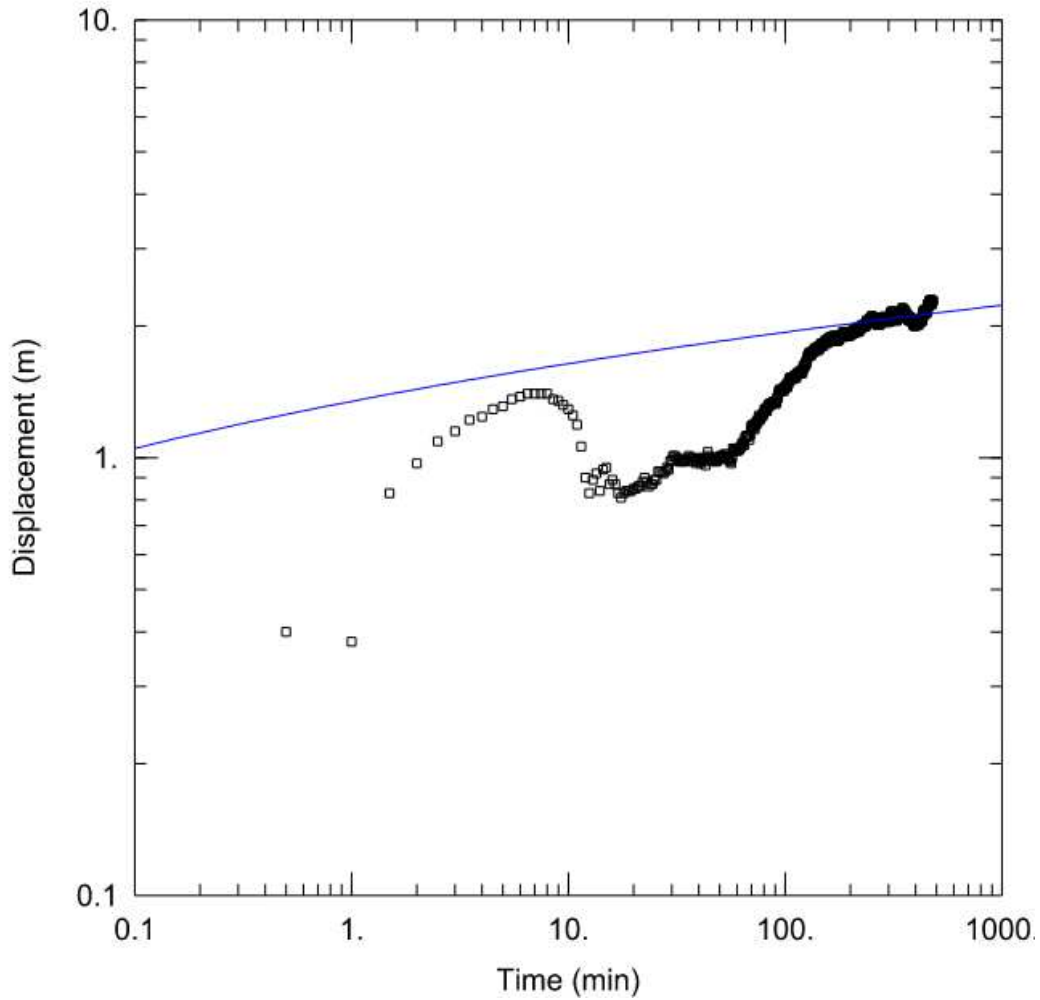
**Pumping Test Analysis Report**

File No.	PH4991	Well ID:	TW1
Date:	March 4, 2025	Solution Method:	<b>Theis</b>
Client:	Titan Environmental	Transmissivity (m <sup>2</sup> /day):	51
Site Address:	541 Somme Street	Storativity	0.0003793
Project:	Site Plan Control Application	Discharge Rate (L/min)	57
		Analysis performed by:	AS

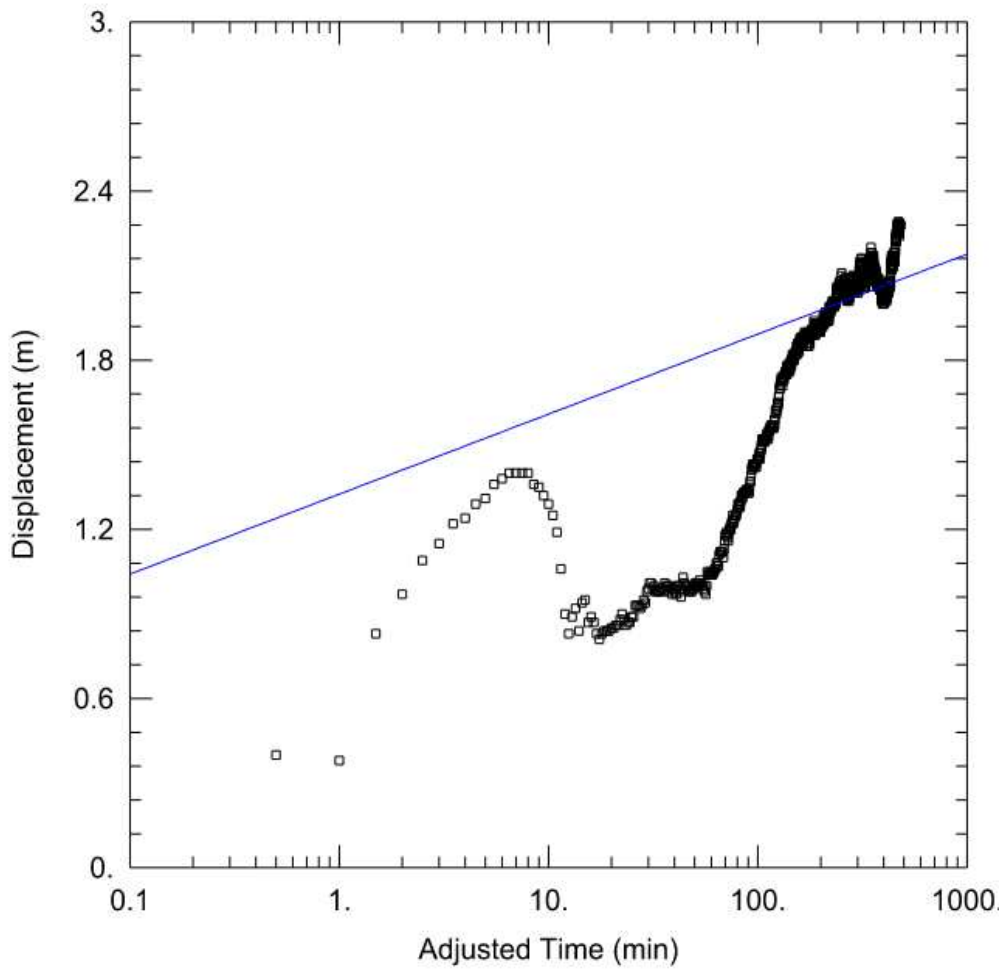
**Pumping Test Analysis Report**

File No.	PH4991	Well ID:	TW1
Date:	March 4, 2025	Solution Method:	<b>Cooper-Jacob</b>
Client:	Titan Environmental	Transmissivity (m <sup>2</sup> /day):	53
Site Address:	541 Somme Street	Storativity	0.0003083
Project:	Site Plan Control Application	Discharge Rate (L/min)	57
		Analysis performed by:	AS

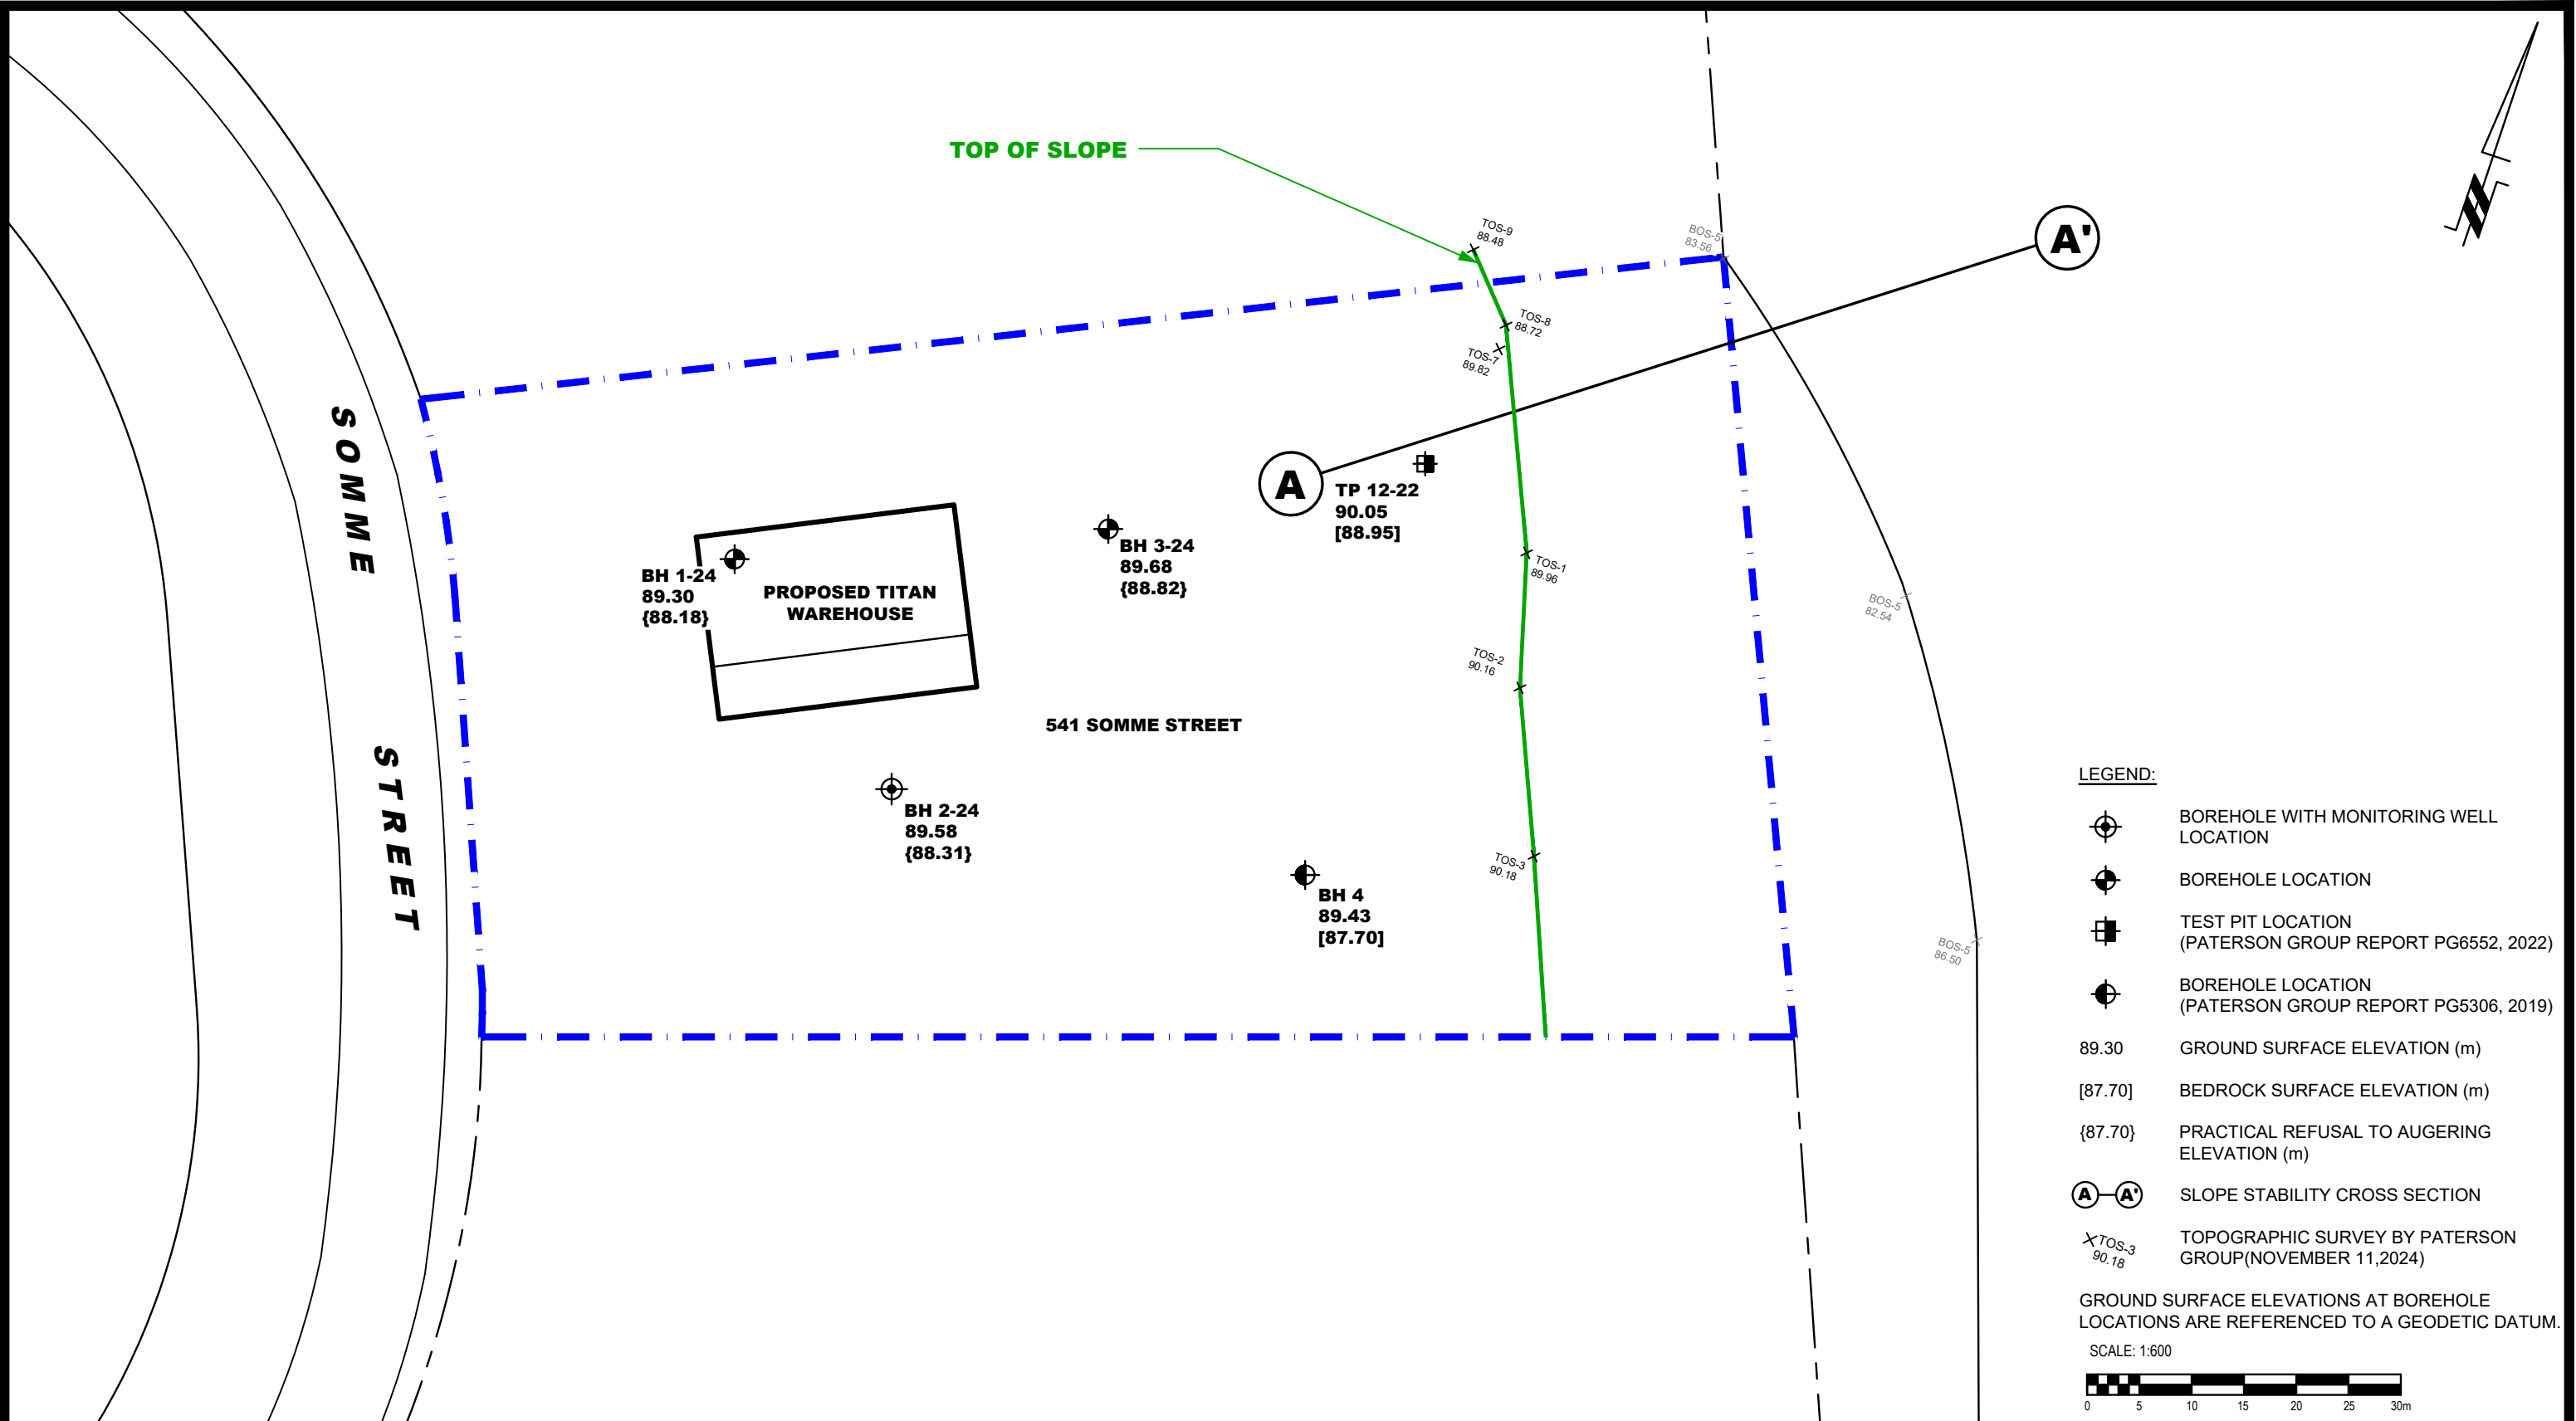
A series of boreholes were put down on the subject parcel to delineate the subsurface soil conditions as part of the Geotechnical Investigation (Paterson Report PG7327-1 dated November 25, 2024). On November 11, 2024 three (3) boreholes were excavated on the property for the design of the proposed building and its associated infrastructure. The boreholes were advanced to a maximum depth of 1.3 m below ground surface (bgs). Additionally, one borehole (Paterson Report PE4828-1R, 2019) and one test pit (Paterson Report PG6452-1, 2022) were excavated at the site during previous investigations. The boreholes were distributed in a manner to provide general coverage of the subject site, taking into consideration underground services and available site access. The locations of the test pits on the property are delineated on the Test Hole Location Plan, drawing PG7327-1, attached.
