## Engineering Report

# South March Battery Energy Storage System (BESS) Preliminary Geotechnical Investigation

H375142-0000-2A0-230-0001

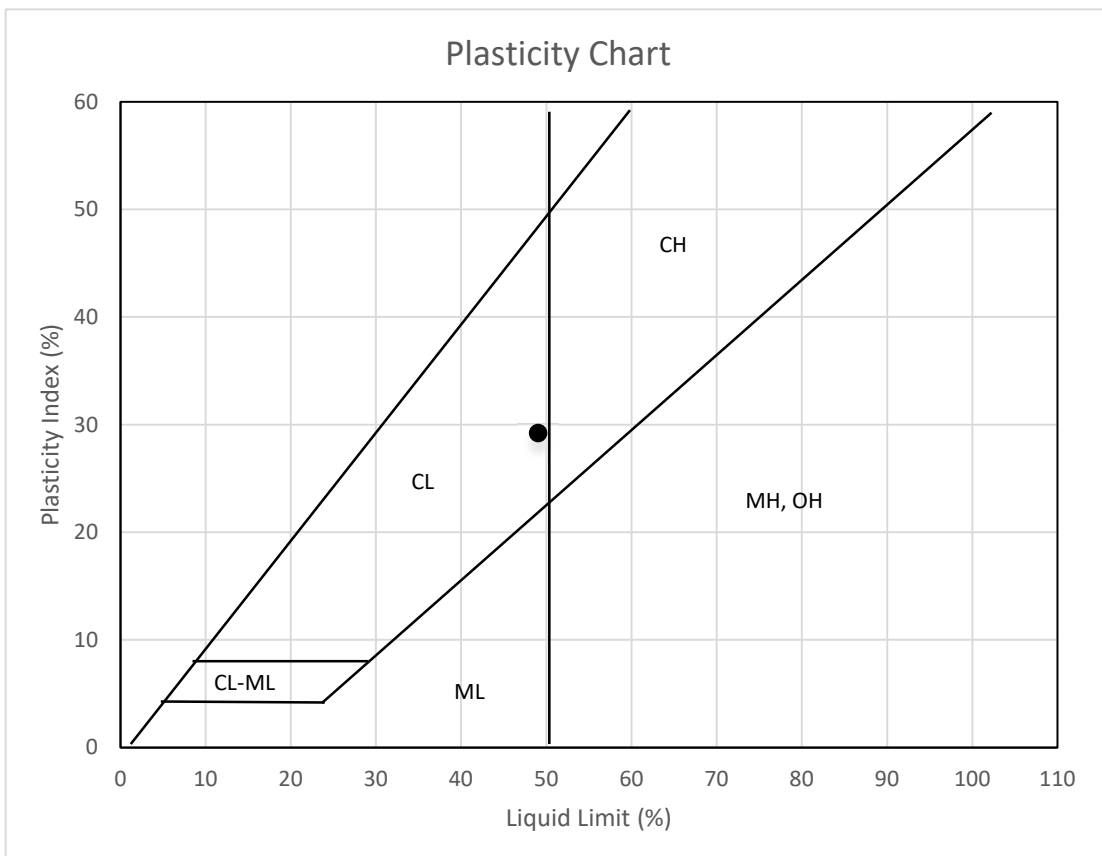
<b>Sample</b>	SS3	<b>Depth</b>	5ft - 7ft
<b>Source</b>	FY24-1

Liquid Limit	49%
Plastic Limit	20%
Plasticity Index	29%

**Comments:** Silty-Clay, grey.

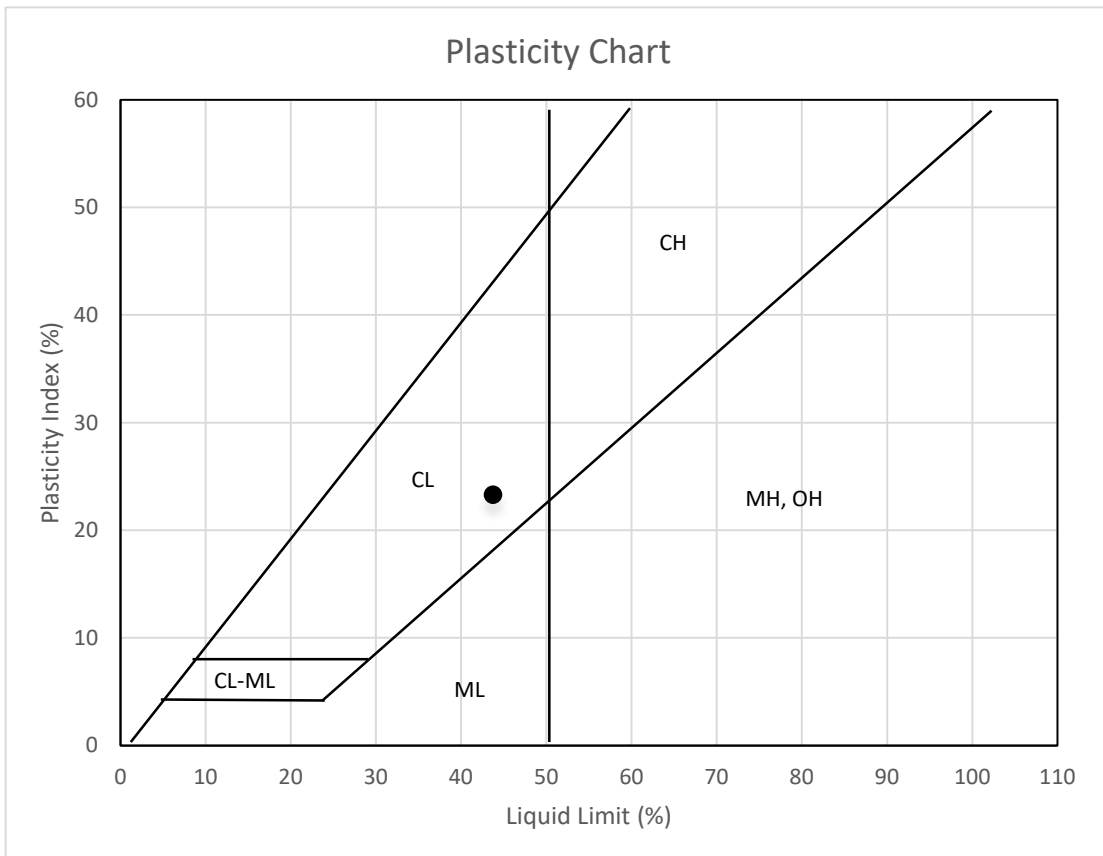
<b>Sample</b>	SS10	<b>Depth</b>	18ft - 20ft
<b>Source</b>	FY24-5

Liquid Limit	44%
Plastic Limit	20%
Plasticity Index	23%

**Comments:** Silty-Clay, grey.

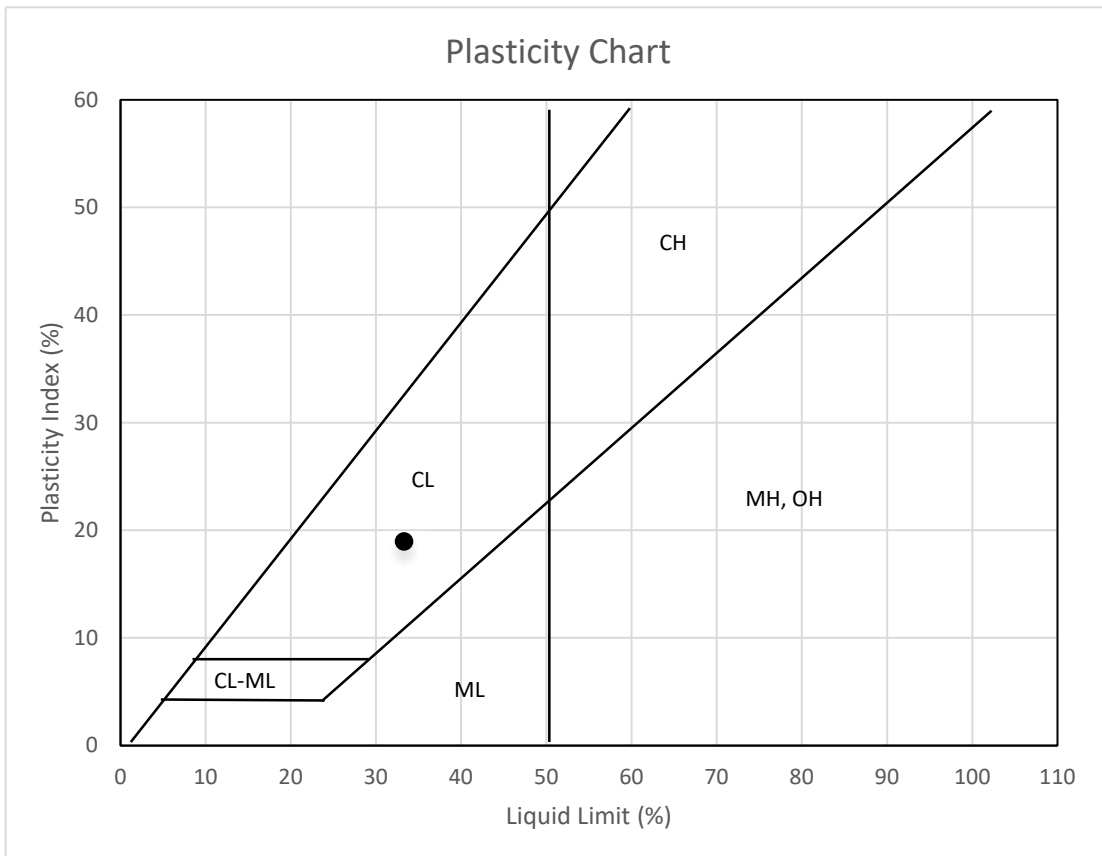
<b>Sample</b>	SS7	<b>Depth</b>	15ft - 17ft
<b>Source</b>	FY24-7

Liquid Limit	33%
Plastic Limit	14%
Plasticity Index	19%

**Comments:** Silty-Clay, grey.

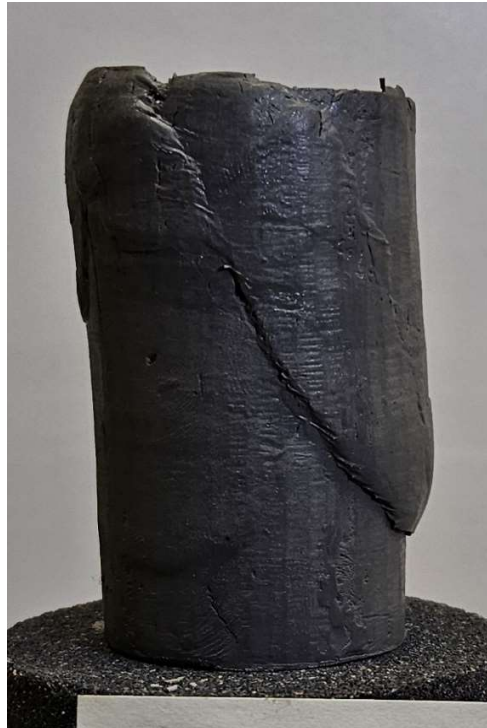
**AFTER**

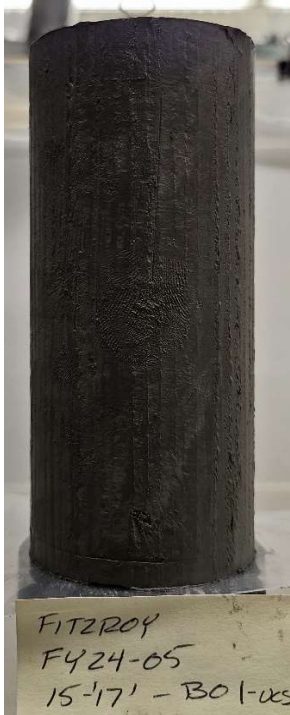
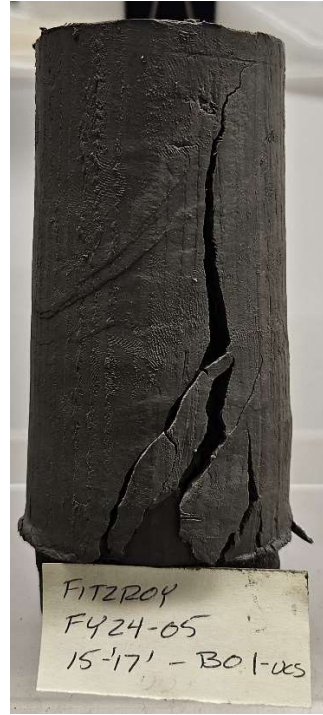
Sample	4.57 m to 5.17 m
Source	FY24-05

**BEFORE**

**AFTER**

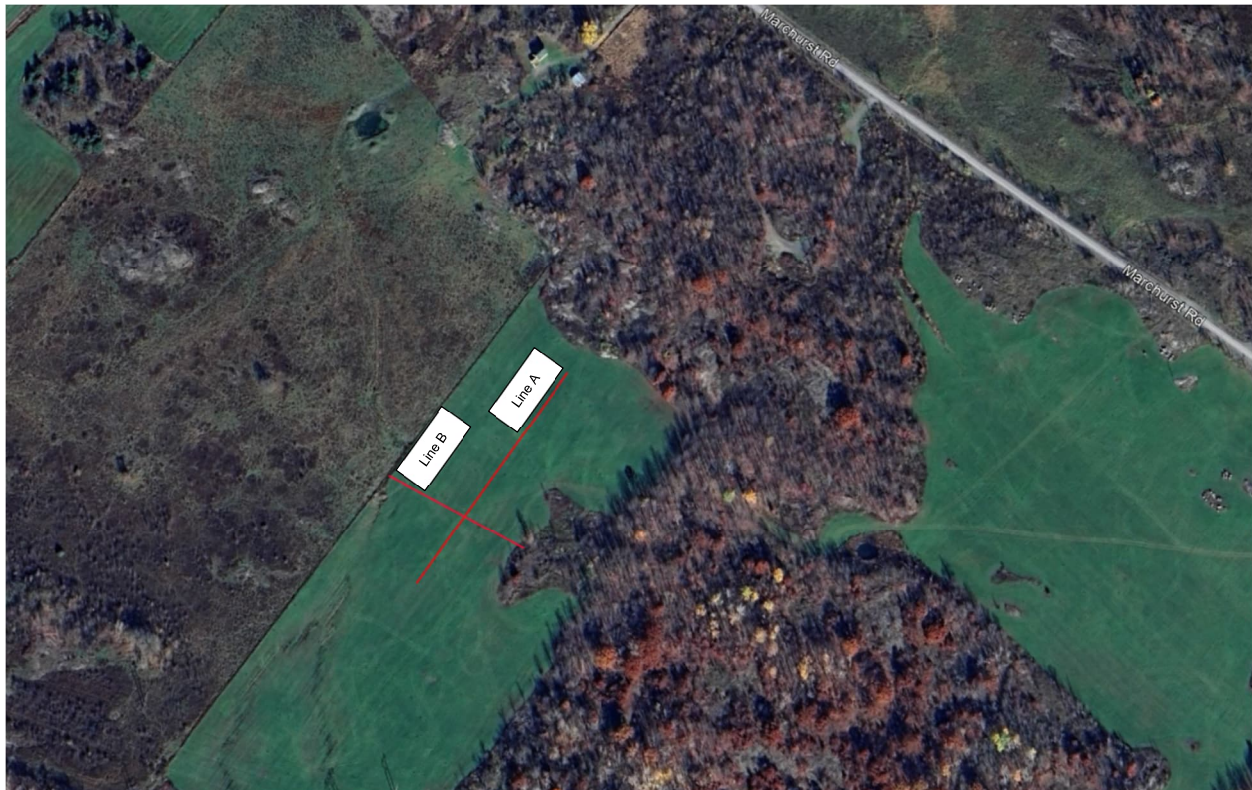
Figure 2: Site Map Showing VES Test Location (Red Line)

Figure 2 displays a general project location map indicating the VES test location.

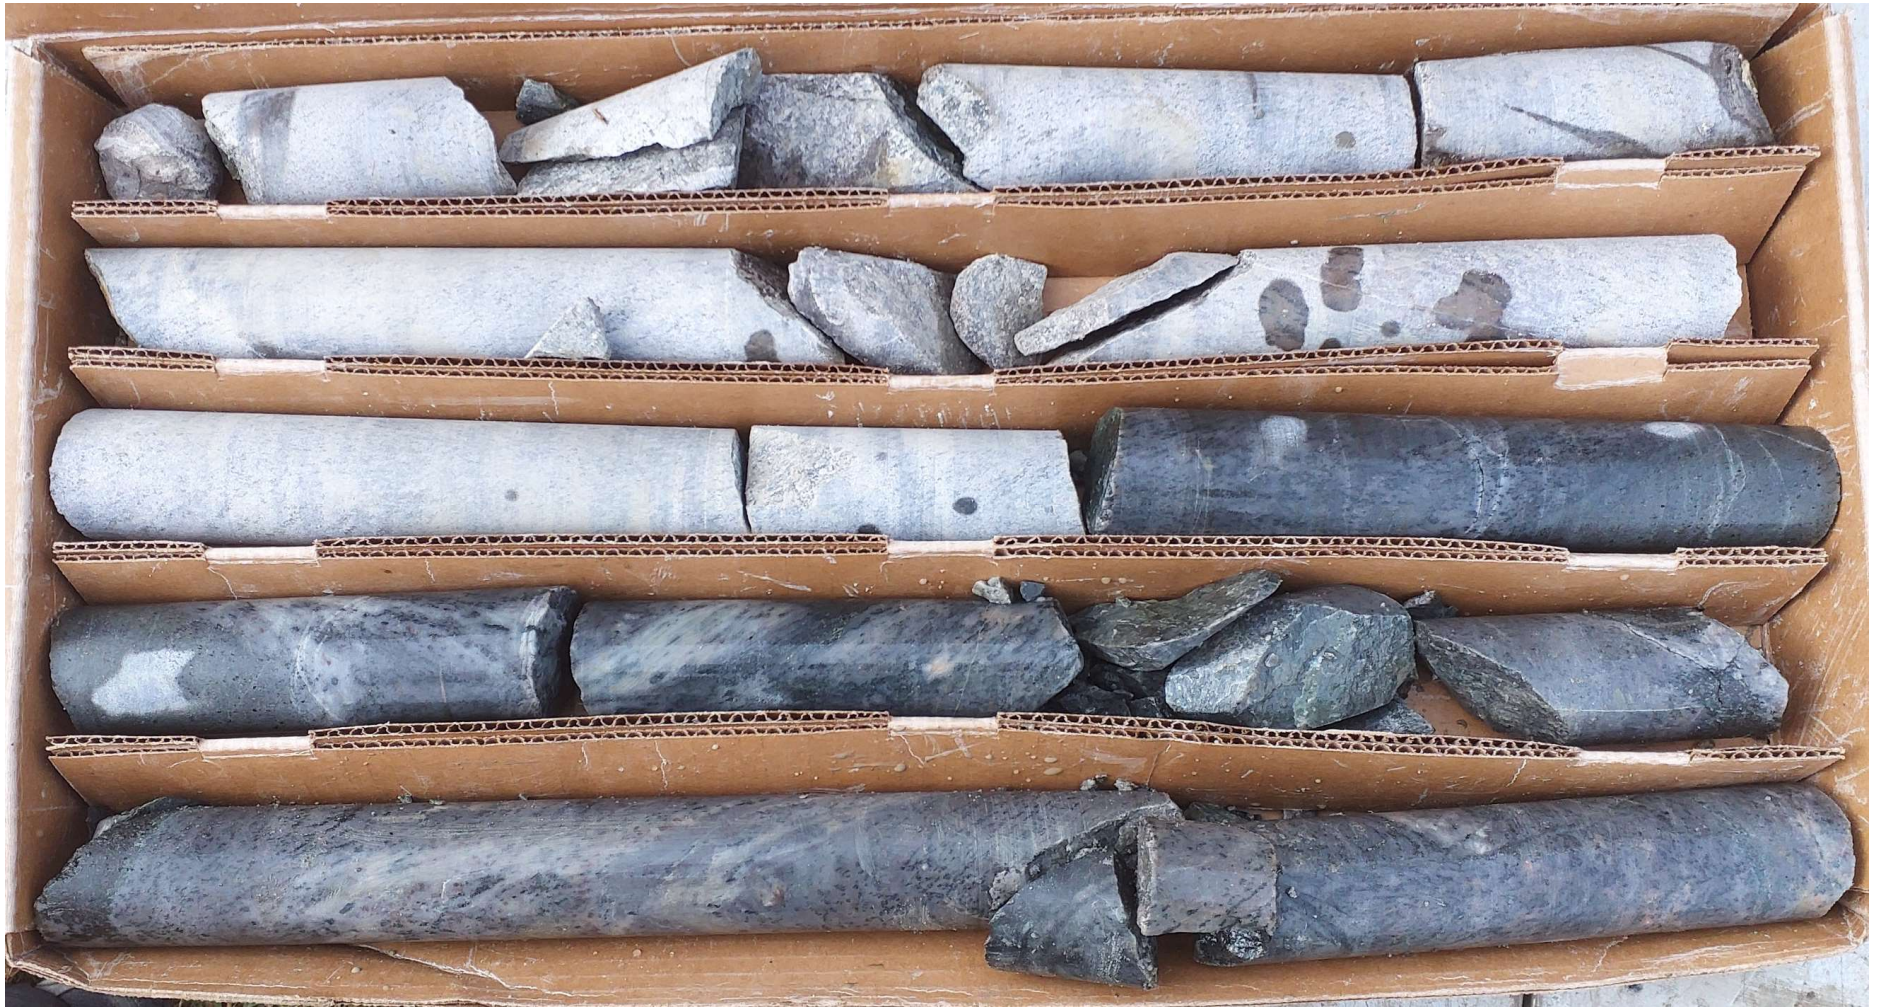
FY24-1- Box 1 - 6.14 m - 9.14 m

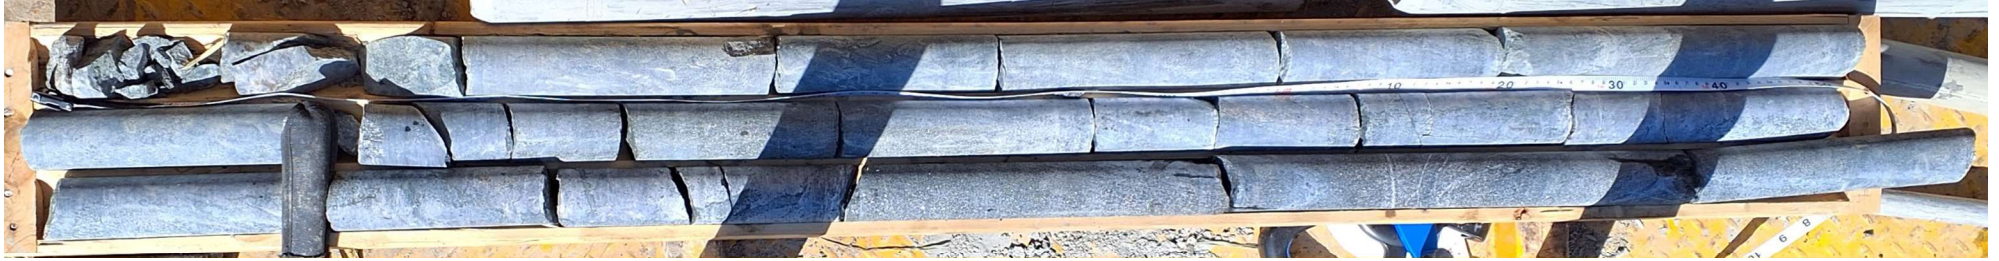
FY25-1- Box 1 – 5.70 m – 10.55 m

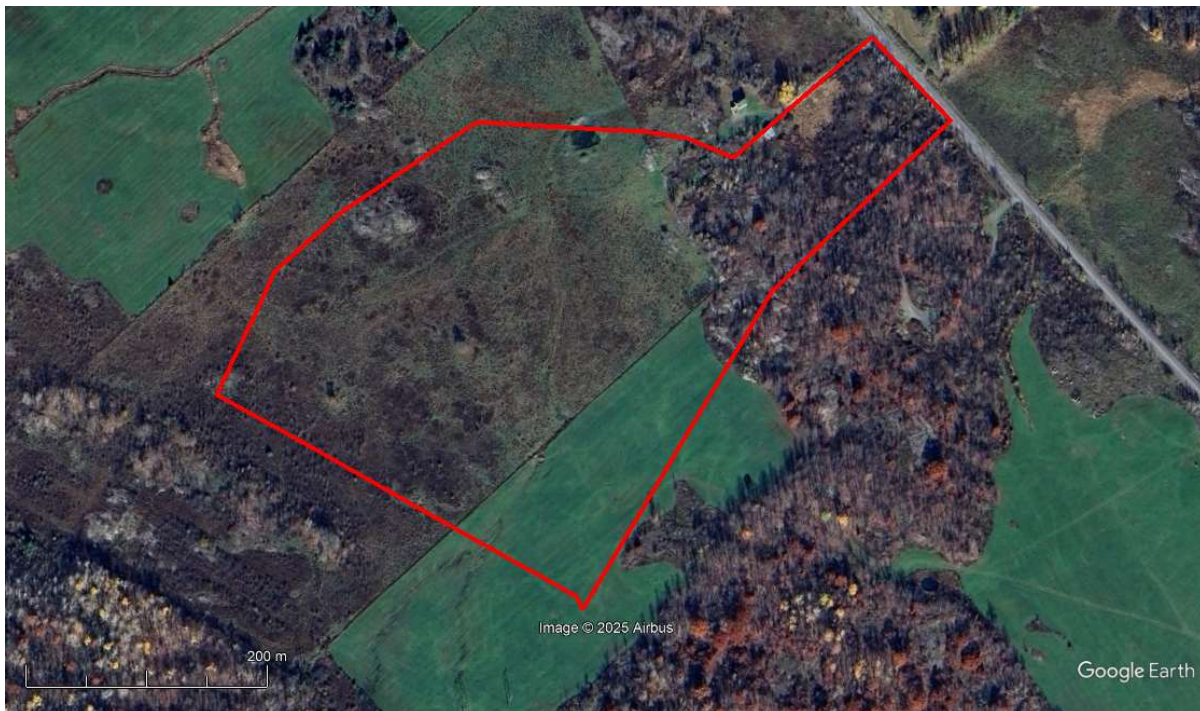
Figure 1: Overview Map with the extent of survey area in red

A future BESS (Battery Energy Storage System) is proposed with a footprint spanning across 2555 & 2625 Marchurst Road in Dunrobin, ON. Simcoe Geoscience (herein referred to as Simcoe) was requested by HATCH to conduct seismic site class testing and bedrock tomography mapping spanning an area roughly encompassing the extents of the operation (Buildings, structures and buried utilities). A Geonics EM31-mk2 Terrain Conductivity Meter combined with seismic refraction, seismic MASW and a few boreholes to generate a bedrock tomography map. Figure 1 shows the extent of the scanned area using all geophysical methods.

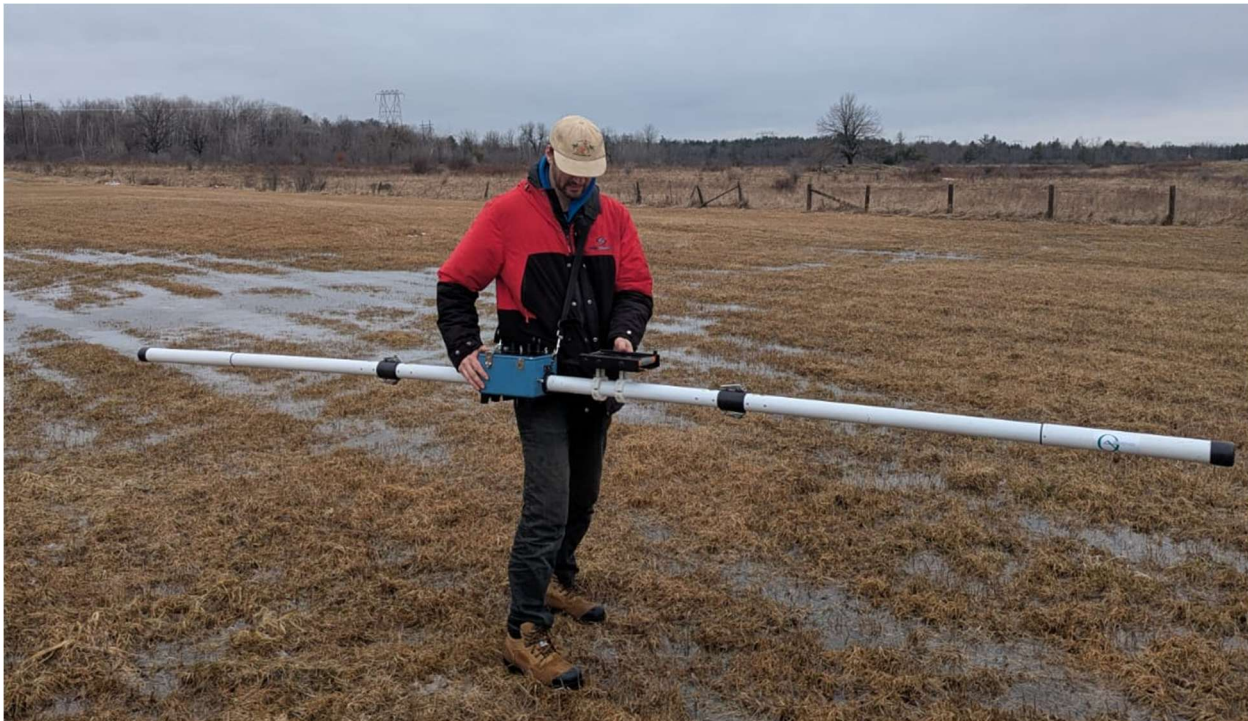
the property properly, the instrument's lateral range of detection was taken into consideration therefore a 10 meter of separation between profiles was chosen. The instrument and operator can be tracked and their path recorded and displayed on a tablet in real-time so the operator could maintain even coverage. Obstructions on site were mostly avoided, with only some small patches of thorny bushes and a swamp to the north-east being too hazardous to pass. Figure 2 shows the EM-31 Mk2 device on site.

Figure 2: Geonics EM-31 Mk2 on site

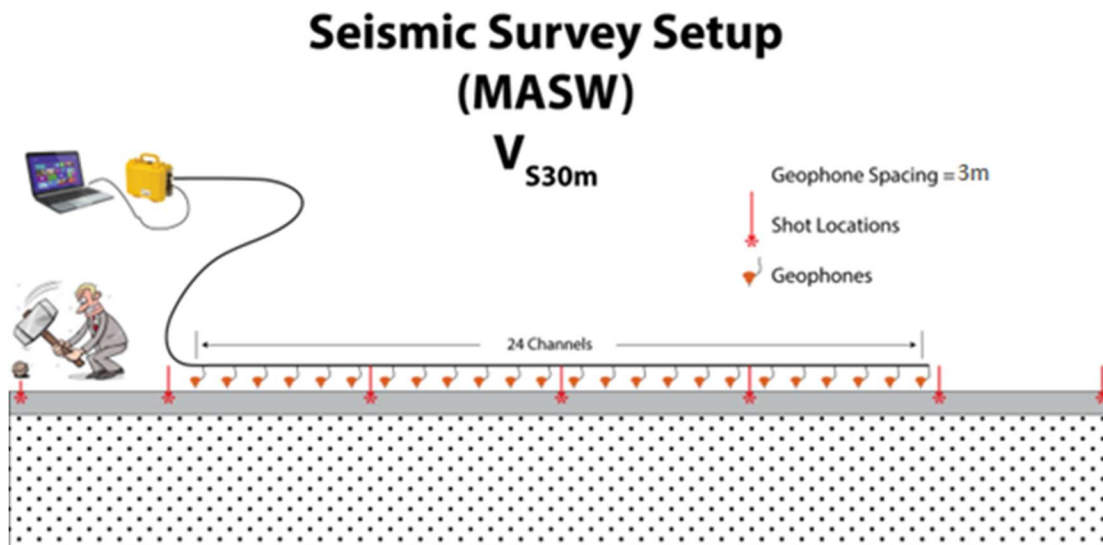
Figure 3: Seismic 3-meter Spacing Field Setup, Geophones (orange), Shot Locations (red)

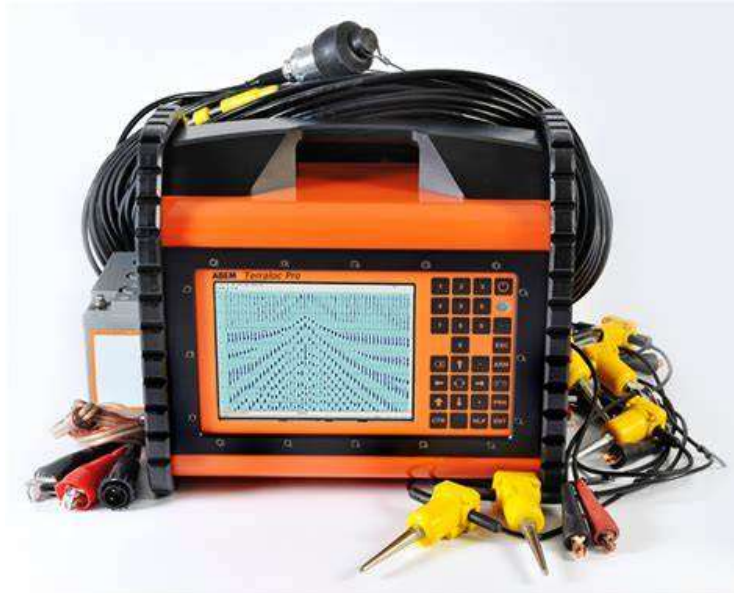
For this study, data was collected with ABEM Terraloc Pro 2™ seismograph - 24 channels and 4.5 Hz geophones. Figure 4 shows both pieces of equipment. A sledgehammer was used as the primary energy source with traces being recorded at 7 locations: one shot at centre, two shots at 6m and 20m offset beyond the end of the line and two shots between the first two and last two geophones. Each shot records P and S waves simultaneously. Figure 3 shows typical field setup for 3-meter receiver interval. Note that the shot locations are different in Figure 3 than in the executed survey. It is common to adjust shot locations depending on factors such as rock depth, field conditions (like noise) and intended requirements for the survey.

Figure 4: ABEM Terraloc Pro 2 – 24 Channel Seismograph with 4.5Hz geophones.

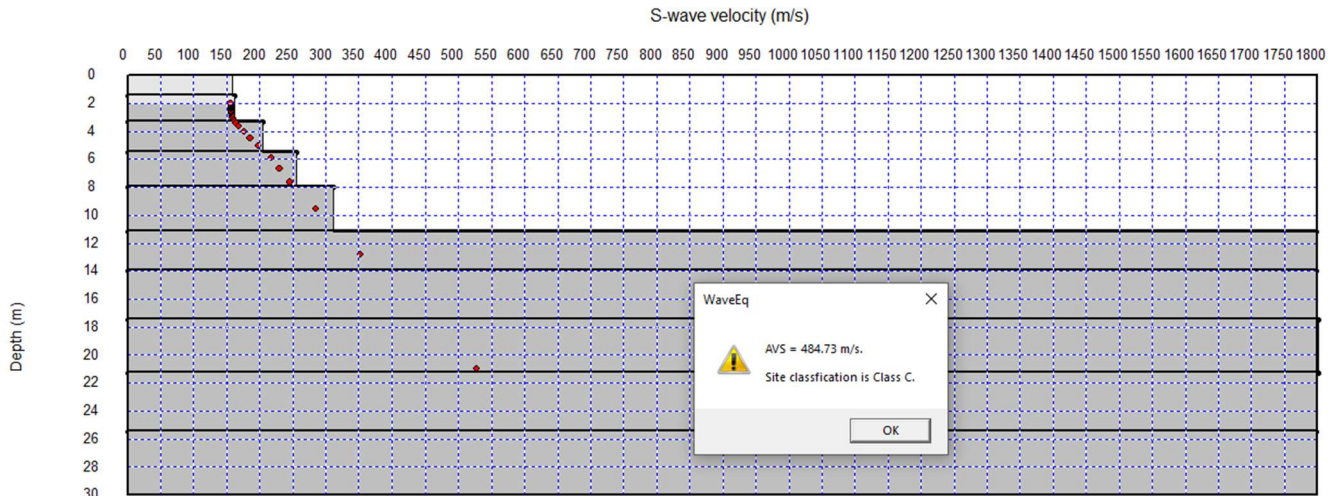
Shear wave velocities for the first 2 meters are characteristic of typical topsoil, often saturated to within a meter of surface. Velocities in this area are typical of topsoil, at about 150-160m/s. The basis material for the soil is silty clay with low plasticity and some trace sand. The velocity of this clay layer steadily increases with depth as compaction builds atop itself, there is evidence of a thin till layer just before bedrock, judging from other boreholes in the area. Velocity of the overburden layer reaches about 300-320m/s as a maximum before reaching the granitic bedrock layer. Following the refraction models, bedrock is predicted to be about 11 metres deep here.

Figure 10: Shear-Wave Model under Line 3

The following Figure 9 is the dispersion curve from Line 3. Figure 10 is the model from the MASW/MAM sounding.
