Phase One Environmental Site Assessment 2413-2415 Carp Road, Carp, Ontario

Prepared for:
Waste Management of Canada
Watford, Ontario

Prepared by:
BluMetric Environmental Inc.
1682 Woodward Avenue
Ottawa, ON K2C 3R8

Project Number: 250442
8 August 2025

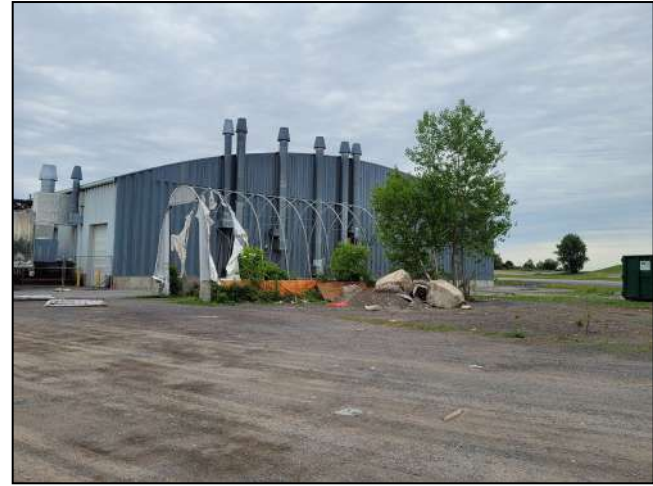
Photo 2: View of shed remnants on-site, with Laurysen
building in background, at 2301 Carp Road
(Photo taken looking southeast).

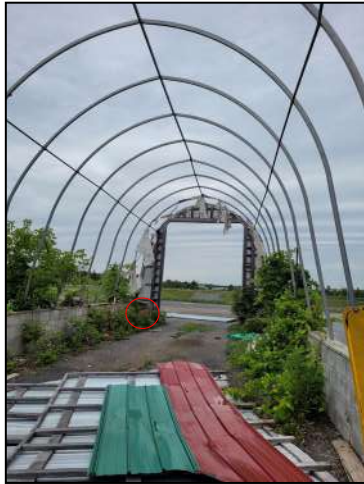
Photo 5: View of shed at northeast corner of property, note jerry can near entrance (red circle)
(Photo taken looking north)

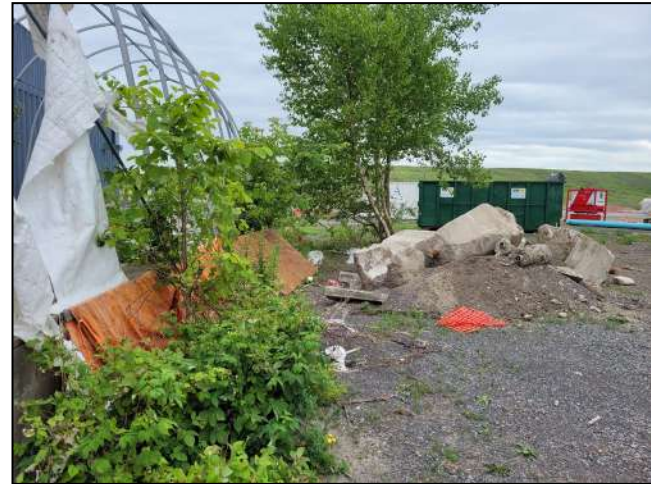
Photo 6: Exterior view of shed, note debris and vegetation
(Photo taken looking south).

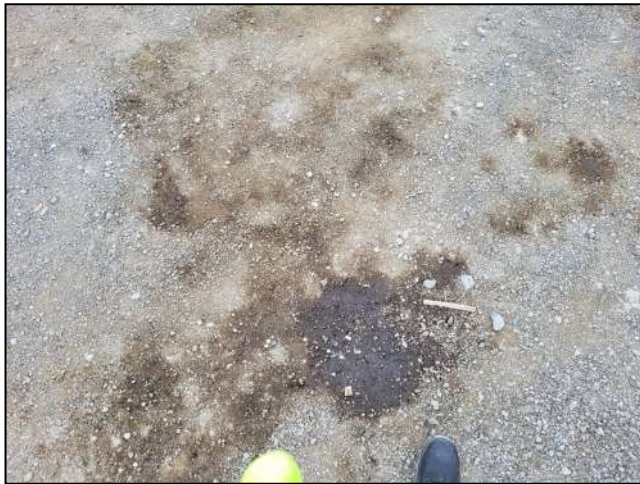
Photo 11: Example of freshly stained gravel.

In July 2025, during site reconnaissance (See Section 5.0), observations were made of oily and stained soil in the area of the shed and at the southwest portion of the Phase One Property. As such, soil was removed to a depth of 0.25 m bgs at the shed area and to 0.20 m depth at the southwest portion of the property, and four surface soil samples were subsequently collected from these areas (one sample was collected at the shed area and three samples were collected at the southwest portion of the property) to determine if impacts were present on the Phase One Property. The reported concentrations for all analytes in soil was less than the MECP Table 7 and Table 2 Site Condition Standards (MECP 2011) at the four sample locations. It was concluded that no impacts to soil were identified at the Site from the stained and oily gravel areas.

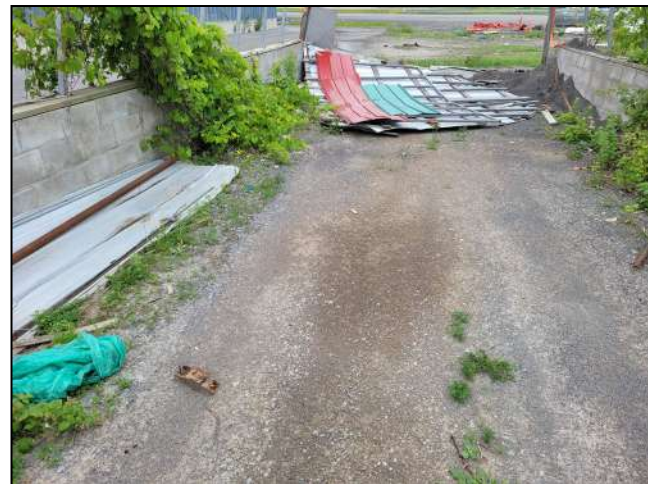
Photo 12: Stained soil in shed area.

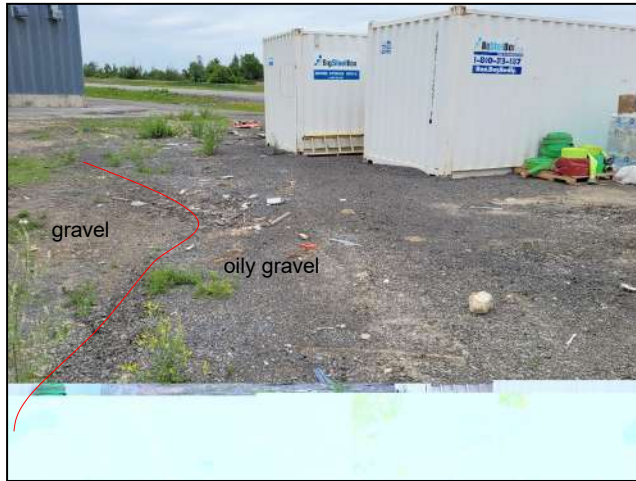
Photo 13: Example of oily gravel placed at the site
(Photo taken looking southeast).

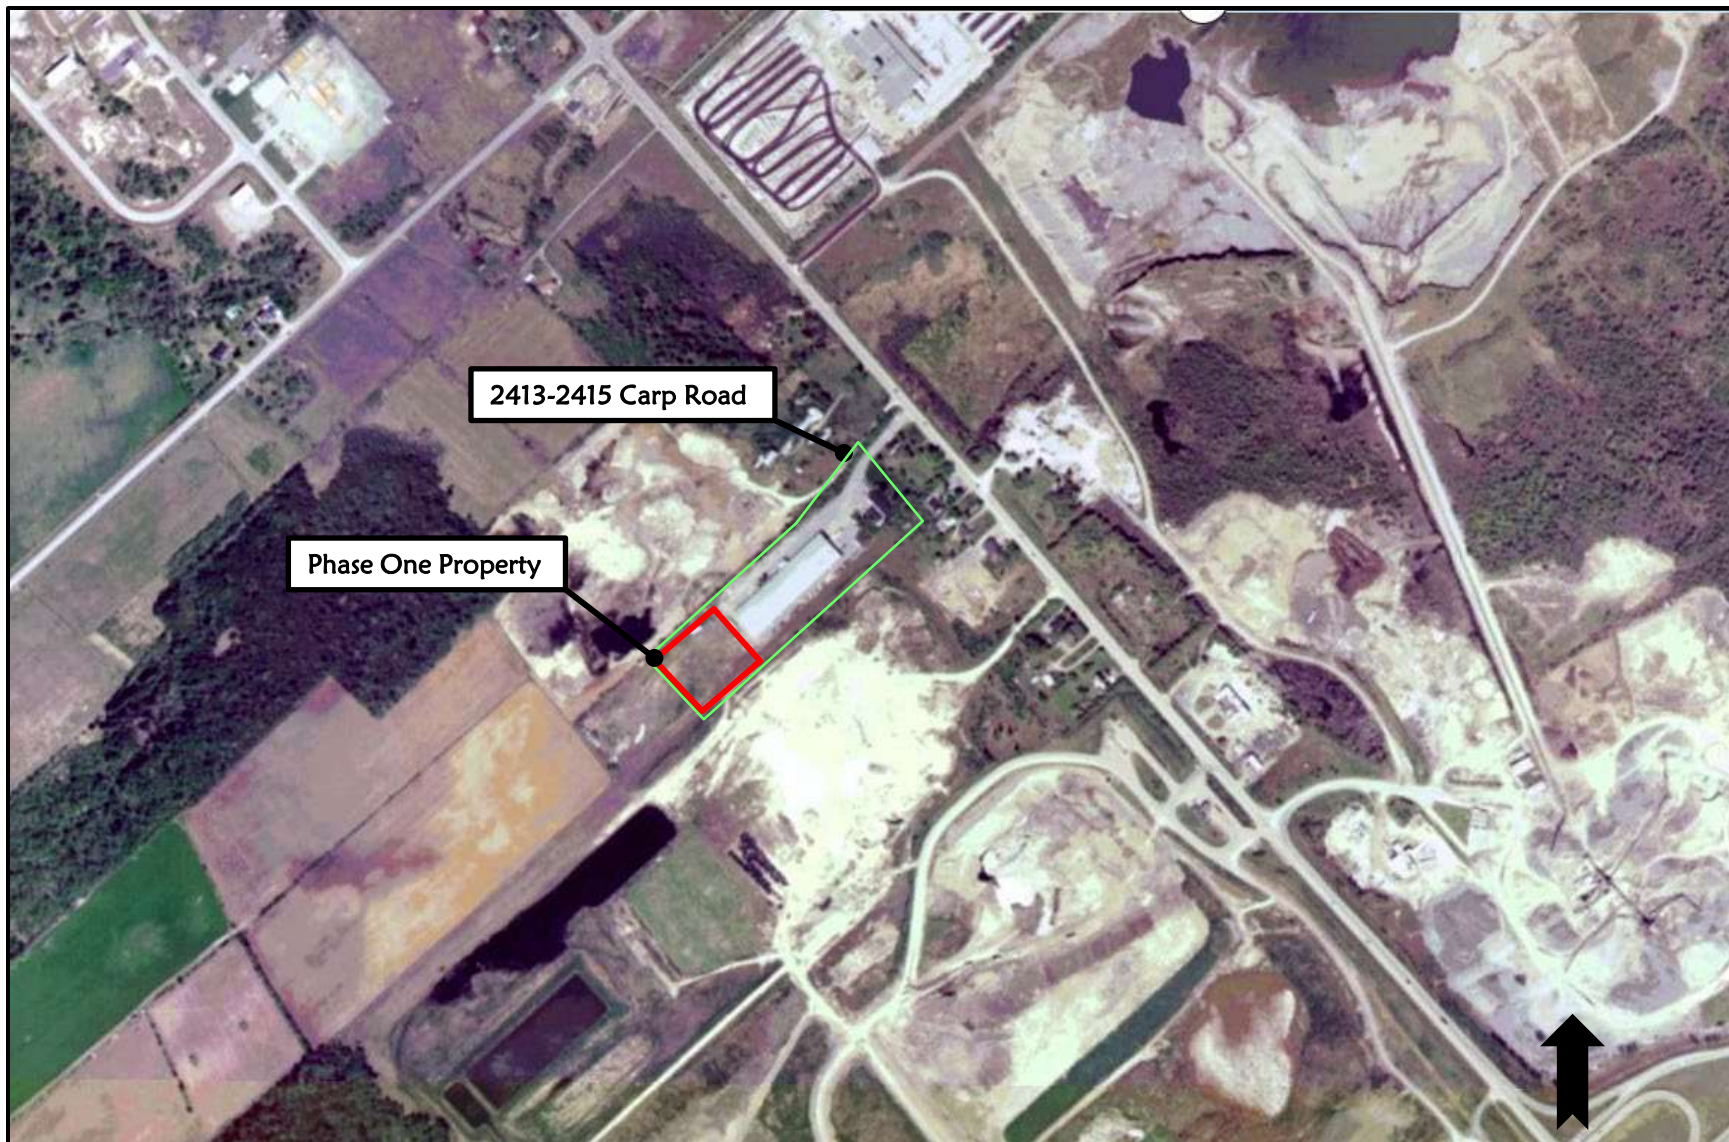
HISTORICAL AERIAL PHOTOGRAPHS – 1999
Phase One Environmental Site Assessment
2413-2415 Carp Road, Ottawa, Ontario

1999	There were no significant changes observed.	Natural wooded areas were removed east of Carp Road and replaced by expanded aggregate quarry operations. The landfill south of the Site has also expanded. Cultivated fields and wooded lands remain to the west-northwest of the Site.
2002	The Phase One property appears to be gravel covered.	There were no significant changes observed.
2005	There were no significant changes observed.	There were no significant changes observed.
2008	There were no significant changes observed. Some storage containers and a shed structure appear to be kept on the property.	There were no significant changes observed.
2011	There were no significant changes observed. Some stockpiled material appears in proximity to the Site, to the southwest.	Aggregate activity to the north of the Site appears to have ceased operation.
2017	There were no significant changes observed. Storage containers are kept on the north part of the Site. Stockpiled soils appear on the south part of the Site.	The quarry area has expanded. Vegetation growth is visible in the landfill area. Some new residential and commercial development is visible north of the Phase One Property.
