# **Geotechnical Investigation**

## **Proposed Commercial Development**

301 Somme Street  
Ottawa, Ontario

Report PG7567 -1 dated August 14, 2025

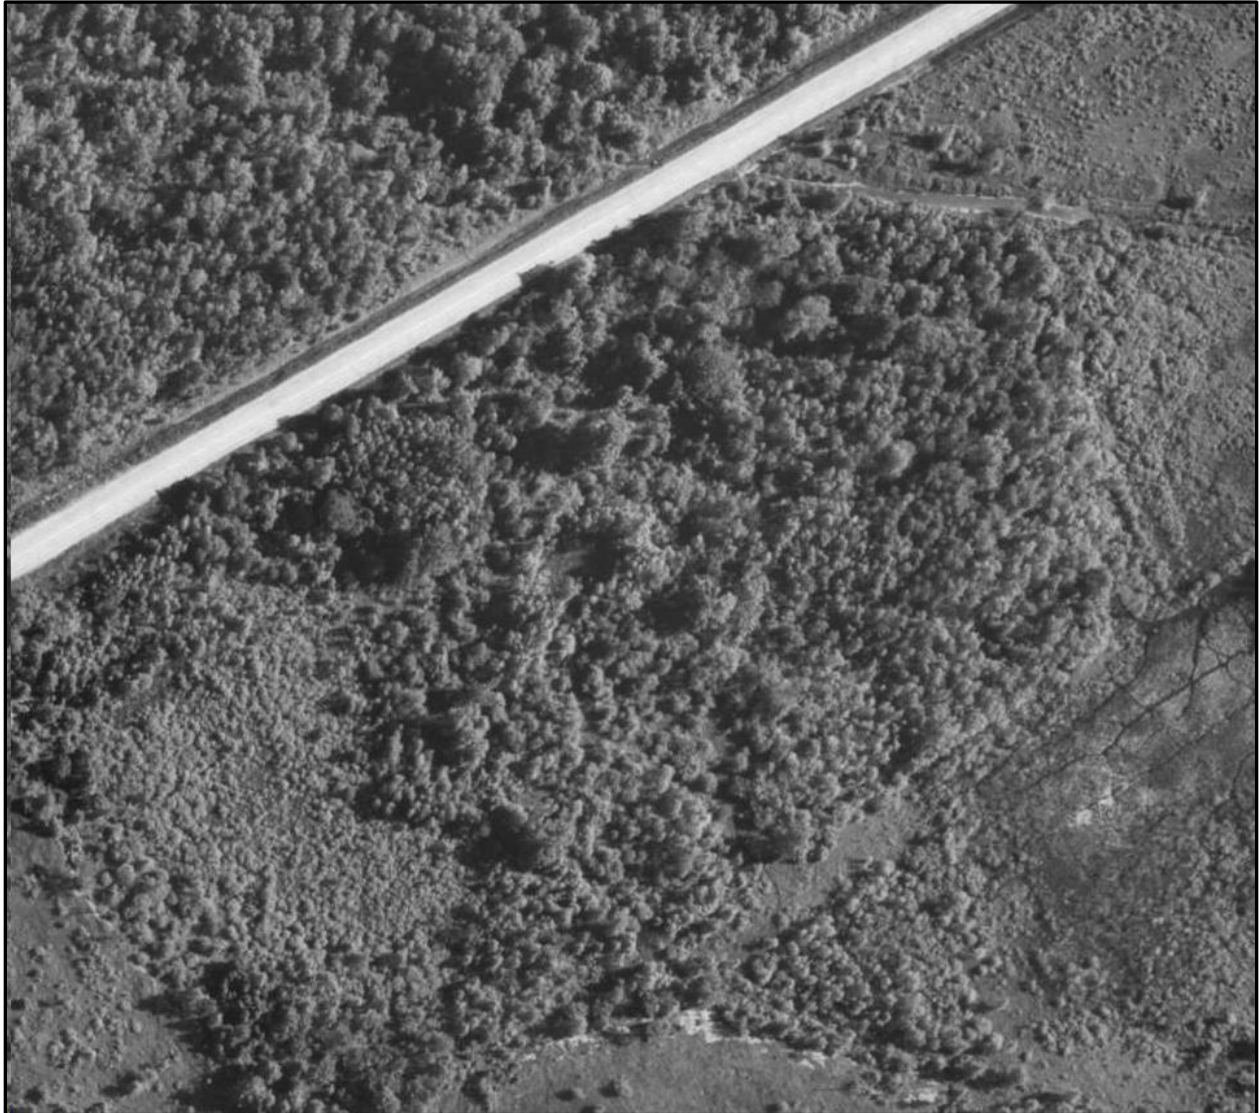
## **FIGURE 2**

Based on available aerial photographs, the subject site was densely forested as recently as 1991. By 1999, tree clearing and earthwork operations were ongoing within the subject site and overall business park. Aerial photographs taken between 1999 and 2017 indicate that the subject site was used for stockpiling fill and that numerous temporary access roads had bisected various areas throughout the site. By 2022, it was observed that the central portion of the subject site had been prepared for a ground improvement program. Reference should be made to Figure 2 – Aerial Photograph – 1991, Figure 3 – Aerial Photograph – 1999 and Figure 4 – Aerial Photograph – 2022.

**Aerial Photograph – 1991**

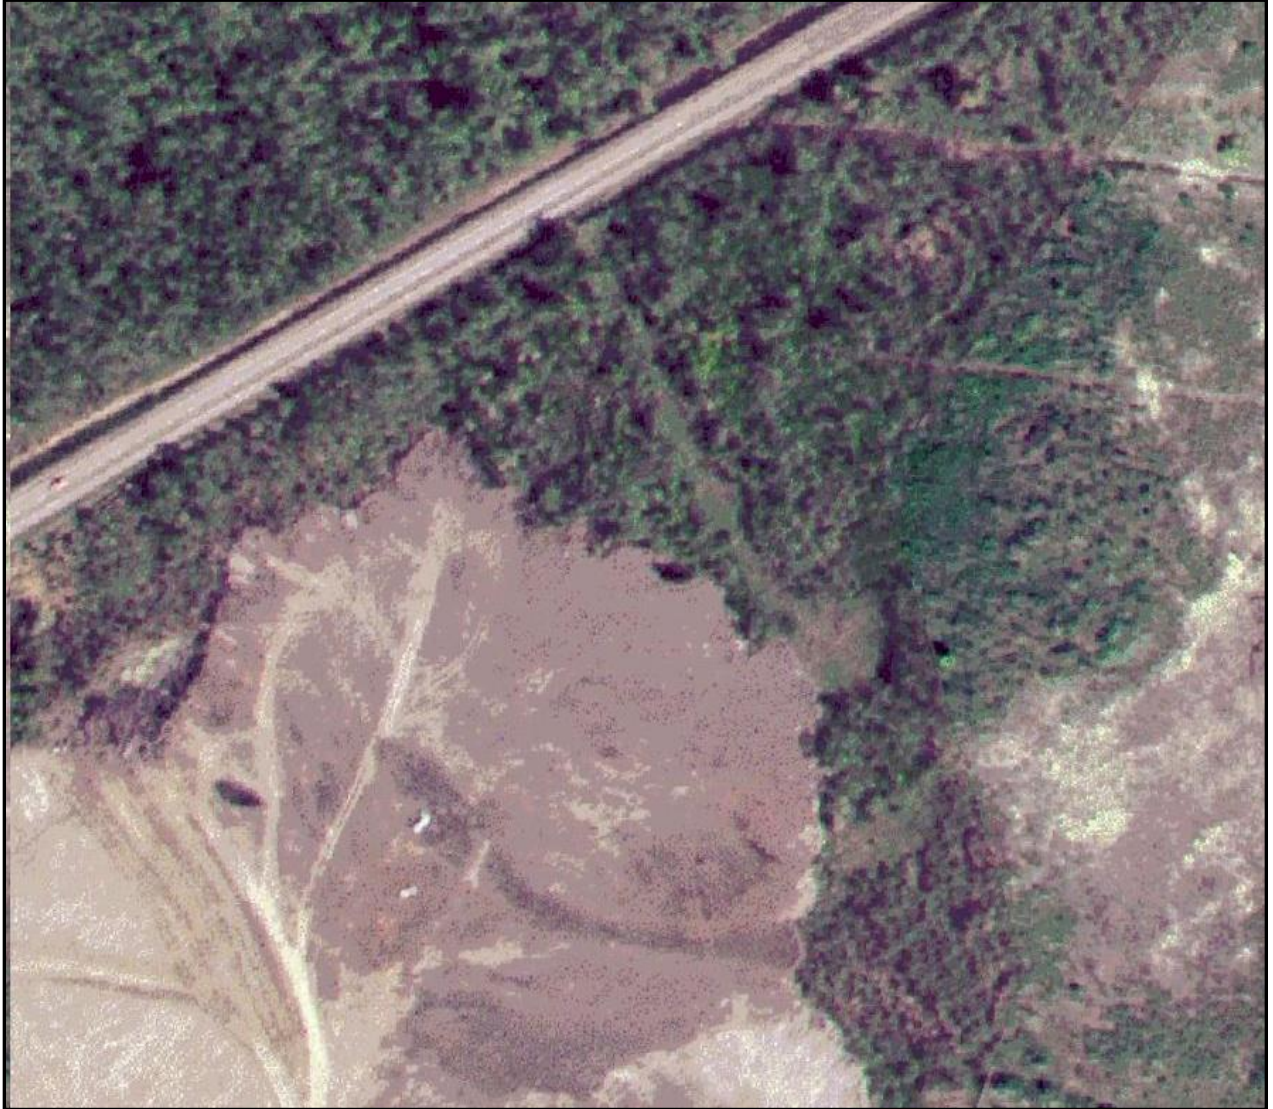
## **FIGURE 3**

**Aerial Photograph – 1999**

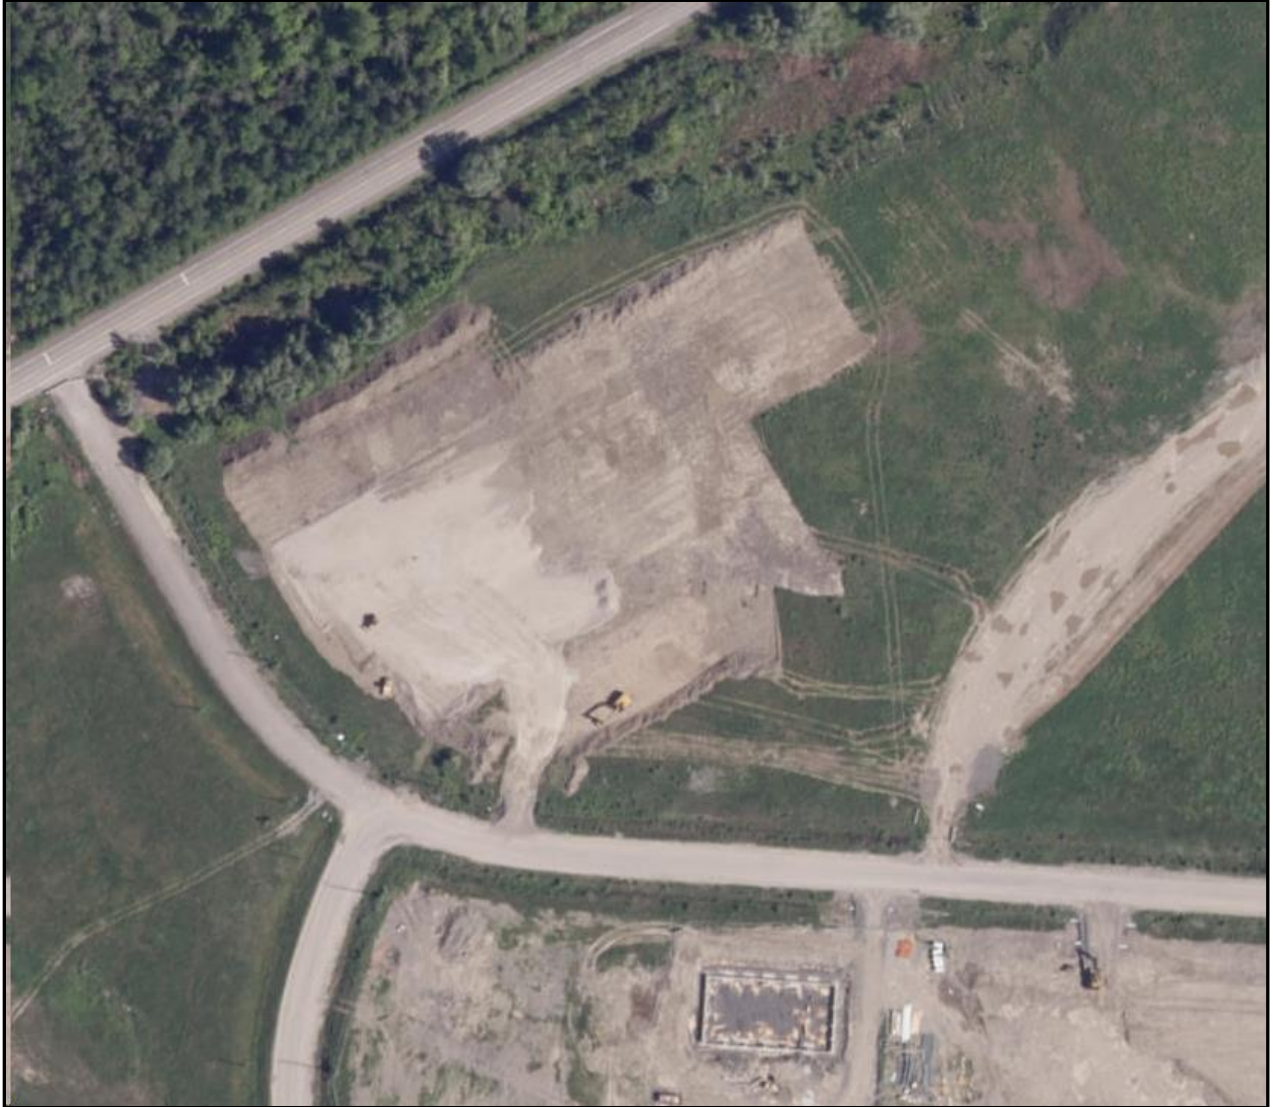
## **FIGURE 4**

**Aerial Photograph – 2022**
