# **Geotechnical Investigation**

## **Proposed Commercial Development**

301 Somme Street  
Ottawa, Ontario

Report PG7567-1 Revision 2 dated July 23, 2026

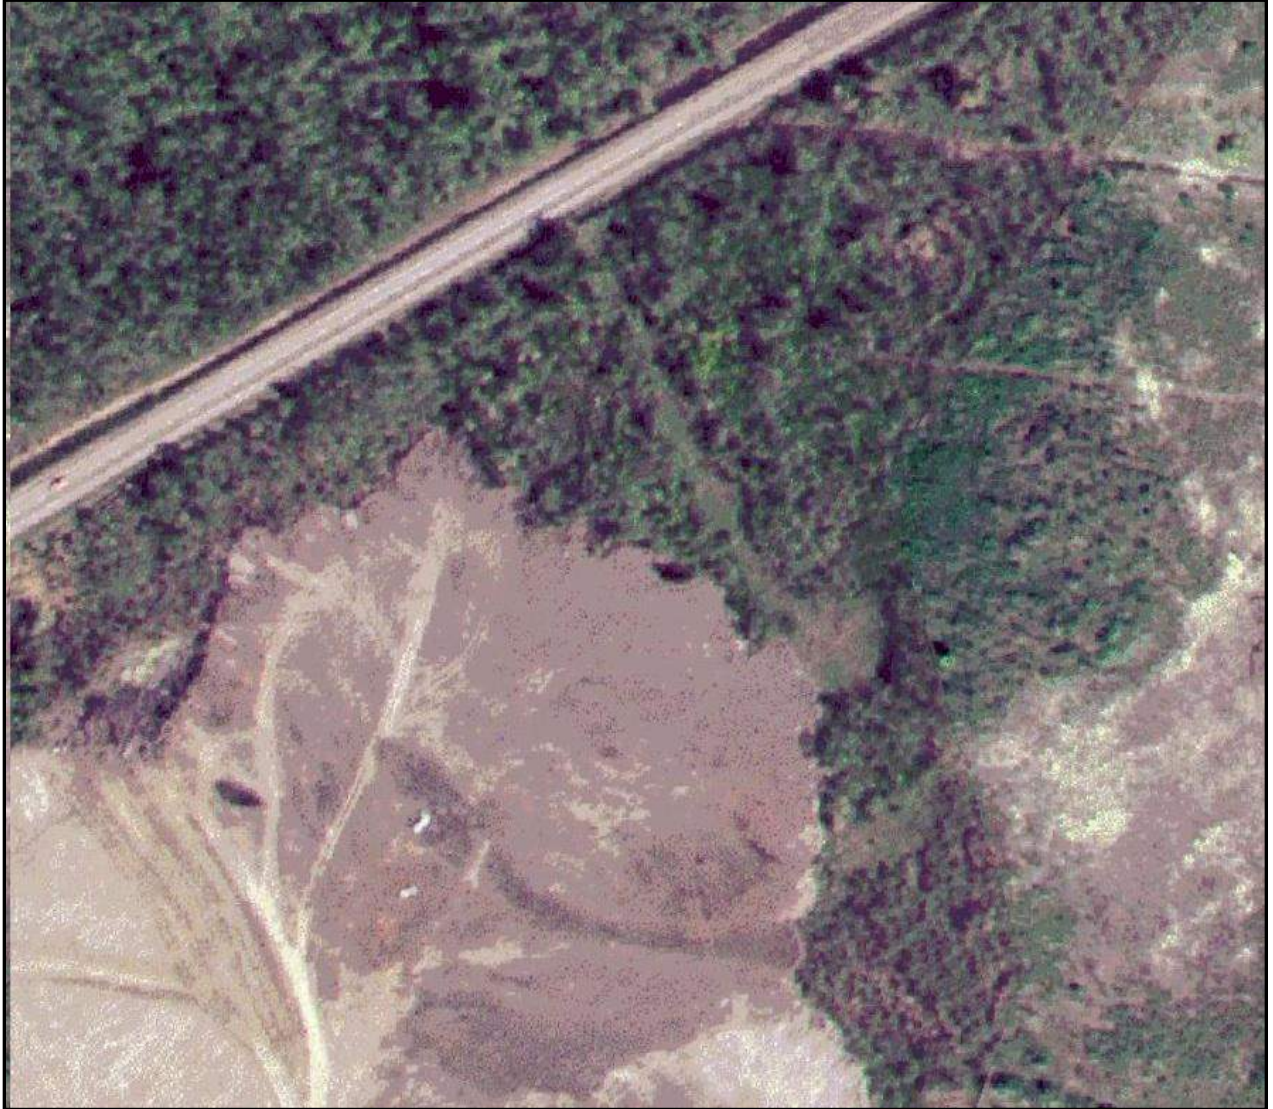
## **FIGURE 1B**

**Aerial Photograph – 1999**

Based on available aerial photographs, the subject site was densely forested as recently as 1991. By 1999, tree clearing and earthwork operations were ongoing within the subject site and overall business park. Aerial photographs taken between 1999 and 2017 indicate that the subject site was used for stockpiling fill and that numerous temporary access roads had bisected various areas throughout the site. By 2022, it was observed that the central portion of the subject site had been prepared for a ground improvement program. Reference should be made to Figure 1A – Aerial Photograph – 1991, Figure 1B – Aerial Photograph – 1999 and Figure 1C – Aerial Photograph – 2022.

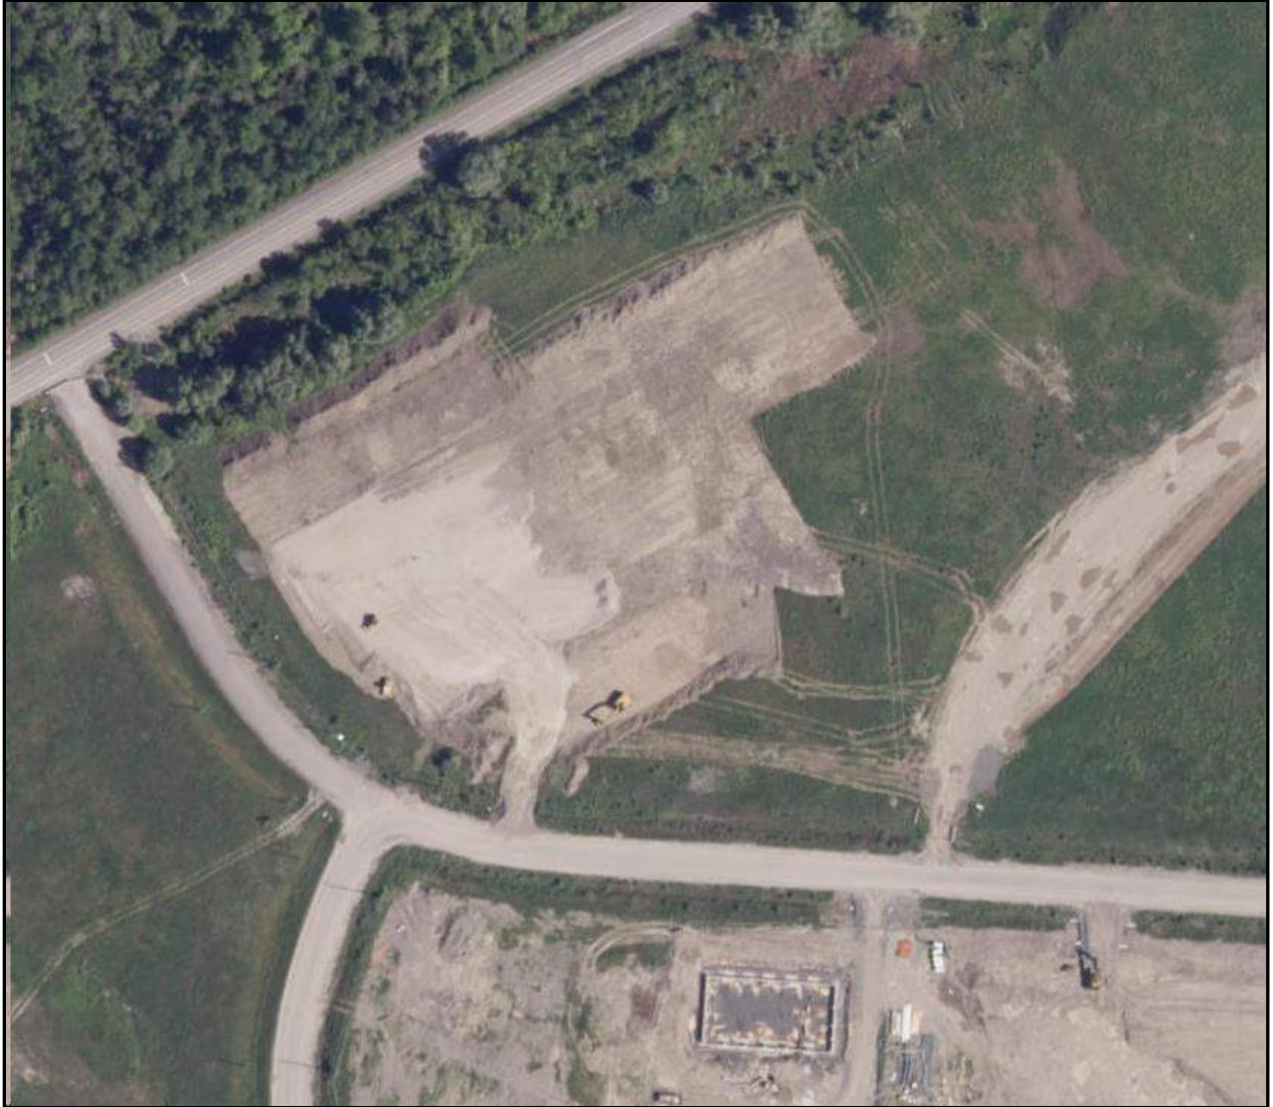
## **FIGURE 1C**

**Aerial Photograph – 2022**

The central portion of the subject site consists of an engineered fill pad which has undergone a successful deep dynamic compaction program by others in June 2022. The remainder of the subject site is generally undeveloped and grass covered, with a slope and watercourse near the northern boundary of the site. Fill piles were also noted within the northern limits of the site, and a gravel surfaced access road bisects the southeast corner of the property.

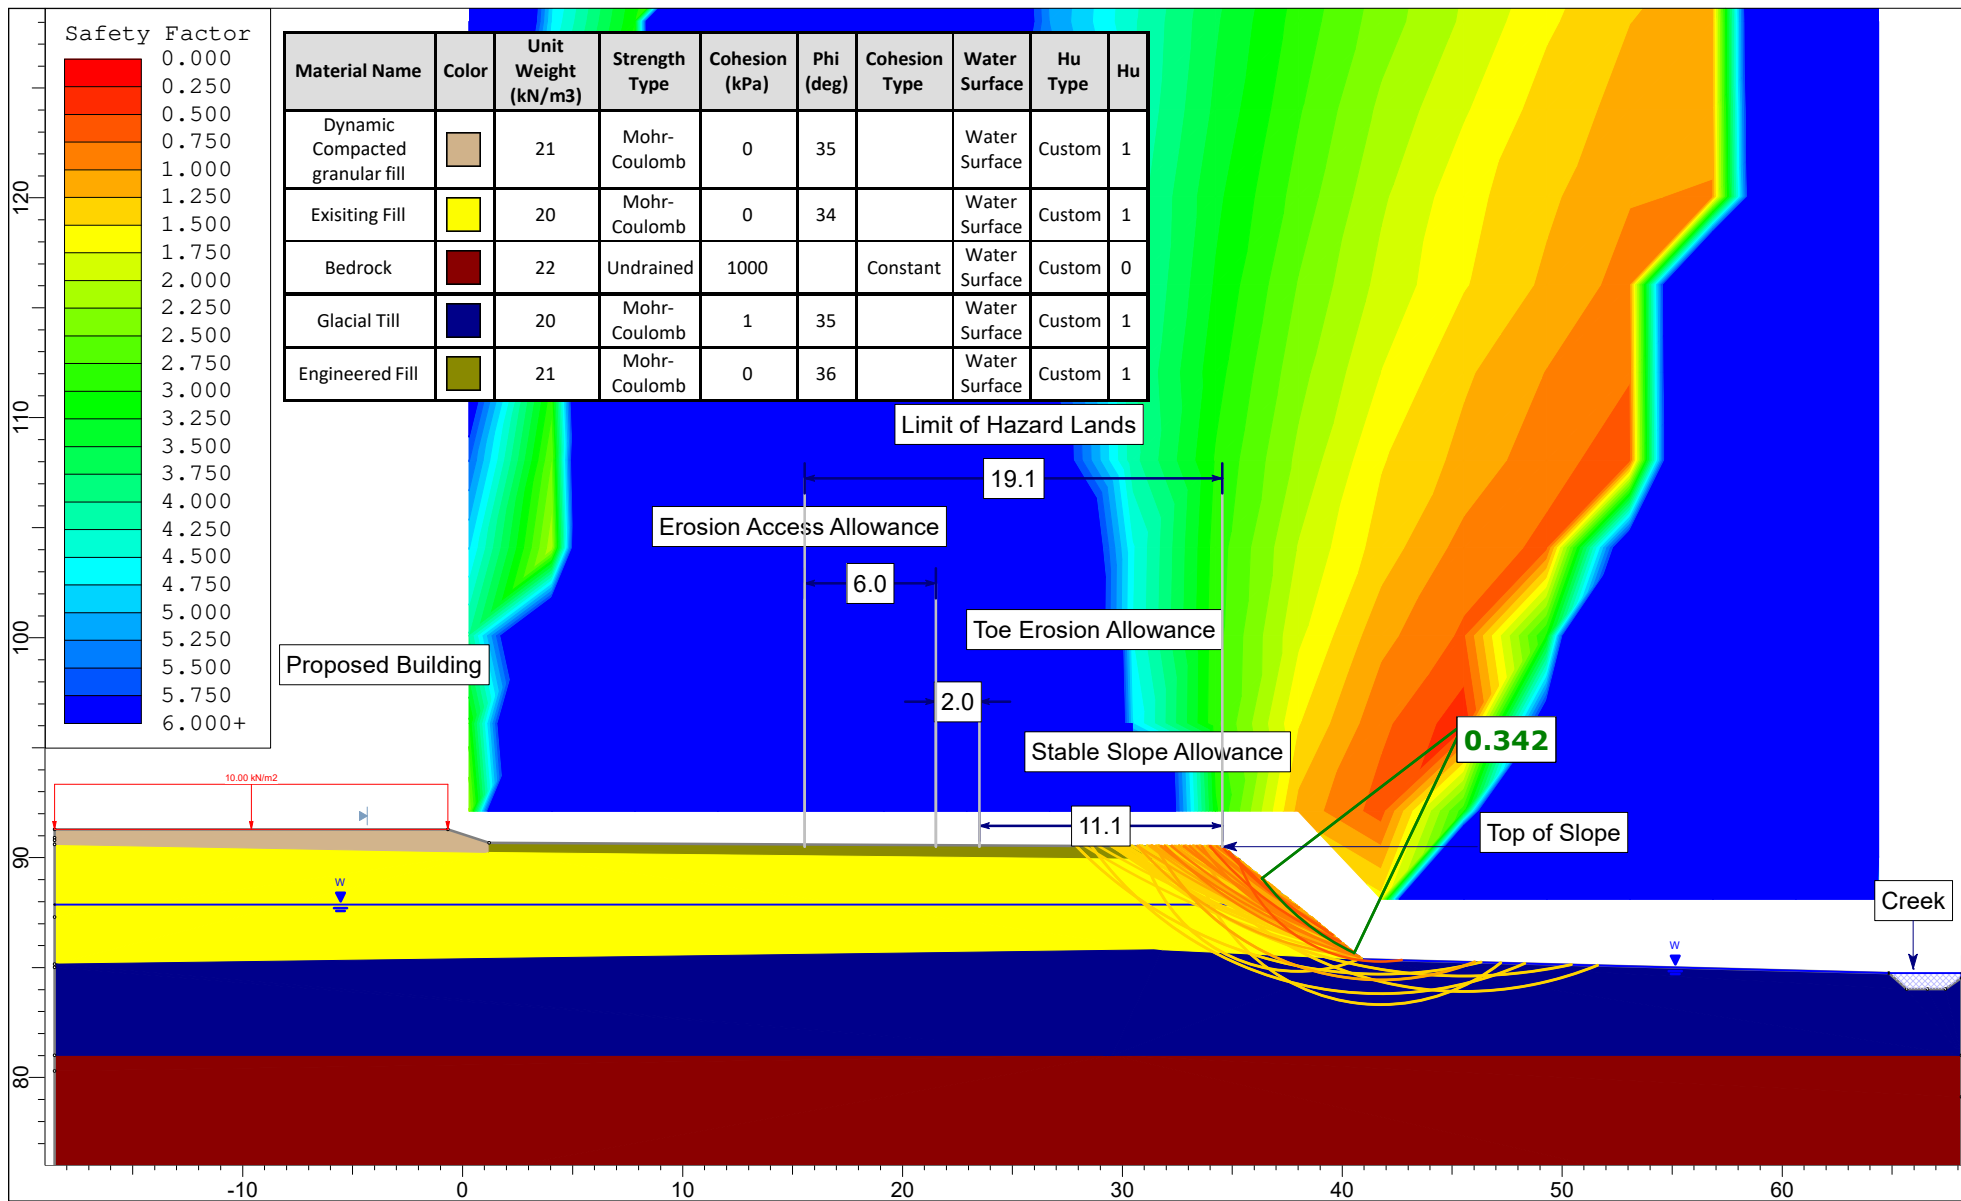
| | | | Figure 2A | |

| | Slope Section | | A | Scenario |

FIGURES 2A TO 3D – SLOPE STABILITY ANALYSIS CROSS-SECTIONS

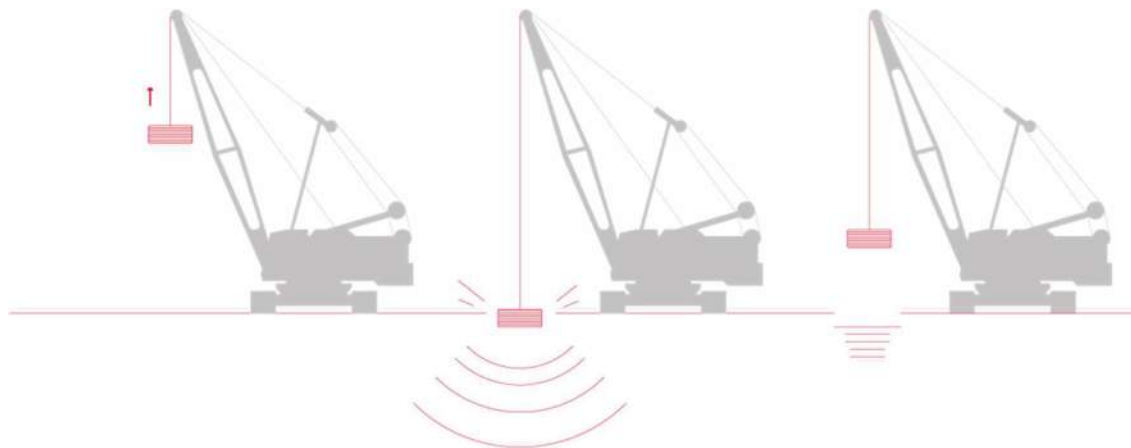
Dynamic Compaction (DC) is used to transmit high impacts to loose and soft soils that have an initial low bearing capacity, high compressibility and/or liquefaction potential in order to significantly improve their mechanical properties.

Figure 1 – Dynamic Compaction process

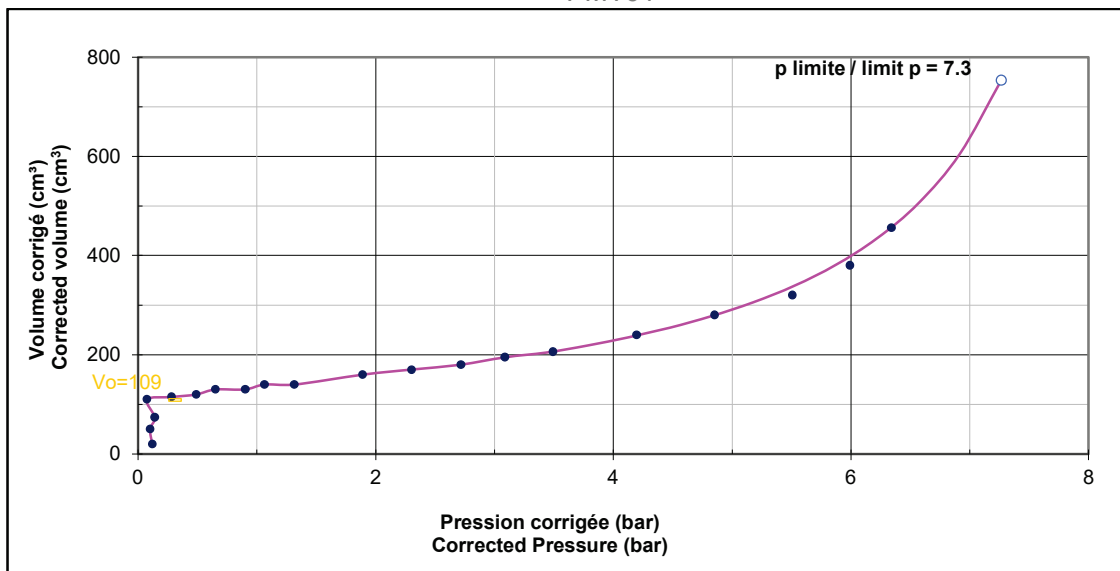
Figure 1: PMT01 curve at 1.5 m depth

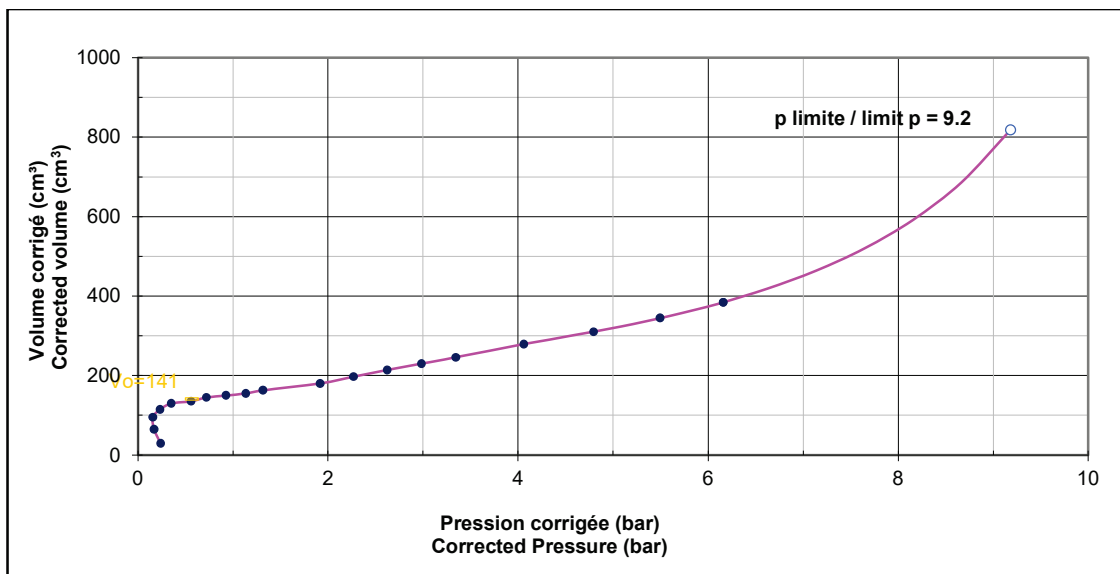
Figure 2: PMT01 curve at 3.5 m depth

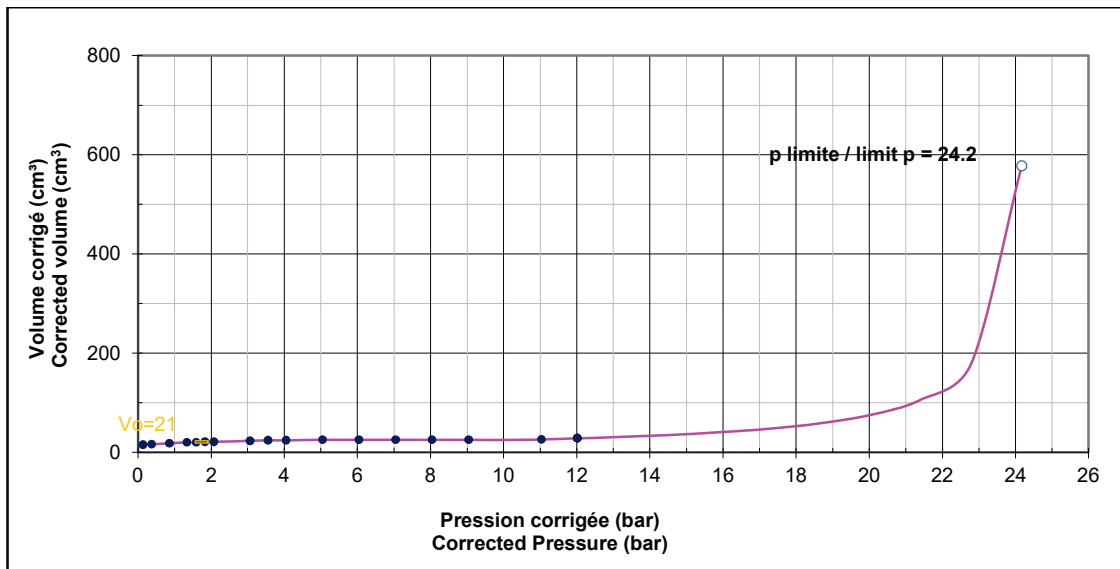
Figure 3: PMT02 curve at 1.2 m depth

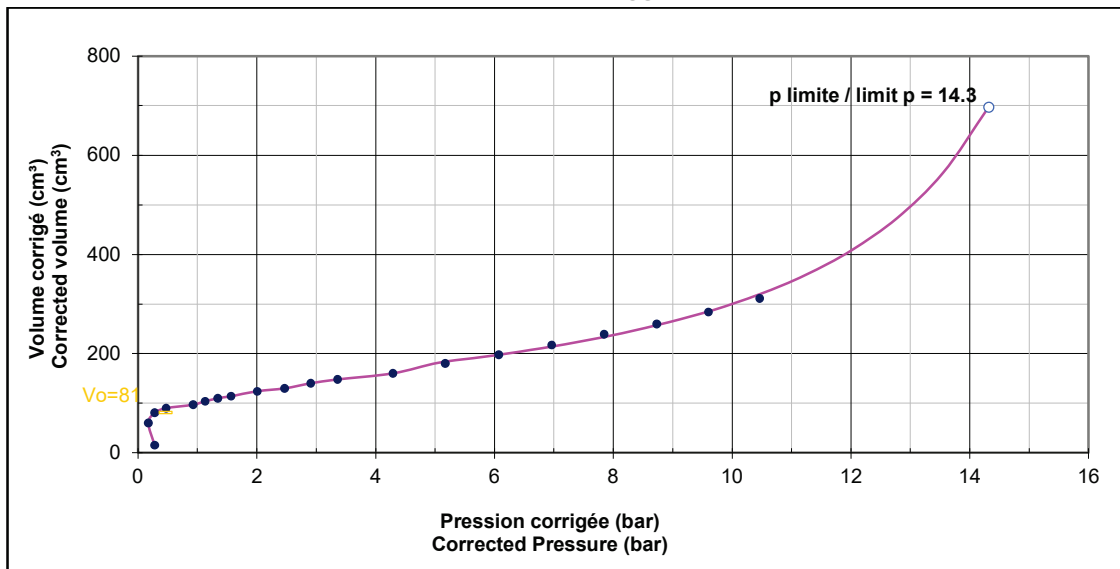
Figure 4: PMT03 curve at 3.0 m depth

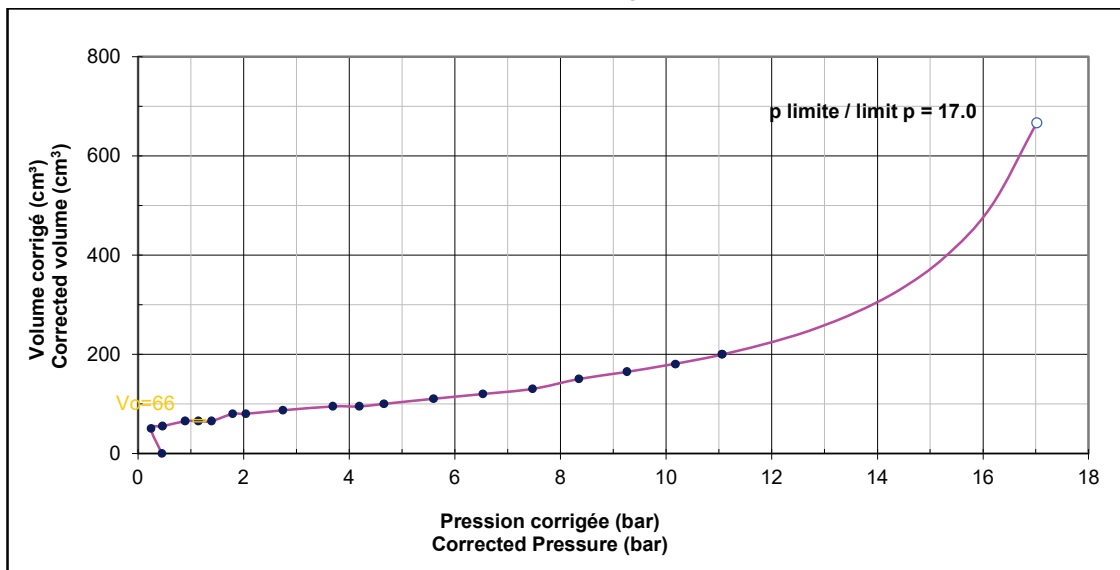
Figure 5: PMT04 curve at 3.0 m depth

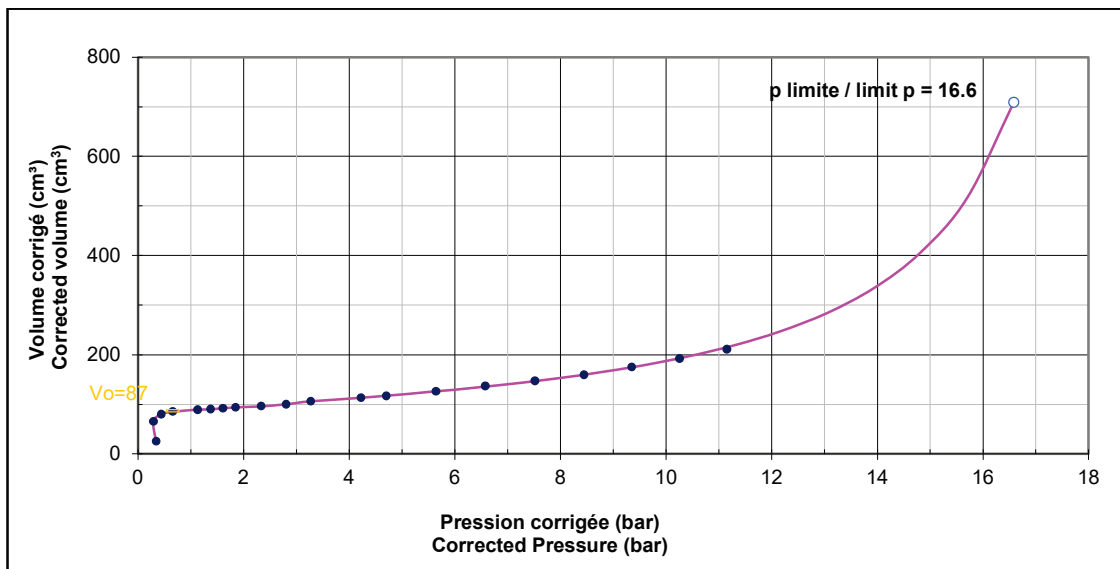
Figure 6: PMT03 curve at 4.5 m depth

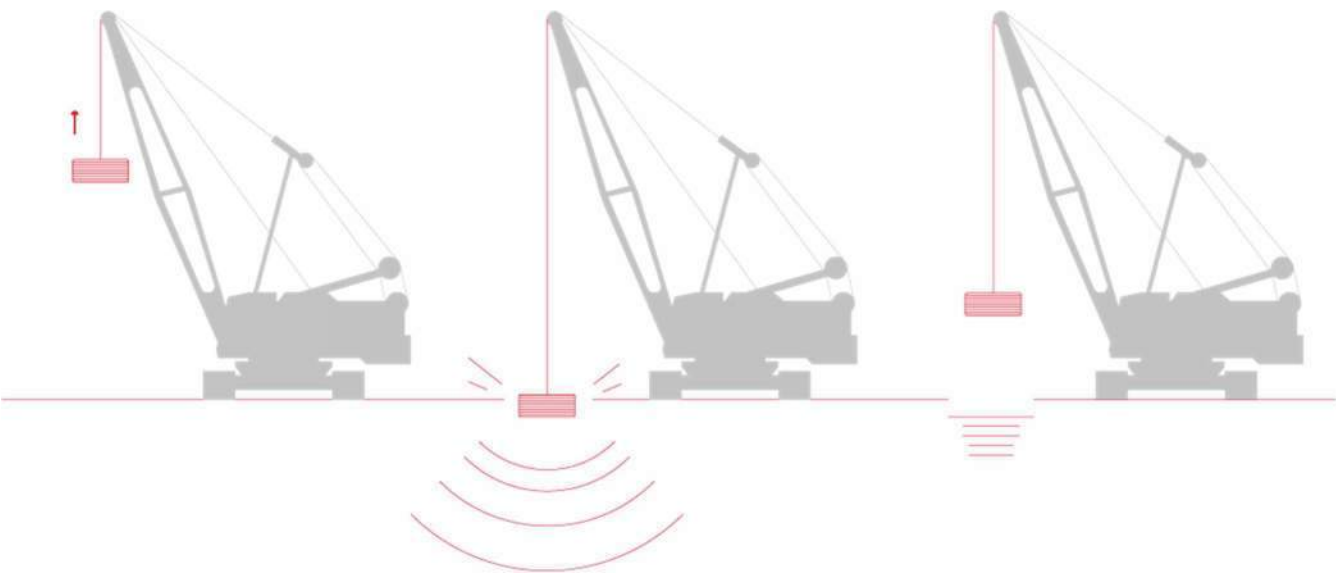
**Dynamic Compaction (DC)** involves the transmission of energy via high impacts to loose and soft soils that initially have low bearing capacity, high compressibility and/or liquefaction potential in order to significantly improve their mechanical properties. The Dynamic Compaction technique achieves ground densification using energy waves from a dropping a  $\pm 12.5$  tonnes hammer from heights ranging from 9 to 36m from a crane. The weights are essentially dropped in a free fall to maximize energy transfer.

The arrangement of the impact points and the other parameters of the treatment (energy, phasing, rest periods) depend on the characteristics of the soil to be treated and on the results of the initial works. The depth of improvement is a function of the pounder weight and drop height, i.e. the amount of energy applied. Dynamic Compaction is used to increase the density and therefore bearing capacity and compressibility of in-situ soils. Using triggering criteria analysis outlined in Idriss and Boulanger (2014), CPT results or SPT results combined with grain size analysis of the targeted soils can be used to confirm that the FOS against liquefaction has increased following treatment with ground improvement.

Figure 1 : Dynamic Compaction Densification Process

The existing ground improvement at the site was completed by deep dynamic compaction, which uses a heavy weight dropped from a crane, and which is effective for compacting loose soils to significant depths. Currently, this same method of ground improvement is proposed for the remaining areas to be improved for the currently proposed development.

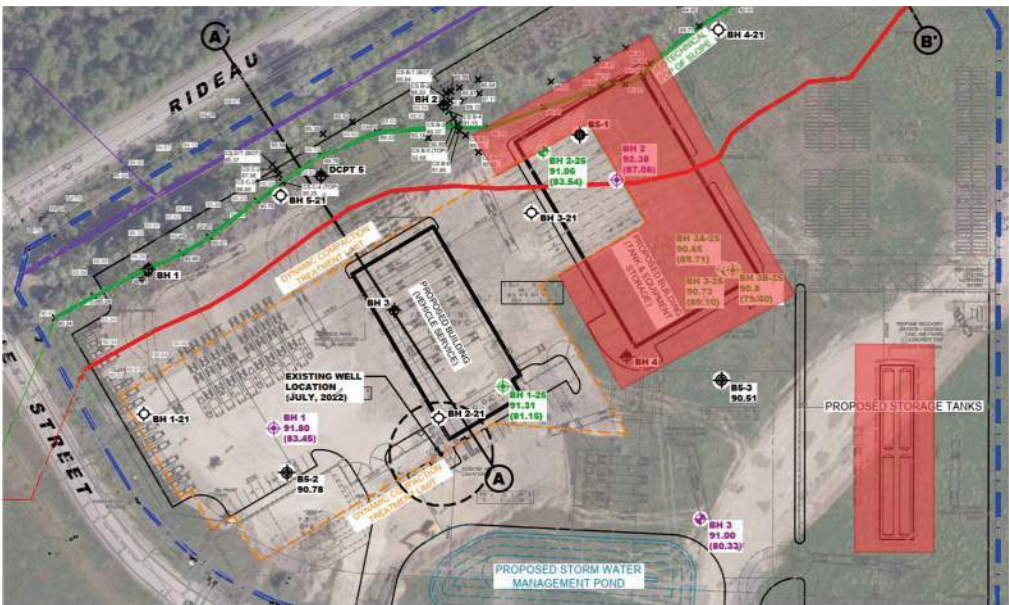
Based on the Site Plan drawings and Paterson's Geotechnical Investigation, the location of the newly proposed buildings are outside of the previously completed ground improvement scope of work. Menard will implement the DC work within the footprint of the newly proposed buildings with a 4m buffer zone outside of the footprints as shown in **Figure 2**.

Figure 2 : Approximate Work Zone for Dynamic Compaction (photo: Paterson 2025)

As noted above in Section 5.1, additional ground improvement will be required at the subject site in order to encompass the entirety of the currently proposed buildings. This is discussed in the letter in Appendix 4, which has been prepared by the ground improvement contractor.

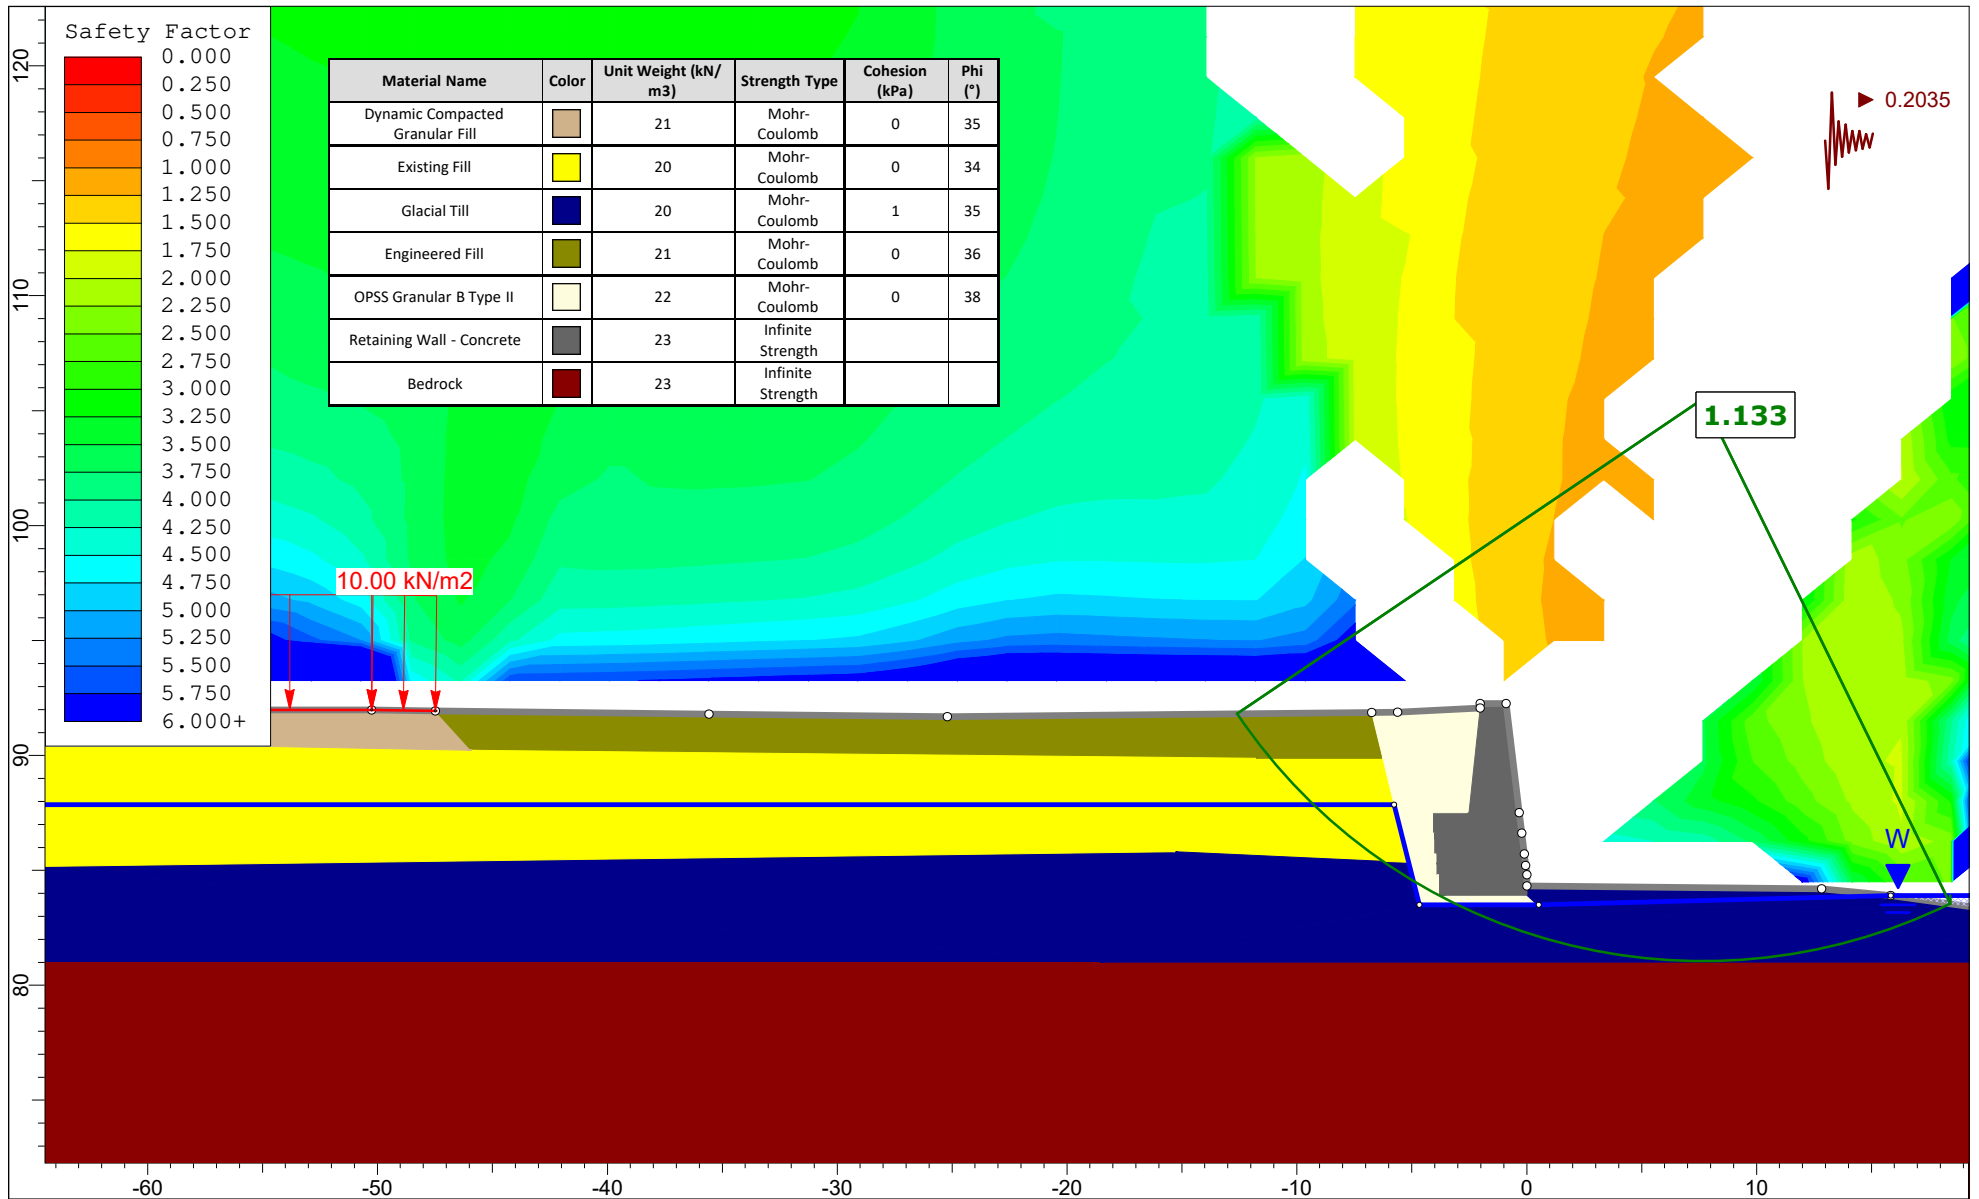
| | Drawing No.: <b>Figure 1B - Seismic Loading - Proposed Retaining Wall</b> | | |
