# **Geotechnical Investigation**

## **Proposed Multi-Storey Building**

320 Bren-Maur Road  
Ottawa, Ontario

Report PG7253 – 1 Revision 1 dated July 9, 2026

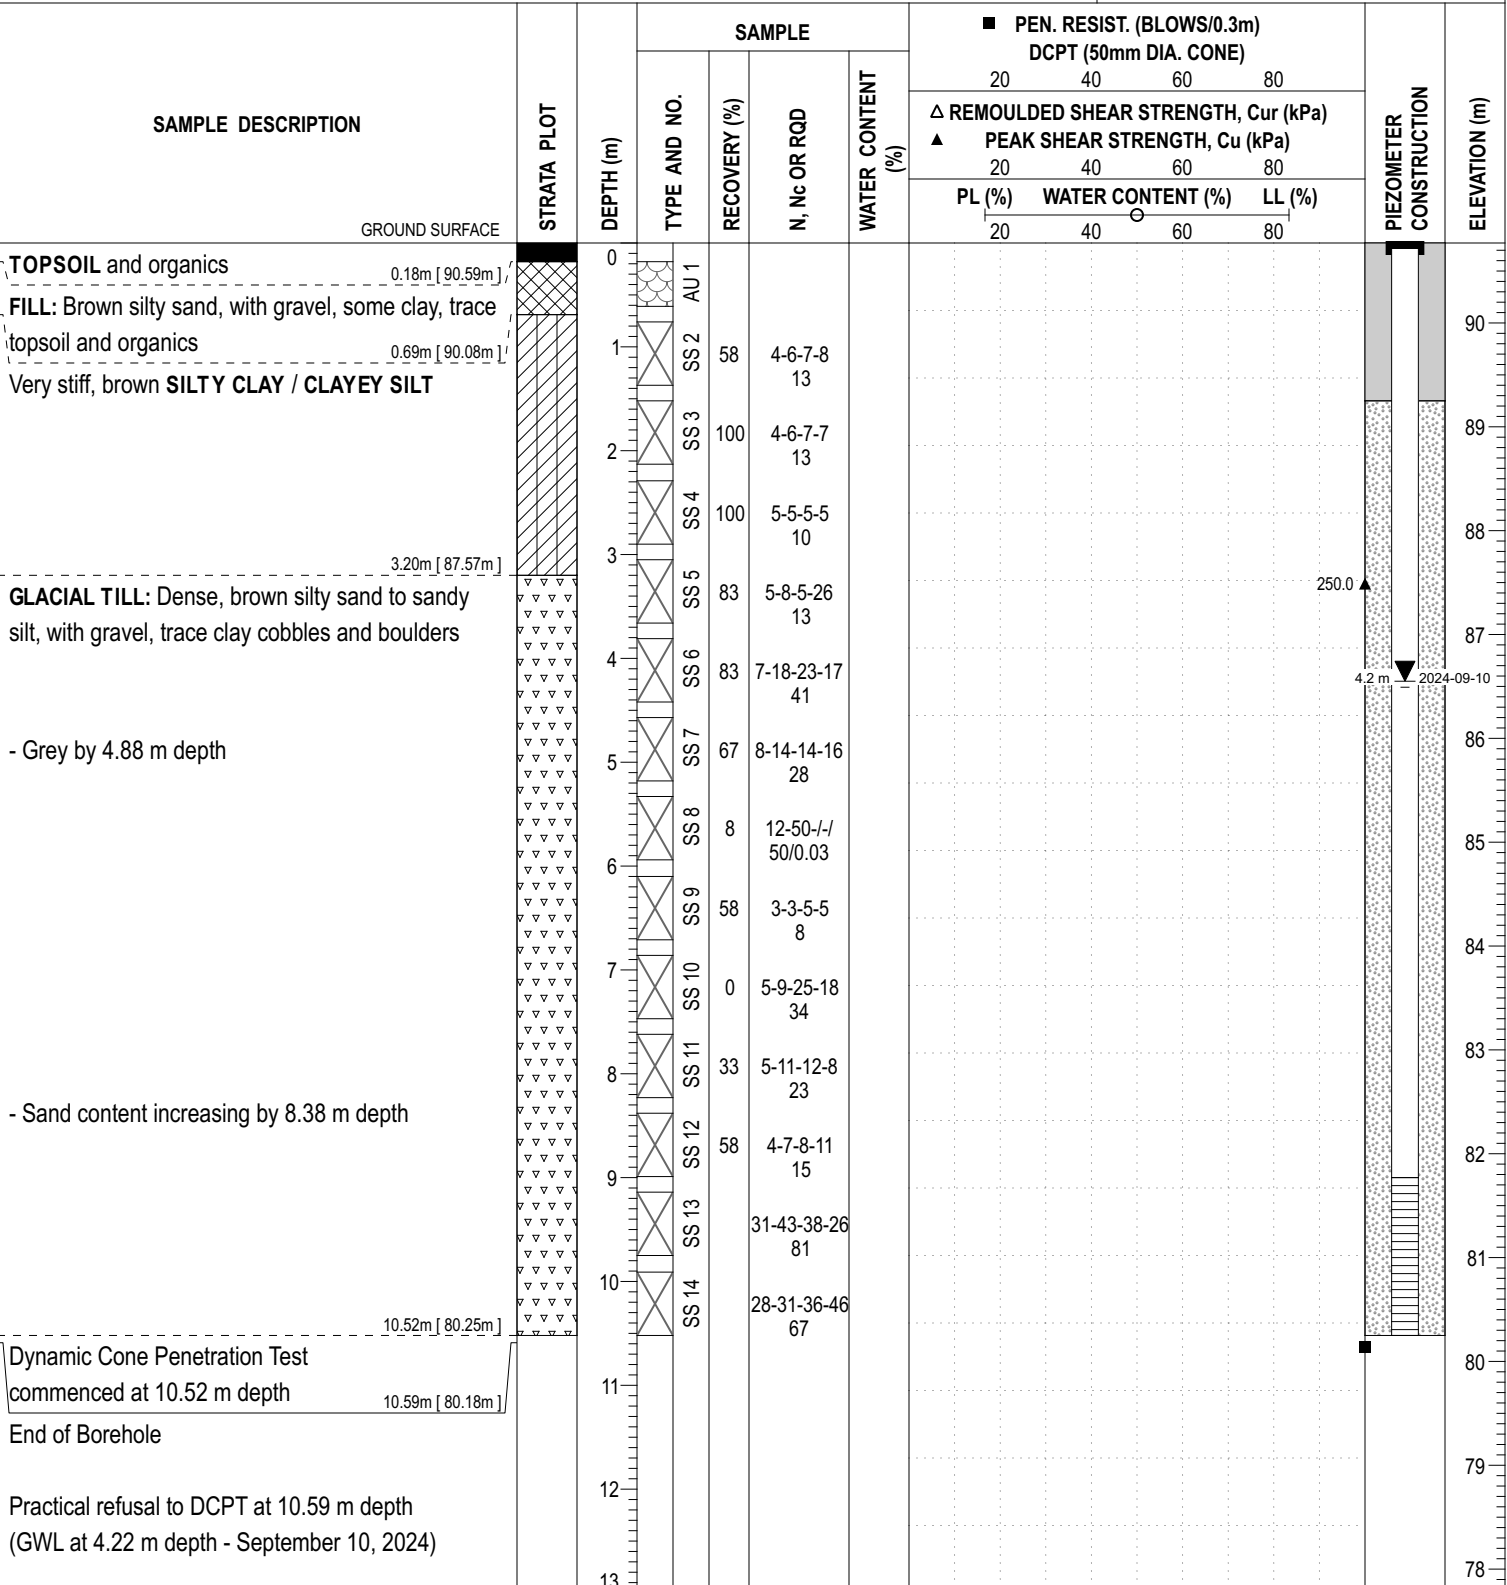
**HOLE NO. :** BH 2-24

The subsurface conditions observed in the boreholes were recorded in detail in the field. The soil profiles are logged on the Soil Profile and Test Data sheets in Appendix 1 of this report.

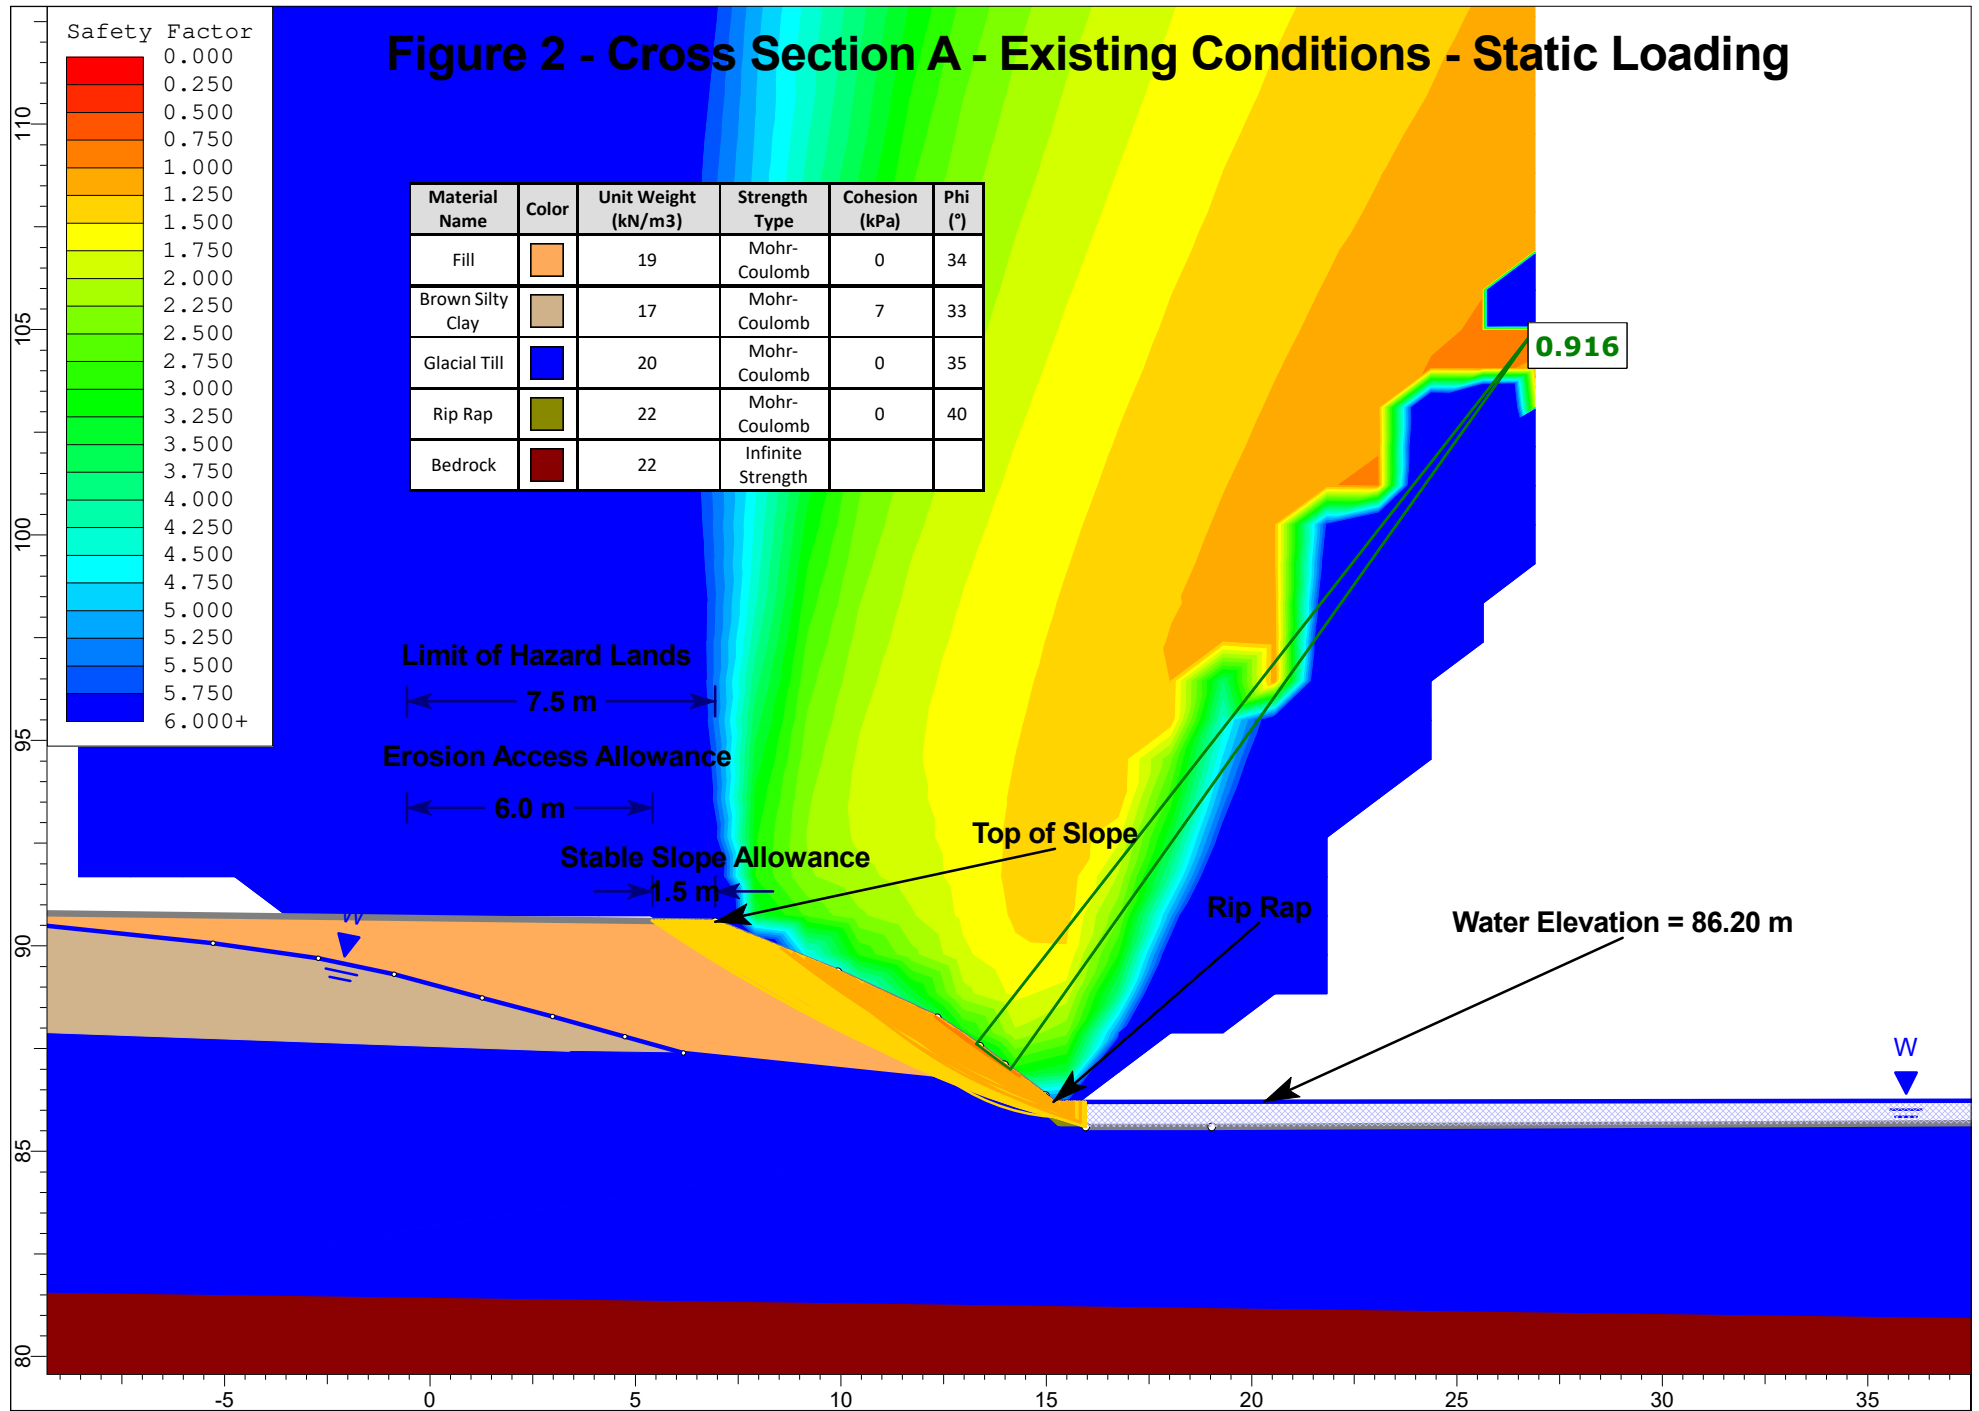
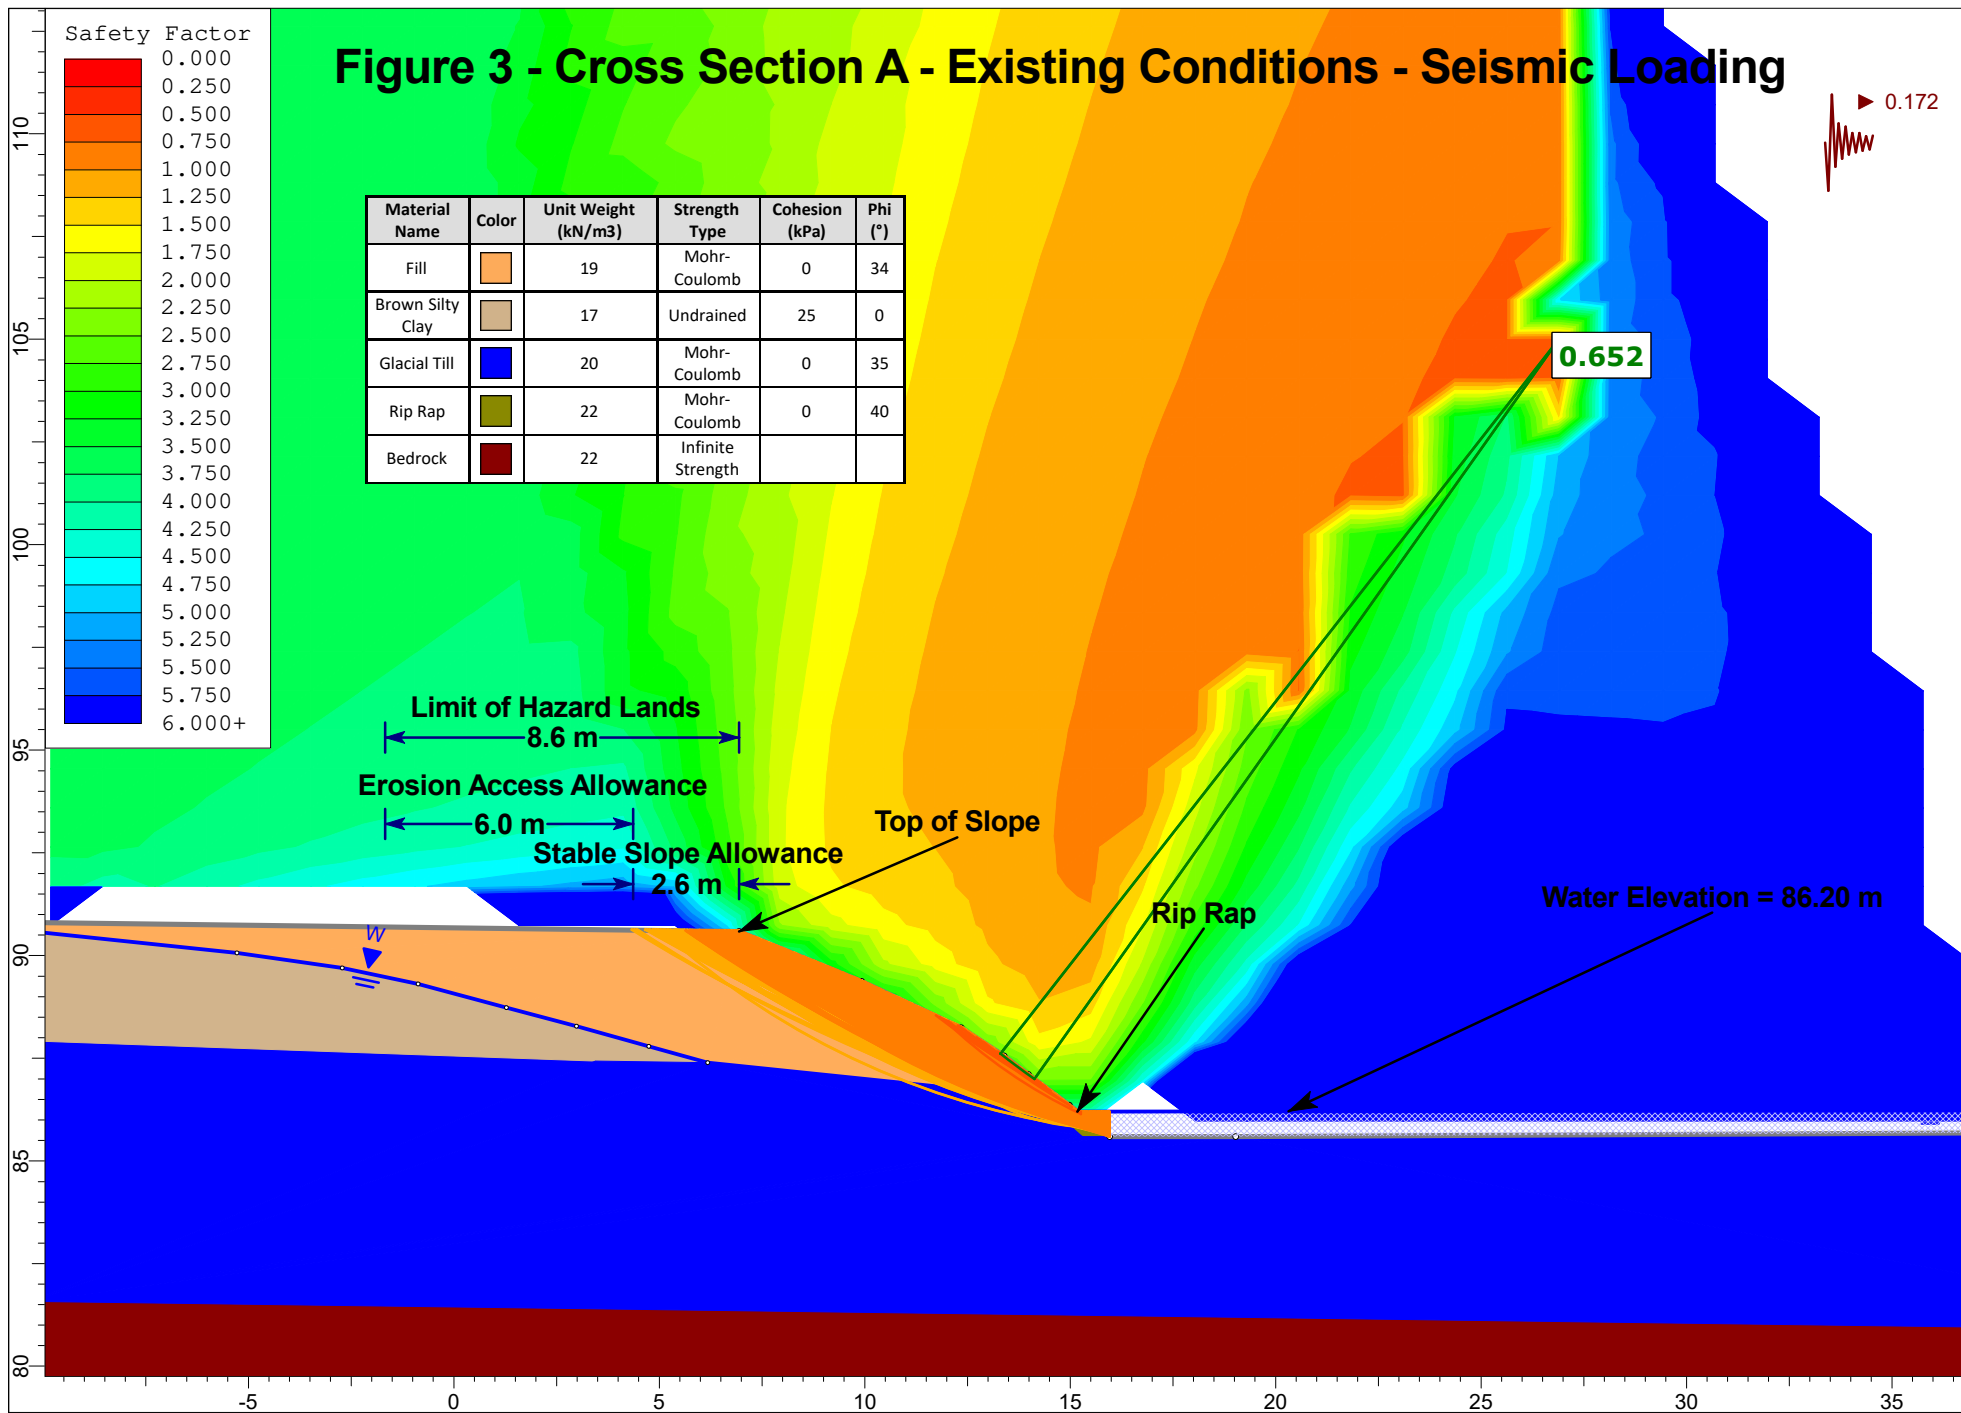
# Figure 2 - Cross Section A - Existing Conditions - Static Loading

The static analysis results for slope cross-section A-A are presented in Figures 2 and 4 provided in Appendix 2. The factor of safety of less than 1.5 was noted; therefore, a stable slope setback would be required if the existing slope was not re-graded as part of the proposed development. A stable slope setback of 1.5 m, for slope cross-section A-A, would be required if the existing slope is not modified.

The results of the analyses with seismic loading are shown in Figures 3 and 5, presented in Appendix 2. The factor of safety for the slopes was noted to be less than 1.1; therefore, a slope stability setback would be required if the existing slope was not re-graded as part of the proposed development. A stable slope setback of 2.6 m, for slope cross-section A-A, would be required if the existing slope is not modified.

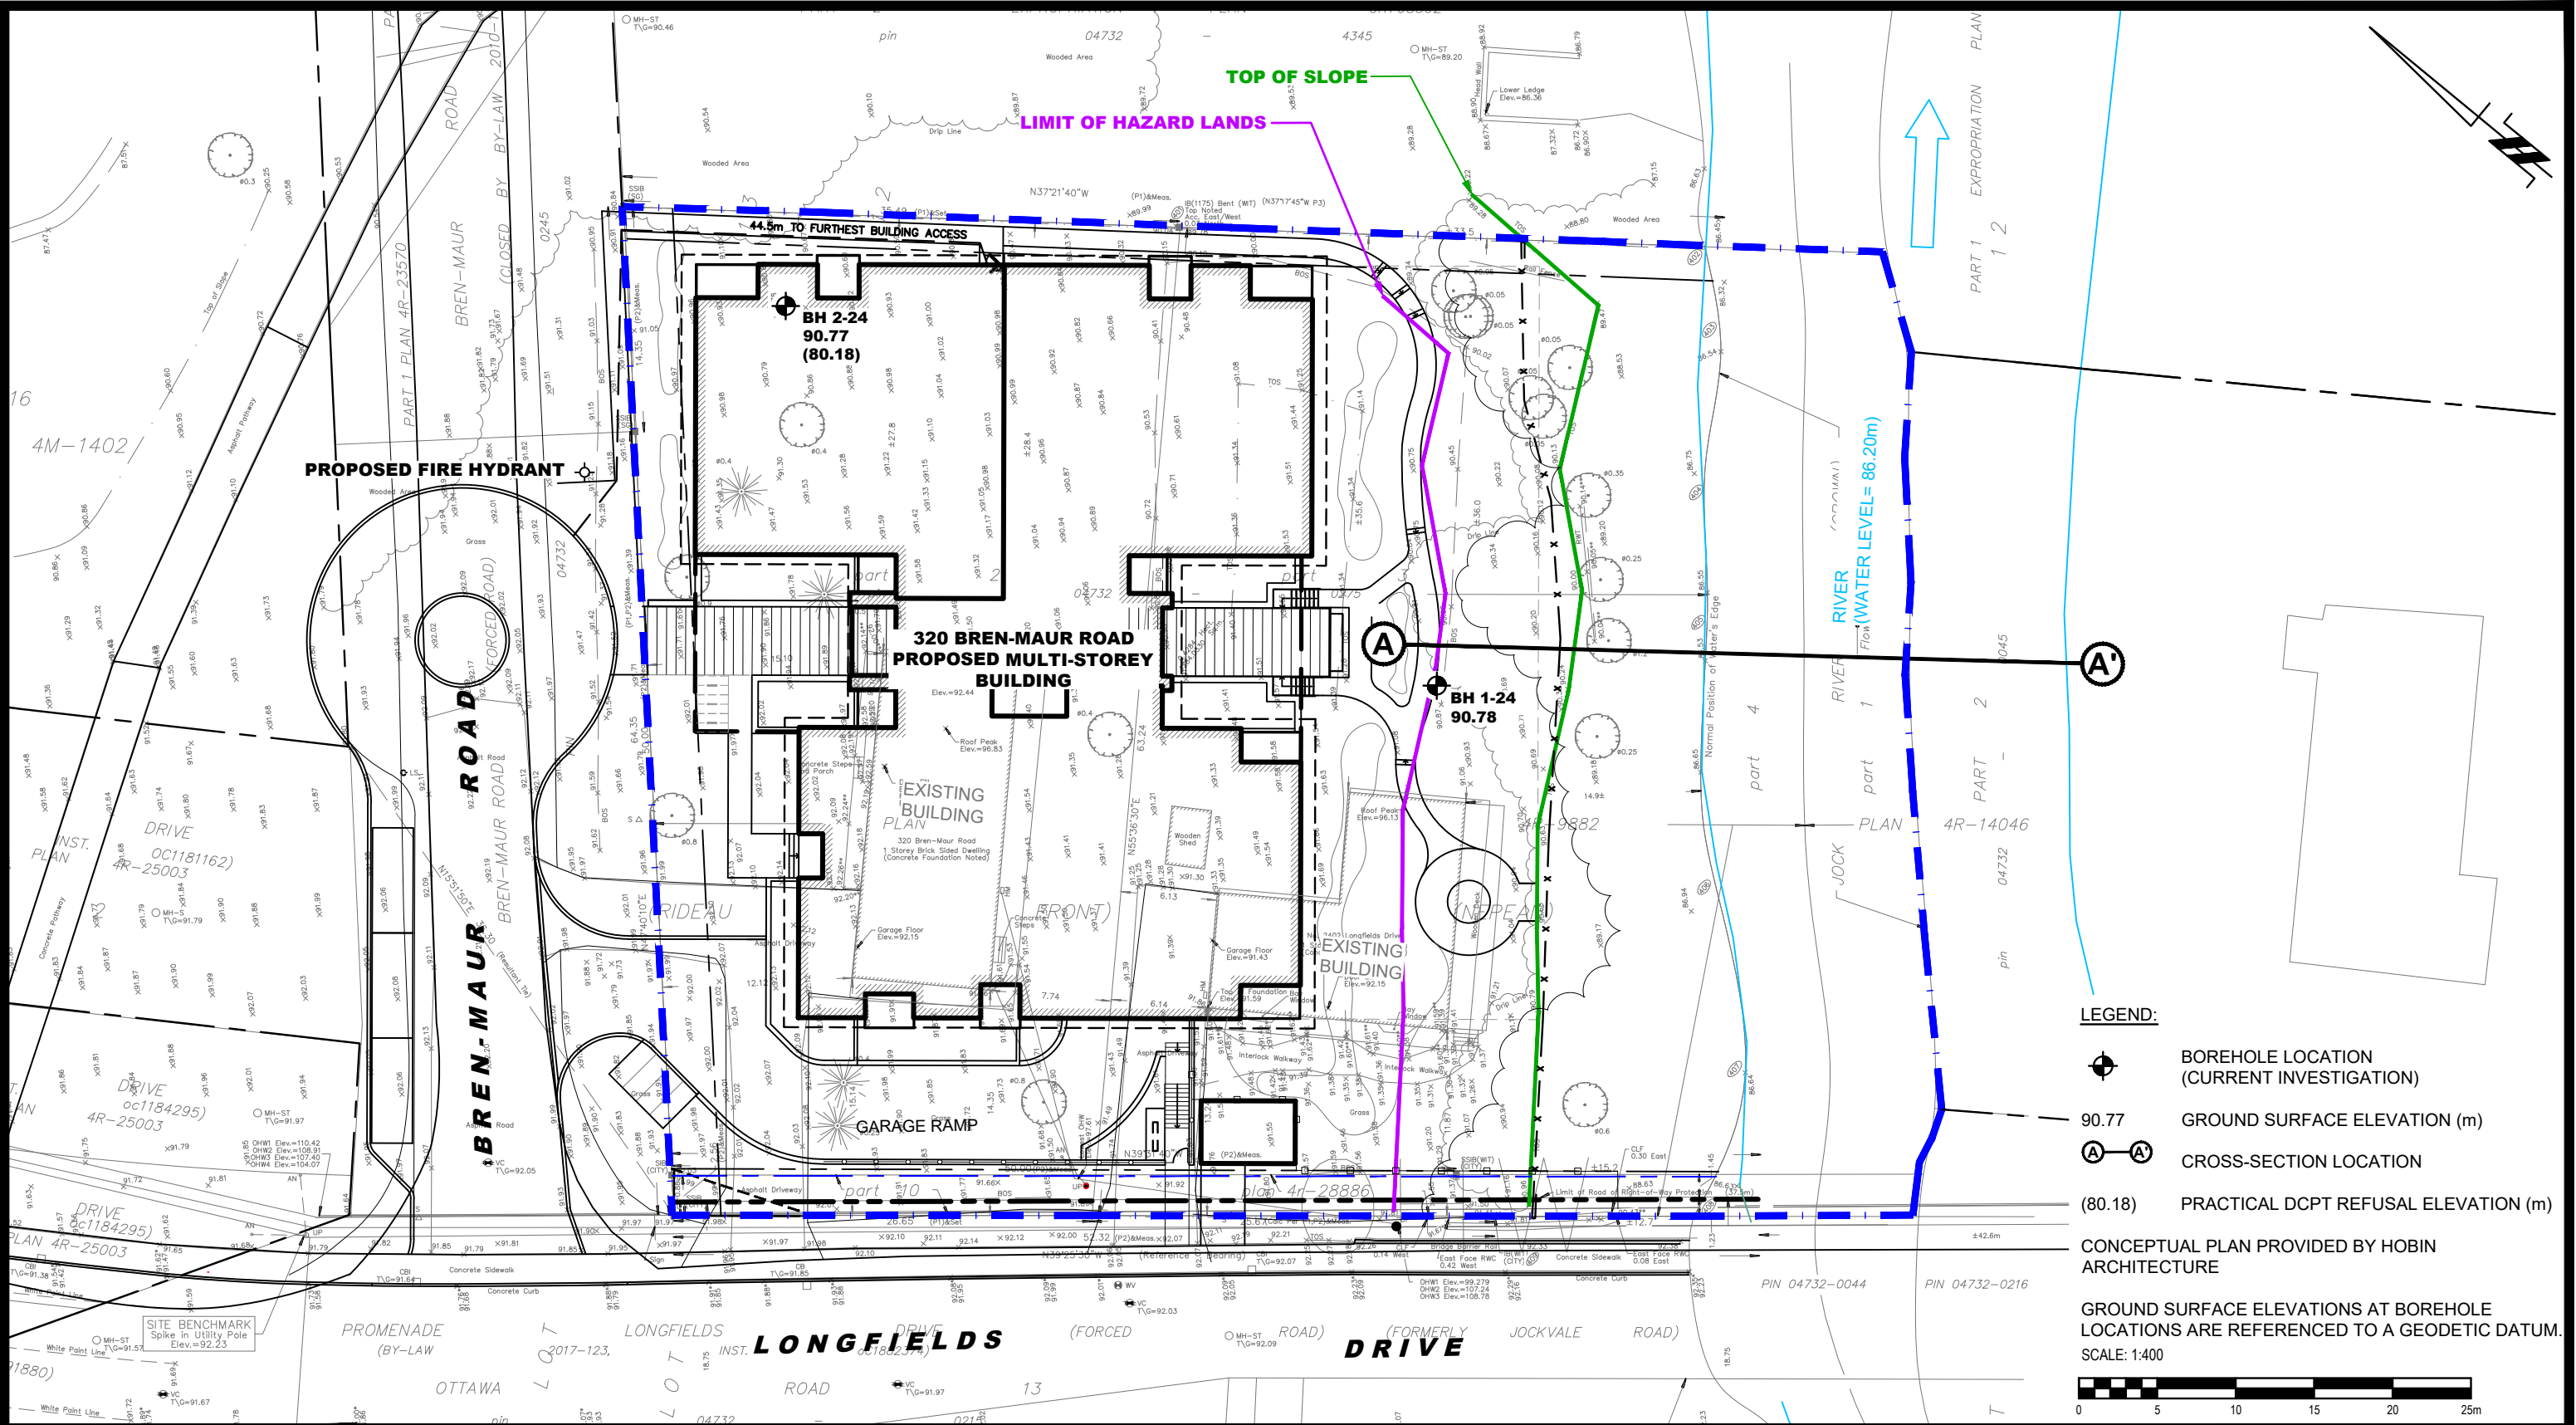
| Checked by: | YZ | Dwg. No.: | <b>PG7253-1</b> |

Based on the results of our field observations and slope stability analysis, a Limit of Hazard Lands was assigned from the top of the slope for the above-noted cross-section A-A. The cross-section locations and associated Limit of Hazard Lands setbacks are presented on Drawing PG7253-1 – Test Hole Location Plan in Appendix 2.

The results of the slope stability assessment indicate that the Limit of Hazard Lands setback of **8.6 m** measured from the top of the slope should be provided for any proposed structures at the subject site. The Limit of Hazard Lands setback line is shown on the attached Drawing PG7253-1 – Test Hole Location Plan.

One (1) slope cross-section (Section A) was studied as the worst-case scenario for the proposed and existing conditions. The cross-section location is presented in Drawing PG7253-1 – Test Hole Location Plan in Appendix 2. It should be noted that details of the slope height and slope angle at the cross-section locations are presented in Figures 2 through 5 in Appendix 2, based on the topographic data obtained during the field investigation, as well as the available topographic data.

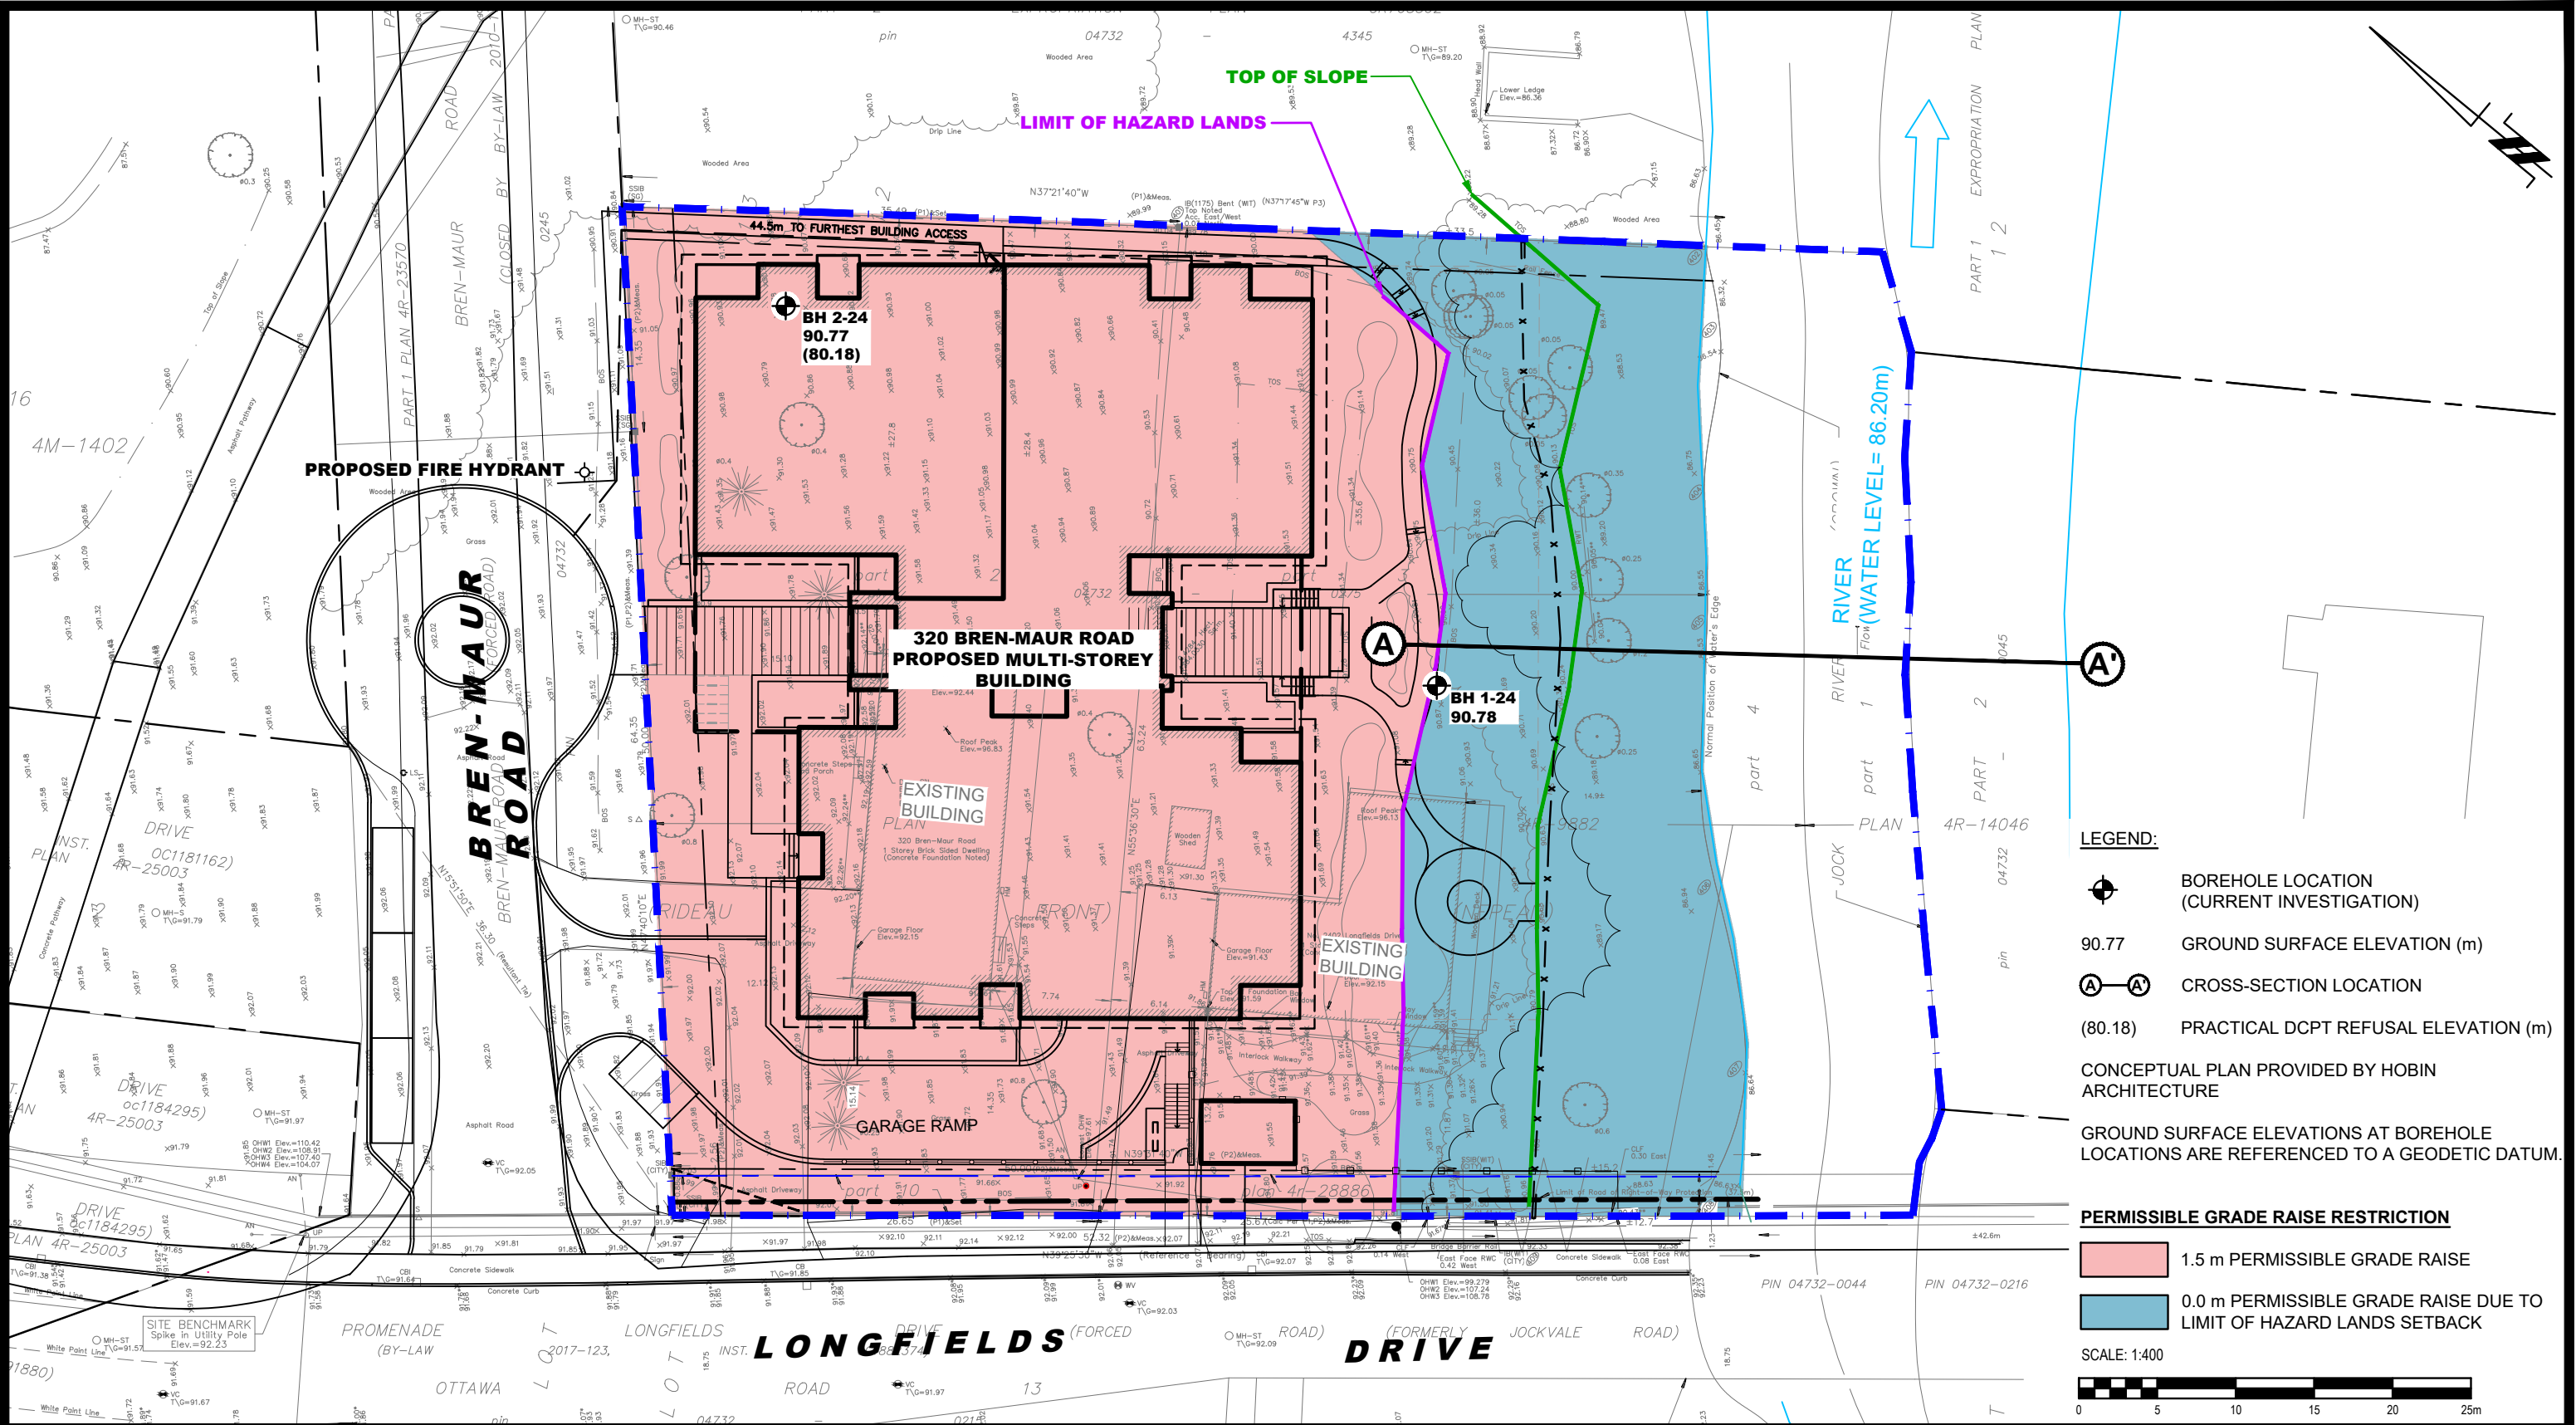
DRAWING PG7253-2 – PERMISSIBLE GRADE RAISE RESTRICTION PLAN

Due to the presence of the silty clay deposit throughout the western portion of the subject site, a permissible grade raise restriction of **1.5 m** is recommended for grading at the subject site where silty clay is present. **However, it should be noted that grade raises are not permitted within the Limit of Hazard Lands.**

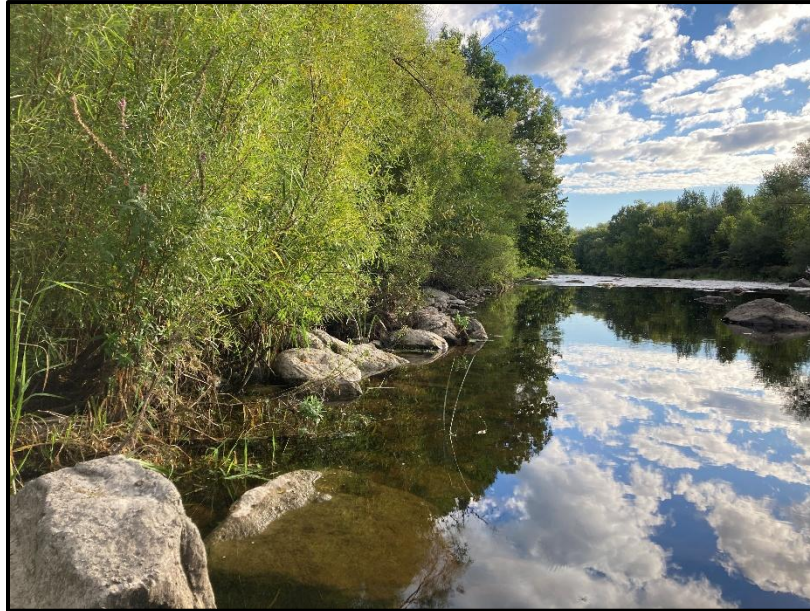
**Photo 1:** Observed riprap at the toe of the slope along the full property frontage adjacent to the river. In addition, the slope face was observed to be covered by mature vegetation and small trees. No evidence of active erosion was observed along the toe of the slope – facing northeast.

Riprap was observed along the toe of the slope and extending into the water course bordering the Jock River. The existing riprap extends along the full property frontage adjacent to the river and extends above the observed high-water mark. The recorded high-water mark elevation is at a geodetic elevation of 86.9 m. No signs of erosion, distress, or sloughing were observed throughout the slope surface at the time of our field review.

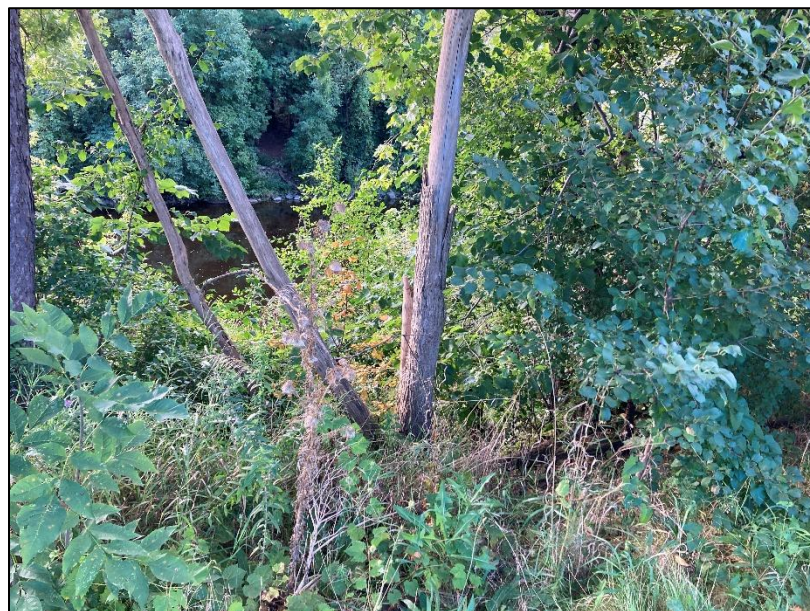
**Photo 2:** The existing slope face was observed to be covered by mature vegetation and small trees– facing northwest.

The slope observed at the eastern portion of the site was observed to have an approximate incline ranging between 2H:1 to 3H:1V and surfaced with mature vegetation and small trees. The slope was noted to range between 4 m and 6 m in height.

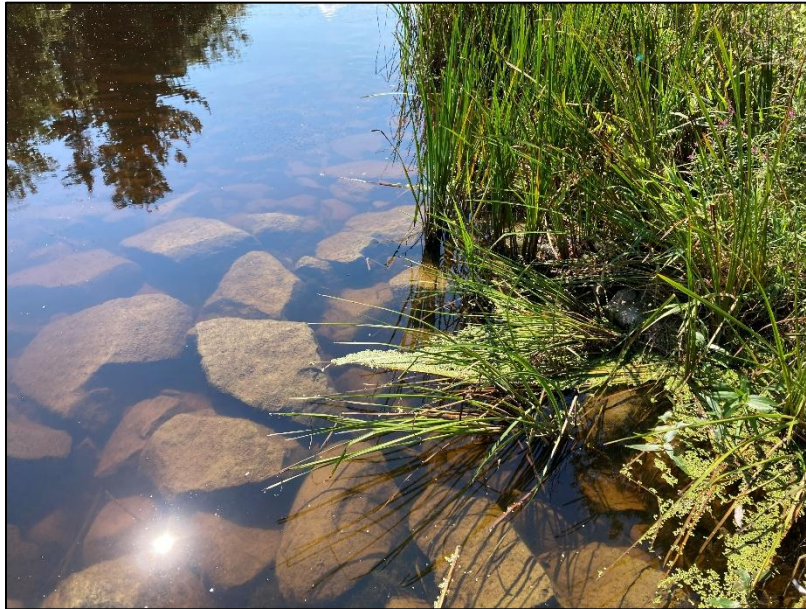
**Photo 3:** Size of the riprap material at the toe of the slope along the river.

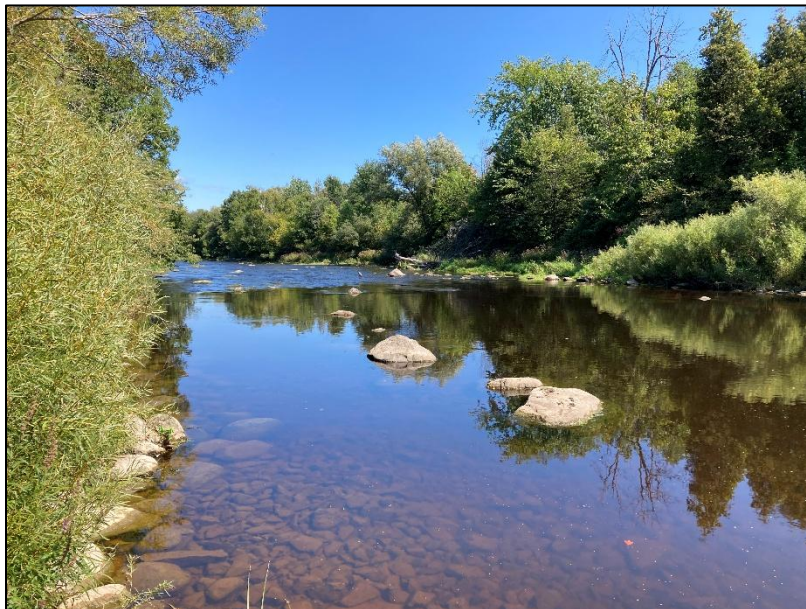
**Photo 4:** Observed riprap at the toe of the slope along the full property frontage adjacent to the river. In addition, the slope face was observed to be covered by mature vegetation and small trees. No evidence of active erosion was observed along the toe of the slope – facing northeast.

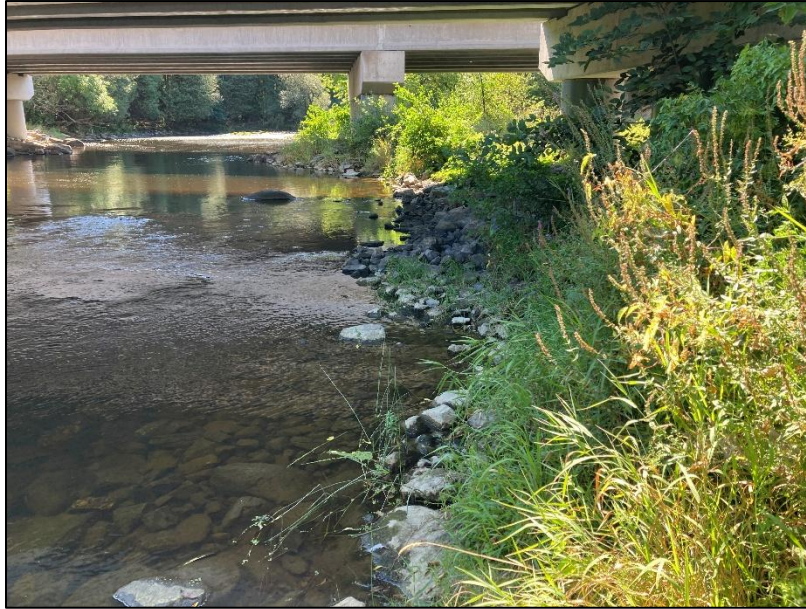
**Photo 5:** Observed riprap at the toe of the slope along the full property frontage adjacent to the river. In addition, the slope face was observed to be covered by mature vegetation and small trees. No evidence of active erosion was observed along the toe of the slope – facing southwest.
