FINAL REPORT

Phase Two Environmental Site Assessment

30 Cleary Avenue, Ottawa Ontario

CA0008376.9447-Rev0

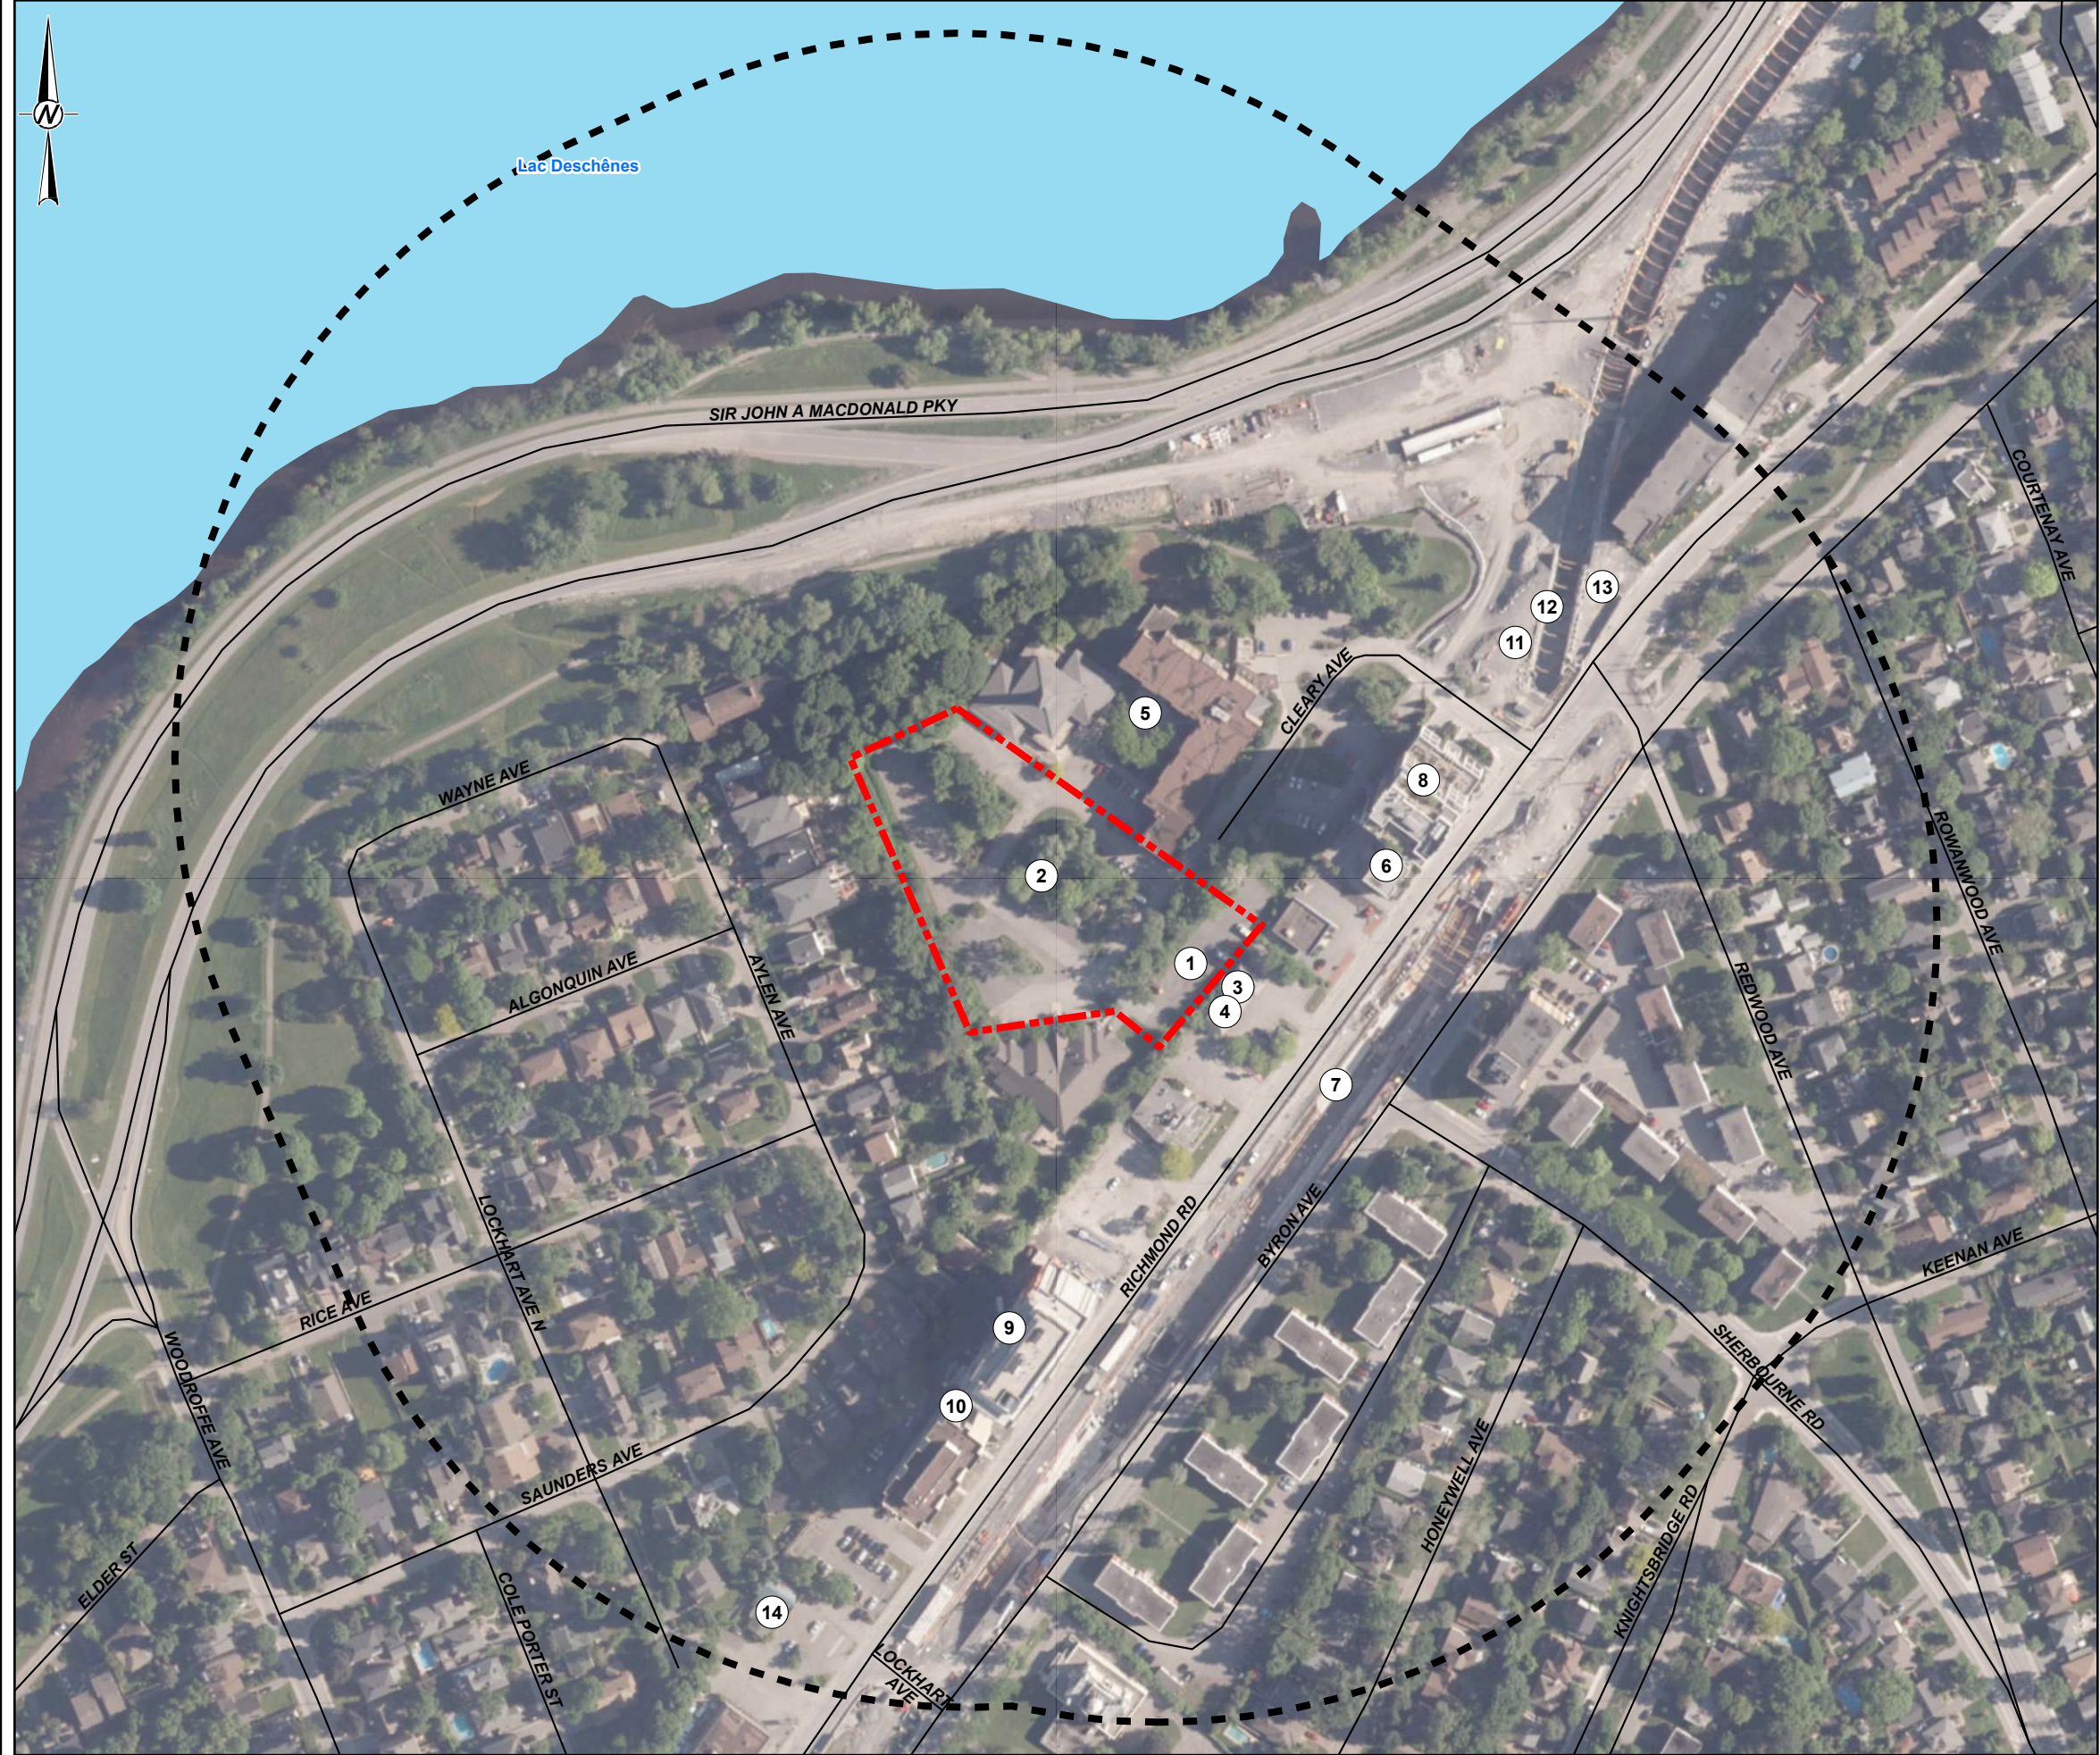
- POTENTIALLY CONTAMINATING ACTIVITY (PCA) LOCATION
- ROADWAY
- WATERBODY
- PHASE TWO SITE
- PHASE TWO STUDY AREA (250 m)

PCA ID	PCA Category	Description
1	46	Rail tracks
2	30	Fill of unknown quality
3	28	Gasoline UST
4	10	Auto repair shop
5	28	Fuel oil UST
6	28	Two gasoline USTs - Gas station
7	46	Ottawa Electric Railway
8	28	Multiple gasoline and oil tanks - Gas station
9	28	Gasoline USTs and ASTs
10	28	Two USTs - Gas Station
11	28	Multiple gasoline and fuel oil USTs
12	37	Dry cleaning depot
13	28	Two USTs - Gas station
14	28	Three gasoline USTs - Multiple gas stations

NOTE(S)
 1. ALL LOCATIONS ARE APPROXIMATE
 2. SEVERAL SPILLS WERE NOTED IN THE PHASE ONE STUDY AREA THAT ARE NOT MAPPED, BUT THESE SPILLS ARE NOT CONSIDERED PCAS OR AS RESULTING IN AN APEC.

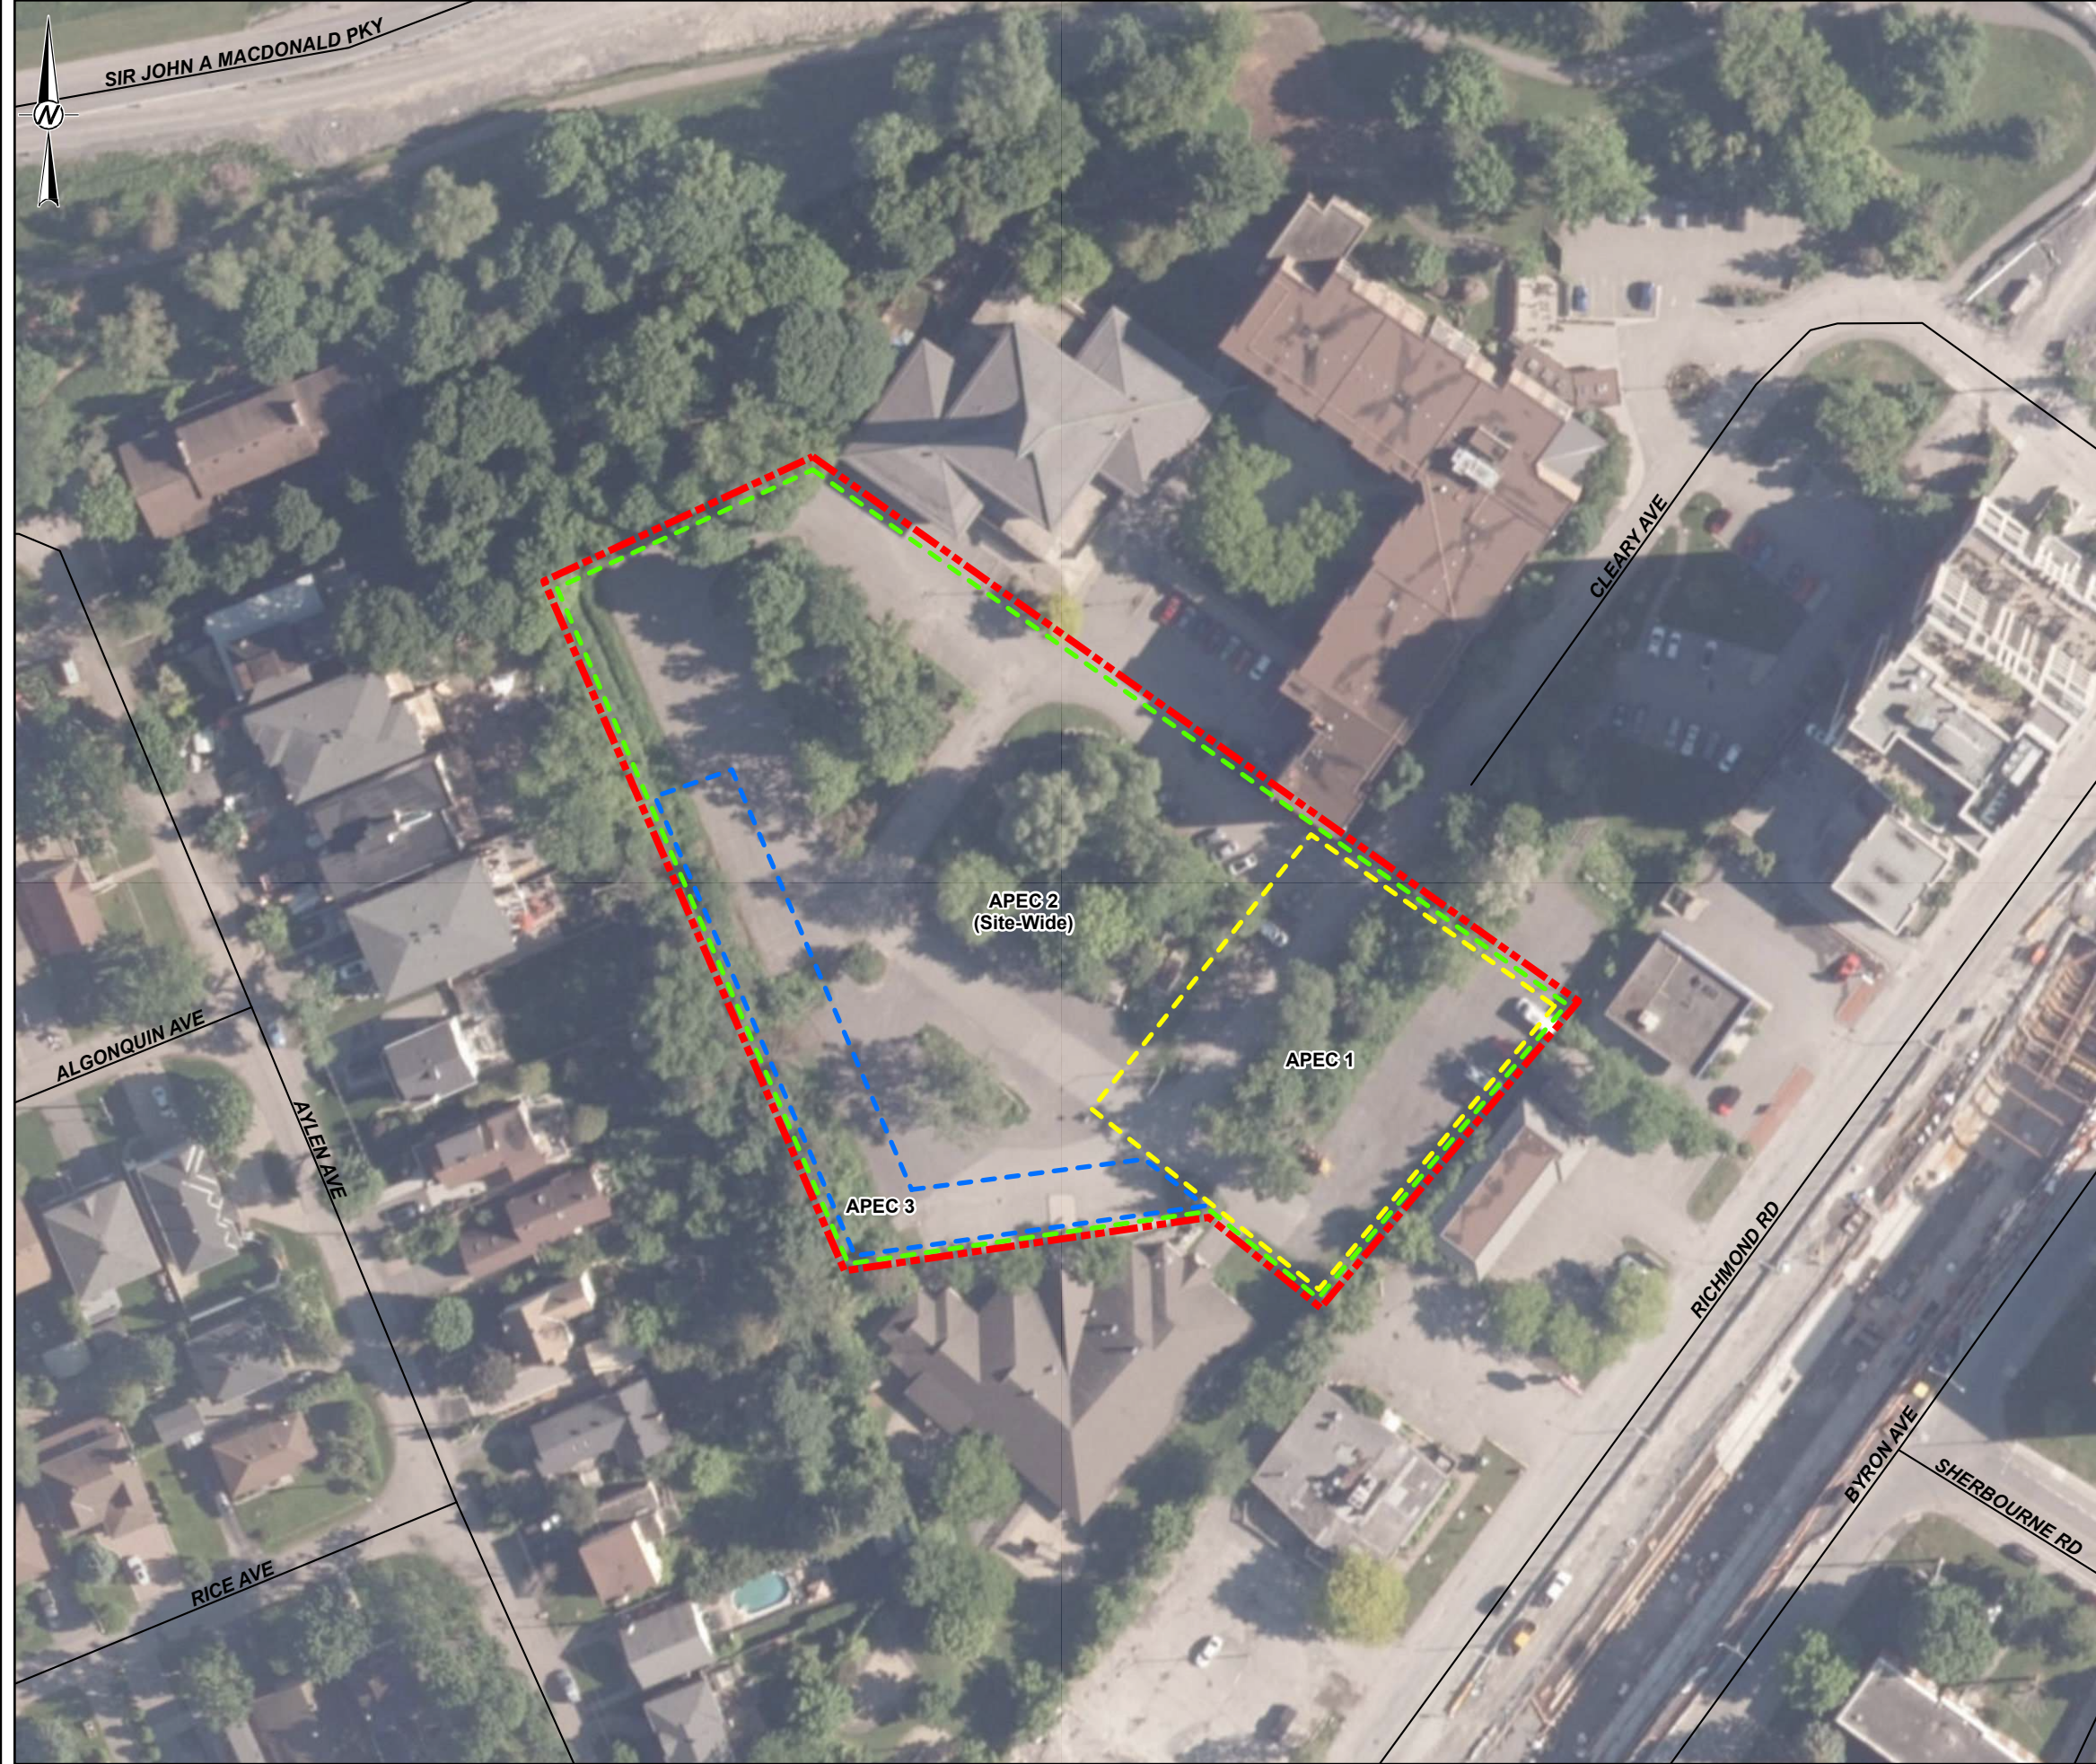
APEC ID	PCA Category	Description of PCAs attributing to APEC
APEC 1	10, 28, 46	PCA 1: Former railway on-site PCA 3, 6, 8: Multiple gasoline service stations and USTs/ASTs PCA 4: Auto repair shop off-site
APEC 2	30	PCA 2: Fill material of unknown quality
APEC 3	28	PCA 9, 10: Multiple gasoline service stations and USTs/ASTs

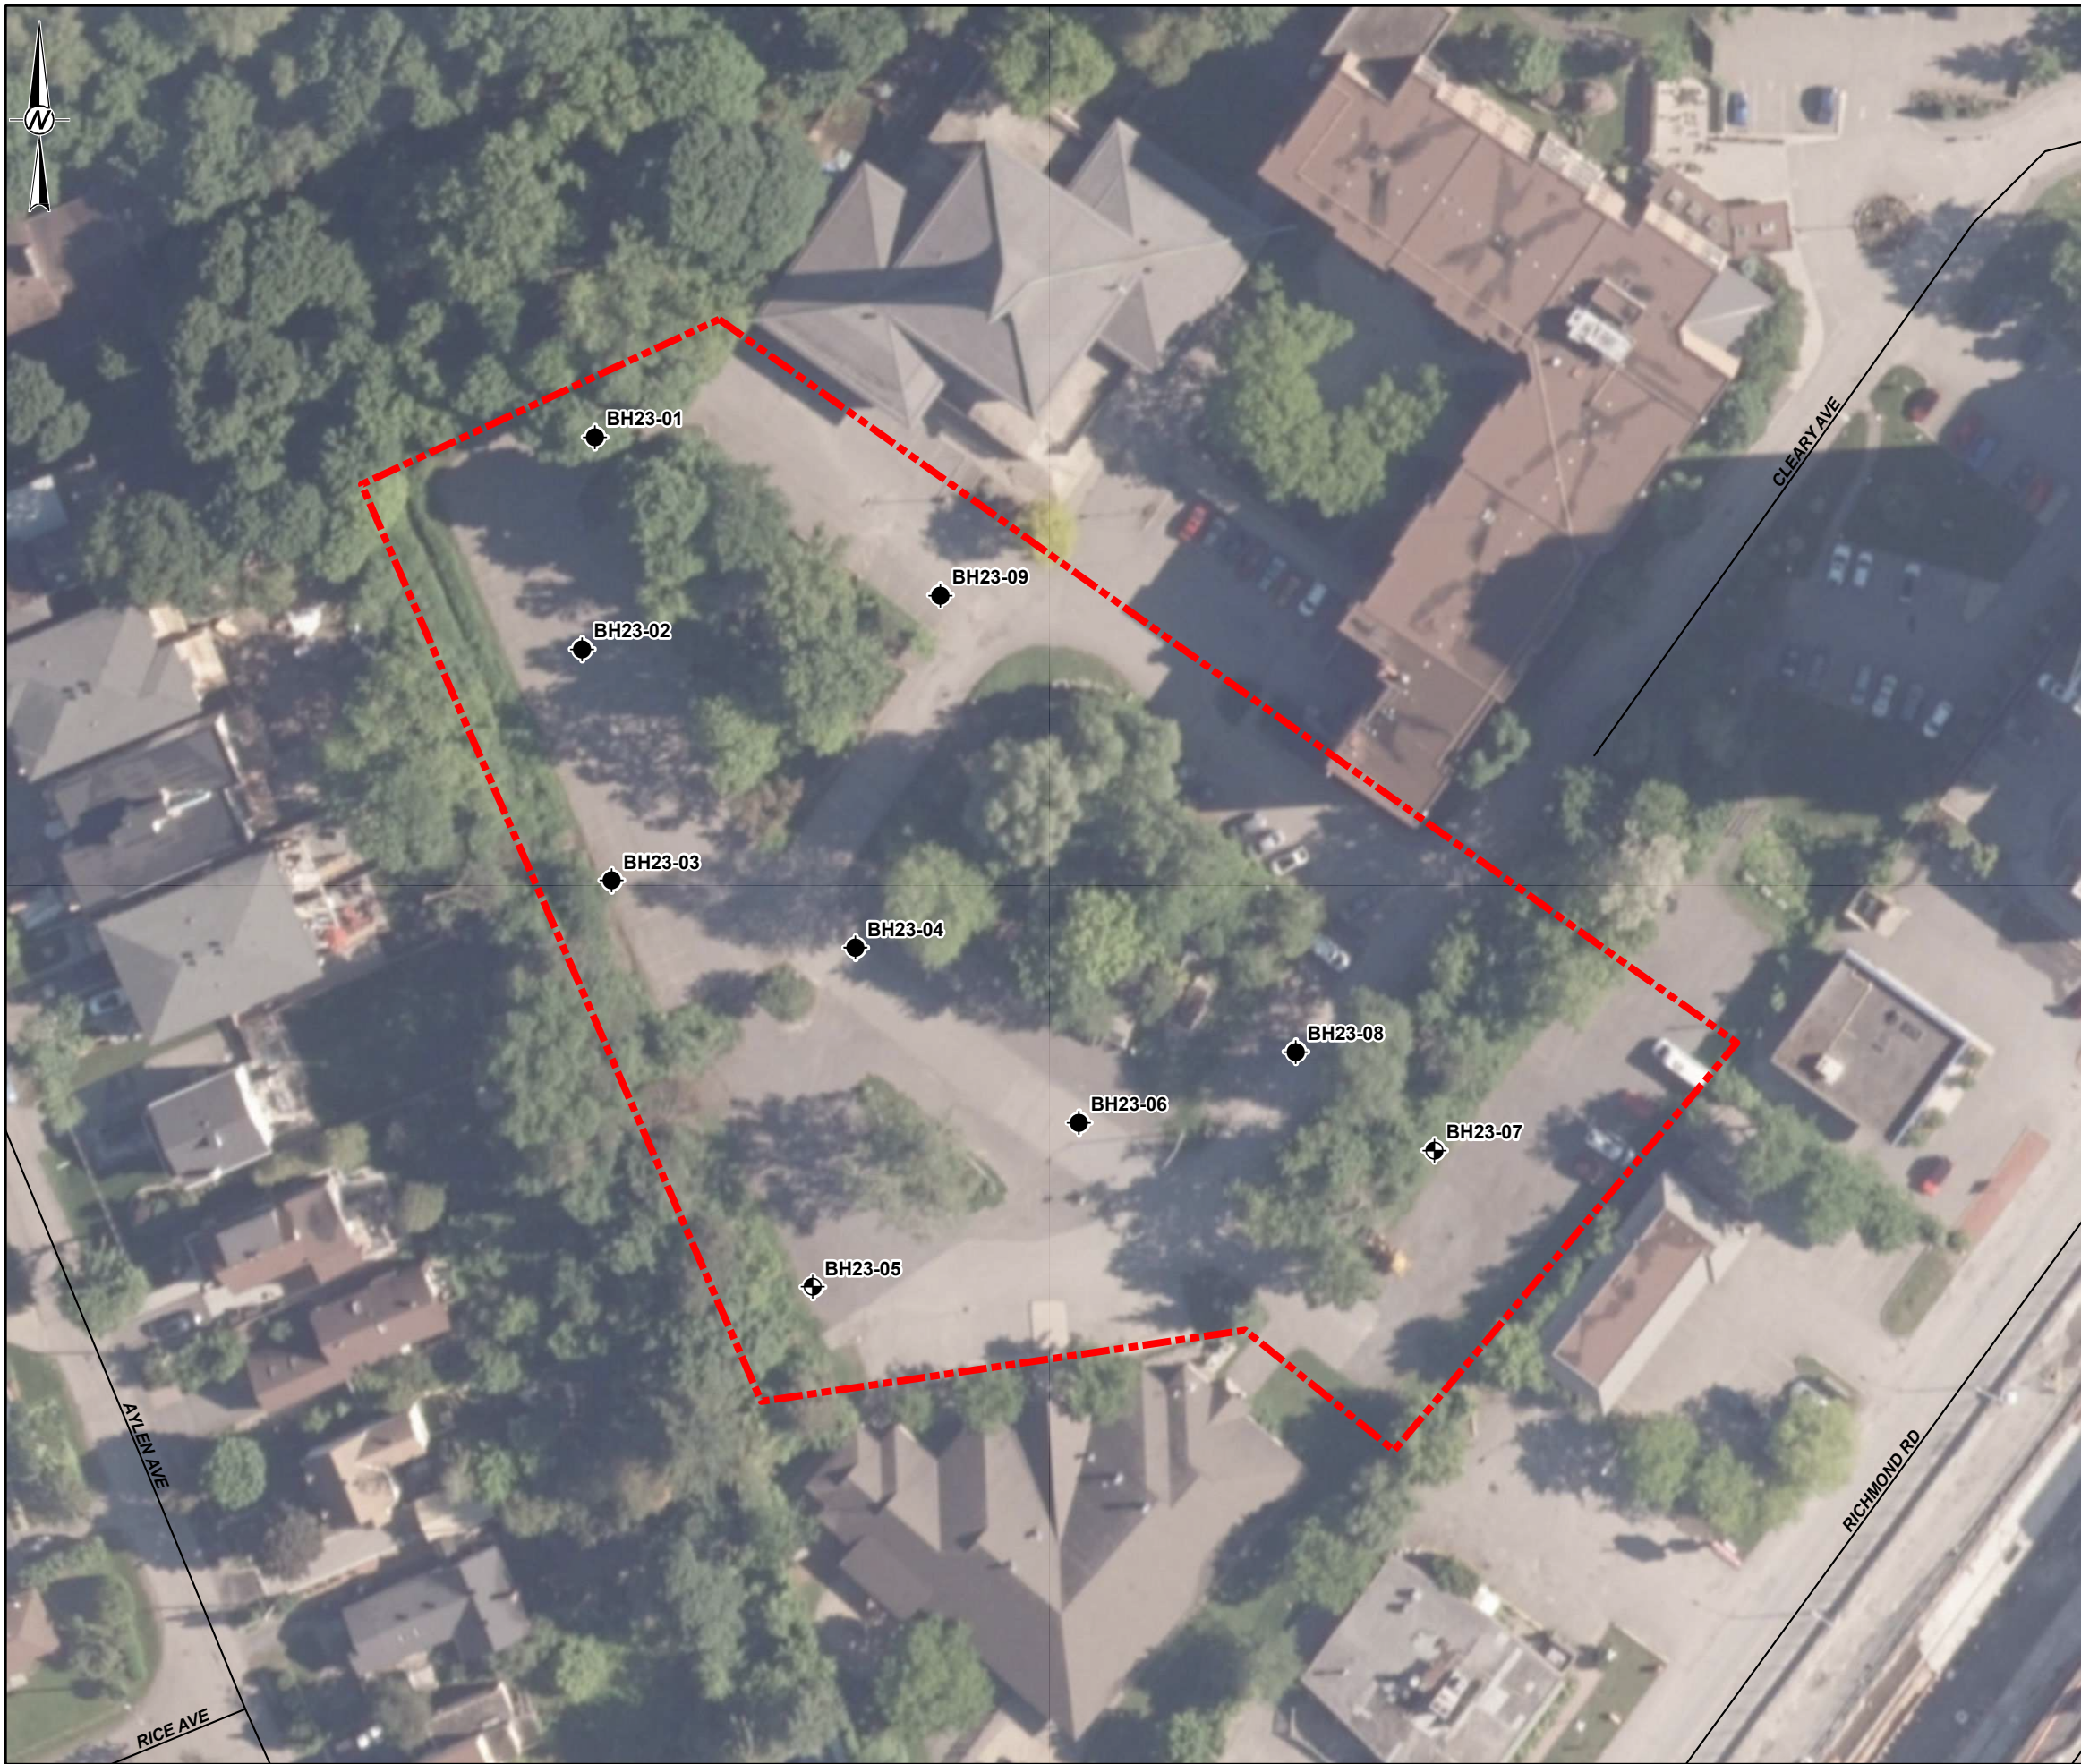
- BOREHOLE LOCATION
- BOREHOLE/MONITORING WELL LOCATION
- ROADWAY
- PHASE TWO SITE
