**FINAL REPORT**

# Phase I Environmental Site Assessment

*30 Cleary Avenue, Ottawa, Ontario*

CA0008376.9447-Rev0

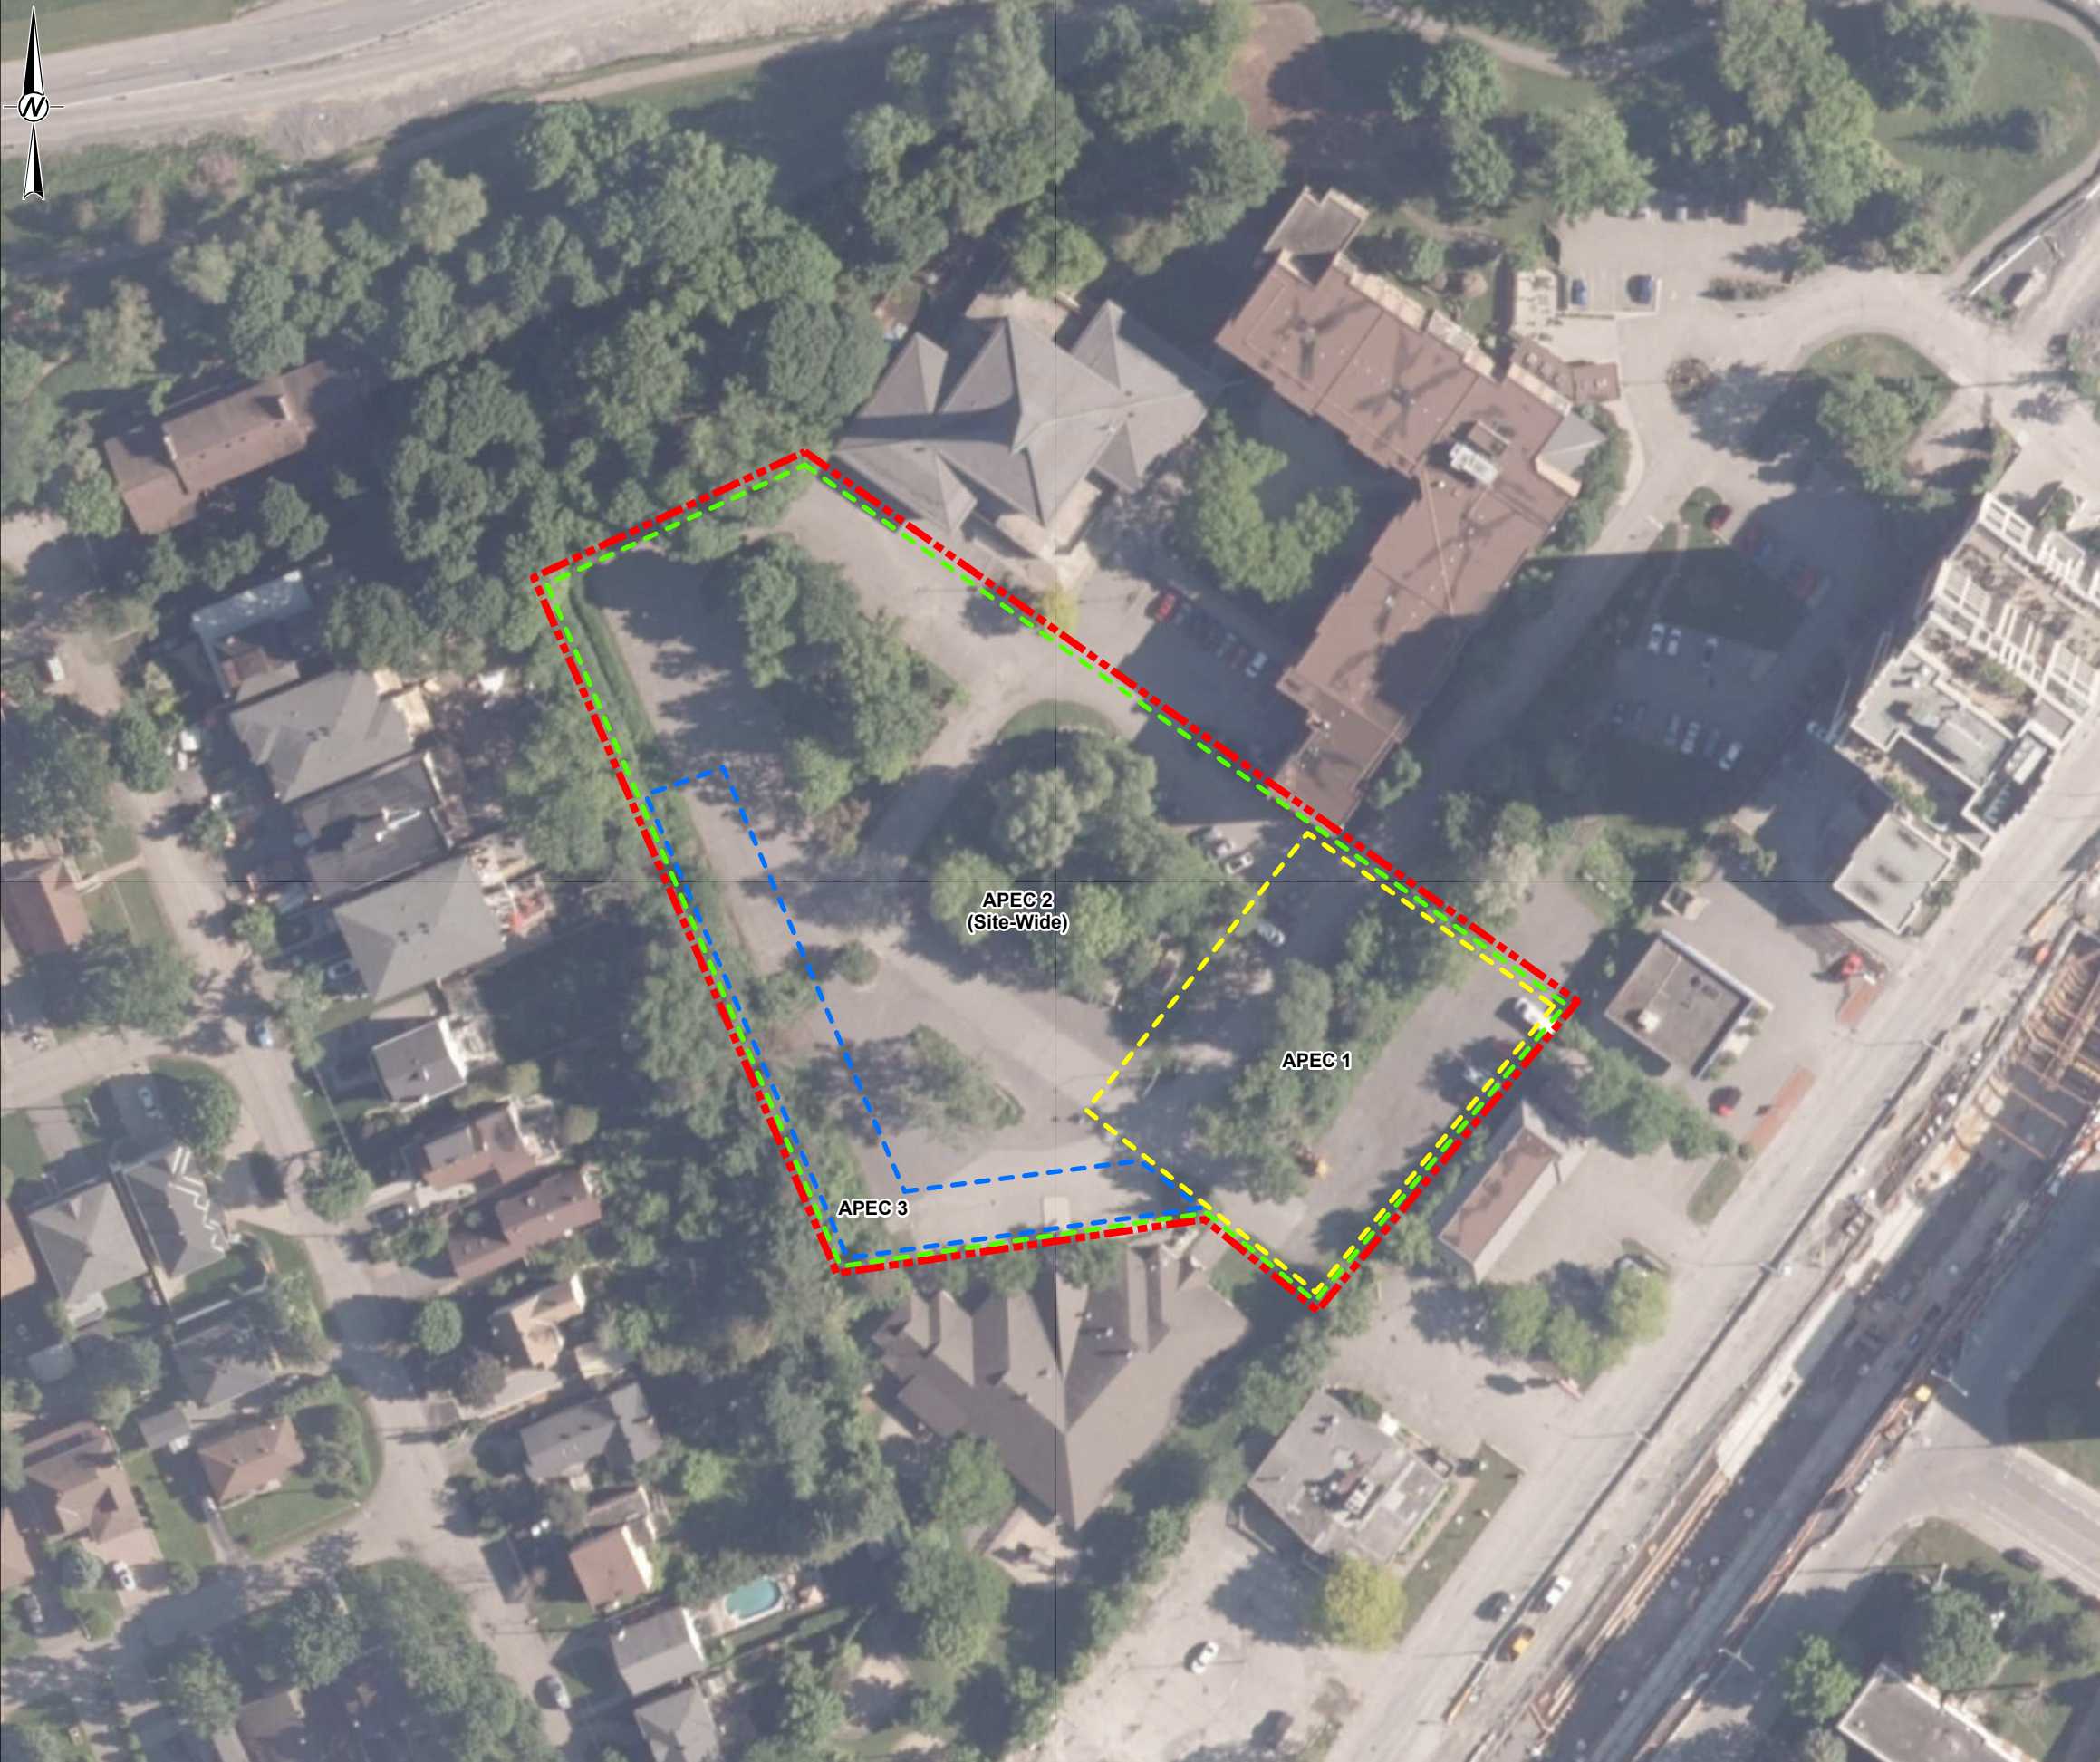
| APEC ID | PCA Category | Description of PCAs attributing to APEC |
|---|---|--|
| APEC 1 | 10, 28, 46 | PCA 1: Former railway on-site<br>PCA 3, 6, 8: Multiple gasoline service stations and USTs/ASTs<br>PCA 4: Auto repair shop off-site |

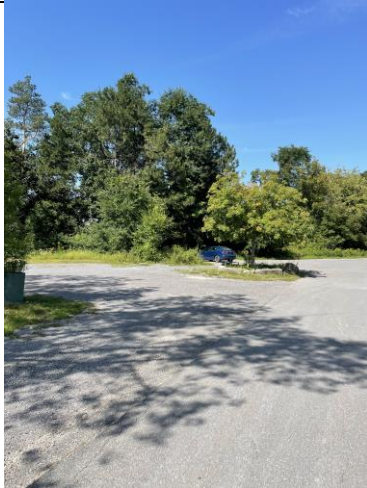
Photo 1 - Paved and gravel parking area, facing western Site boundary.

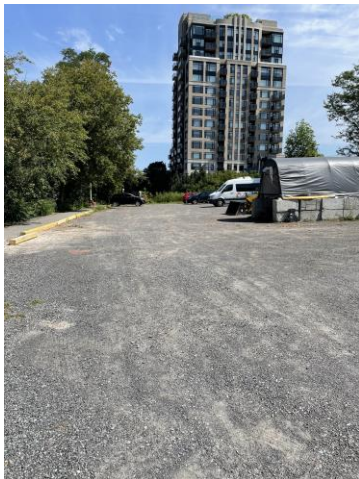
Photo 3 - Gravel parking area at southern portion of Site. Former railway corridor, facing east.

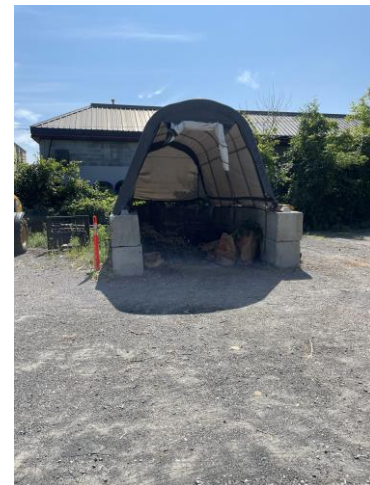
Photo 4 - Structure storing landscaping equipment. Dave Rennie's auto-repair behind, facing south.

No waste storage or chemical storage was noted on the Property, however there is compost bin storage on the east side of the paved parking lot and there was an open storage building containing landscaping equipment and materials on the south side of the gravel parking area.

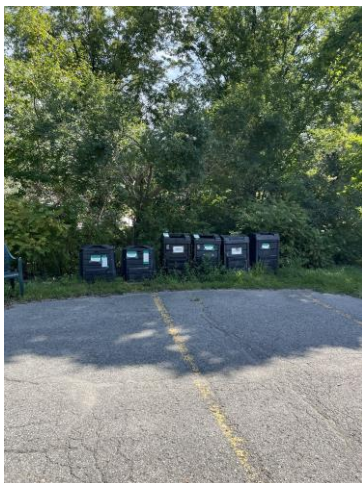
Photo 5 - Compost bin storage, forested patch in centre of Site.

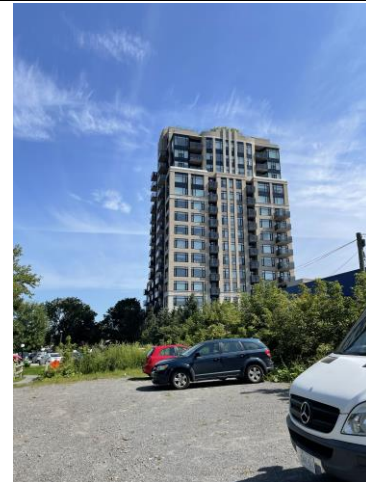
Photo 8 - High rise condominium east of Property. Location of former gas station.

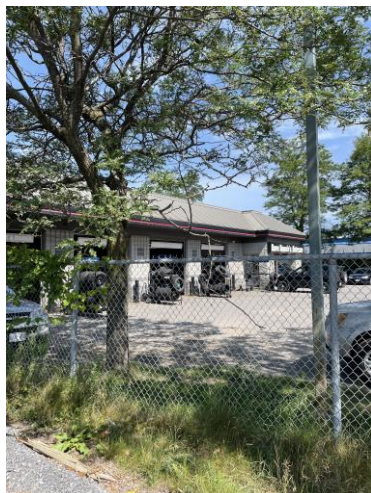
Photo 9 - Dave Rennie's Auto-repair, taken from Richmond Road, facing north.

The auto repair shop (Dave Rennie’s) to the south of the Phase One Property was the only off-site PCA identified during the site reconnaissance. No relevant or significant observations pertaining to water bodies or areas of natural significance within the Phase One Study Area were made during the site reconnaissance.
