Preliminary Geotechnical Investigation Report

Costco Gloucester Conversion to Business
Center – Fuel Station Addition
1900 Cyrville Road, Gloucester, Ontario

Project No. 121626297

May 2025

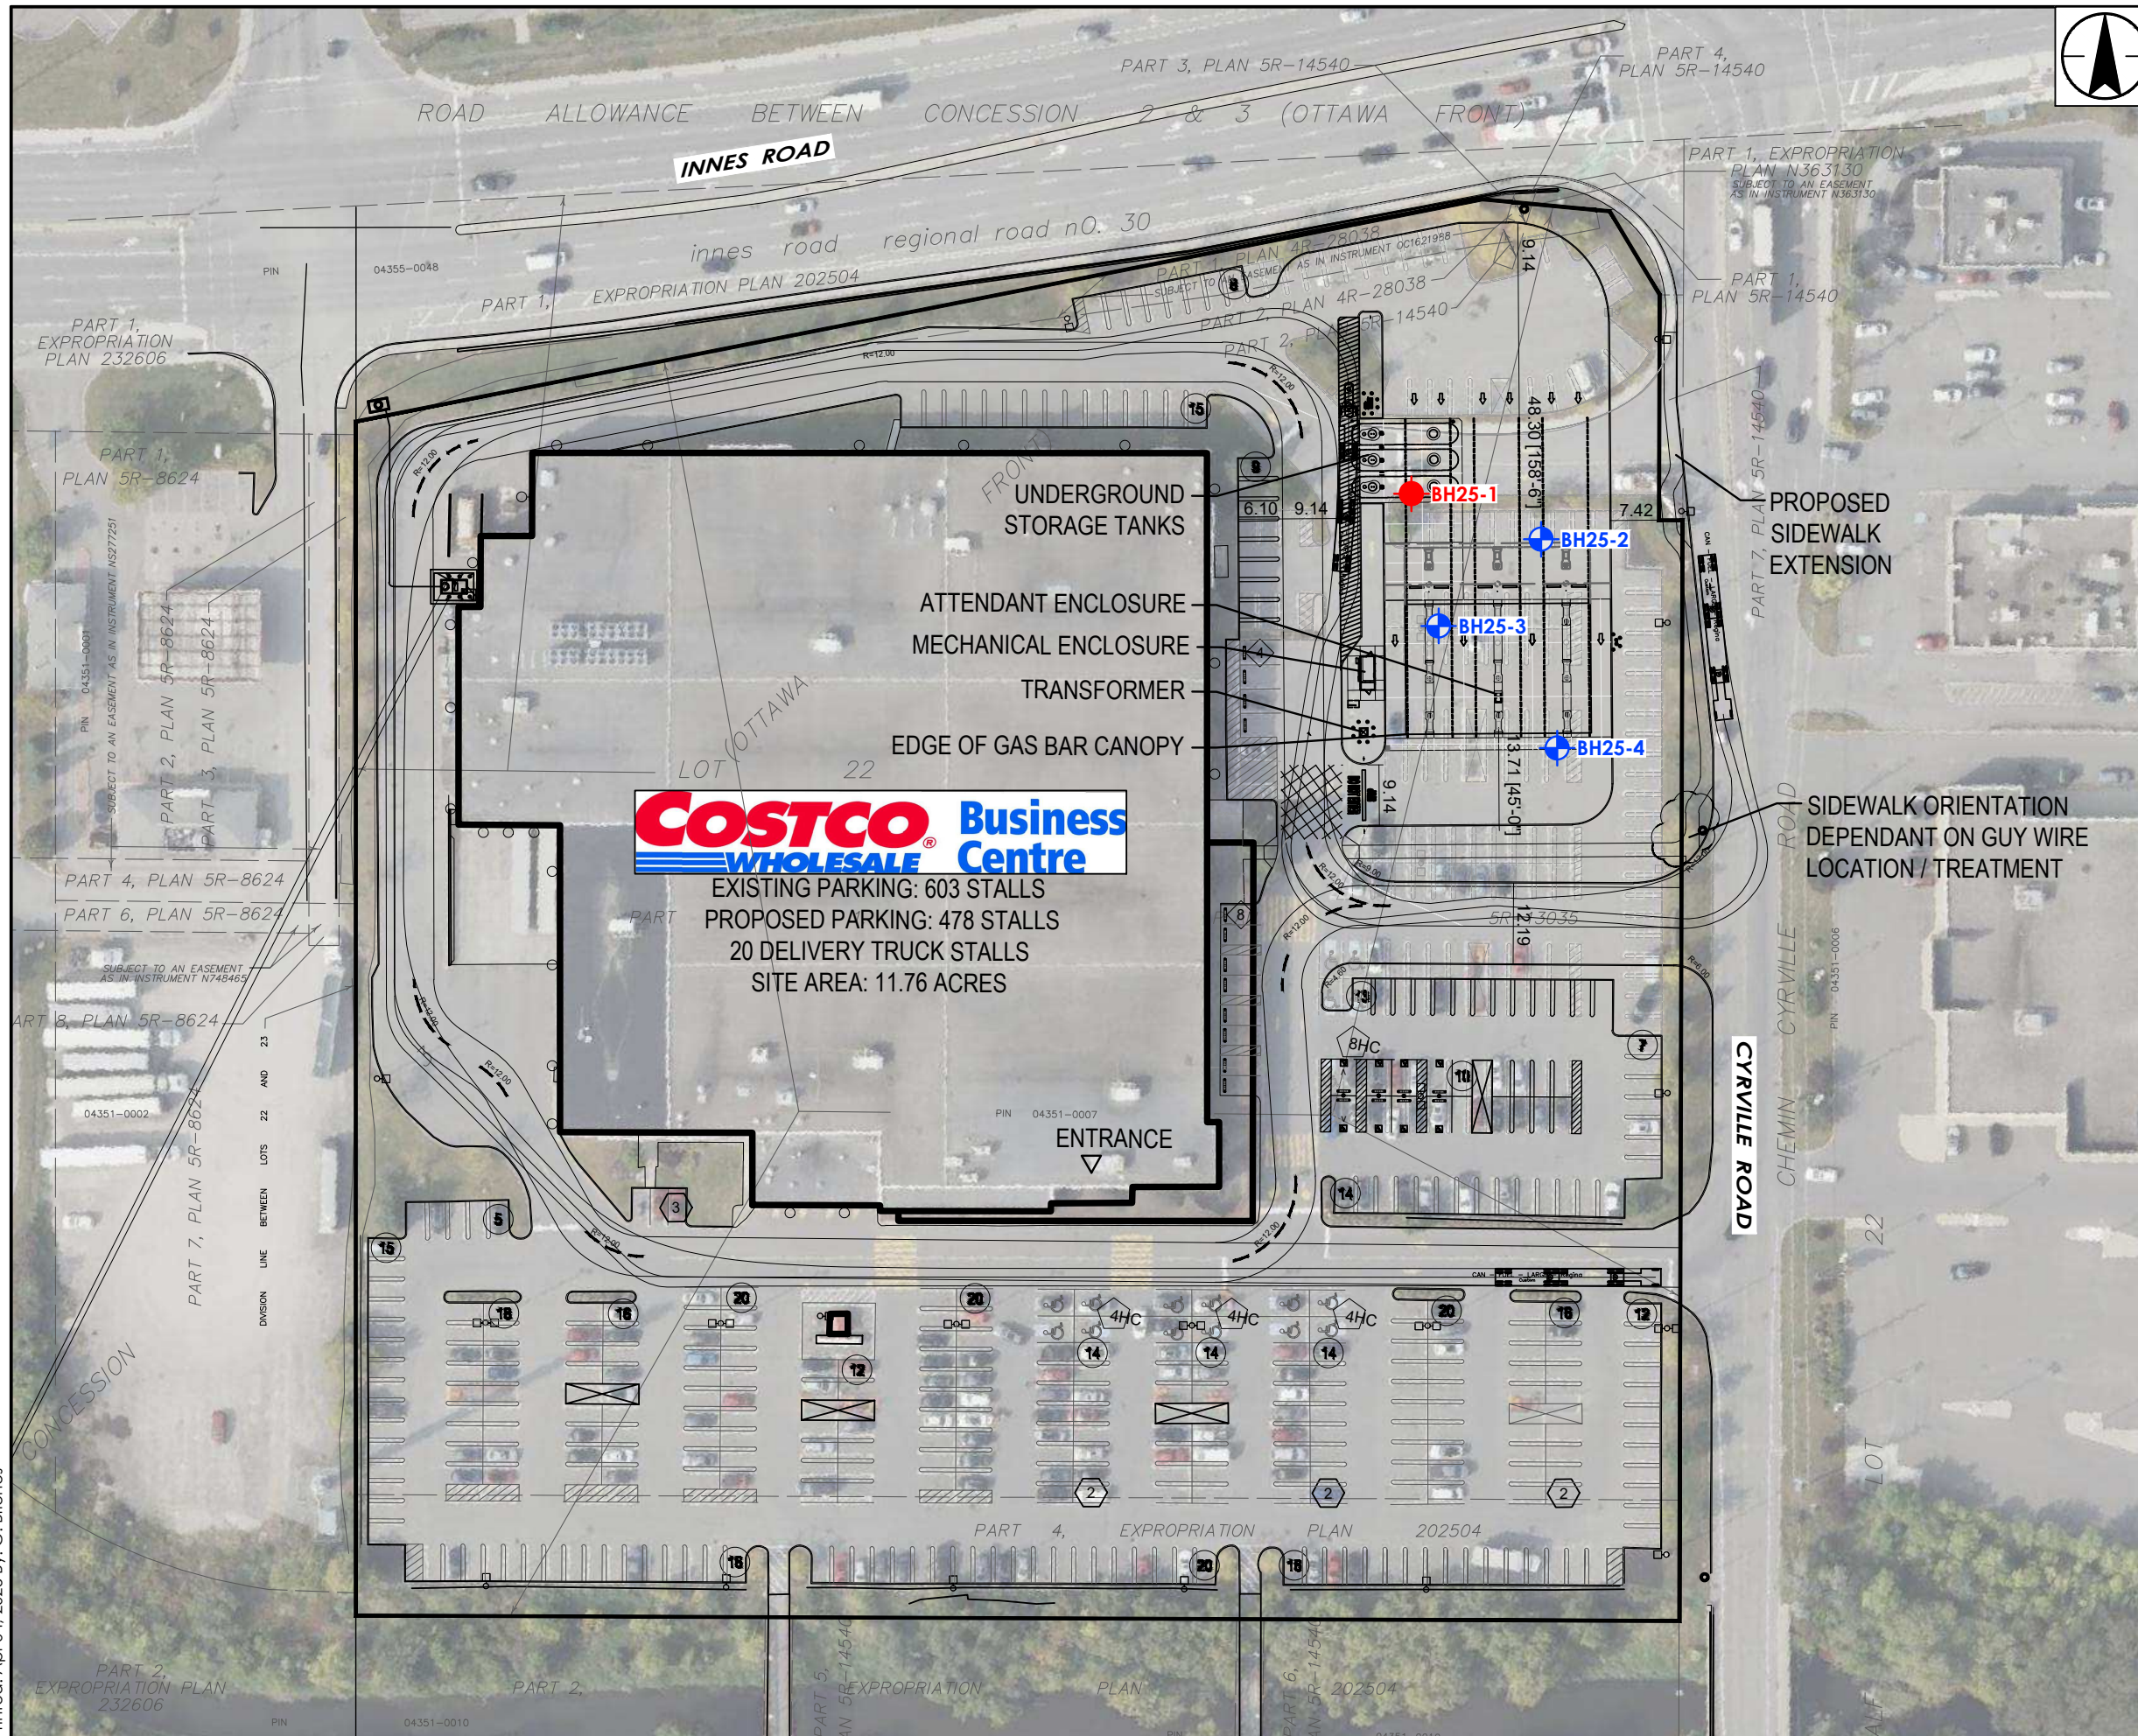
1. COORDINATE SYSTEM: NAD 1983 UTM ZONE 18N.
2. BASE PLAN: PDF COPY OF THE SITE PLAN PREPARED BY WSP, DWG. No. SP-11, DATED APRIL 29, 2022.
3. IMAGERY: © 2025 MICROSOFT CORPORATION © 2025 TOM TOM.

Boreholes BH25-01 was advanced at the location of the proposed underground storage tanks and boreholes BH25-02, BH25-03, and BH25-04 were advanced for the proposed pavement structures, pump foundations, and canopy foundations within the footprint of site plan SP-11.

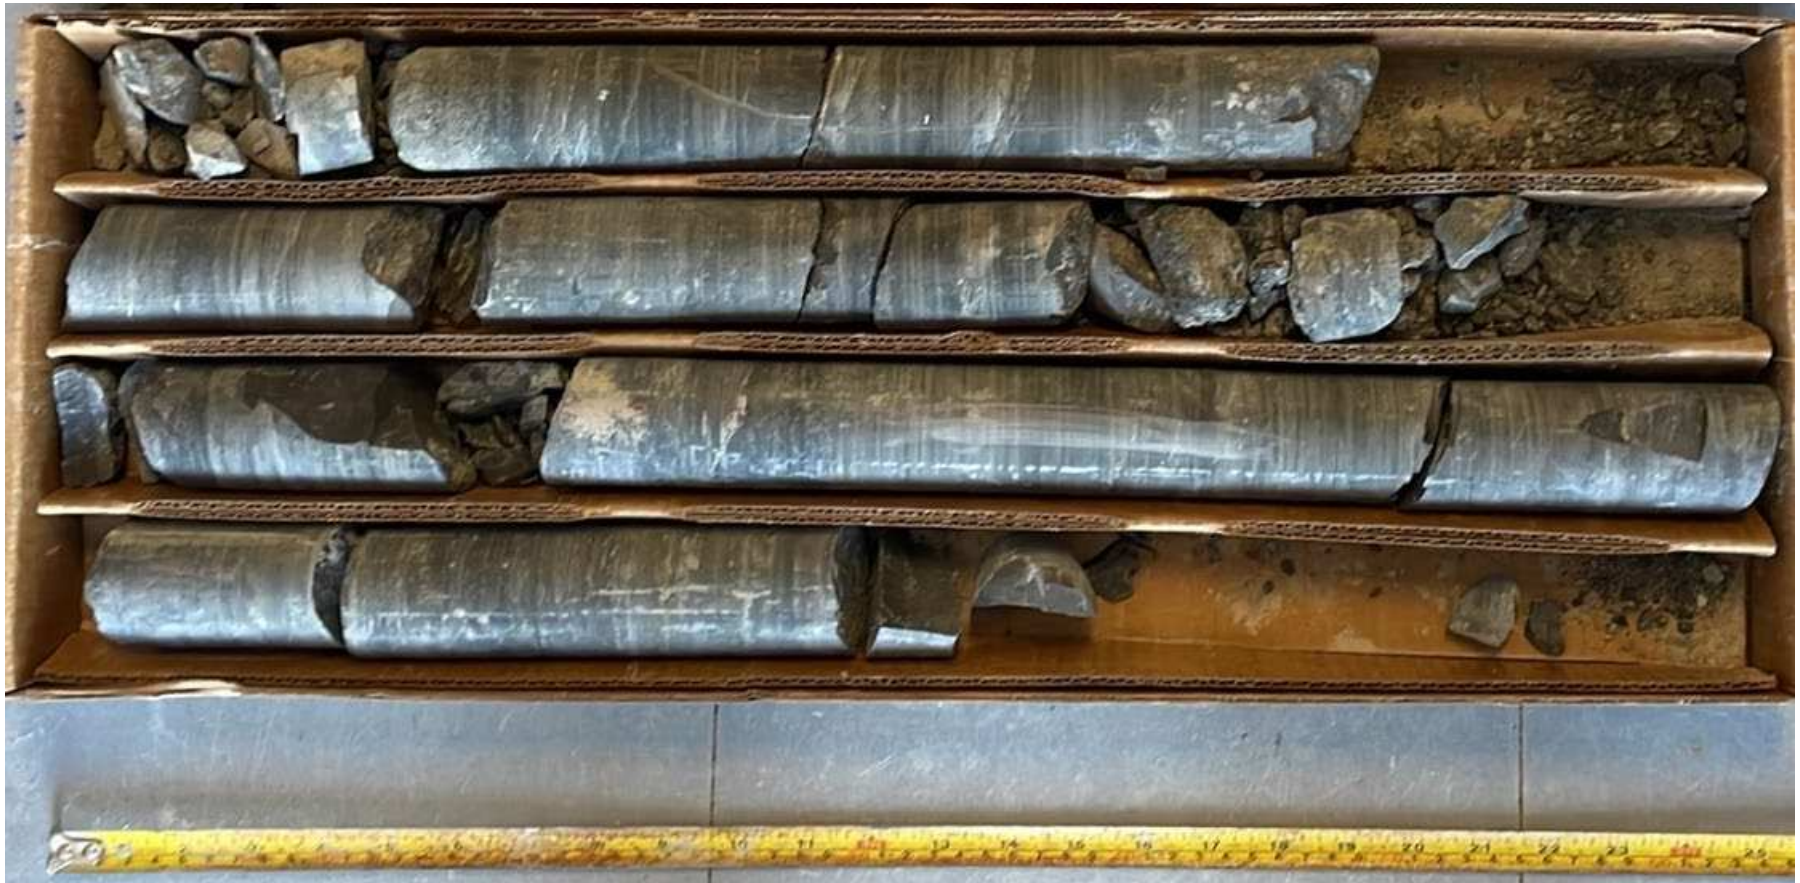
Rock Core Photo No.: 1

Rock Core Photograph

Borehole: BH25-01
