Geotechnical Investigation Report – Block 21, 200 Codd’s Road, Ottawa

February 26, 2026

Wateridge Lifestyles Ltd. And Canada Lands
Corporation

Cambium Reference: 24896-001 Rev.2

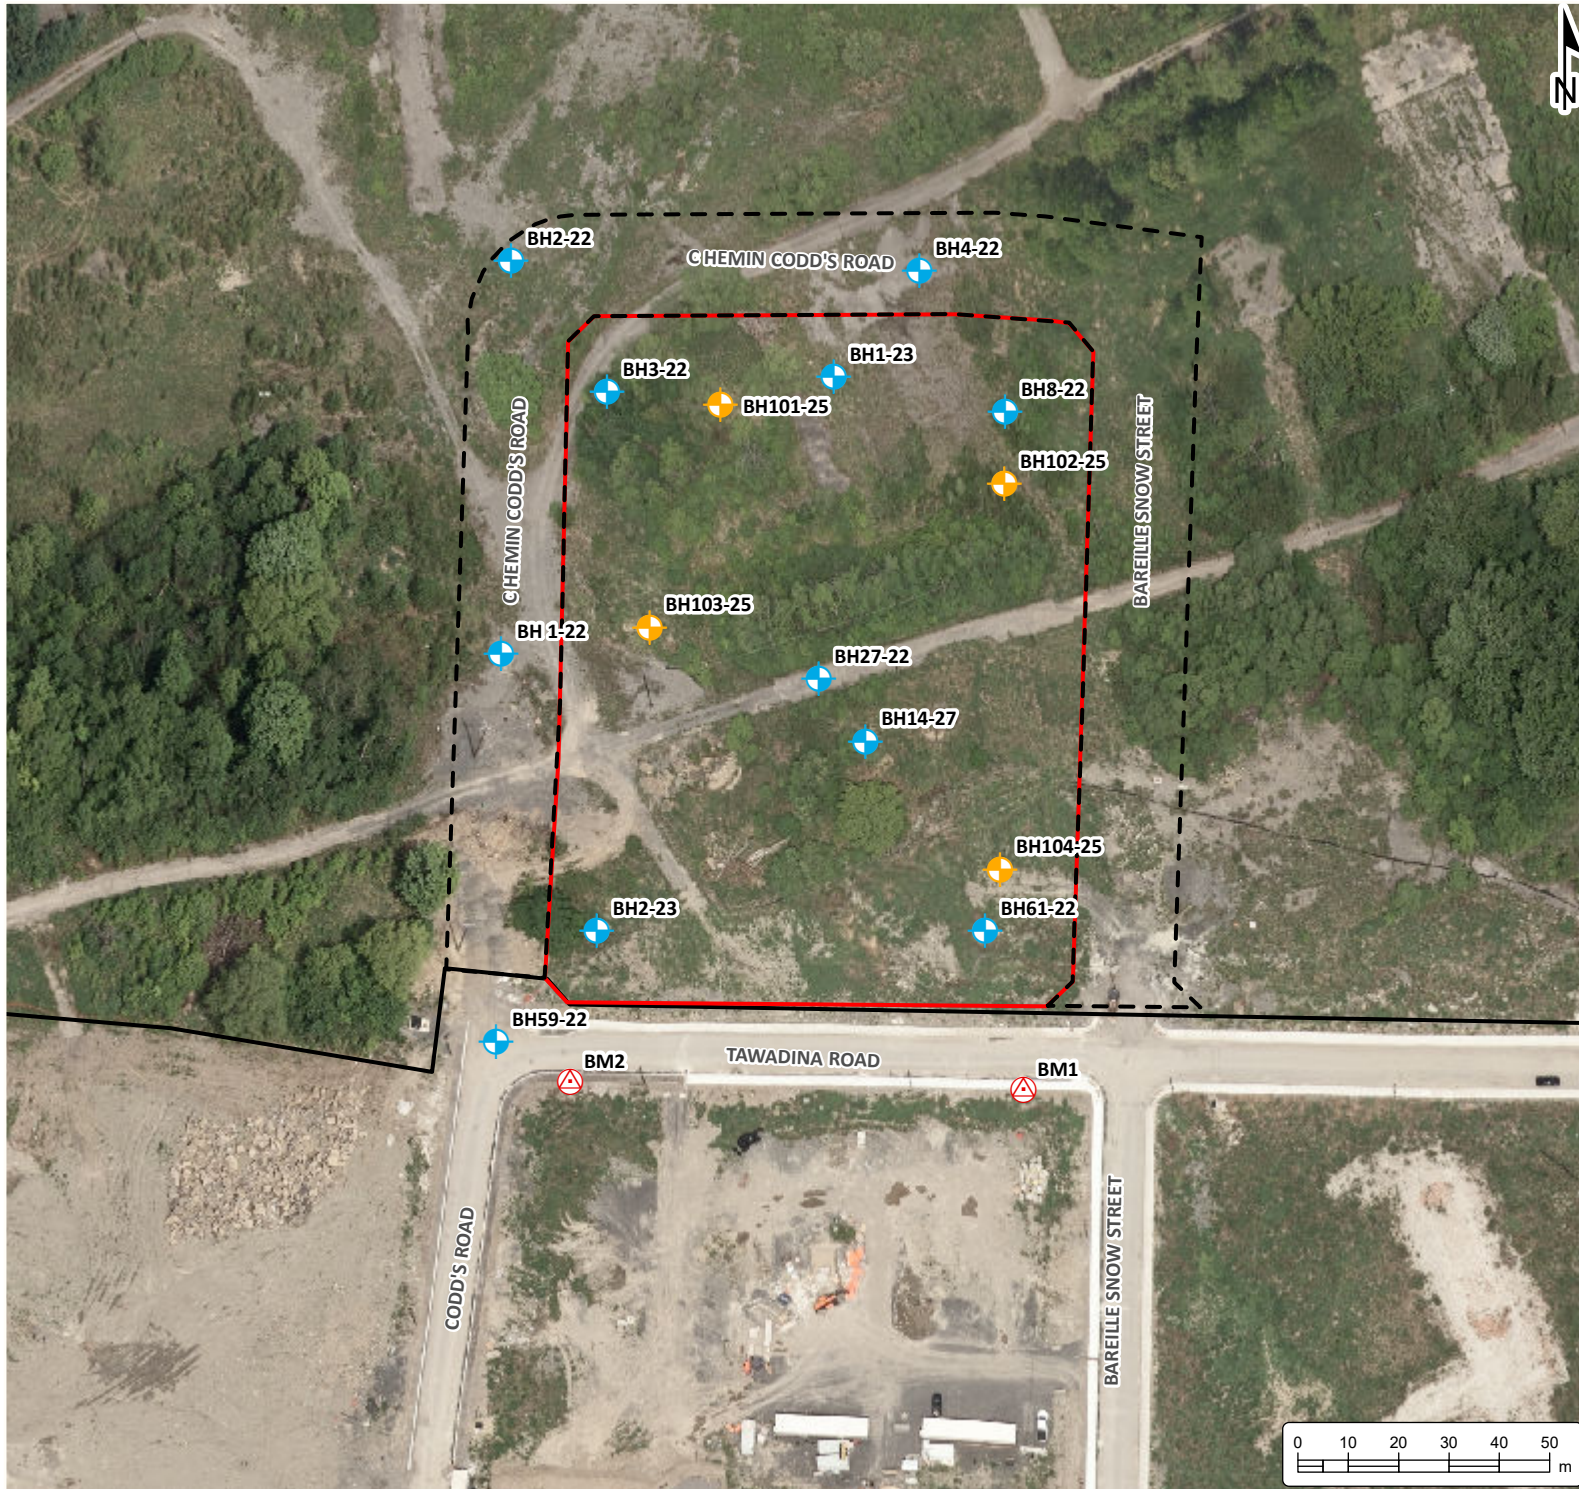
GEOTECHNICAL INVESTIGATION
WATERIDGE LIFESTYLES LTD.
 Block 21 - Wateridge Village
 Ottawa, Ontario

The geotechnical field investigation was conducted on December 8 and 9th, 2025, during which time four (4) boreholes, designated as BH101-25 to BH104-25, were advanced across the Site. Table 1 provides a summary of the boreholes. All boreholes encountered practical refusal within investigation depths and rock coring was completed at all borehole locations. The boreholes for the investigation were terminated at a depth of 6.1 metres below ground surface (mbgs). The approximate borehole locations relative to existing conditions are shown on the Borehole Location Plan, Figure 2. Elevations were measured based on the topographic survey [2] and provided based on geodetic metres above seal level (mASL).

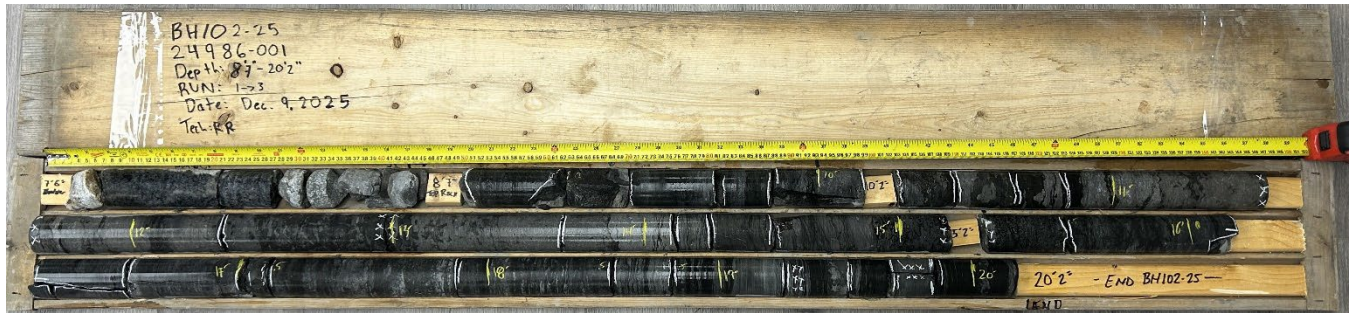
Borehole BH102-25 Rock core runs 1 through 3, 2.6 to 6.1 mbgs

The bedrock is limestone of the Gull River Formation, the rock in this area is generally grey, thinly to medium bedded, slightly decomposed, moderately fractured, and of very poor to good quality. The Rock Core Logs and Rock Core Photos are provided in Appendix B and Appendix C, respectively.

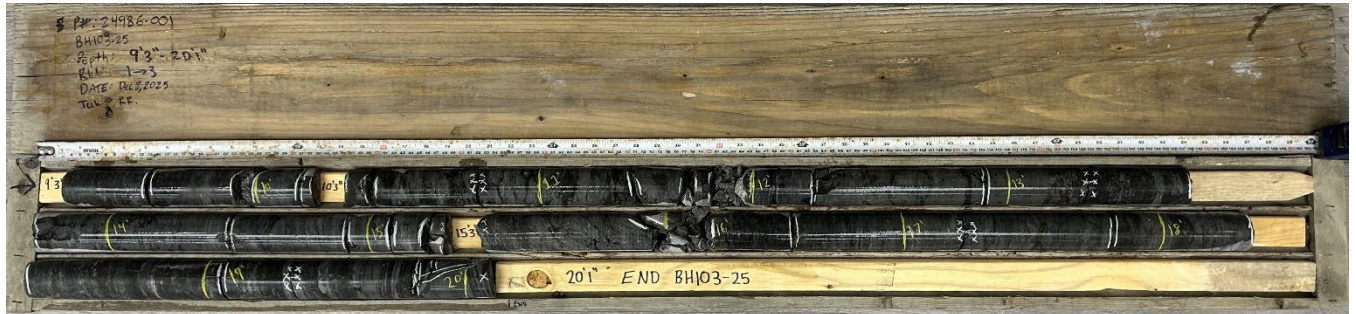
Borehole BH103-25 Rock core runs 1 through 3, 2.8 to 6.1 mbgs

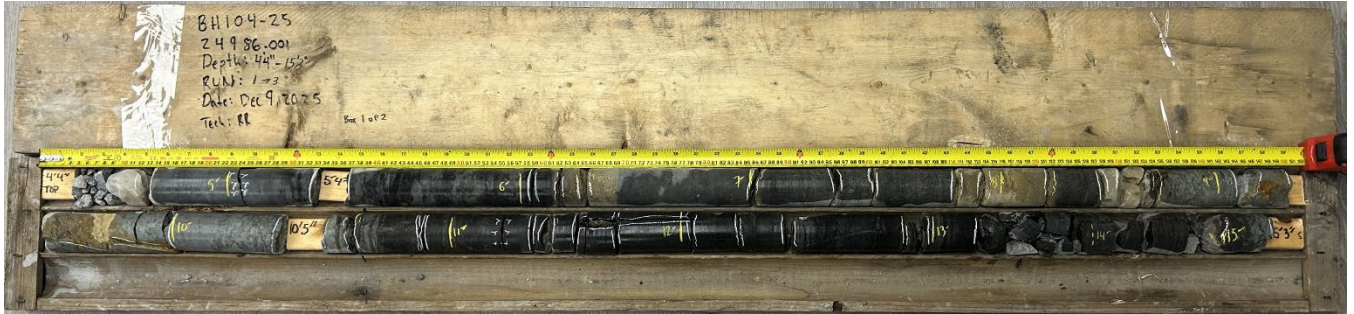
Borehole BH104-25 Rock core runs 1 through 3, 1.3 to 4.7 mbgs

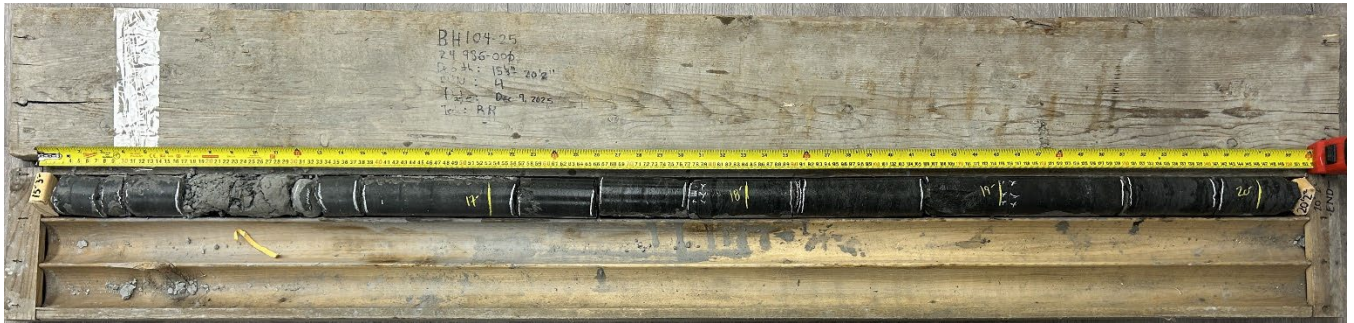
Borehole BH104-25 Rock core run 4.7 to 6.1 mbgs

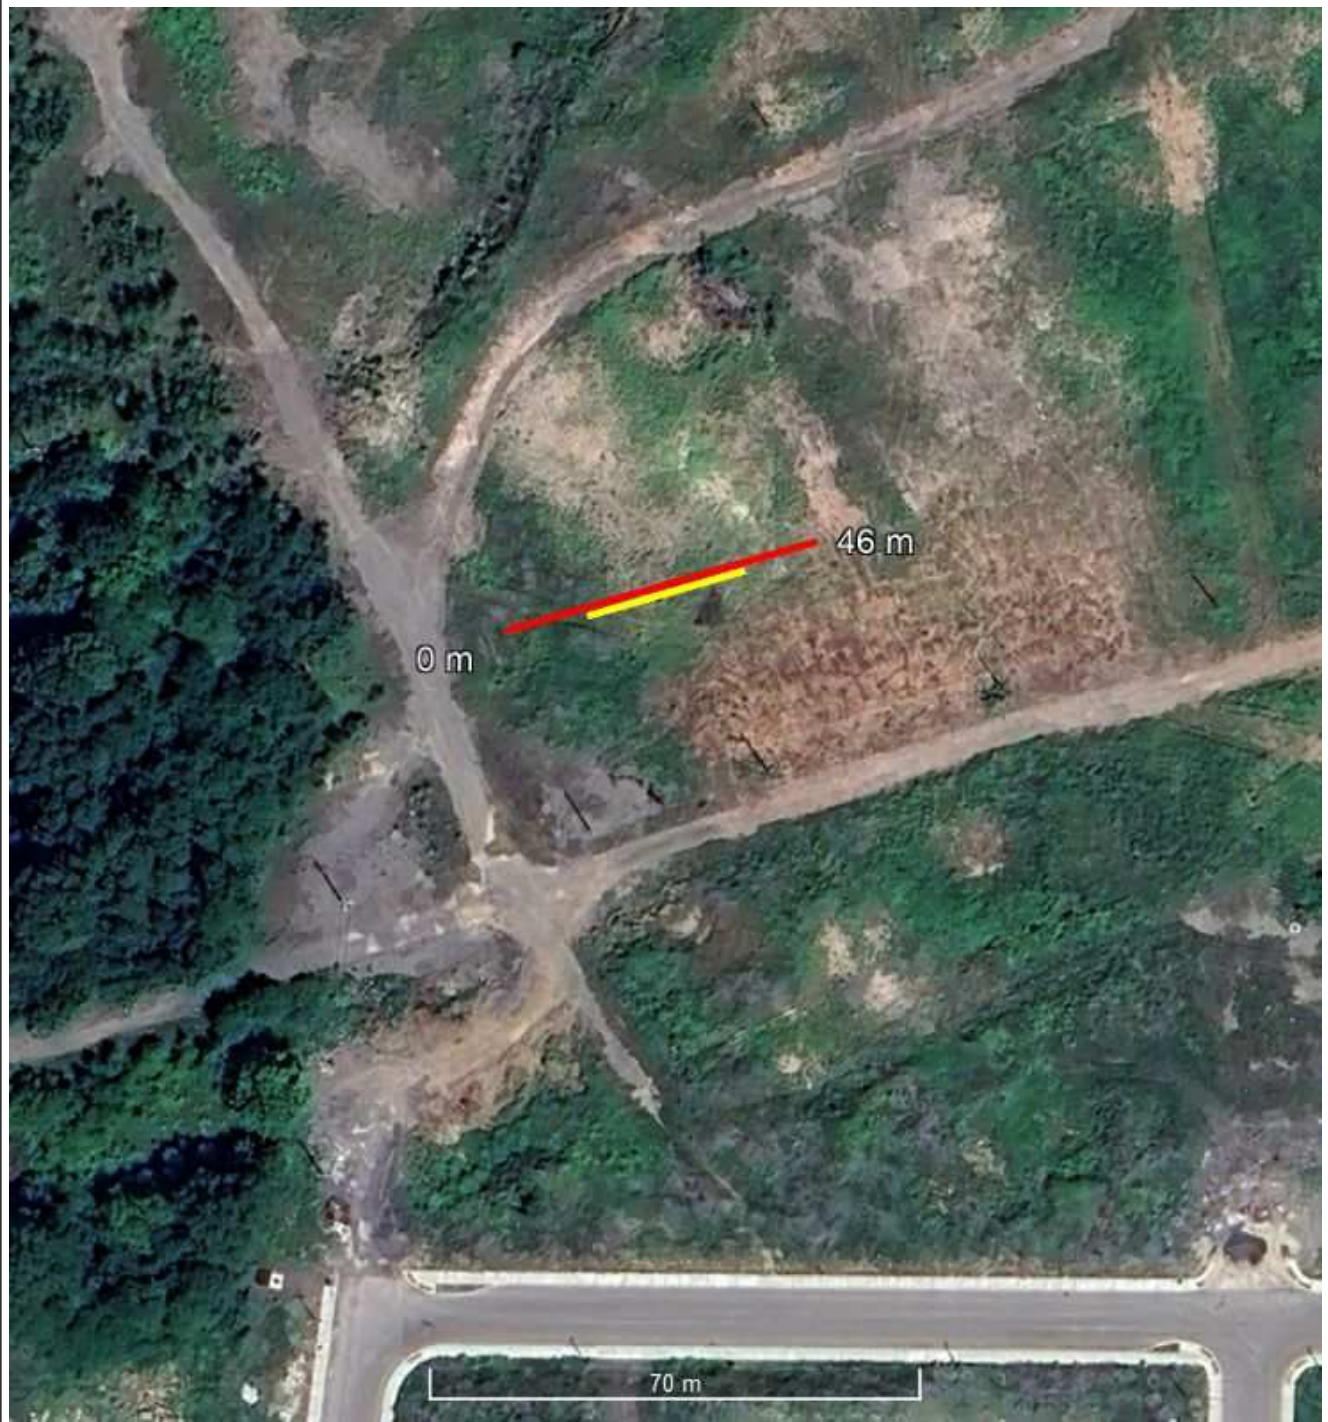
The acquisition layout consisted of 24 receivers in a linear array (spread), connected with a multicore cable to a DAQLink 4 seismograph. 4.5 Hz natural frequency vertical geophones were used for this survey. The measurements were conducted with a spread length of 23 m (1 m spacing between geophones).

An 8-kg sledgehammer was used as an energy source. Shots were executed at three locations: one shot in the middle of the spread and two shots close to the ends of the spread. The record length was set to 1500 ms with a 0.05 ms sampling interval.

The accuracy of MASW generally depends on the complexity of the subsurface and specific site conditions (noise levels, topography, etc.). Lateral velocity variations and steeper bedrock topography increase the dispersion uncertainty. The presence of high-velocity contrast layers such as bedrock will require the use of a-priori information to optimize model parameters for more accurate results. Hence, if the a-priori information is not available (e.g. when the data are overly noisy to carry out refraction analysis), the accuracy decreases.

Refraction data were used for parameterization of the initial MASW inversion model. The measured shear wave velocity for the bedrock is representative of the top of competent rock. According to Commentary J (Paragraph 145) of the National Building Code of Canada 2020 (NBC 2020), the measured value may be extrapolated if the rock conditions are known to be continuous to a depth of 30 m.

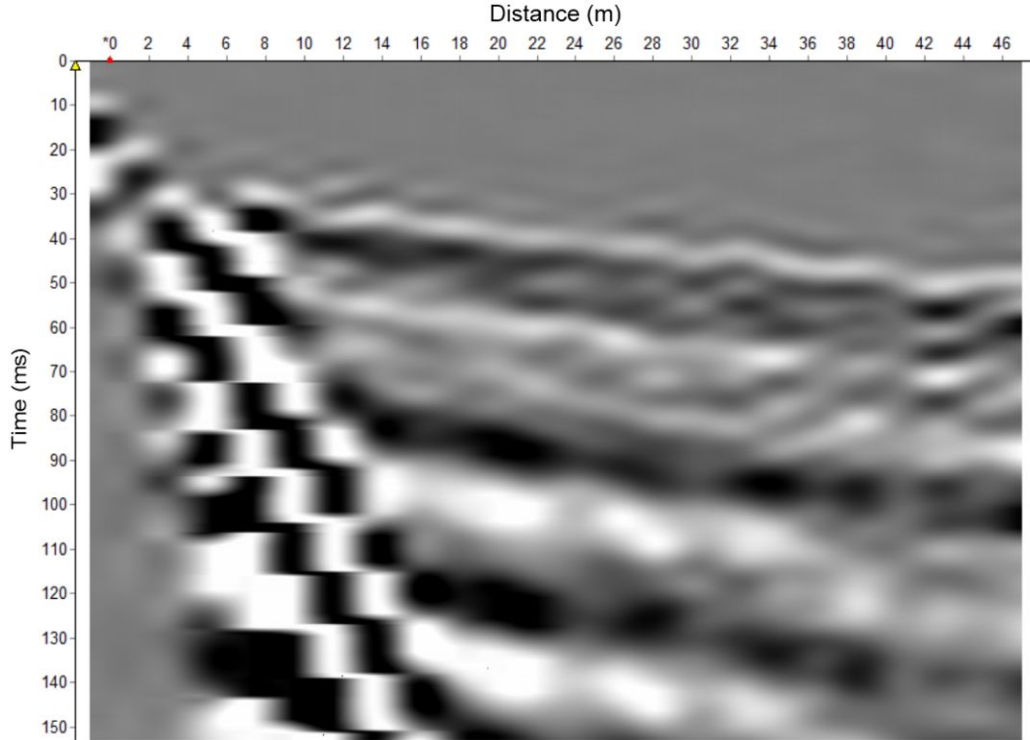
Figure 4 Data examples displaying a stacked S-wave refraction shot record (top) and MASW dispersion image (bottom).

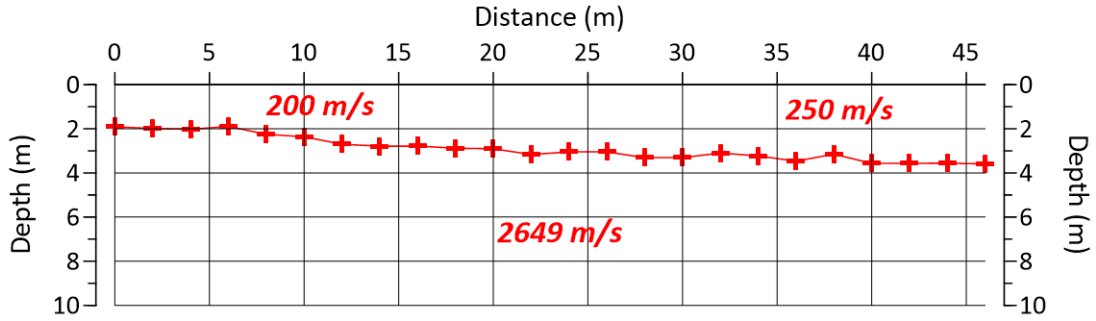
Figure 5 Interpreted depth to bedrock from S-wave refraction.
