# Geotechnical Investigation Report – 100 Bareille-Snow Street, Ottawa

July 16, 2026

Cambium Reference: 24896-001 Rev.4

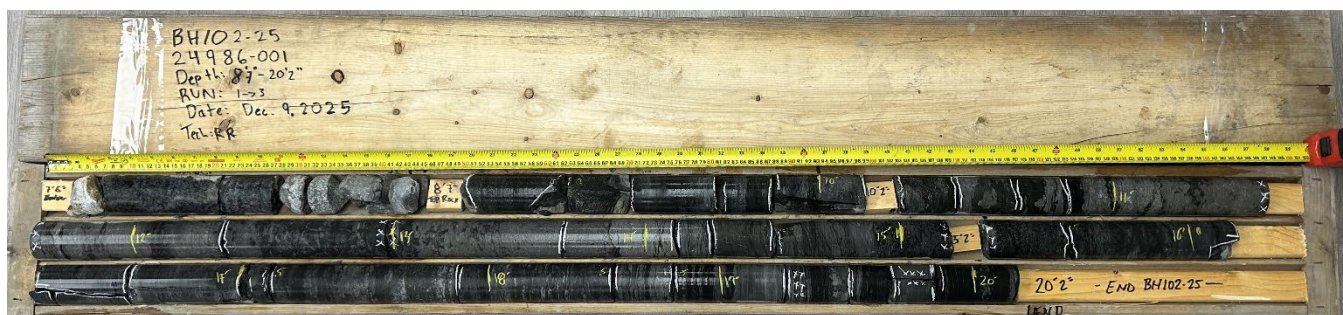
**Borehole BH102-25 Rock core runs 1 through 3, 2.6 to 6.1 mbgs**

The bedrock is limestone of the Gull River Formation, the rock in this area is generally grey, thinly to medium bedded, slightly decomposed, moderately fractured, and of very poor to good quality. The Rock Core Logs and Rock Core Photos are provided in Appendix B and Appendix C, respectively.

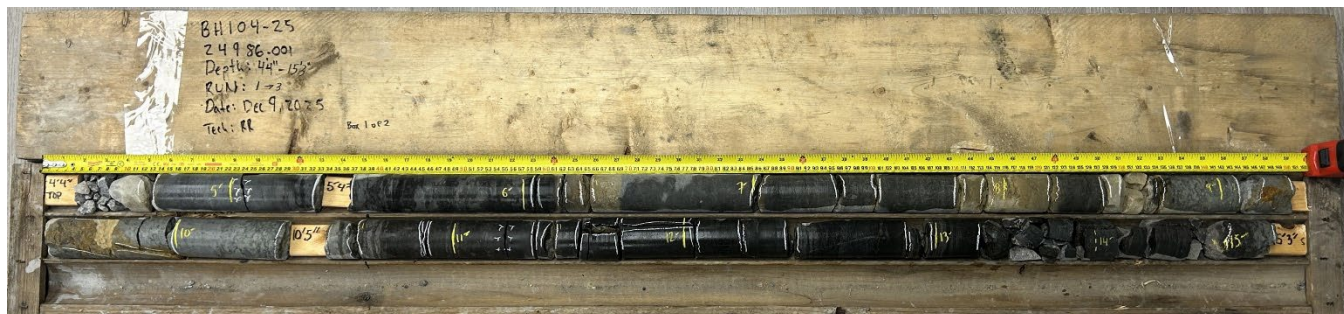
**Borehole BH104-25     Rock core runs 1 through 3, 1.3 to 4.7 mbgs**

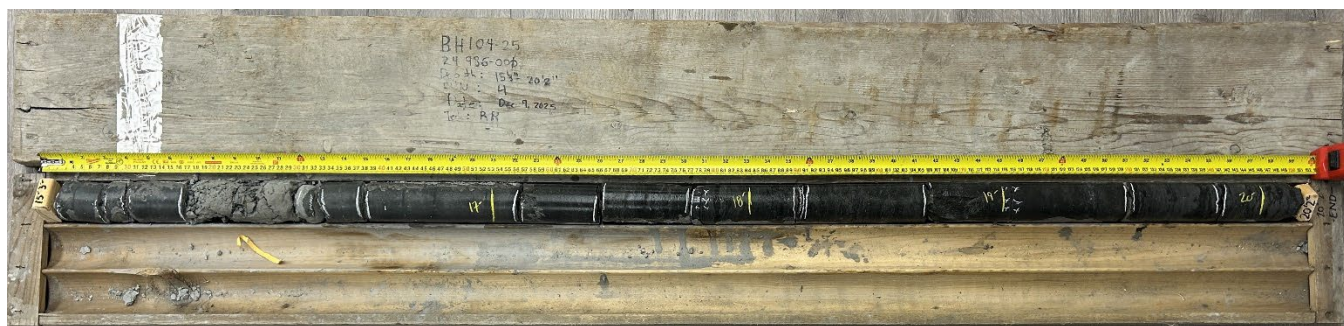
**Borehole BH104-25     Rock core run 4.7 to 6.1 mbgs**

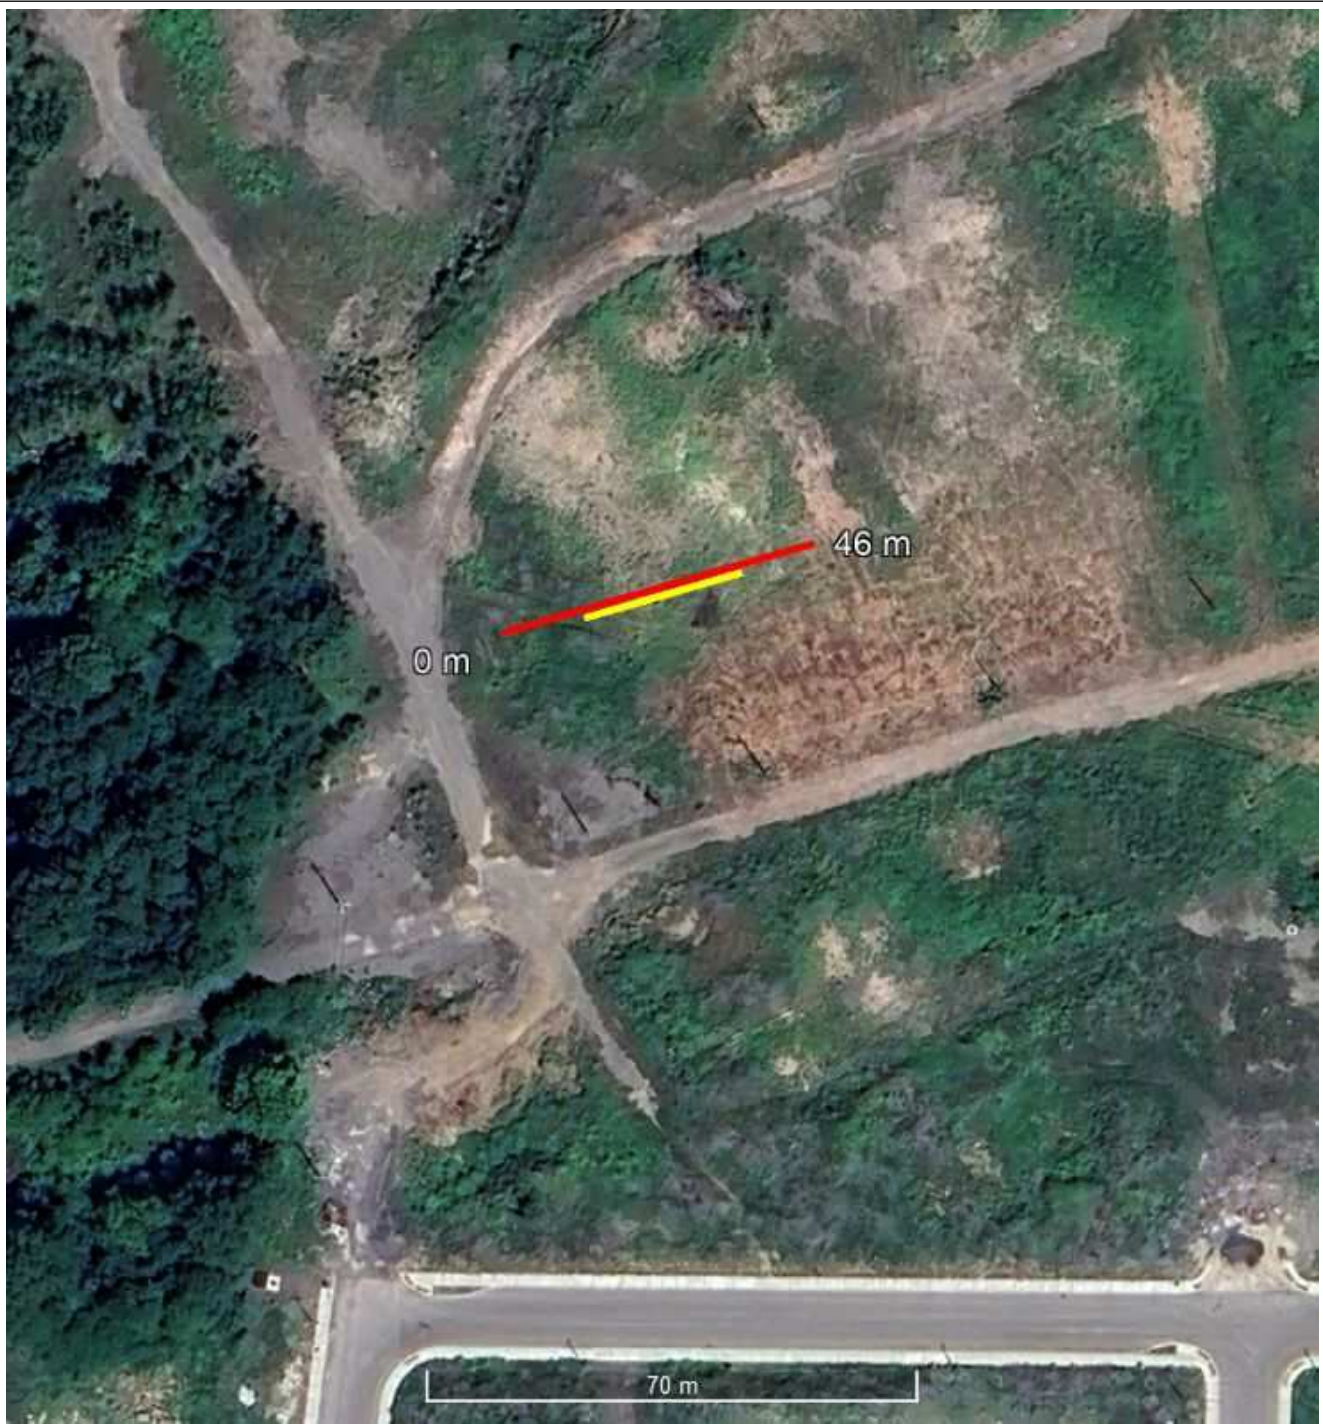
| <div><div><div></div></div><div>Location of 23 m, 24-geophone MASW spread</div></div> <div><div><div></div></div><div>Location of 46 m, 24-geophone seismic refraction spread</div></div> <div>Image: Google Earth 2025</div> | Date: | 2025-12-05 | <div><div> FRONTWAVE<br/>GEOPHYSICS</div></div> |
| | Title: | Survey location plan | |

The acquisition layout consisted of 24 receivers in a linear array (spread), connected with a multicore cable to a DAQLink 4 seismograph. 4.5 Hz natural frequency vertical geophones were used for this survey. The measurements were conducted with a spread length of 23 m (1 m spacing between geophones).
