# **Geotechnical Investigation**

## **Proposed Residential Development**

319 Huntmar Drive  
Ottawa, Ontario

Report PG7718-1 Revision 2 dated September 8, 2026

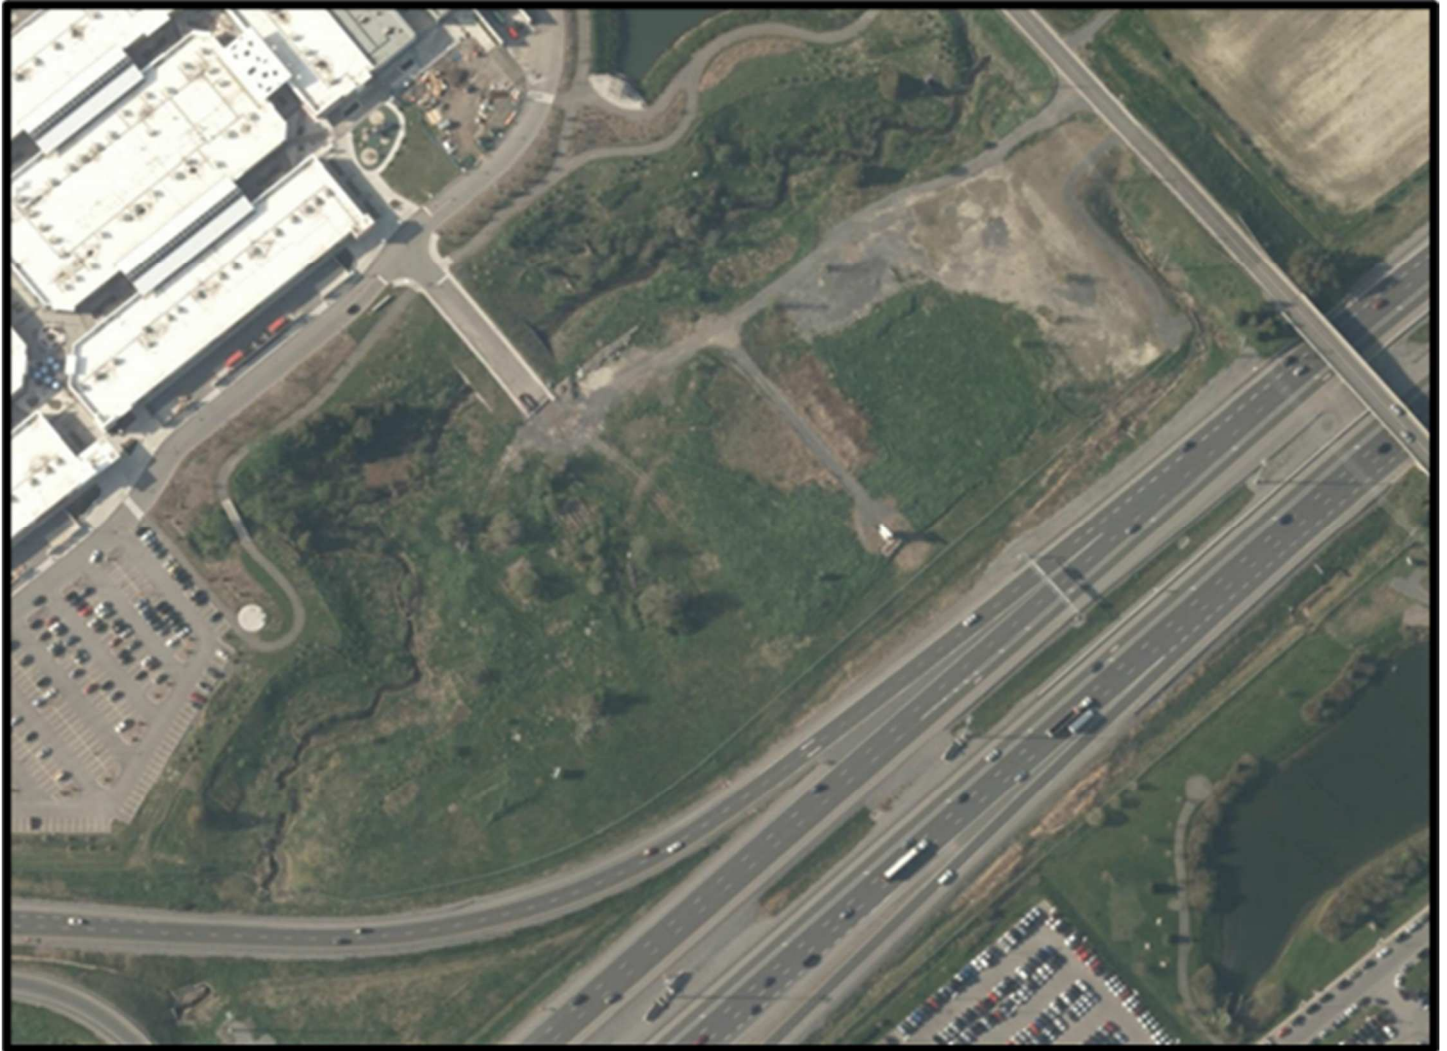
## **FIGURE 2**

**Aerial Photograph - 1991**

The subject site consists of a relatively flat undeveloped grassed area, with the exception of an existing billboard structure located in the south portion of the site, and an access road that bisects the site in a northwest to southeast direction. Foundations of old buildings have been encountered throughout the site and as indicated on Drawing PG7718-1 – Test Hole Location Plan in Appendix 2. Based on historical aerial photographs available through GeoOttawa, it is understood that a residential dwelling, multiple agricultural buildings and a crossing of Feedmill Creek were located along the northwest portion of the property. Reference should be made to Figure 2 and Figure 3 included in Appendix 1 of this report.

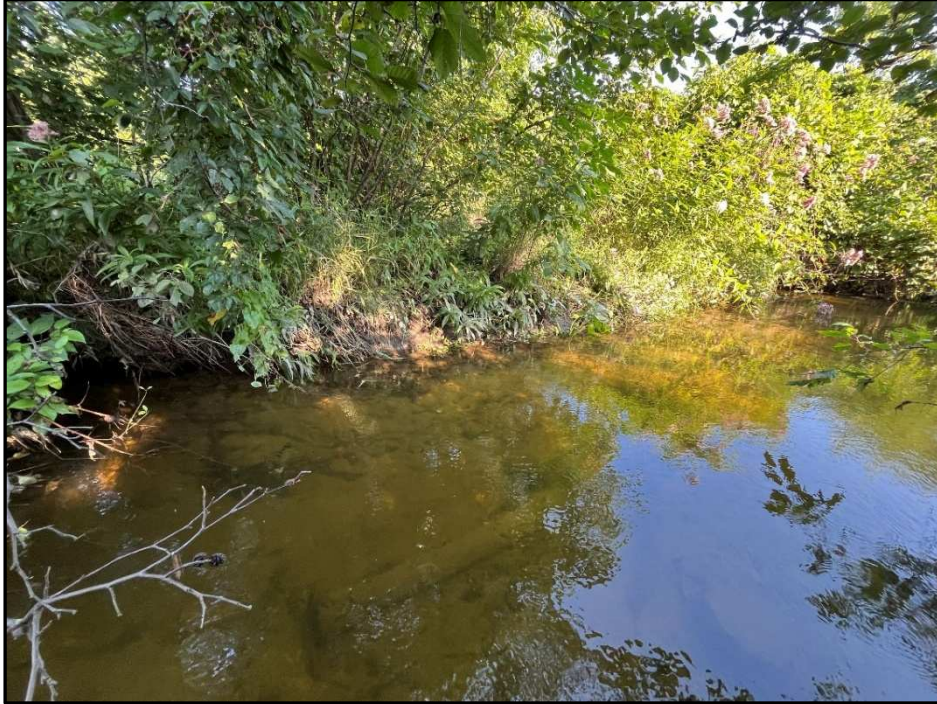
**Photo 1:** Photograph along the east portion of Feedmill Creek facing north and depicting the northern bank of the watercourse. The face slope along the north and south side of the watercourse were observed to be vegetated with brushes and some mature trees. Signs of erosion were not observed along this section.

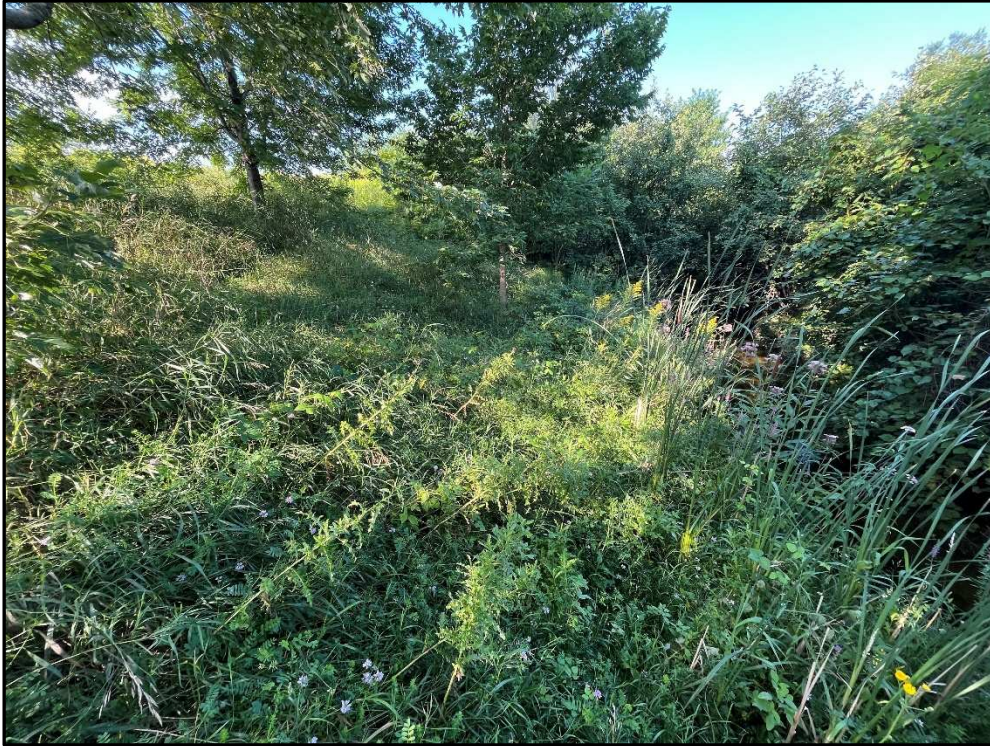
**Photo 3:** Photograph of south slope face along the central north boundary of the subject site. The bank at this location is observed to present a slight gradual slope. However, from a geotechnical perspective, the overall behavior of the watercourse is considered confined and in agreement with the remaining of the subject site.

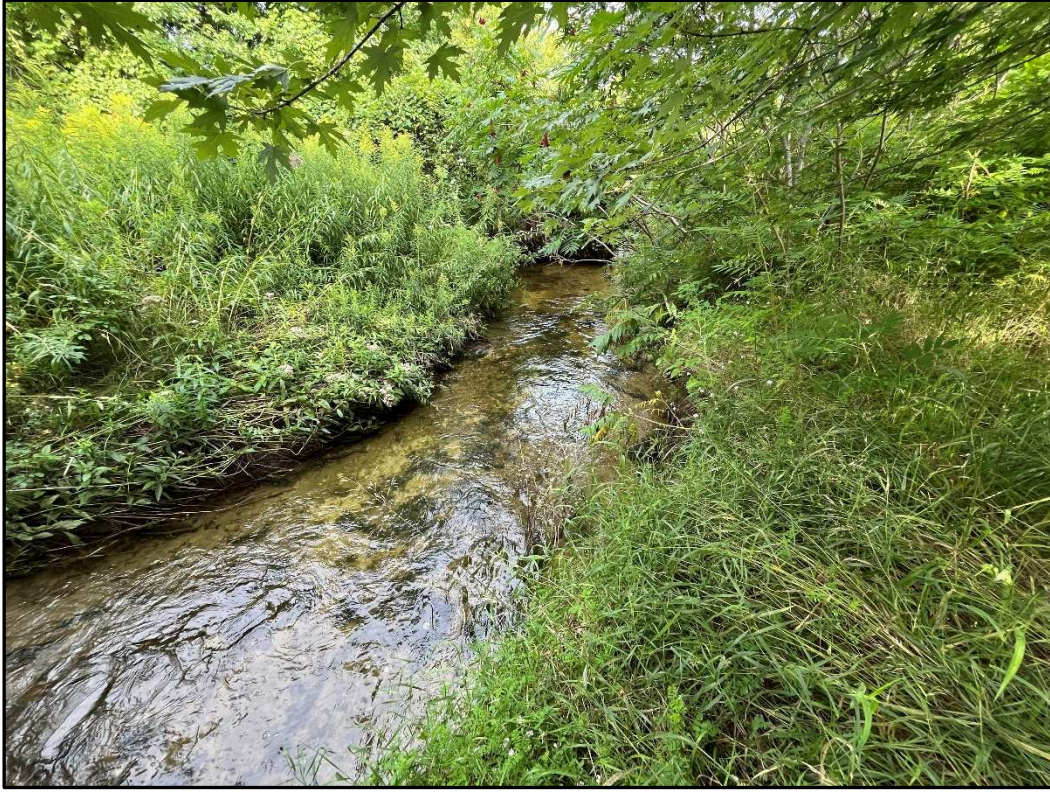
**Photo 5:** Photograph of the area of slope section F facing northeast. The slope face was observed to be vegetated with dense brush and some mature trees.

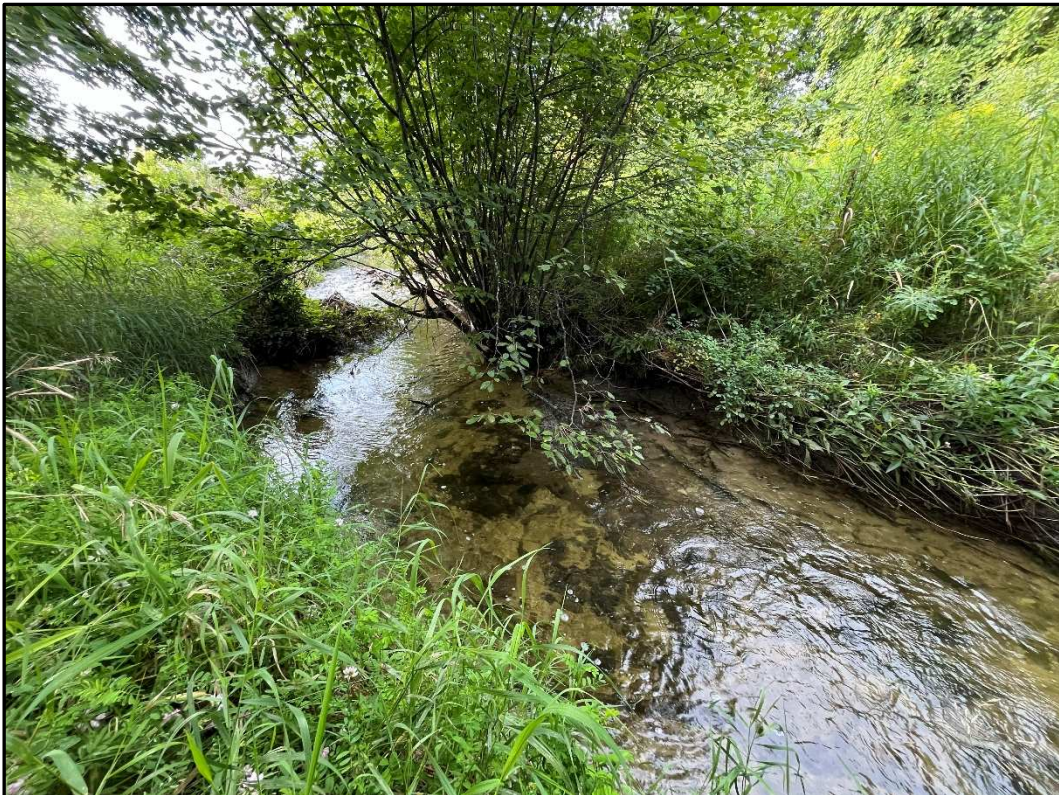
**Photo 6:** Photograph of the area of slope section F facing south. The slope face was observed to be vegetated with dense brush and mature trees. Signs of erosion were not observed.
