To:	Ashbury College 362 Mariposa Avenue	From:	Stantec Consulting Ltd. 1331 Clyde Avenue
Project/File:	Ashbury College – Supplementary Geotechnical and Hydrogeological Investigation	Date:	August 19, 2025

Reference: Ashbury College – Supplementary Geotechnical and Hydrogeological Investigation in Support of the Redevelopment of the Outdoor Field

1 Background Information

2 Field Program

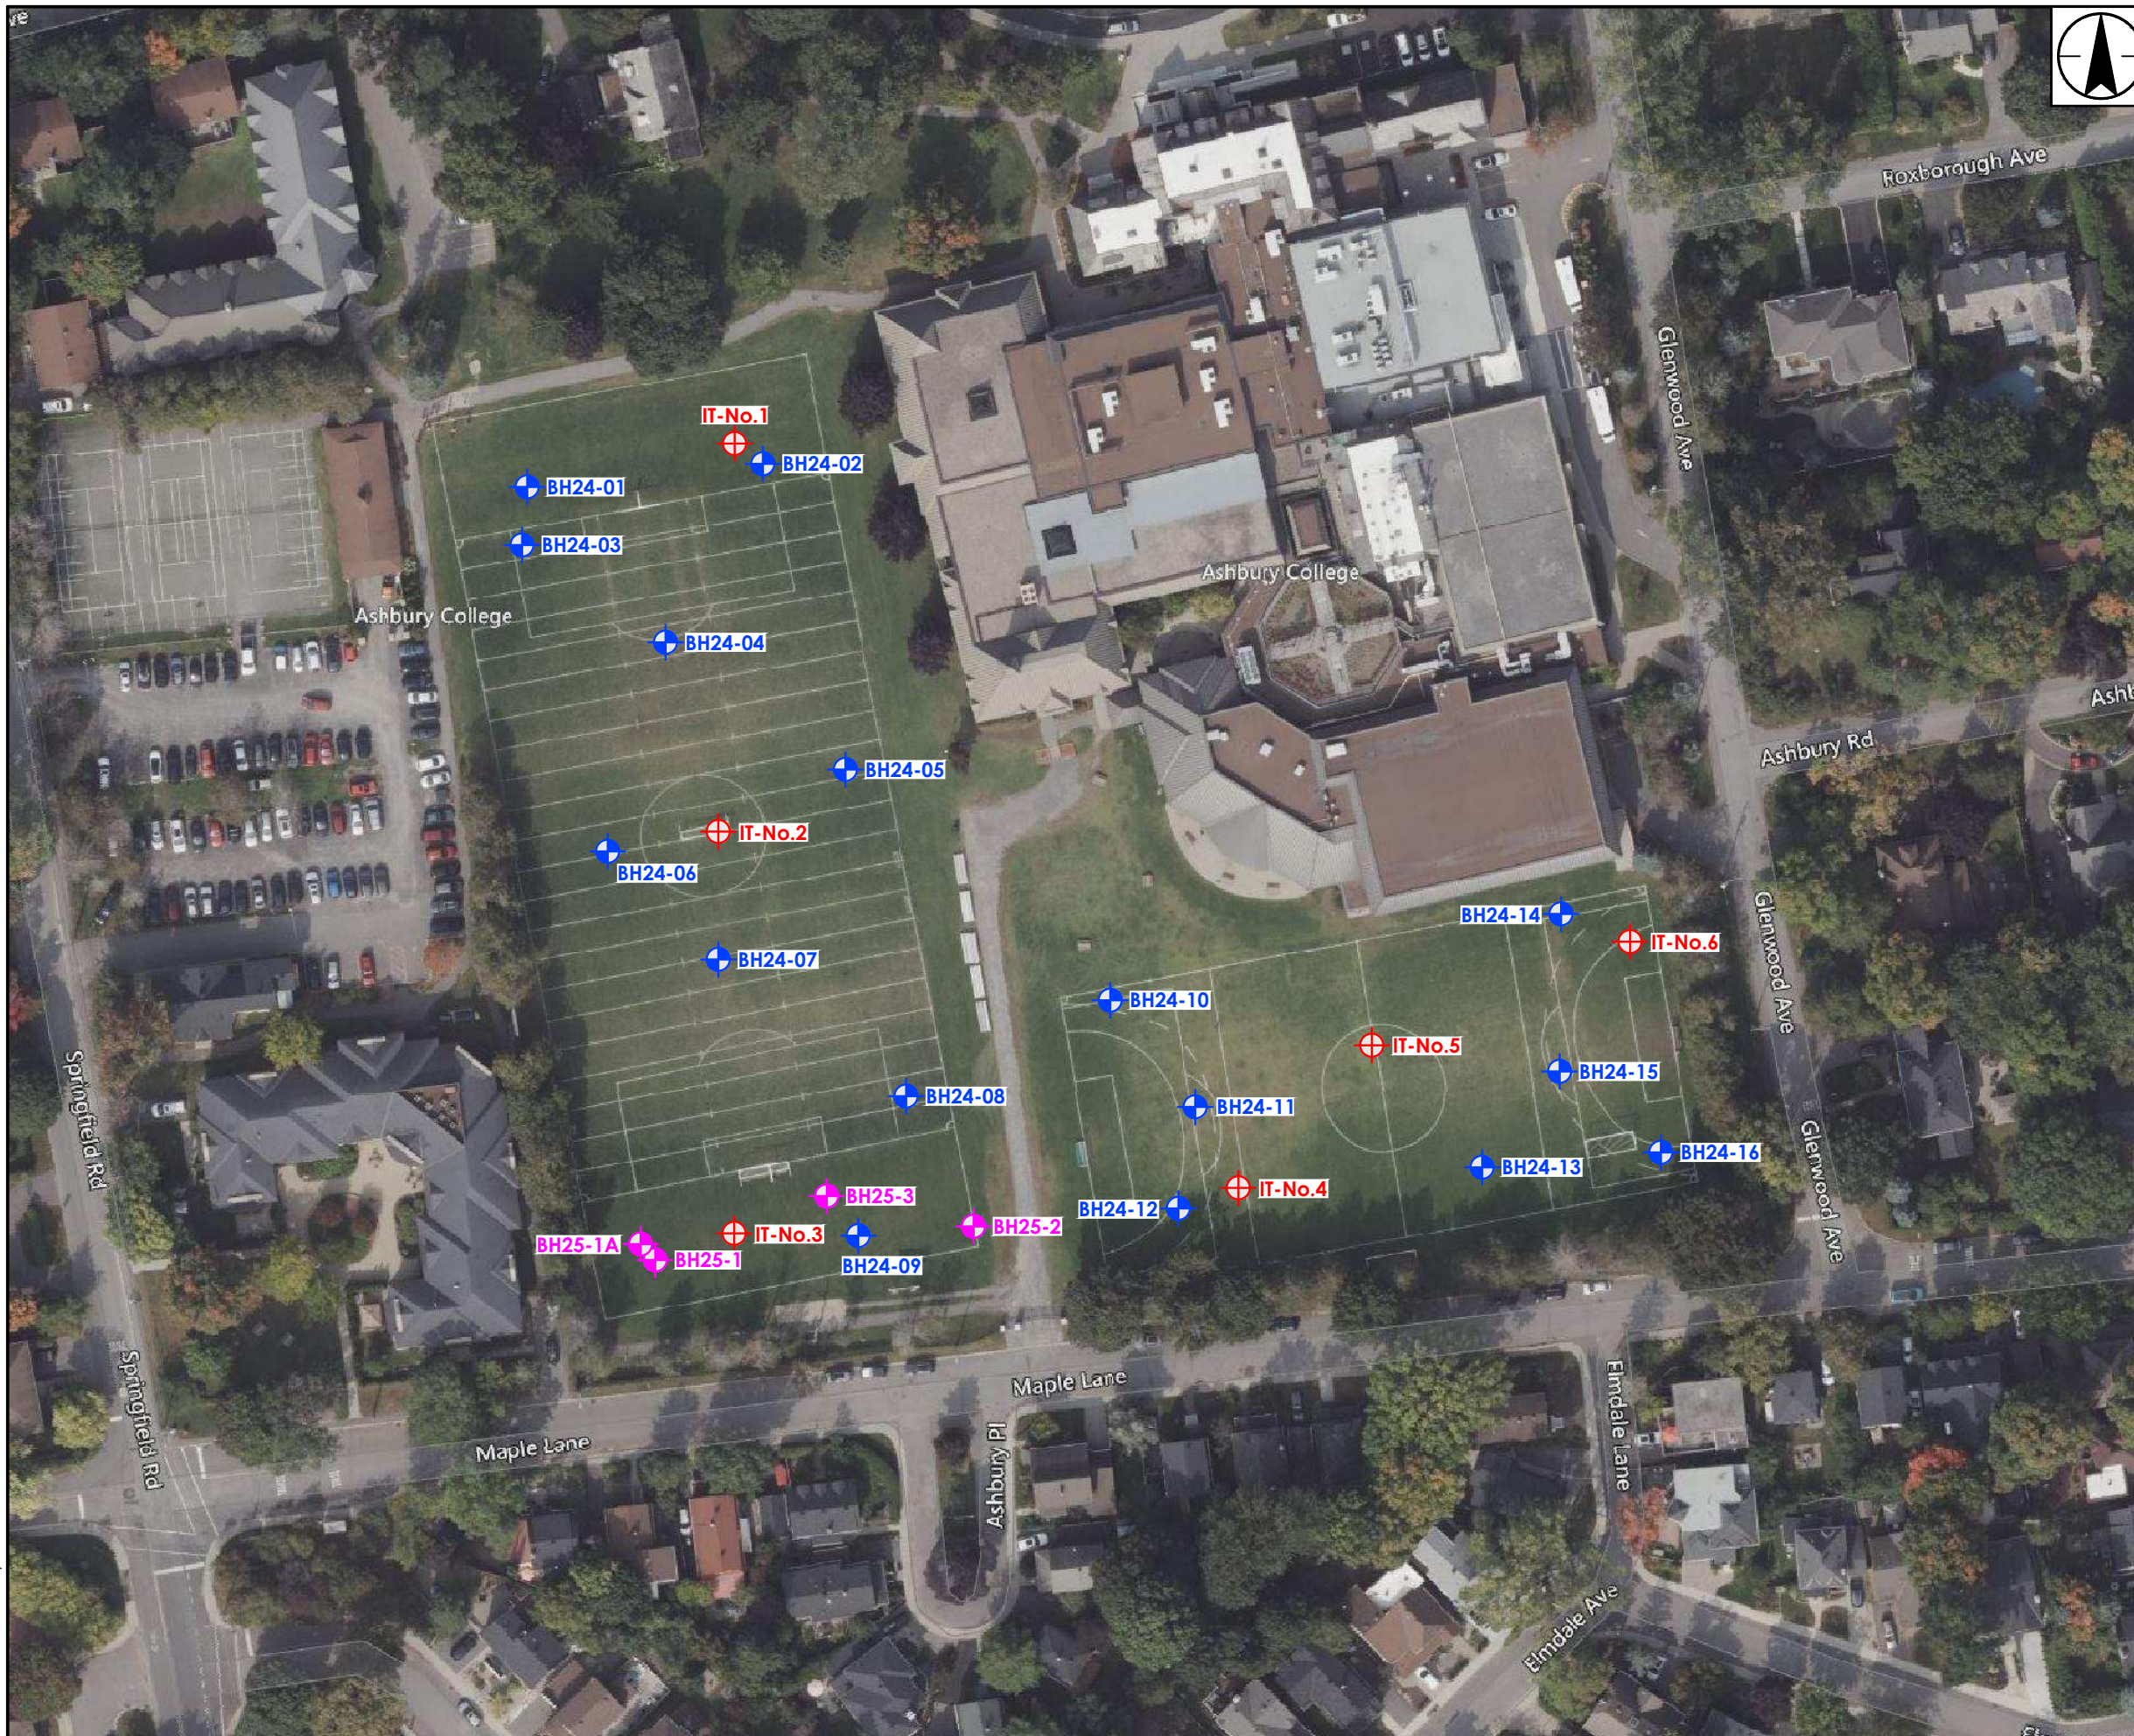
B.1 Borehole Location Plan

BOREHOLE (STANTEC, 2025)

The supplementary investigation program consisted of advancing three boreholes identified as BH25-1, BH25-2, and BH25-3 to depths ranging from 3.4 m to 9.2 m below the existing ground surface. An alternate borehole, identified as borehole BH25-1A, located approximately three meters north of BH25-1, was augured to the top of the bedrock to install multi-level monitoring well at this location (i.e., one in the overburden at BH251A and one in the bedrock at BH25-1). Two boreholes (BH25-1, and BH25-2) were located at the proposed stormwater tank, and one borehole (BH25-3) was located near the sprint track. Their locations are shown in Drawing No.1 presented in **Appendix B**.

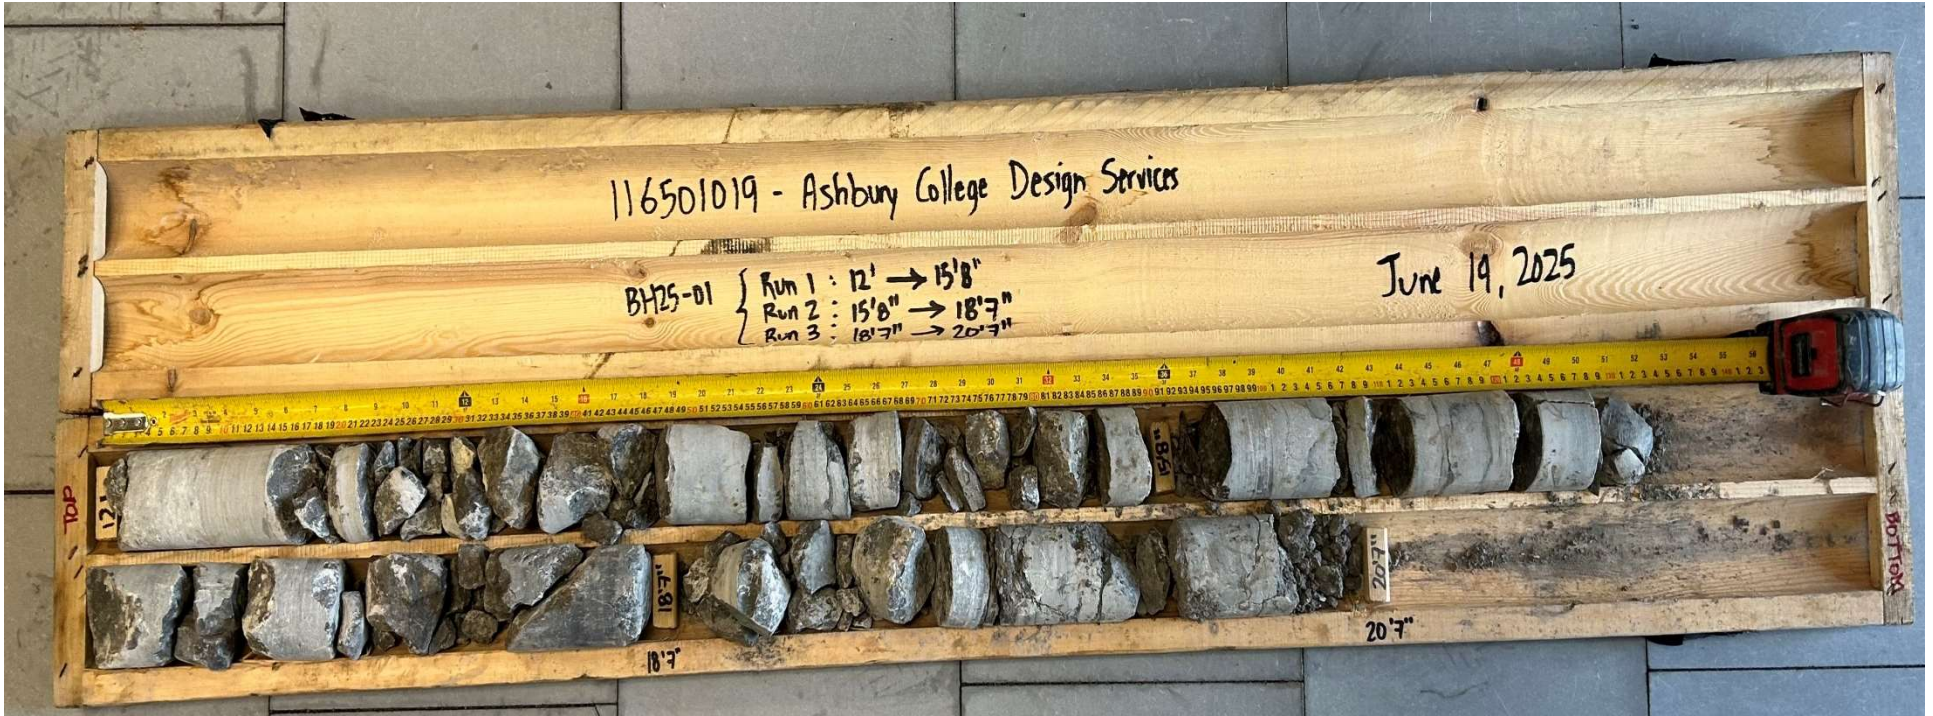
Rock Core Photo No.: 1

Borehole: BH25-1

The sampled bedrock consisted of grey to black limestone with shale interbeds. The rock has been noted as highly to slightly weathered near the surface and becomes fresh at depth. The Rock Quality Designation (RQD) value ranged from 0% to 31%, indicating a very poor to poor quality rock.

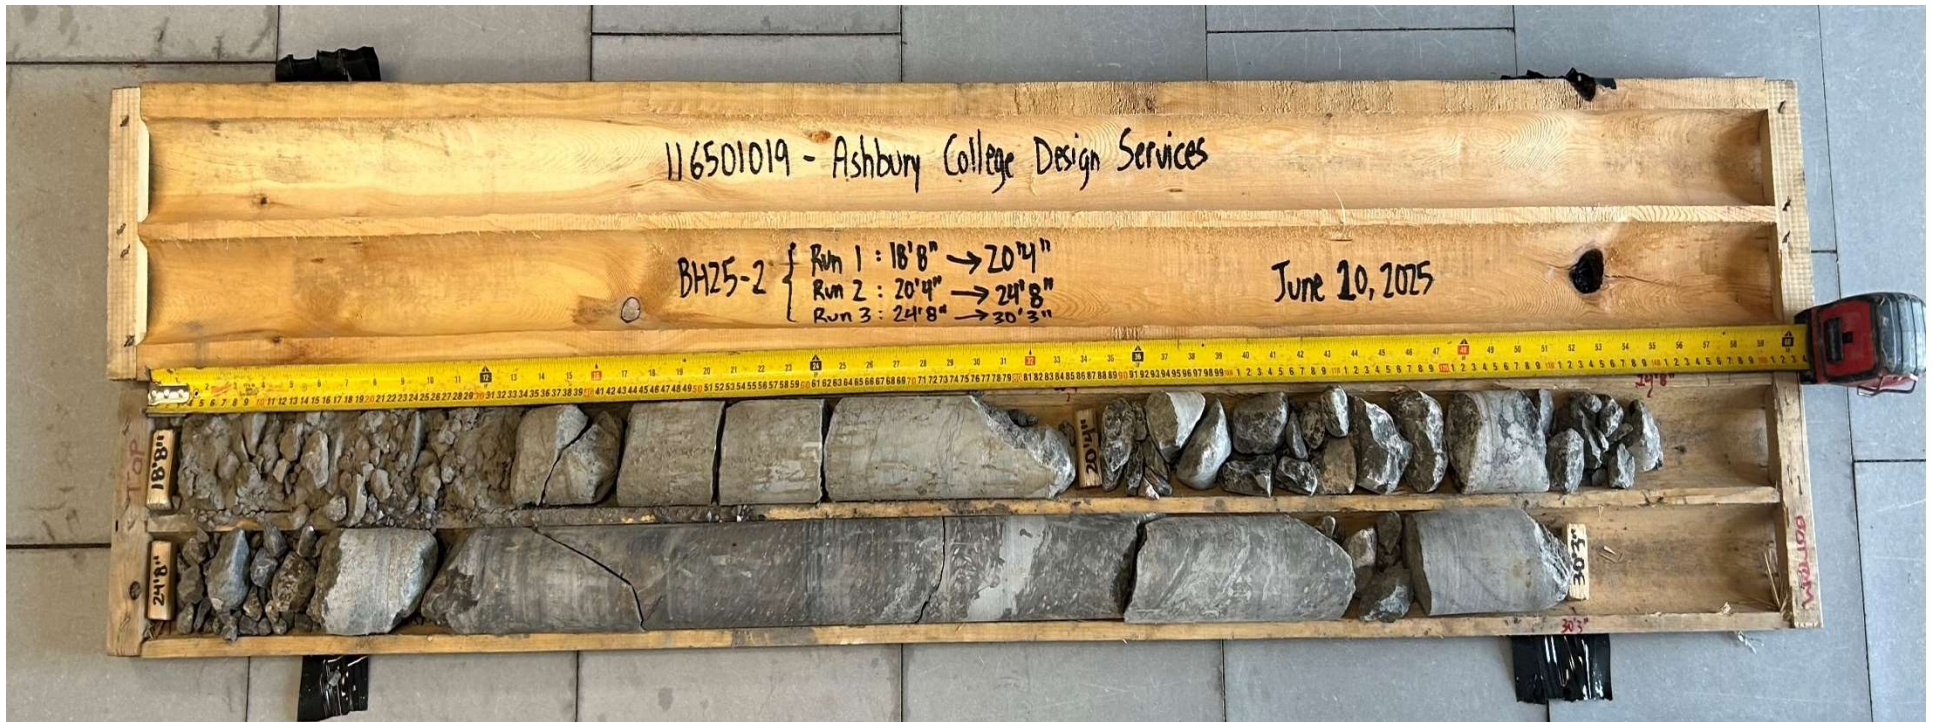
Rock Core Photo No.: 2

Borehole: BH25-2

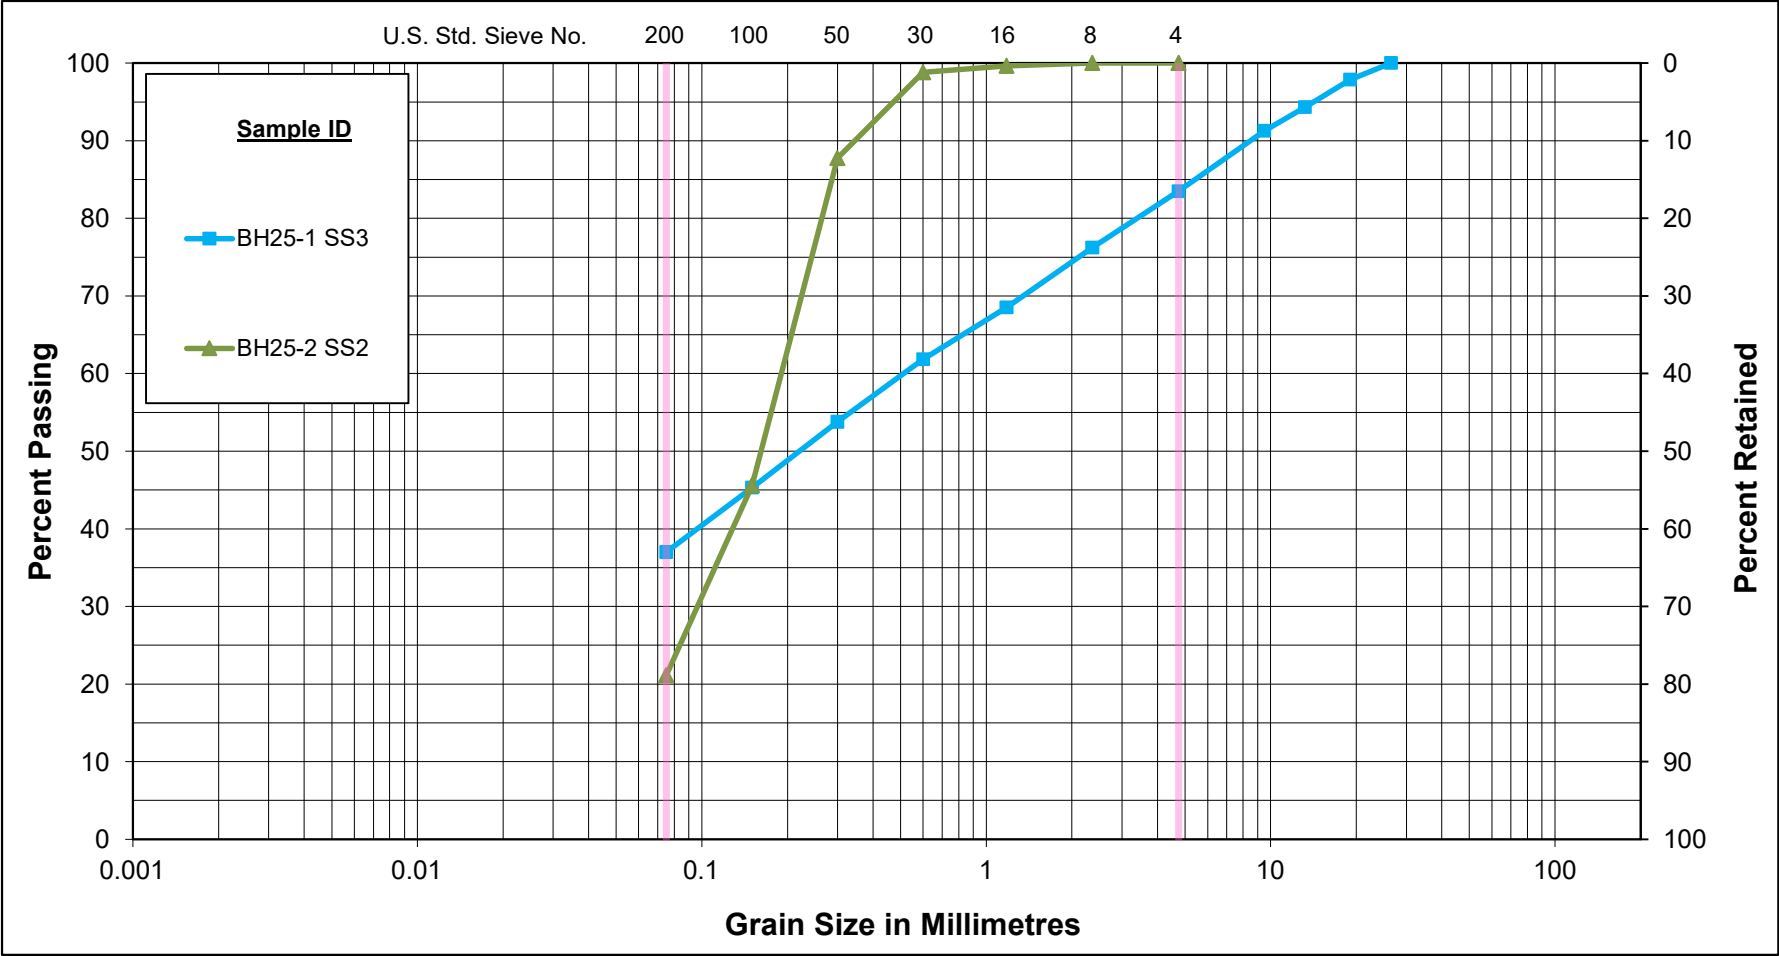
GRAIN SIZE DISTRIBUTION

Fill Material

Two (2) samples of fill were selected for grain size distribution testing. The grain size distribution curve for the fill is provided in Figure D1 in **Appendix D**, and a summary of the test results is provided in Table 2 below.

Borehole No.	Sample No.	Depth (m)	Gravel (%)	Sand (%)	Silt and Clay (%)
BH25-1	SS3	1.5 – 2.1	17	46	37
BH25-2	SS2	0.8 – 1.2	0	79	21

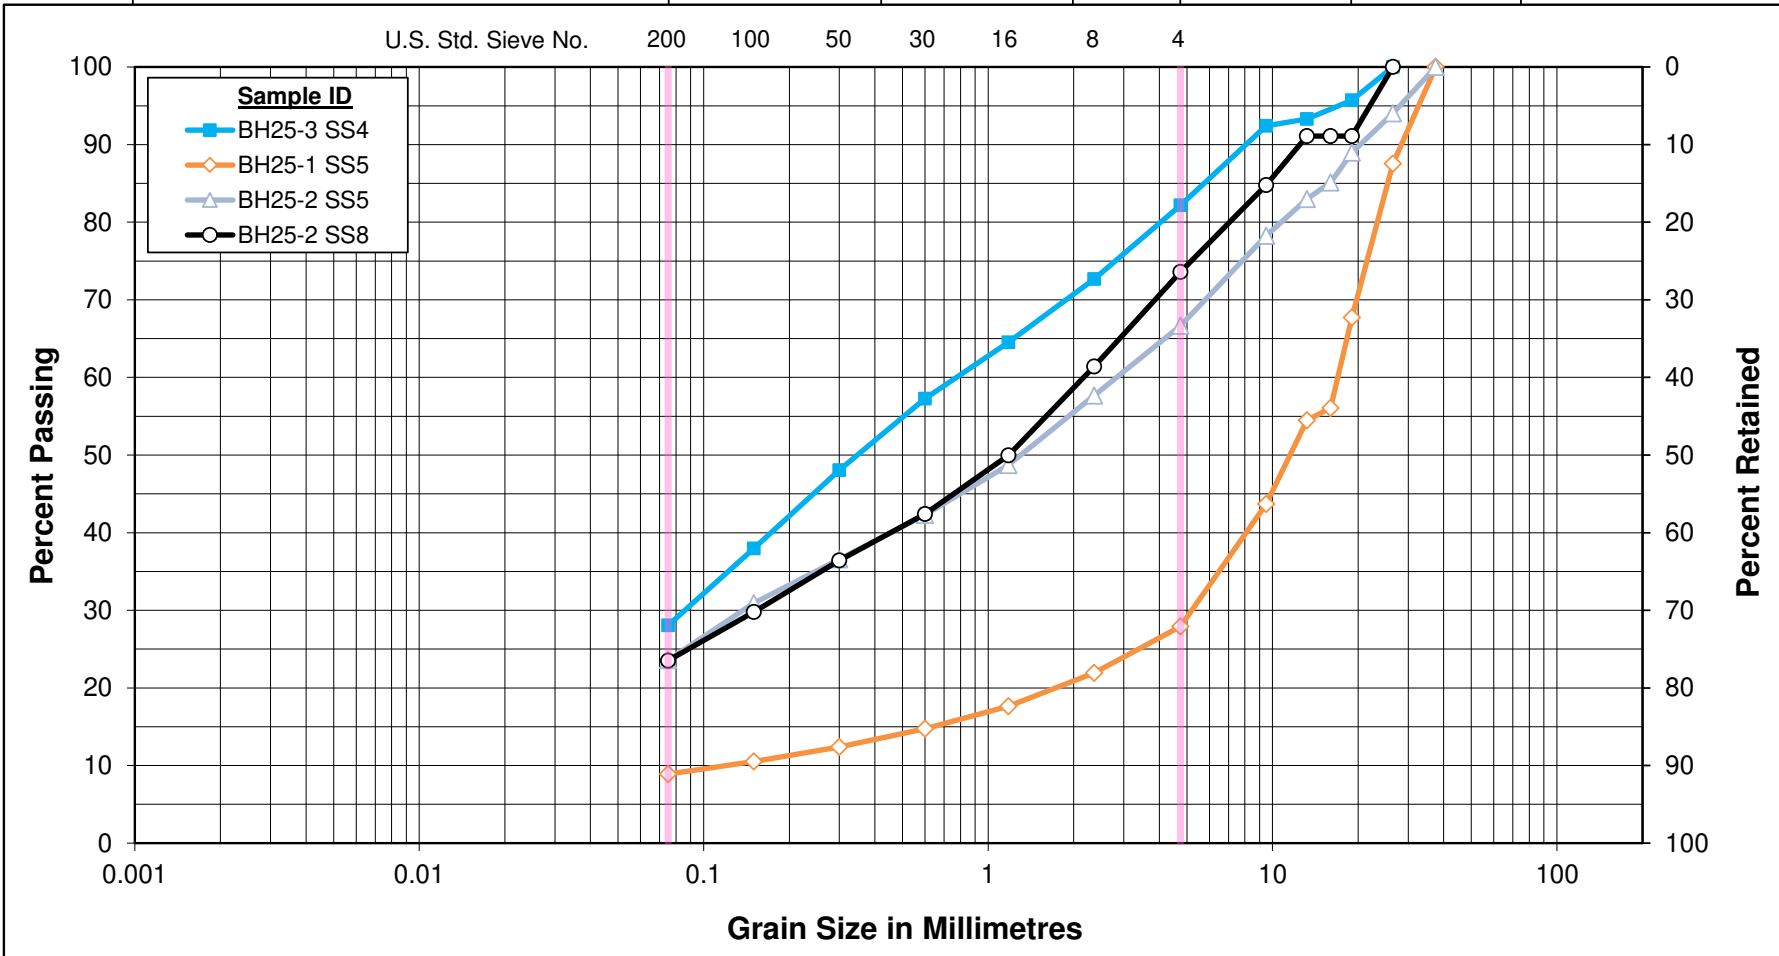
GRAIN SIZE DISTRIBUTION

Glacial Till
Ashbury College

Four (4) samples of till were selected for grain size distribution testing. The grain size distribution curve for the till is provided in Figure D2 in **Appendix D**, and a summary of the test results is provided in Table 3 below.

Borehole No.	Sample No.	Depth (m)	Gravel (%)	Sand (%)	Silt and Clay (%)
BH25-1	SS5	3.1 – 3.6	72	19	9
BH25-2	SS5	3.1 – 3.3	33	43	24
BH25-2	SS8	5.3 – 5.6	26	50	24
BH25-3	SS4	2.3 – 2.5	18	54	28

In accordance with the Unified Soil Classification System (USCS), the till material selected for testing can be classified as poorly-graded gravel with silt and sand (GP) to silty sand with gravel (SM).

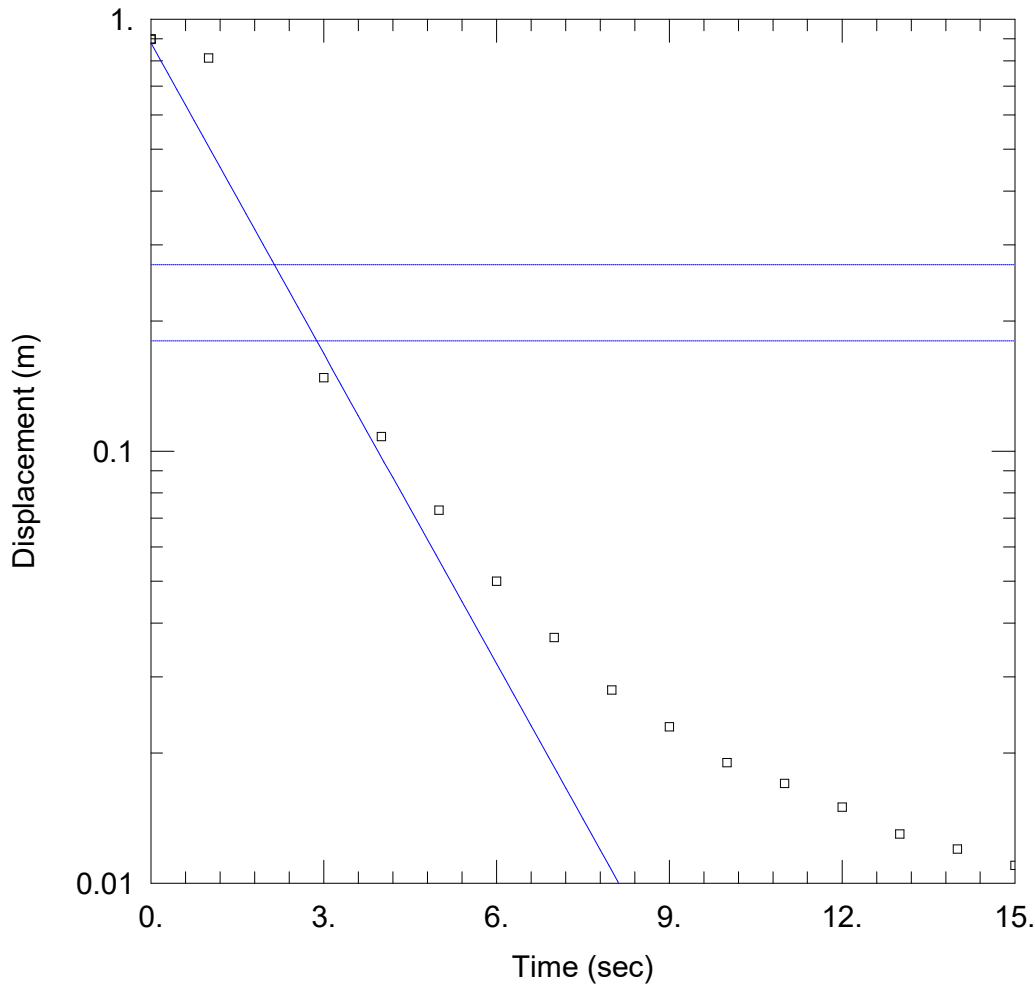
BH25-01 - FALLING HEAD TEST

K = 0.00041 m/sec

y0 = 0.8799 m

Stantec performed in-situ hydraulic response testing on BH25-1 and BH25-2, which are screened at elevations ranging between 65.6 to 61.4 m AMSL in slightly to moderately weathered limestone. The tests consisted of creating an instantaneous change in each monitoring well water level by introducing a slug into the well below the static water level (i.e., falling head test), followed by recording the time taken for the resulting water level to return to its static condition using a combination of manual and continuous (i.e., data logger) water level measurements. After the water level returned to static conditions, the slug was then

removed quickly and smoothly to create another instantaneous change in water level (i.e., rising head test), followed by recording the time taken for the water level to return to its static condition again using a combination of manual and continuous water level measurements. Table E.1 (**Appendix E**) presents the calculated horizontal hydraulic conductivity for each tested well, with the analytical solutions for these data being presented in **Appendix F**.

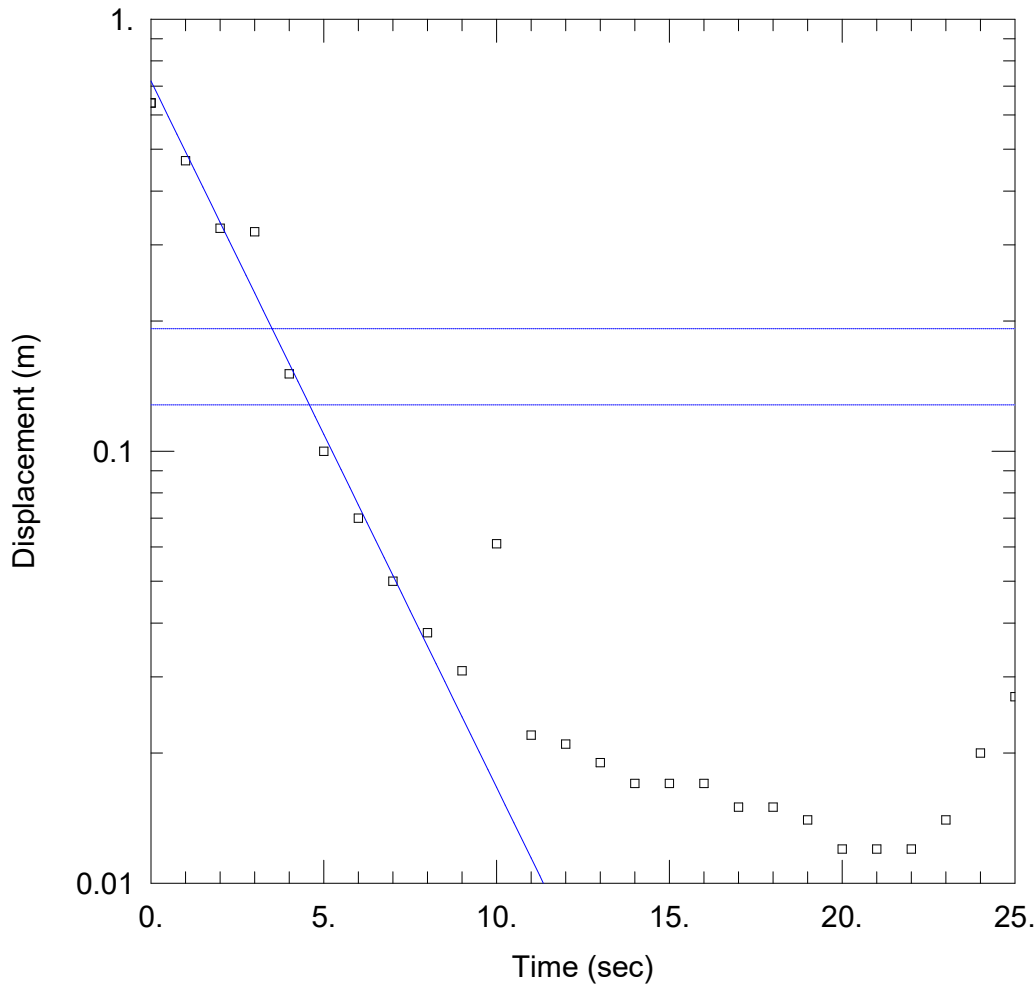
BH25-01 - RISING HEAD TEST 2

K = 0.00028 m/sec

y0 = 0.7187 m

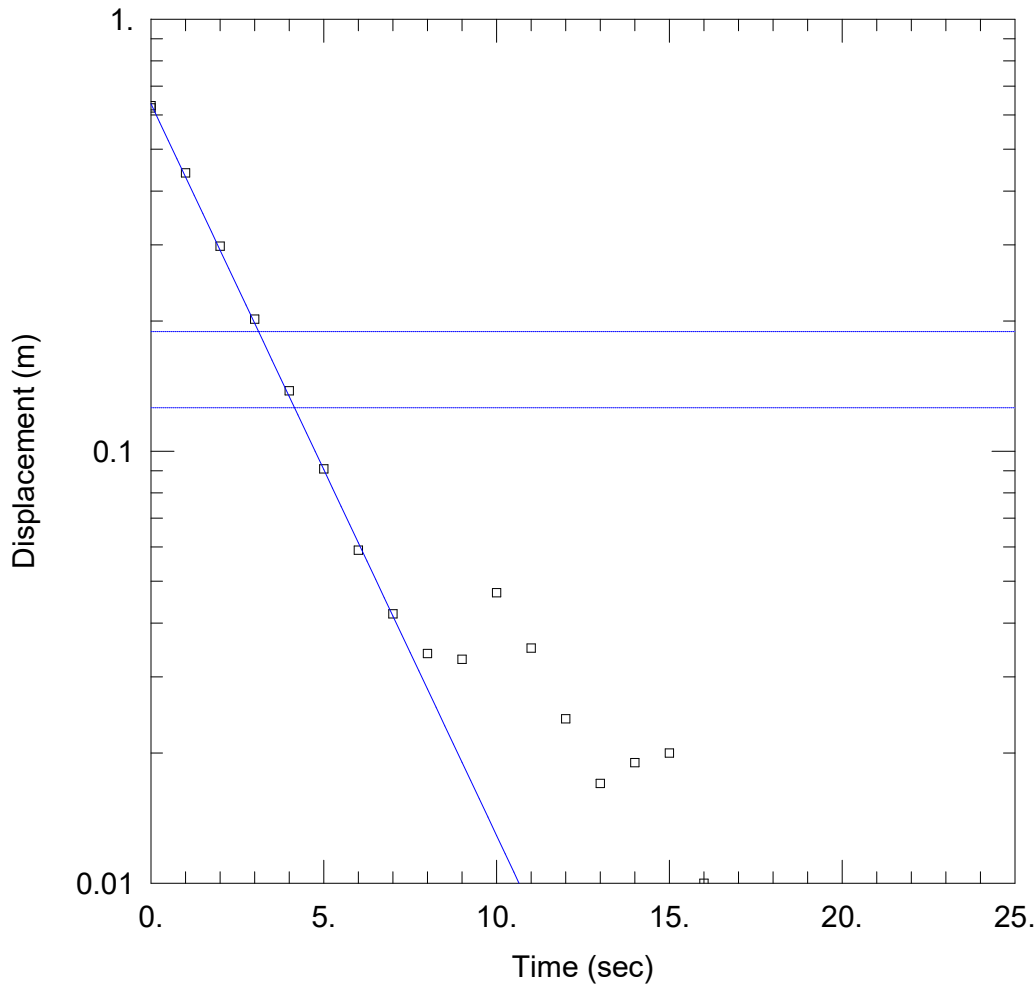
BH25-01 - RISING HEAD TEST 3

K = 0.00029 m/sec

y0 = 0.6365 m

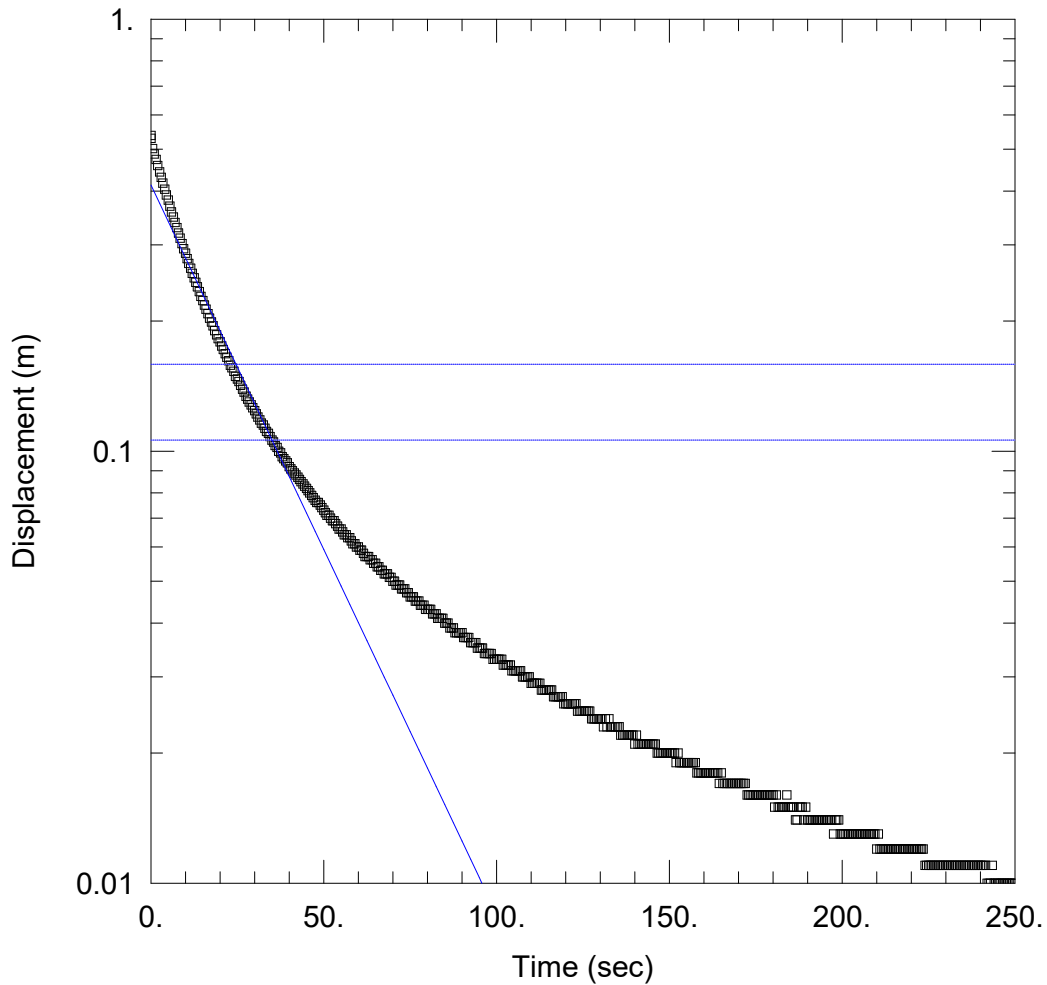
BH25-02 - FALLING HEAD TEST 1

K = 3.2E-5 m/sec

y0 = 0.4129 m

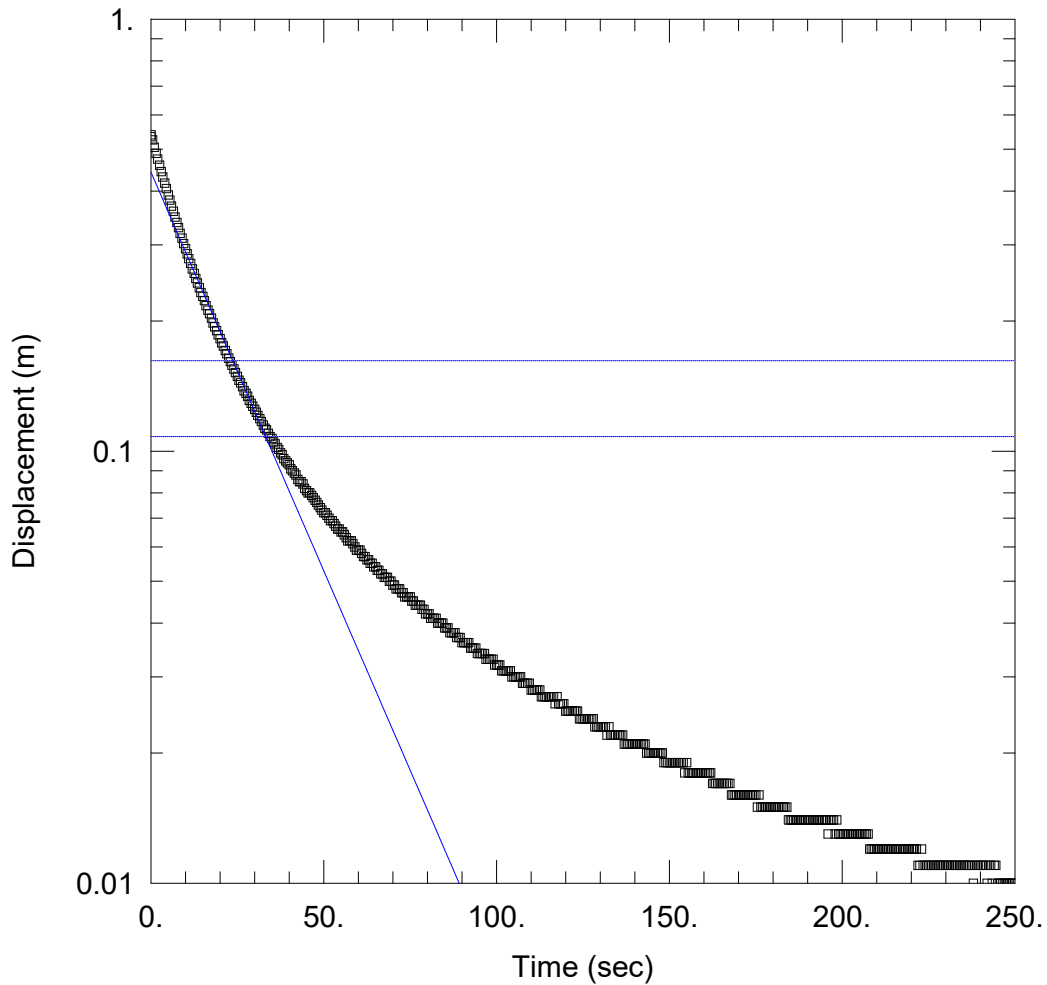
BH25-02 - FALLING HEAD TEST 2

K = 3.5E-5 m/sec

y0 = 0.4421 m

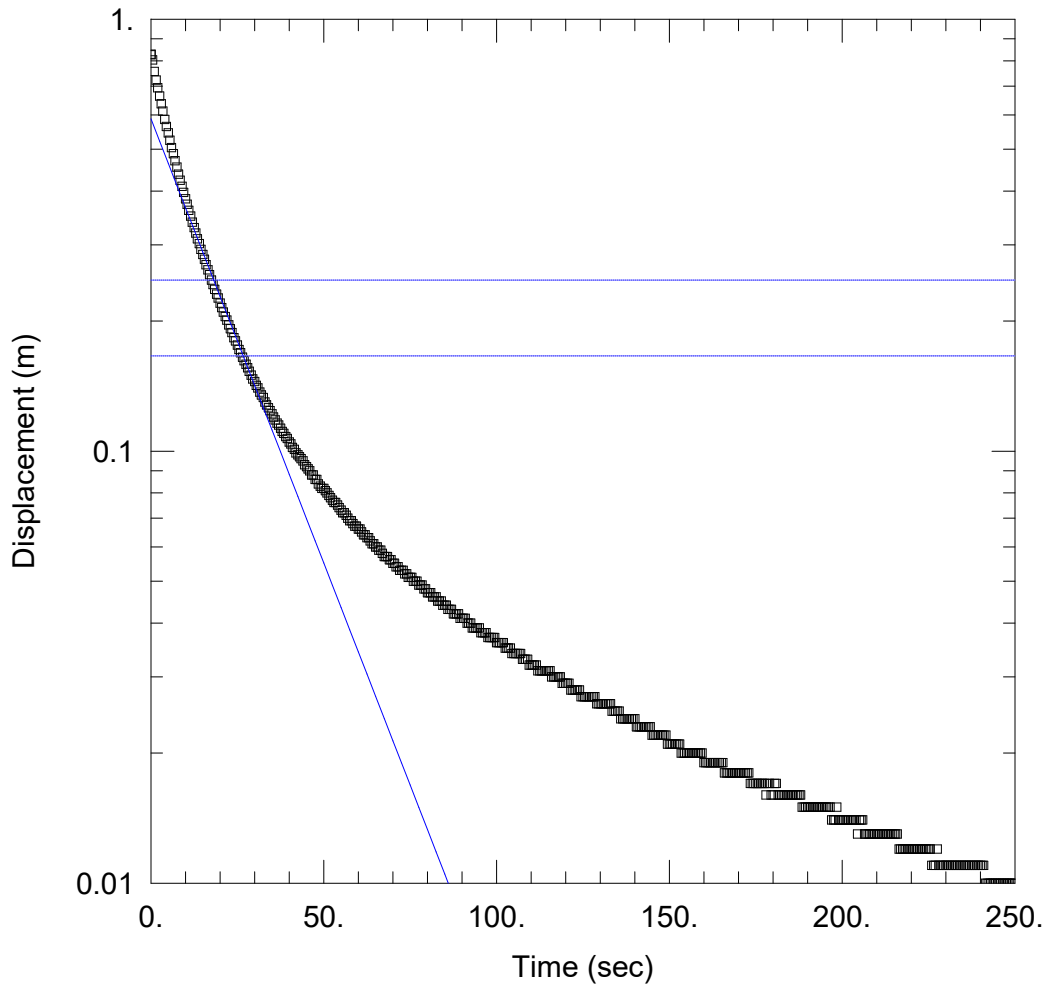
BH25-02 - RISING HEAD TEST 1

K = 3.9E-5 m/sec

y0 = 0.5874 m

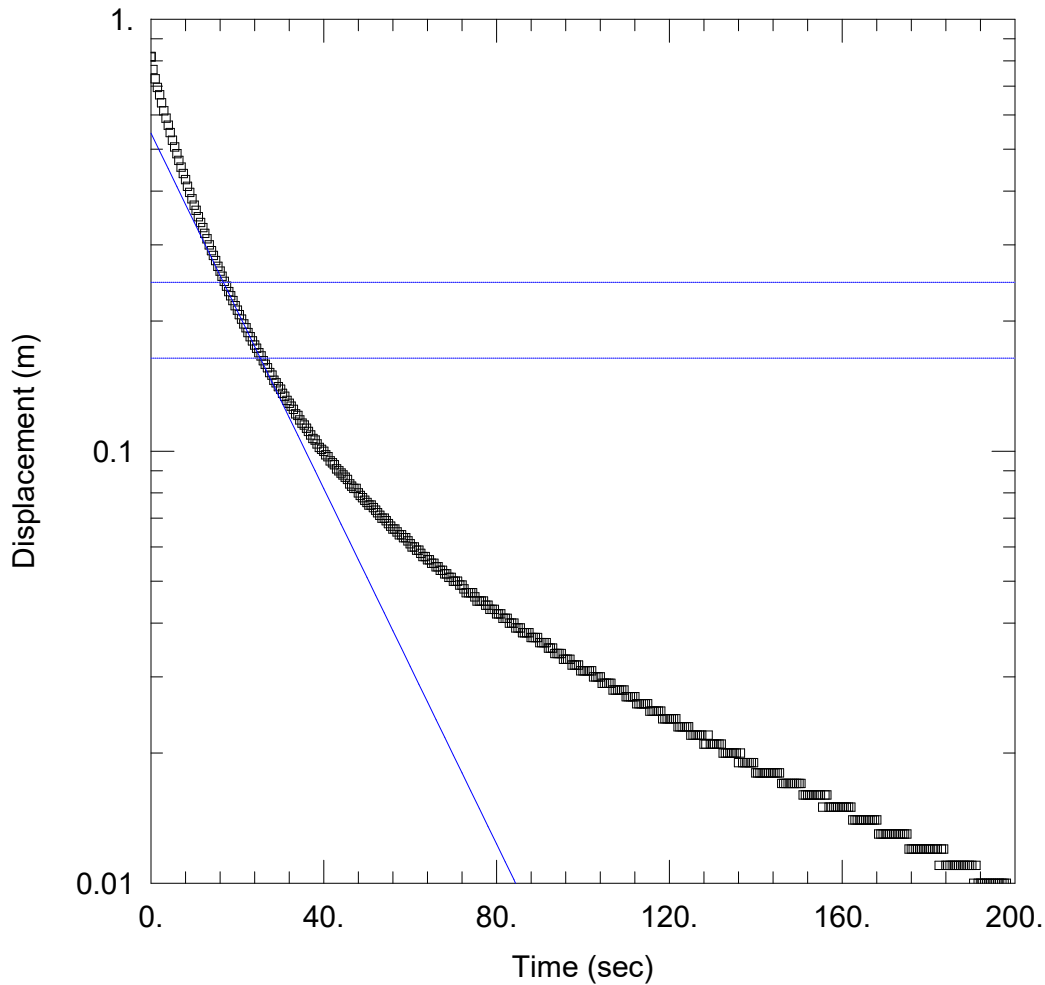
BH25-02 - RISING HEAD TEST 2

Data Set: \\...\BH25-02 - Rising Head Test 2_ST_JK.aqt
