# Phase Two Environmental Site Assessment

951 Gladstone Avenue and 145 Loretta Avenue North  
Ottawa, Ontario

October 19, 2022

Pinchin File: 285722.003

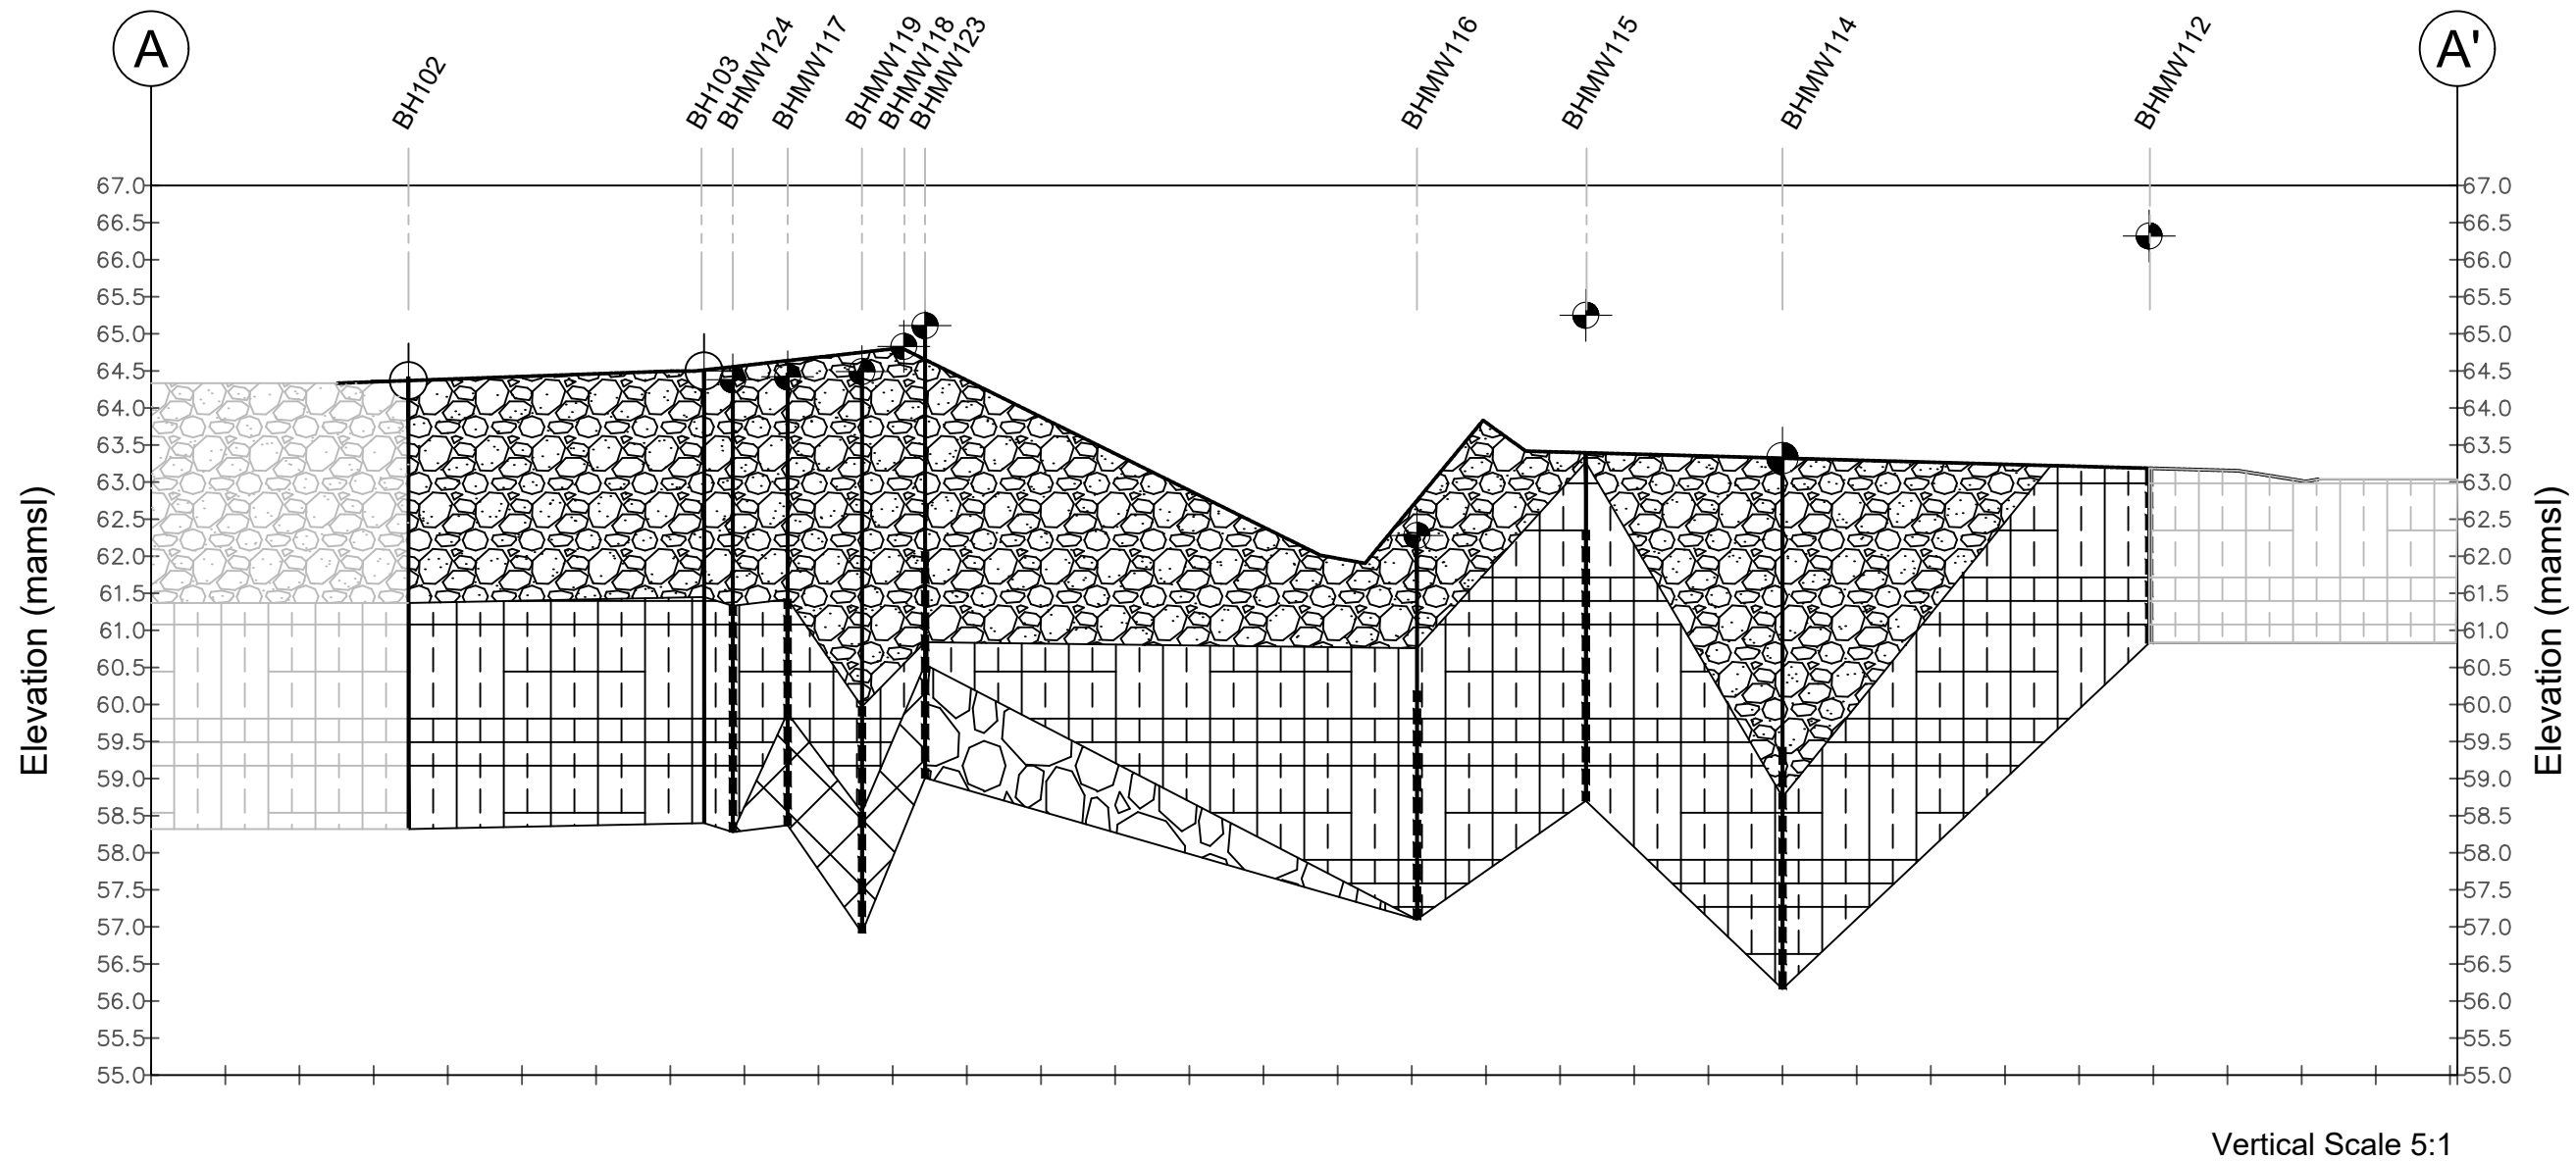
**Cross Section A-A'**

Cross-sections summarizing the subsurface geological conditions have been provided as Figures 8A to 8C.
