# **Geotechnical Investigation**

## **Proposed Residential Development**

50 Flavescent Lane  
Ottawa, Ontario

Report PG8045-1 dated July 10, 2026

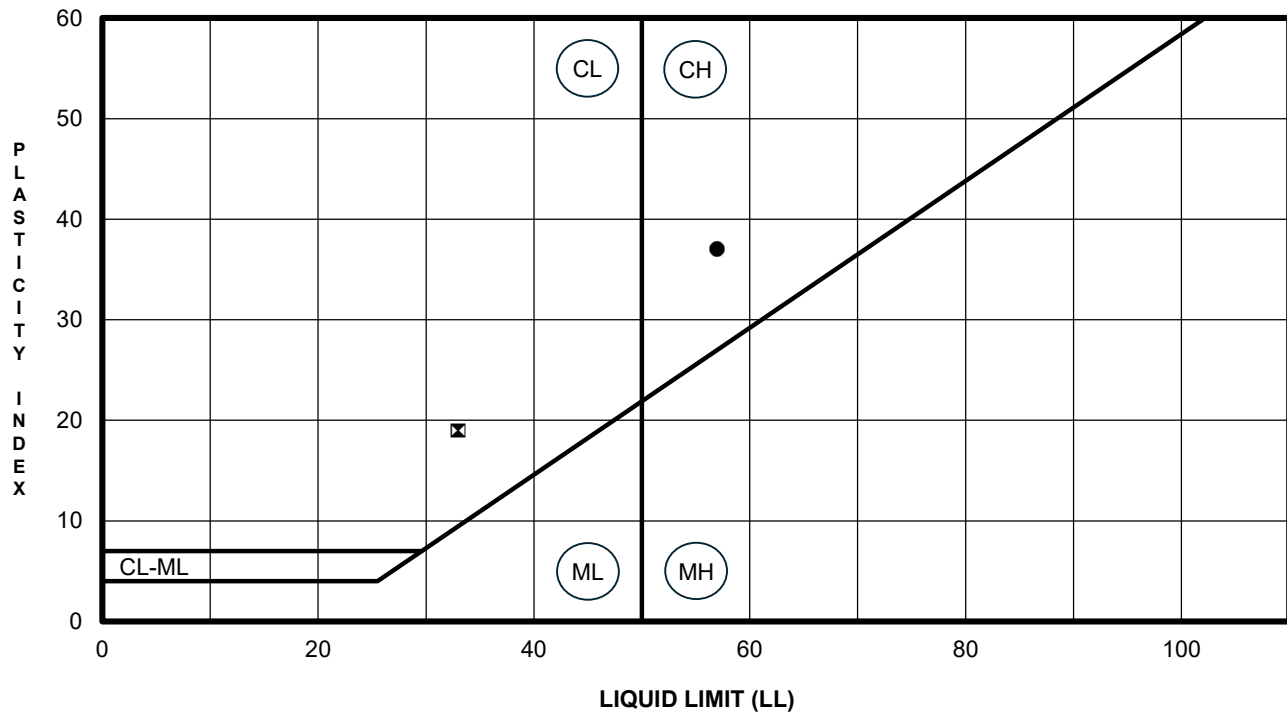
# ATTERBERG LIMITS' RESULTS

| | Specimen Identification | | LL | PL | PI | Fines | Classification |
|---|---|---|---|---|---|---|---|
| ● | BH 1-26 | SS5 | 57 | 20 | 37 | | CH - Inorganic clays of high plasticity |

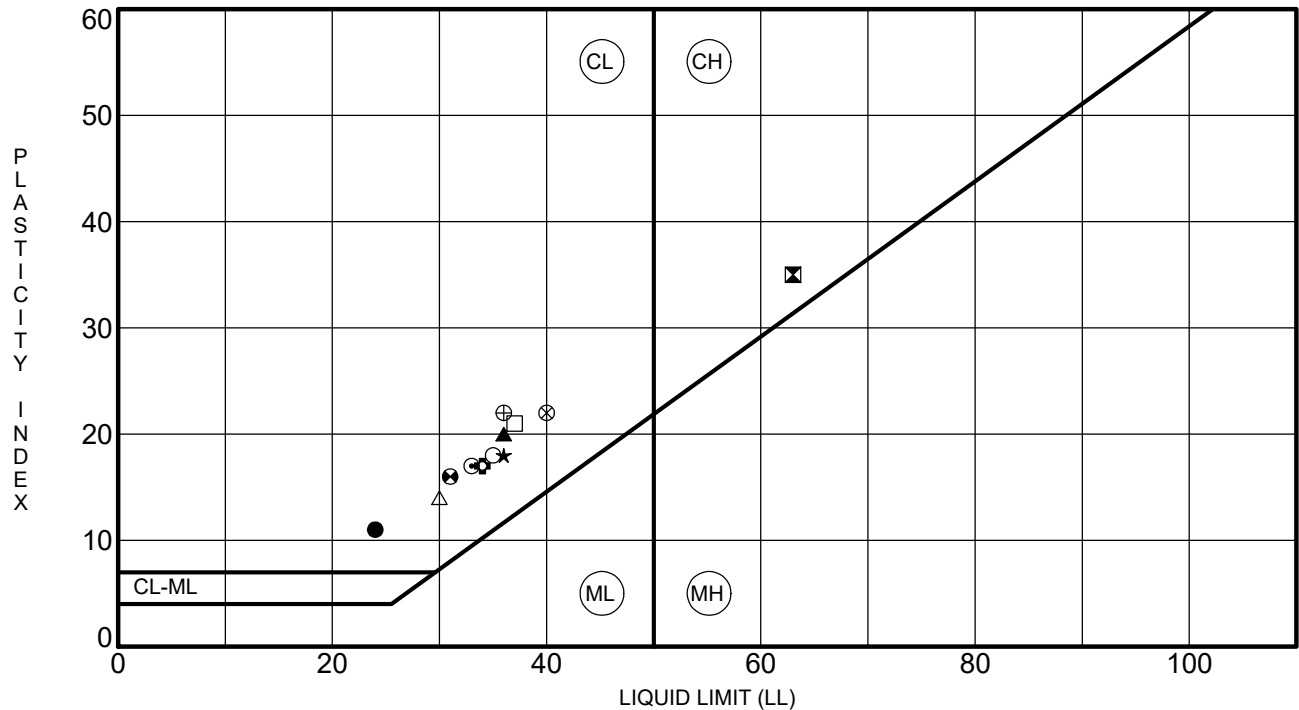
| Specimen Identification | LL | PL | PI | Fines | Classification |
|---|---|---|---|---|---|
| ● BH 1-24 SS 4 | 24 | 13 | 11 | | CL - Inorganic clays of low plasticity |

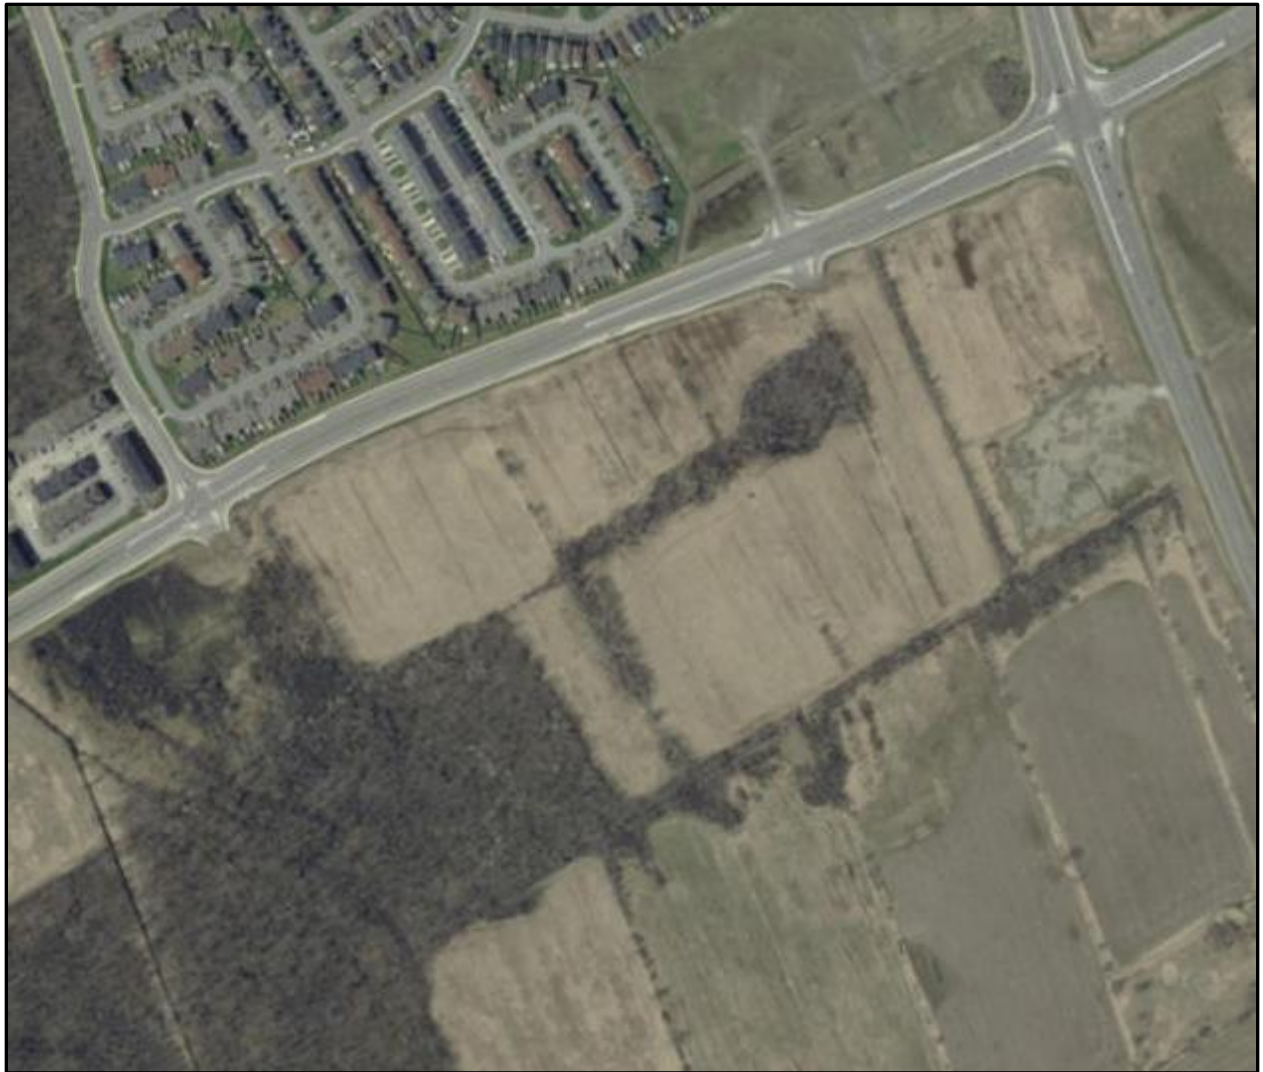
**FIGURE 2**

**AERIAL PHOTOGRAPH - 2014**

The subject site is currently vacant and grass covered, consisting primarily of former agricultural lands. However, based on historical aerial photographs of the subject site, the site appears to have been stripped of topsoil between 2014 and 2015, and stockpiled fill material was observed throughout the site, referenced should be made to Figures 2 and 3 in Appendix 2. By 2019, the fill material appears to have generally been removed from the property, reference should be made to Figure 4 in Appendix 2.

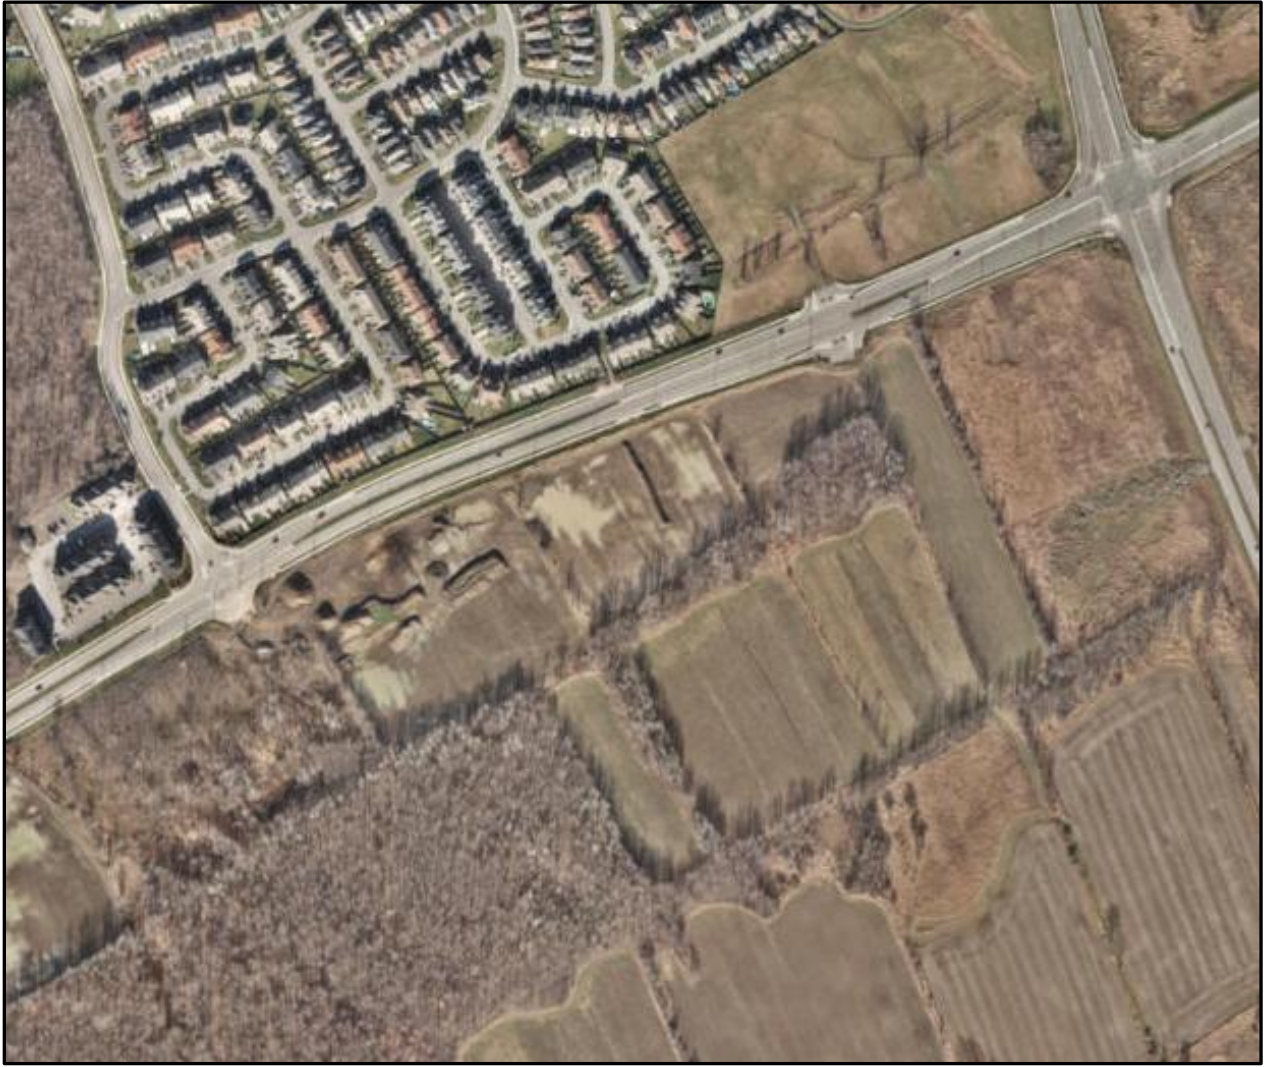
**FIGURE 3**

**AERIAL PHOTOGRAPH - 2015**

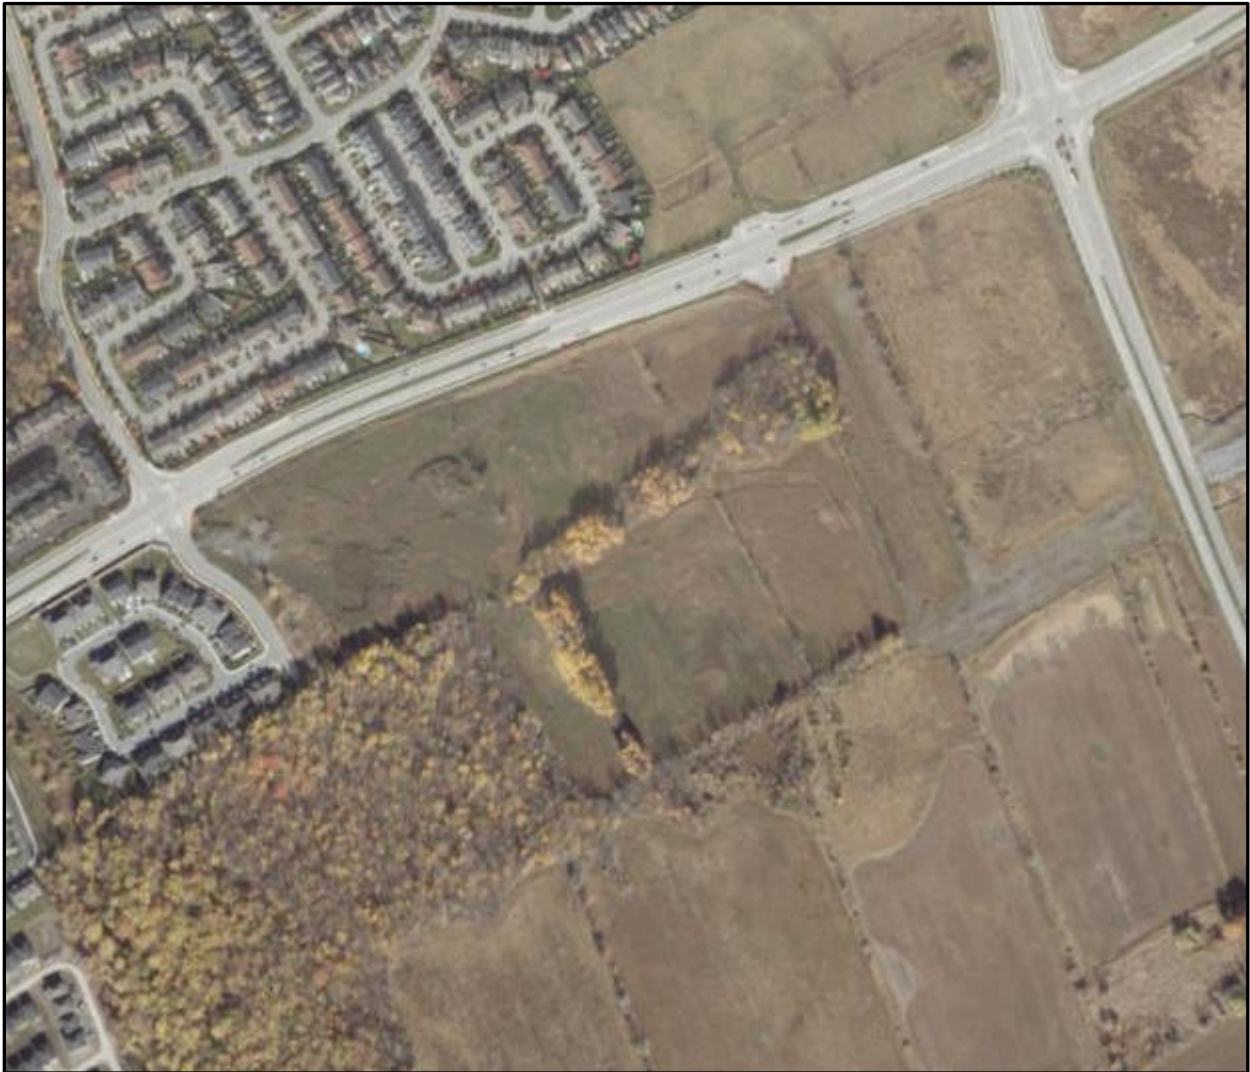
**FIGURE 4**

**AERIAL PHOTOGRAPH - 2019**
