## Geotechnical Investigation

Proposed Indoor Aquatic and Recreation Facility  
2775, 2785 Palladium Drive; and  
Block 244 Plan 4M 1687  
Ottawa, Ontario  
*Revision 1*

LRL File No.: 240720

May 2025; *Revised June 2026*

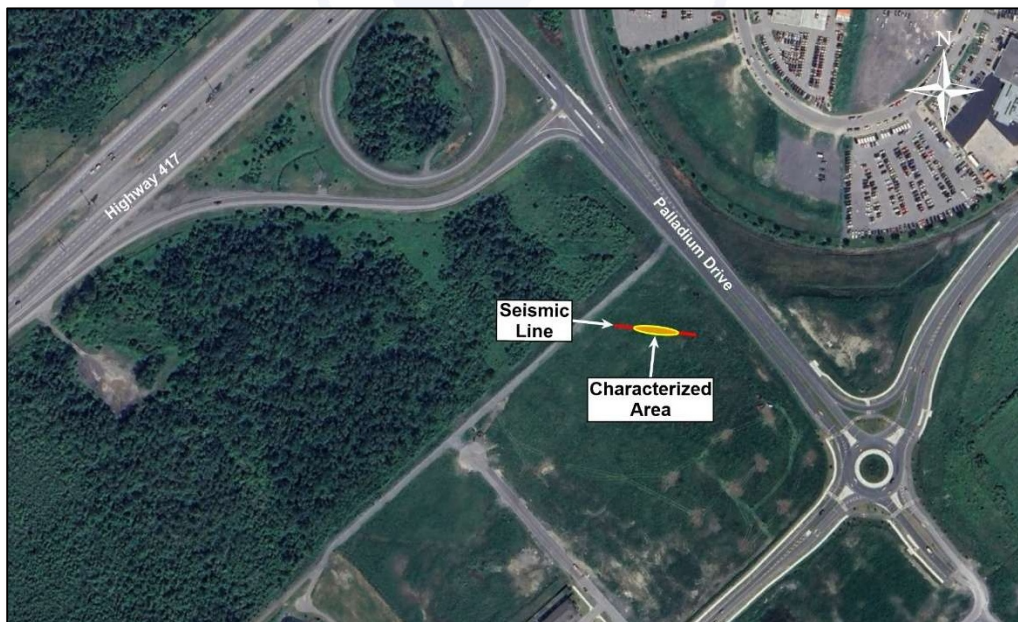
**Figure 2: Location of the seismic spreads**  
(source: Google Earth™)
