# **Geotechnical Investigation**

## **Proposed Residential Development**

551 Riverdale Avenue, Ottawa, ON

Report PG7423-1 dated March 11, 2025

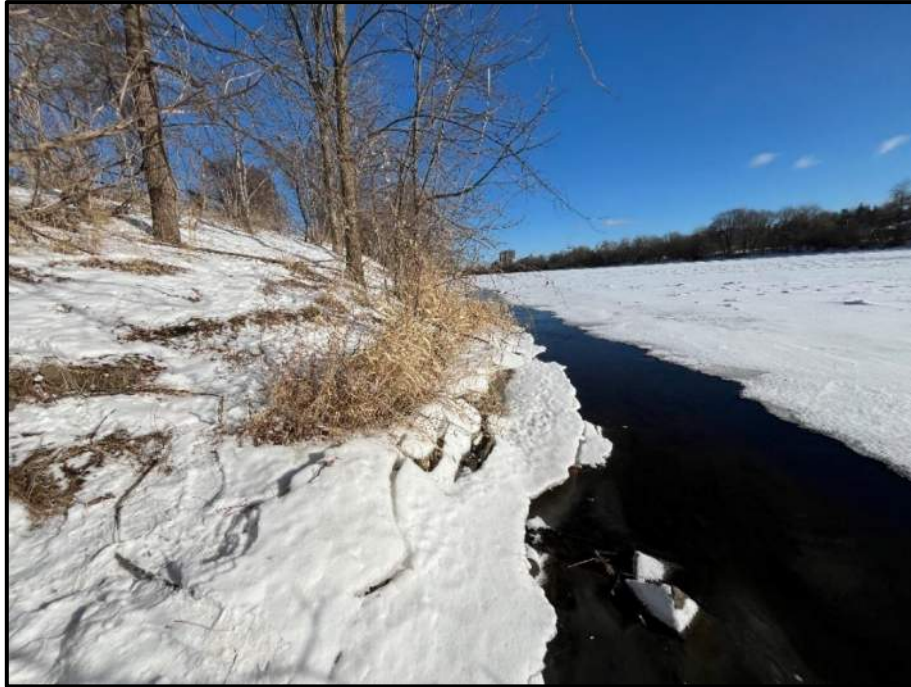
**Photo 1:** Existing conditions of the slope face – Facing to the north.

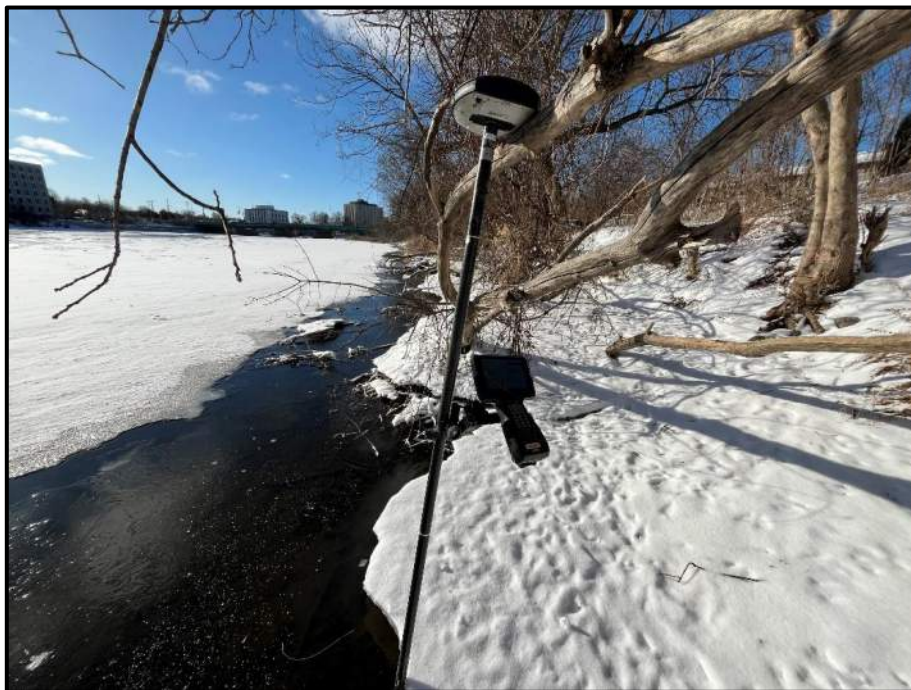
**Photo 2:** Existing conditions of the slope face – Facing to the south.

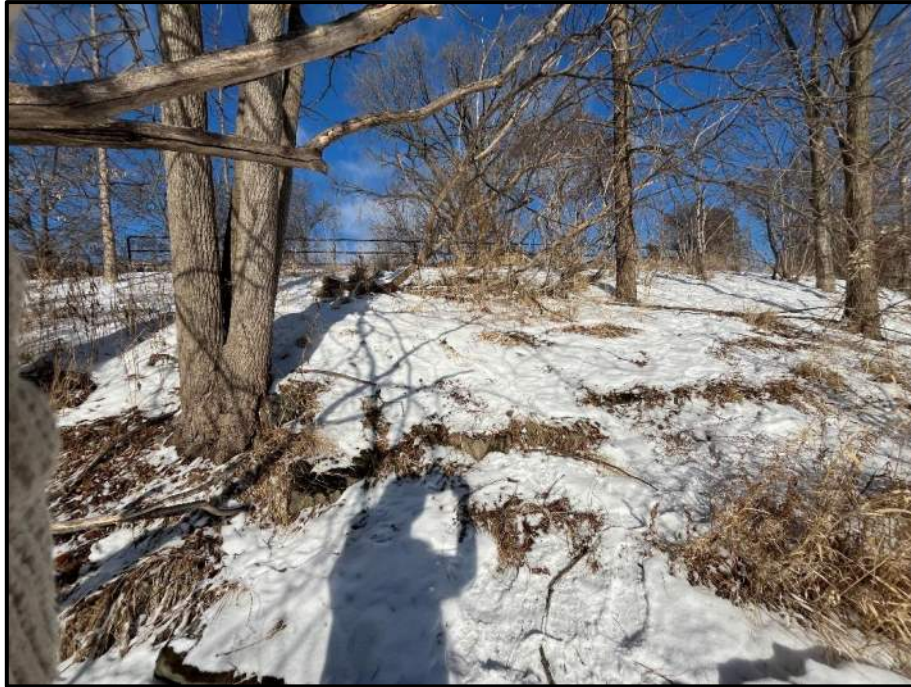
**Photo 3:** Existing conditions of the slope face – Facing to the west.

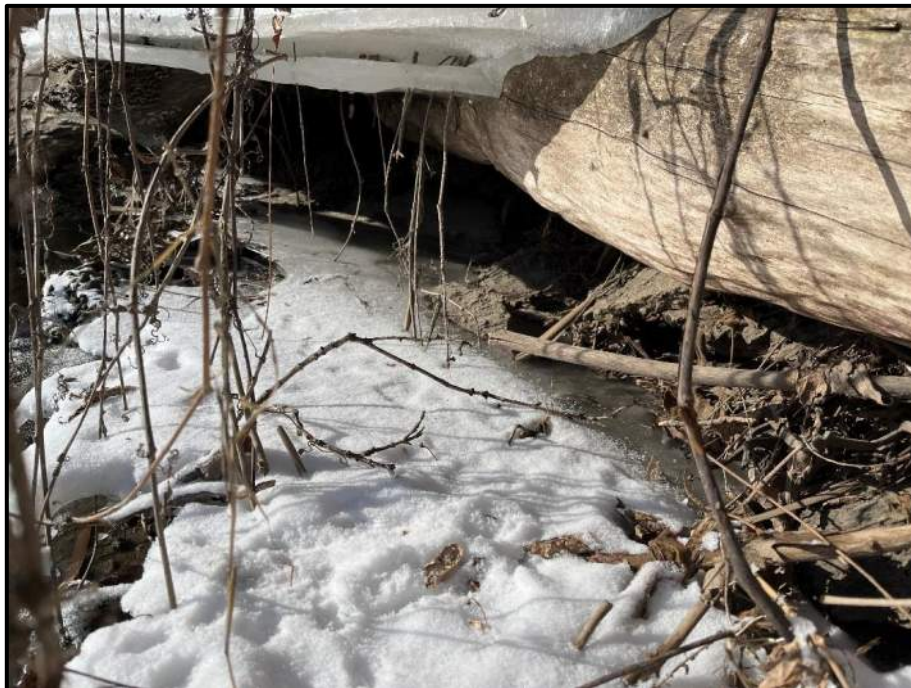
**Photo 4:** Minor to moderate erosion at the bottom of the slope was observed – Facing to the southwest.

The slope was noted to be in relatively stable condition with a vegetative cover. However, minor to moderate erosions were observed at the edge of the watercourse, particularly at the location of cross-section A during the site visit.

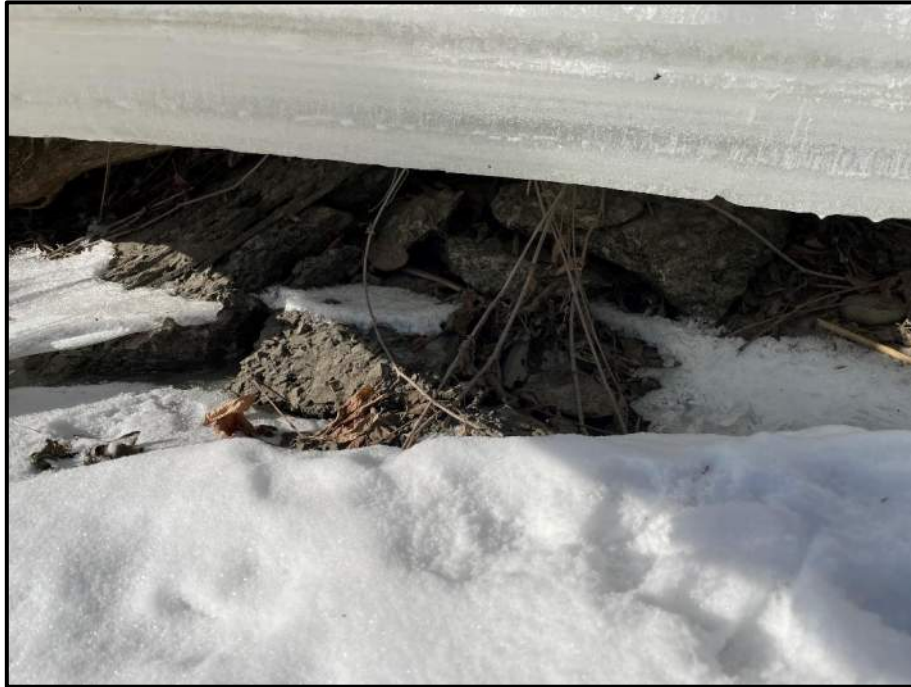
**Photo 5:** Presence of bedrock outcrops at various locations at the bottom of the slope. Minor to moderate erosion at the bottom of the slope was observed – Facing to the west.

Based on the soil profiles encountered at the test hole locations and our knowledge of the area, and the presence of bedrock outcrops and glacial till consisting of cobbles and boulders at the bottom of the slope at various locations, a toe erosion allowance of 2 m and an access allowance of 6 m are required from the top of the slope or geotechnical setback (where applicable). It should be noted that the brown to grey silty clay encountered at the bottom of the slope at the location of HA 2-25 and HA 3-25 is present as a thin layer; therefore, it does not affect the toe erosion allowance setback from a geotechnical perspective.

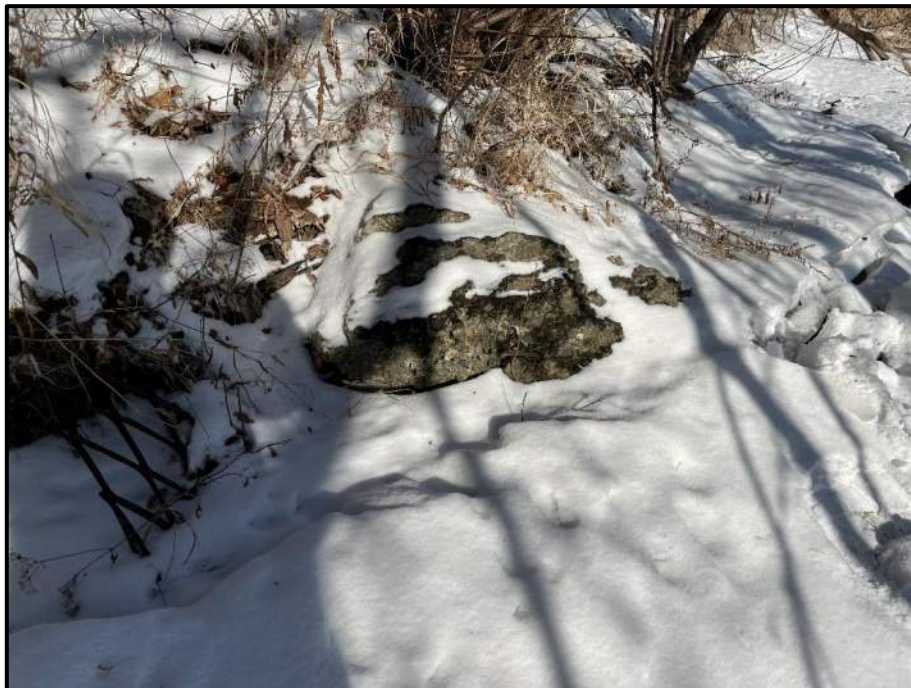
**Photo 6:** Presence of bedrock outcrops at various locations at the bottom of the slope – Facing to the west.

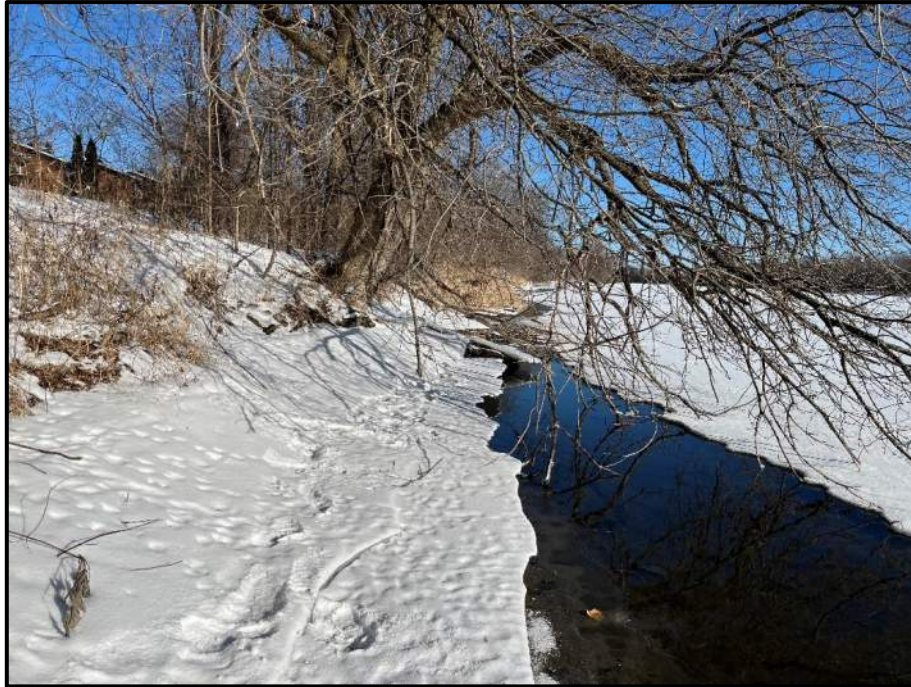
**Photo 7:** Existing conditions of the slope face – Facing to the north.

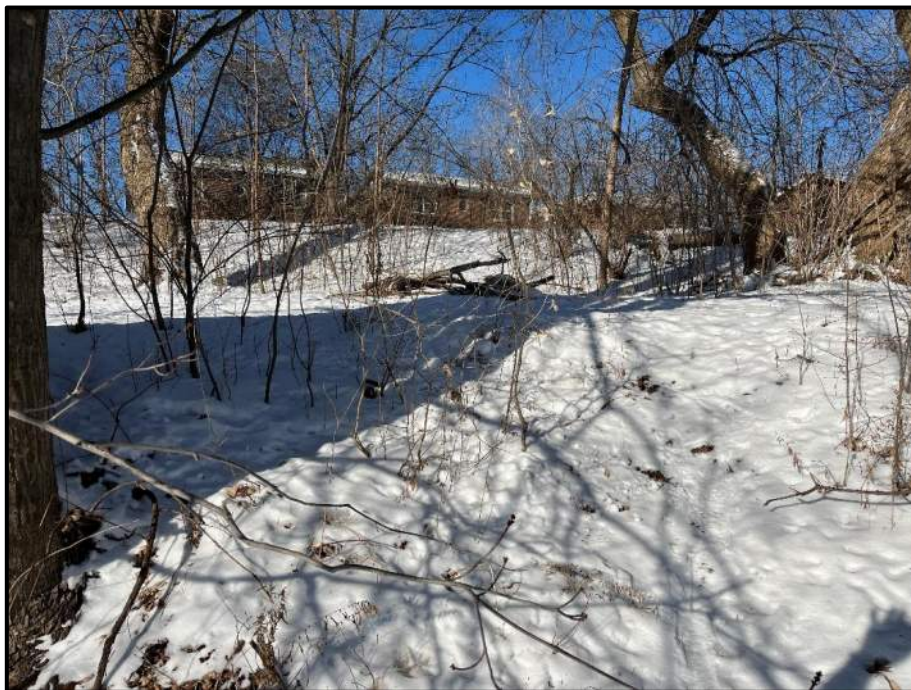
**Photo 8:** Existing conditions of the slope face – Facing to the west.

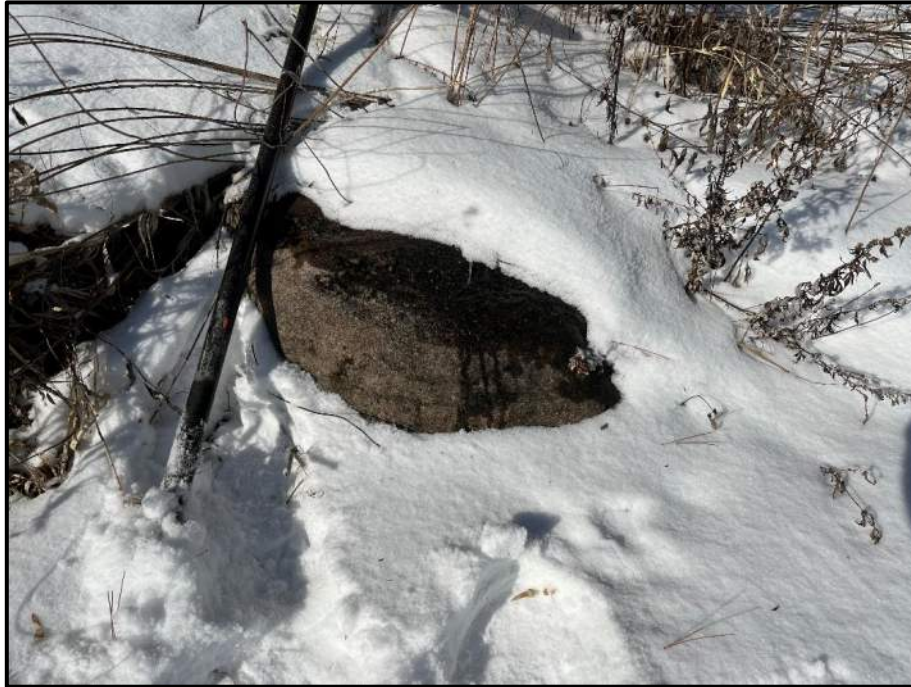
**Photo 9:** Presence of bedrock outcrops at various locations at the bottom of the slope – Facing to the west.

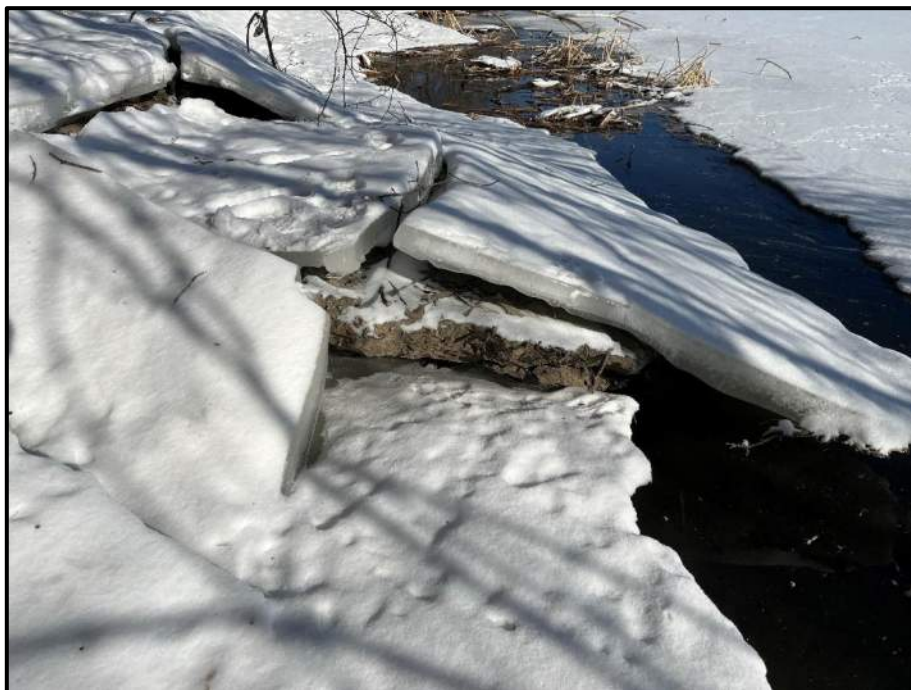
**Photo 10:** Presence of bedrock outcrops at various locations at the bottom of the slope – Facing to the north.

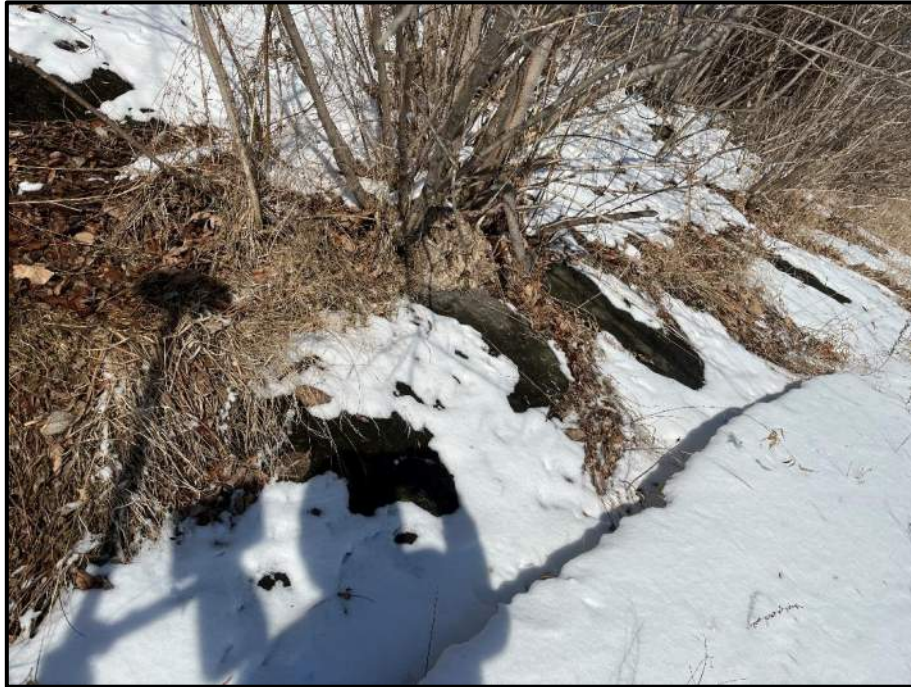
**Photo 11:** Presence of bedrock outcrops at various locations at the bottom of the slope  
– Facing to the west.

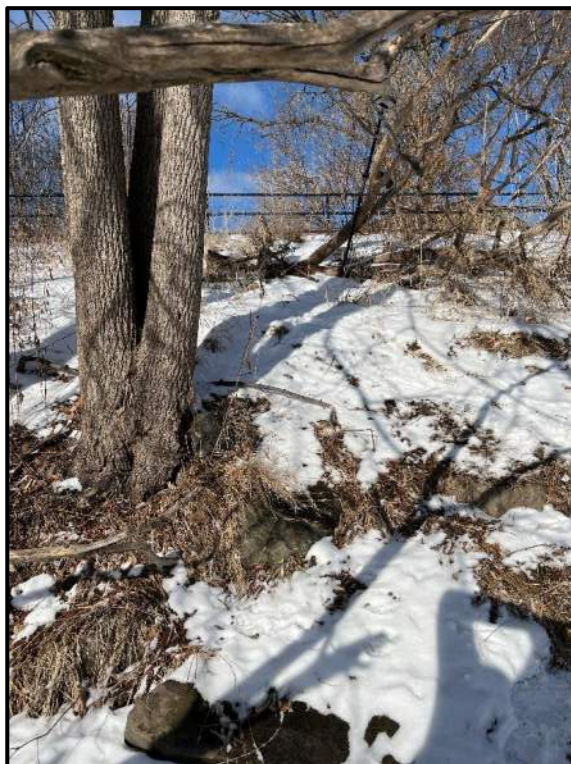
**Photo 12:** Presence of bedrock outcrops at various locations at the bottom of the slope  
– Facing to the west.

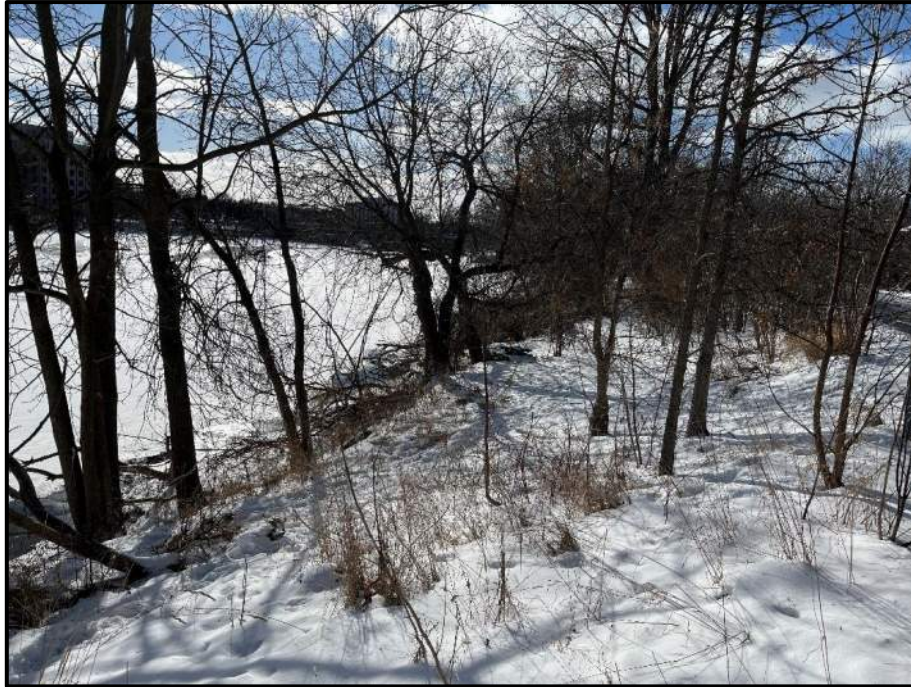
**Photo 13:** Existing conditions of the slope face – Facing to the south.

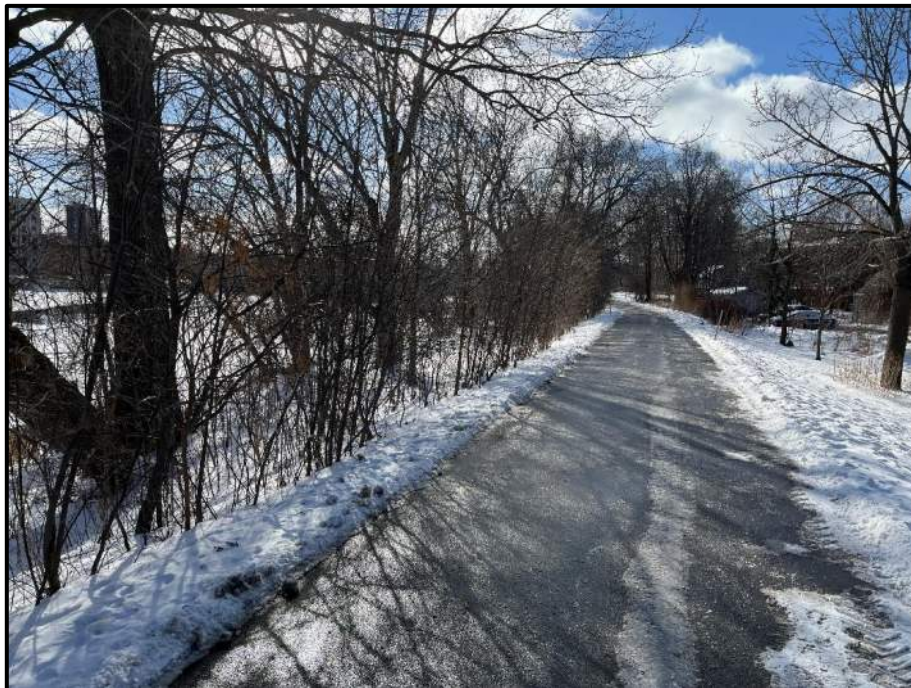
**Photo 14:** An existing asphalt-covered pathway passing along the top of the slope – Facing to the south.

A walk along the top of the slope and a general assessment of the slope conditions were completed during the site visit. Mature and small trees, as well as some fallen trees, were observed along the slope face. Bedrock outcrops were noted at multiple locations at the bottom of slope, particularly toward the north directions at the location of Sections A to C. It was also observed that the edge of the watercourse is approximately at the bottom of the slope. It is also observed that an existing asphalt-covered pathway runs along the top of the slope.
