**Phase One Environmental Site Assessment
Proposed Plan of Subdivision
3160 Carp Road
Ottawa, Ontario**

GEMTEC Project: 102151.001

June 26, 2023
GEMTEC Project: 102151.001

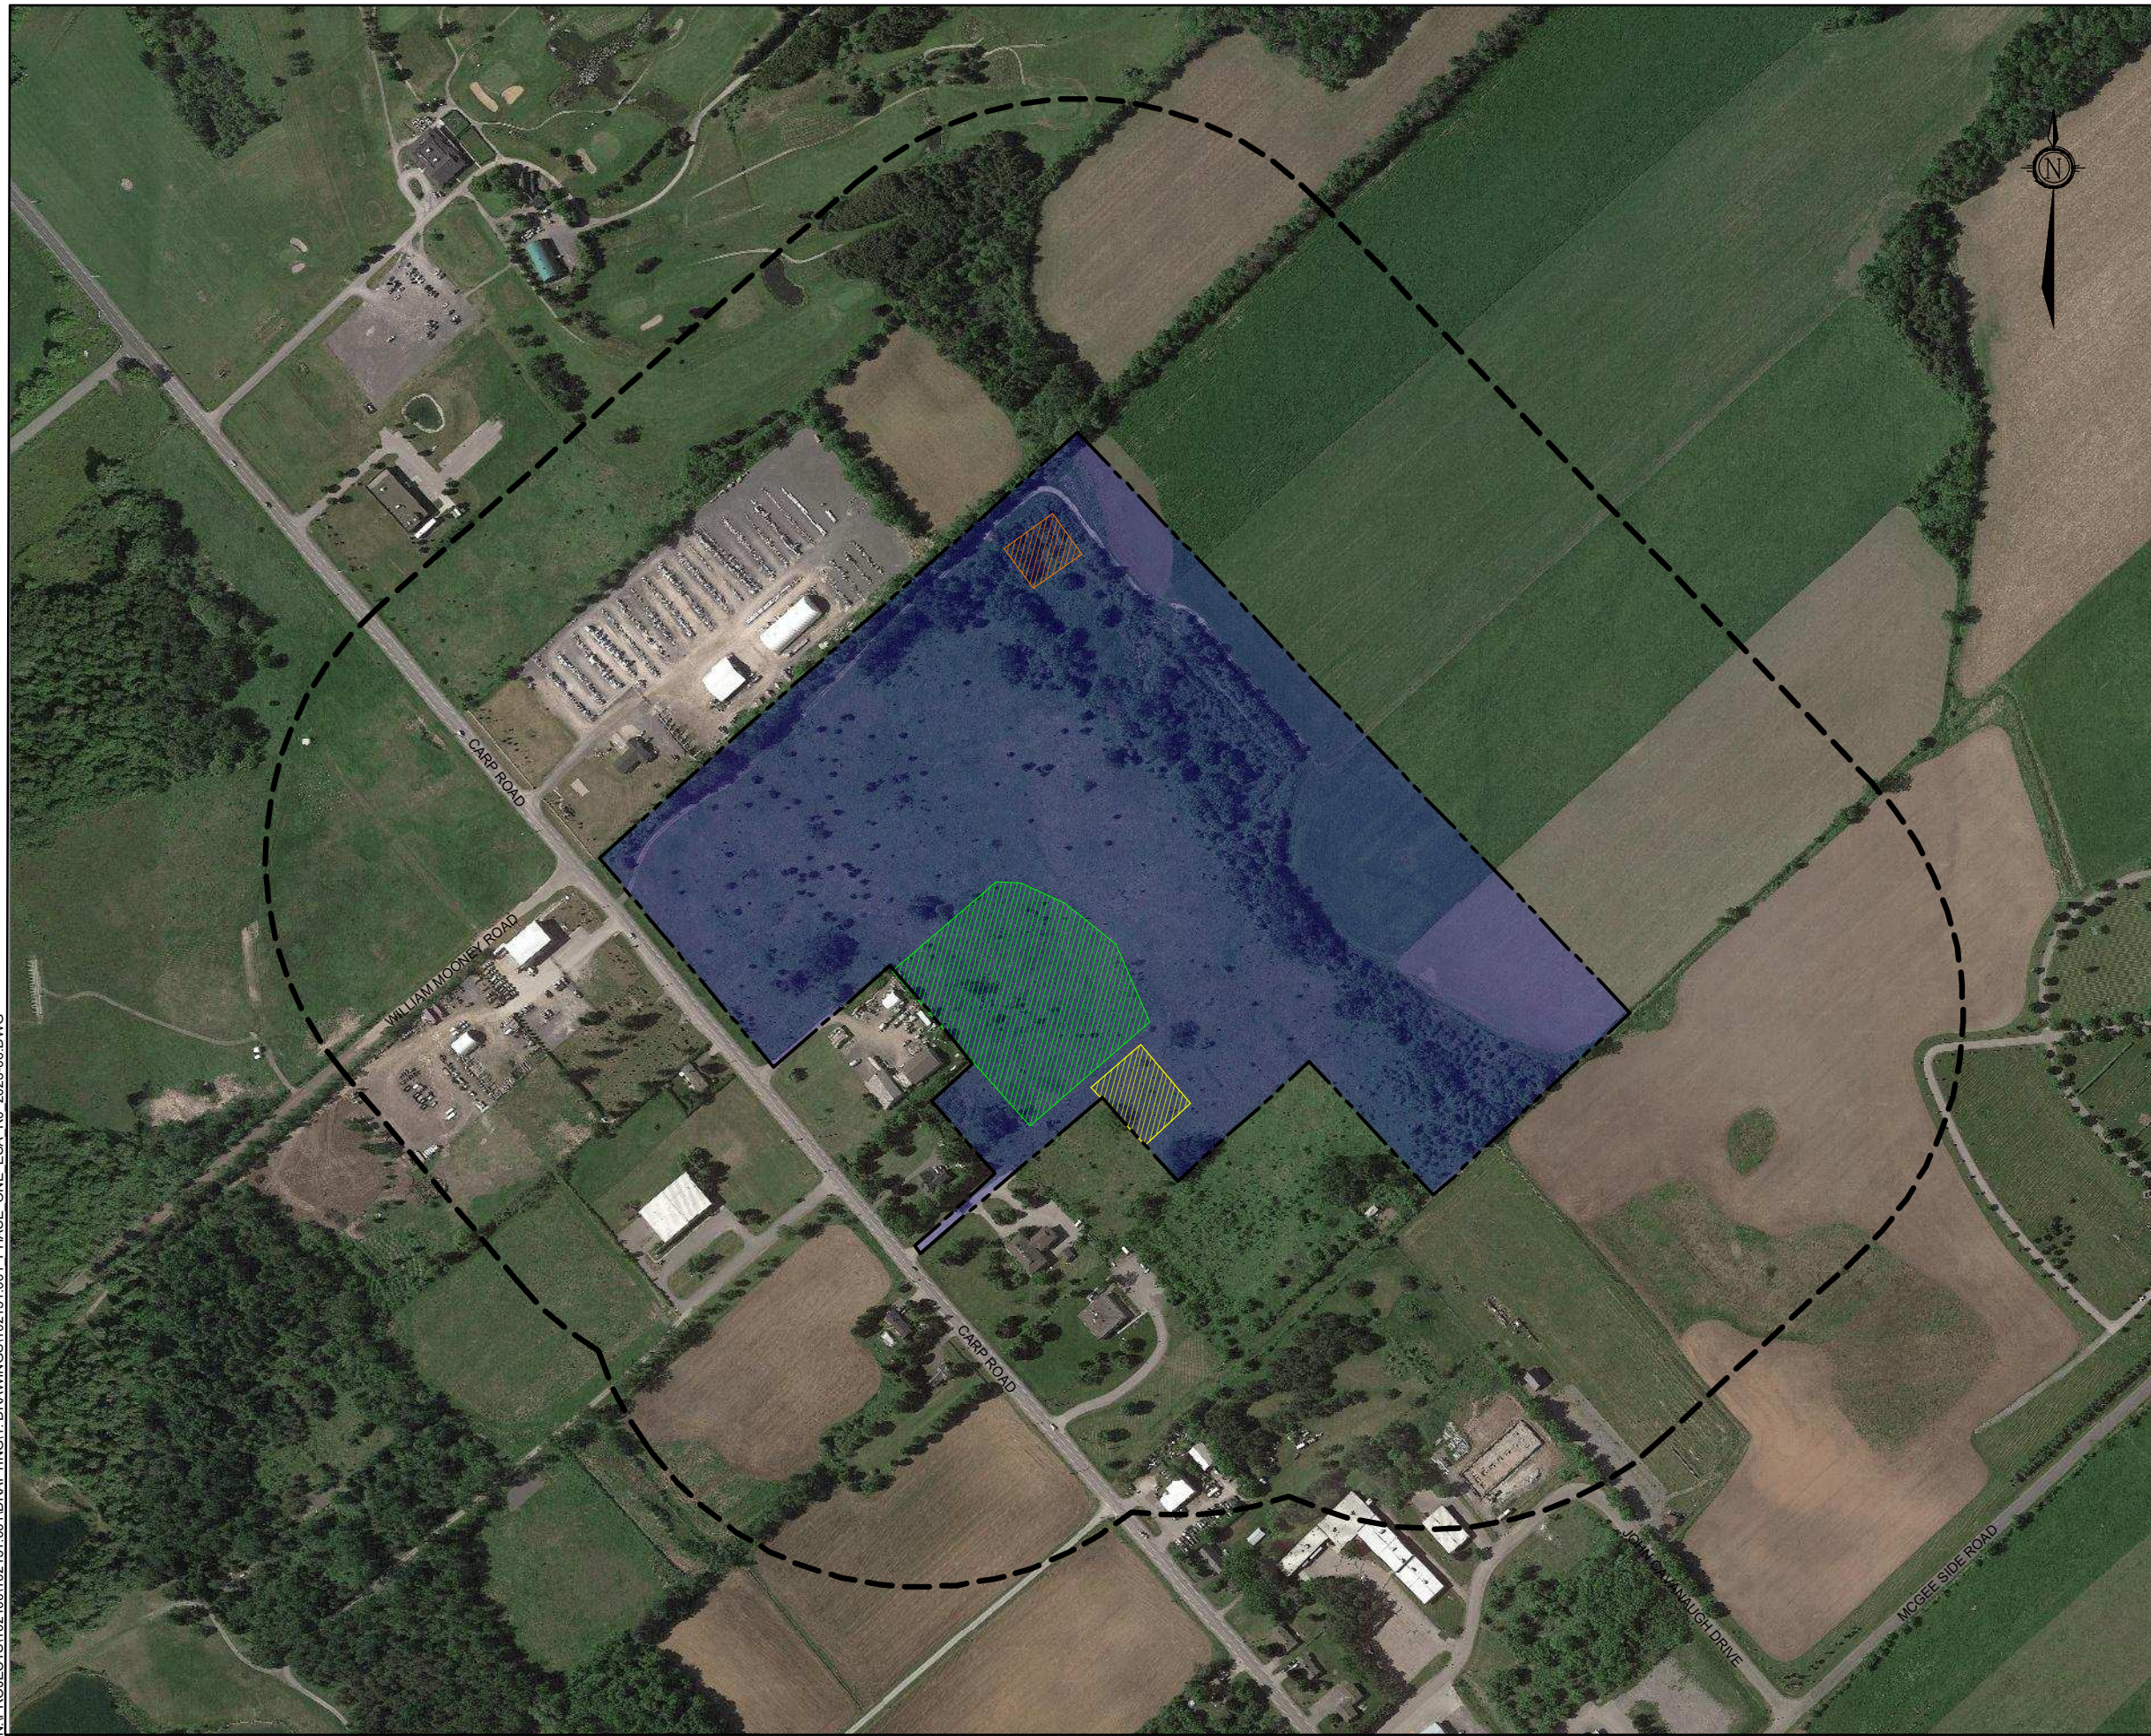
LEGEND	
	APPROXIMATE SITE BOUNDARY
	STUDY AREA (250 m RADIUS AROUND THE SITE BOUNDARY)
LABEL	AREA OF POTENTIAL ENVIRONMENTAL CONCERN
1	HISTORICAL PESTICIDE USE ON SITE
2	FILL MATERIAL OF UNKNOWN ORIGIN (HISTORICAL STRUCTURE)
3	FILL MATERIAL OF UNKNOWN ORIGIN (IMPORTED CRUSHED ROCK)
4	ABOVEGROUND STORAGE TANK AT 3108 CARP ROAD

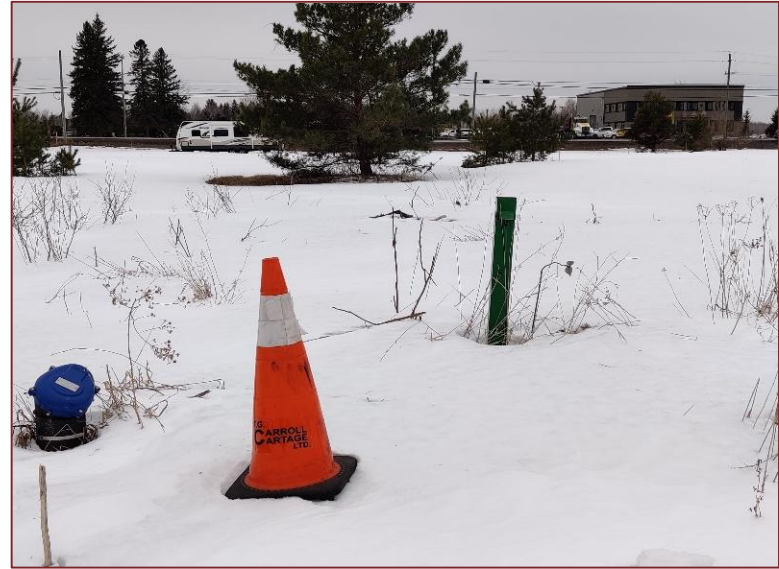
Site Photograph 2 – Monitoring wells present on the east portion of the Site

- The investigation included the excavation of 15 test pits across the Site, installation of five overburden monitoring wells and four groundwater test wells. The wells are still present on the Site.
- Overburden on the Site was noted as being approximately 6 to 8 metres with the exception of a small portion on the south side which was 1.8 metres thick.
- The report did not indicate a groundwater flow direction.

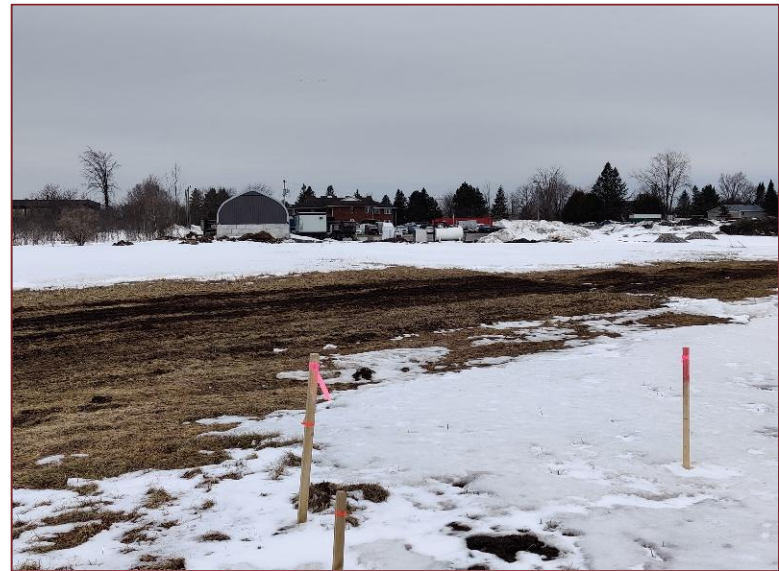
Site Photograph 4 – View looking south from the Site. The AST at 3108 Carp Road is visible in the photograph.

- APEC 4 – An AST was noted approximately 20 meters south of the Site at 3108 Carp Road. COPCs include PHCs and BTEX with potential impacts in soil and groundwater.

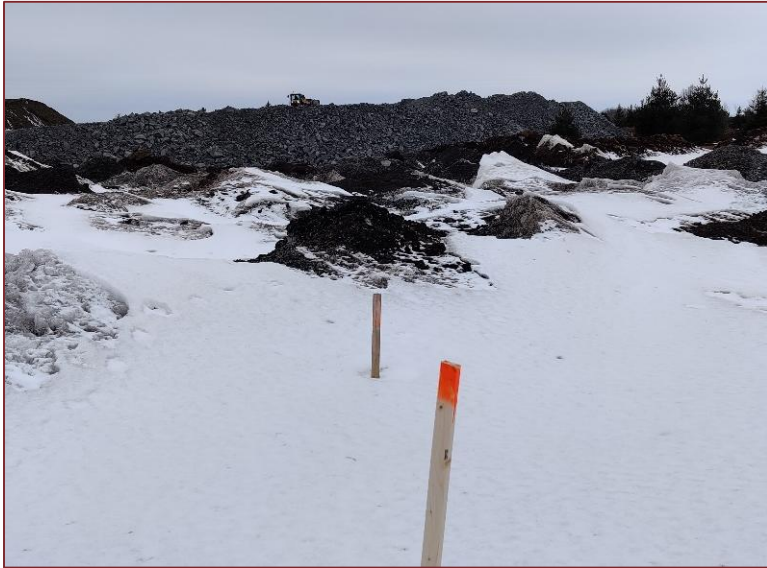
Site Photograph 5 – View of the imported crushed rock on the Site.

- APEC 3 – Imported fill material of unknown quality was observed during the Phase One Site visit. COPCs include M&I, PHCs, BTEX, and PAHs with potential for impacts in soil.

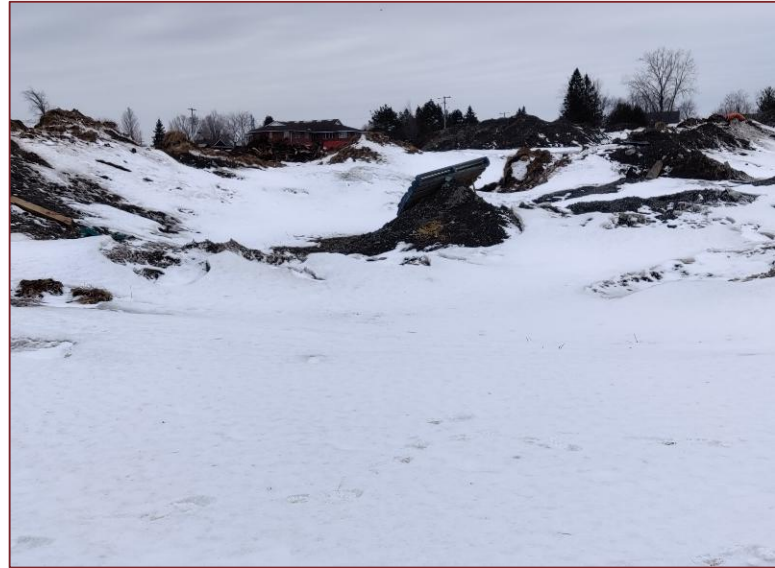
Site Photograph 6 – Pile of crushed asphalt and fill material located on the southwest portion of the Phase One Property

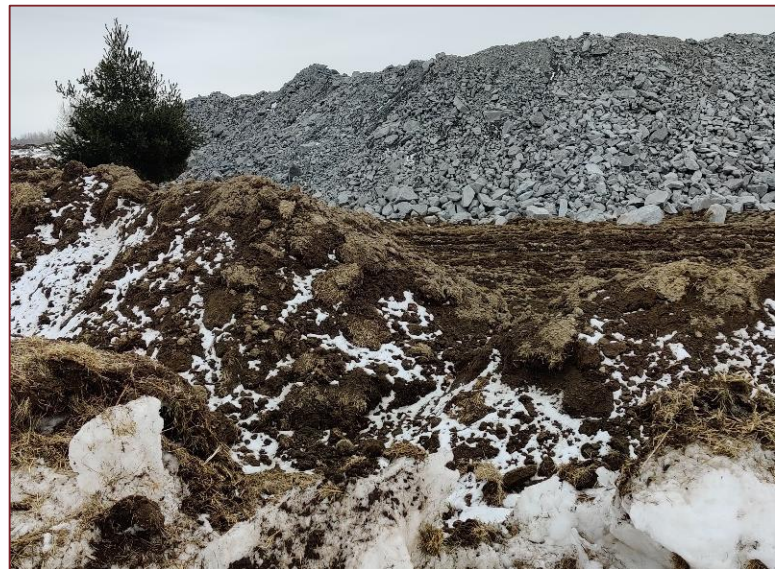
Site Photograph 8 – Crushed rock and tilled native material on the southwest portion of the Site.

8	3160 Carp Road	30. Importation of Fill Material of Unknown Quality	On-Site	Imported, crushed rock was present across the southwest portion of the Site. Insufficient information was available to appropriately characterize the imported material.	Yes PCA is located on the Phase One Property and must be identified as an APEC, as per O.Reg. 153/04.
9	3108 Carp Road	28. Gasoline and Associated Products	20 meters south of the Site	An aboveground storage tank was noted at 3108 Carp Road.	Yes
