# **Hydrogeological Study and Water Budget Assessment**

## **Proposed Residential Development**

East Parcel - 5971 Flewellyn Road and 1770 and 1820 Shea  
Road  
Ottawa, Ontario

Report PH4681-REP.02  
dated April 24, 2026

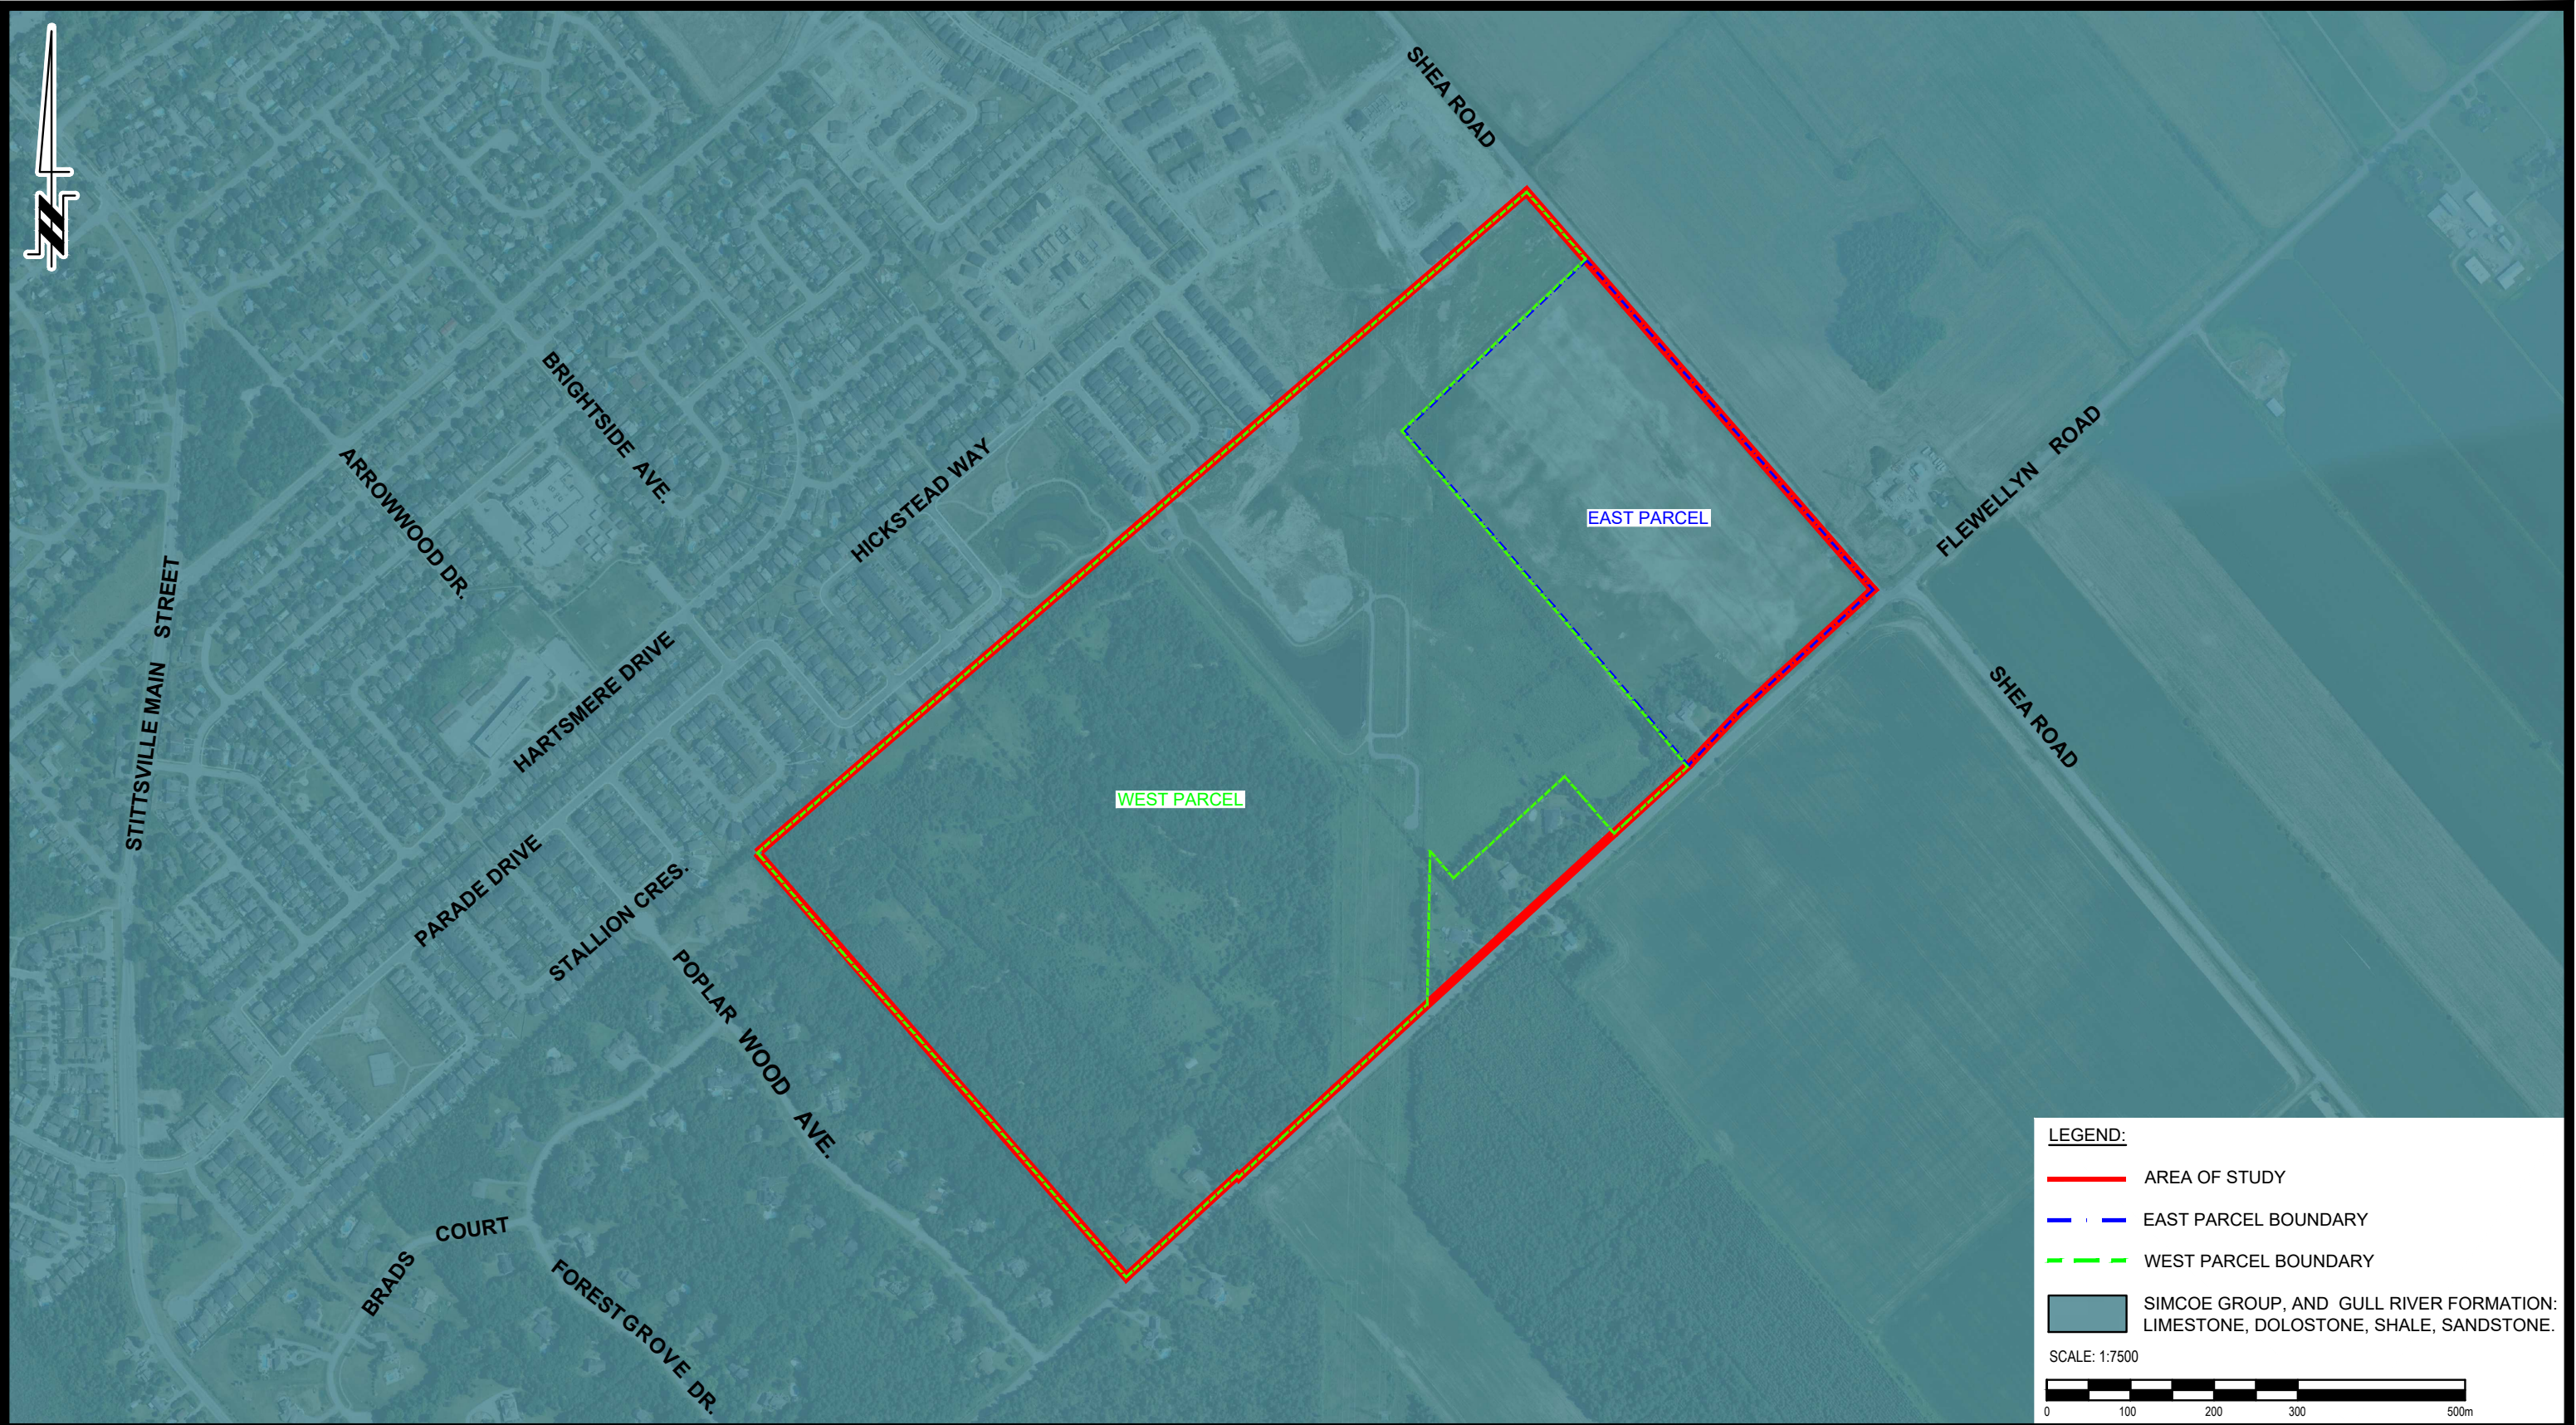
| <div><div><div></div><div>PATERSON GROUP</div><div>9 AURIGA DRIVE<br/>OTTAWA, ON<br/>K2E 7T9<br/>TEL: (613) 226-7381</div></div></div> | | | | | | | | <div>CAIVAN (STITTSVILLE) INC.</div> <div>HYDROGEOLOGICAL STUDY AND WATER BUDGET ASSESSMENT</div> <div>PROPOSED RESIDENTIAL DEVELOPMENT</div> <div>5971, 5993, 6115, 6141 &amp; 6159 FLEWELLYN ROAD, 6070 FERNBANK ROAD &amp; 1770 &amp; 1820 SHEA ROAD</div> <div>OTTAWA, ONTARIO</div> <div>Title: BEDROCK GEOLOGY PLAN</div> | Scale: 1:7500 | Date: 12/2022 |

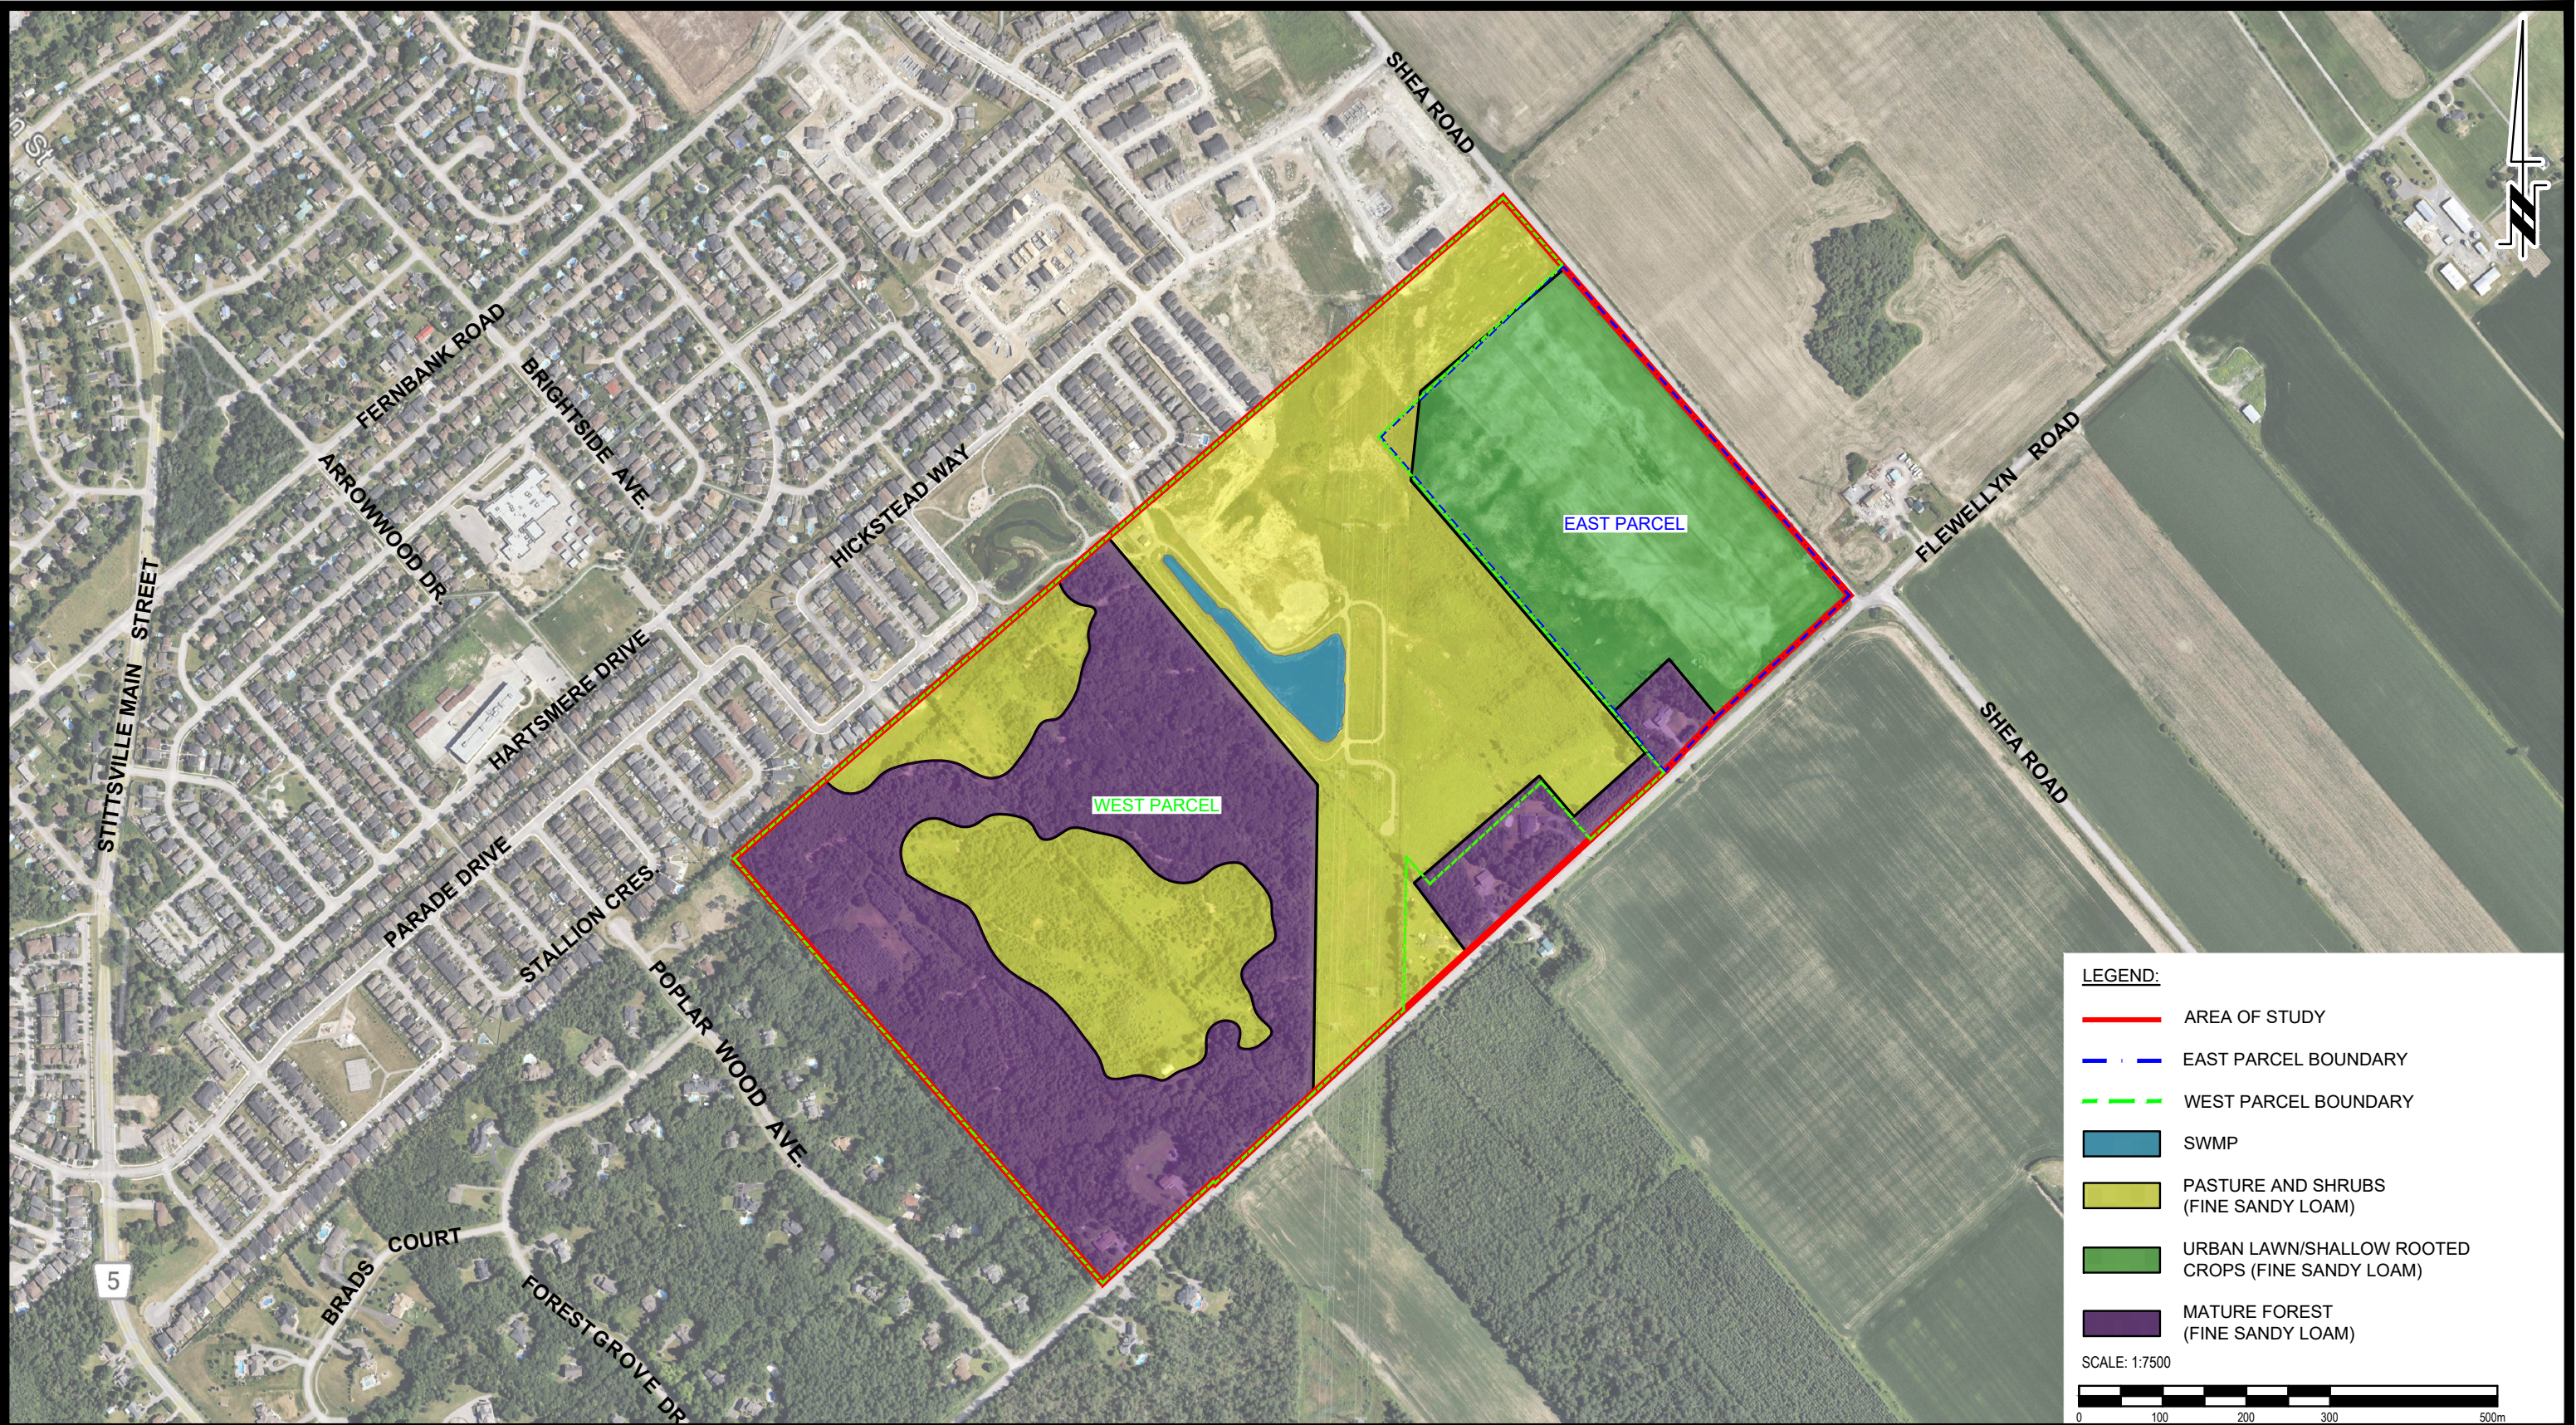
Dwg. No.: PH4681-6

DRAWING PH4681-6 - PRE-DEVELOPMENT TERRAIN COMPOSITION PLAN

The pre and post-development infiltration factors for all materials considered are included in the water budget calculations provided in Table 7 and 8 included in Appendix 3 of this report. The pre and post development terrain compositions are displayed on Drawings PH4681-6 and PH4681-7, respectively, included in Appendix 1.

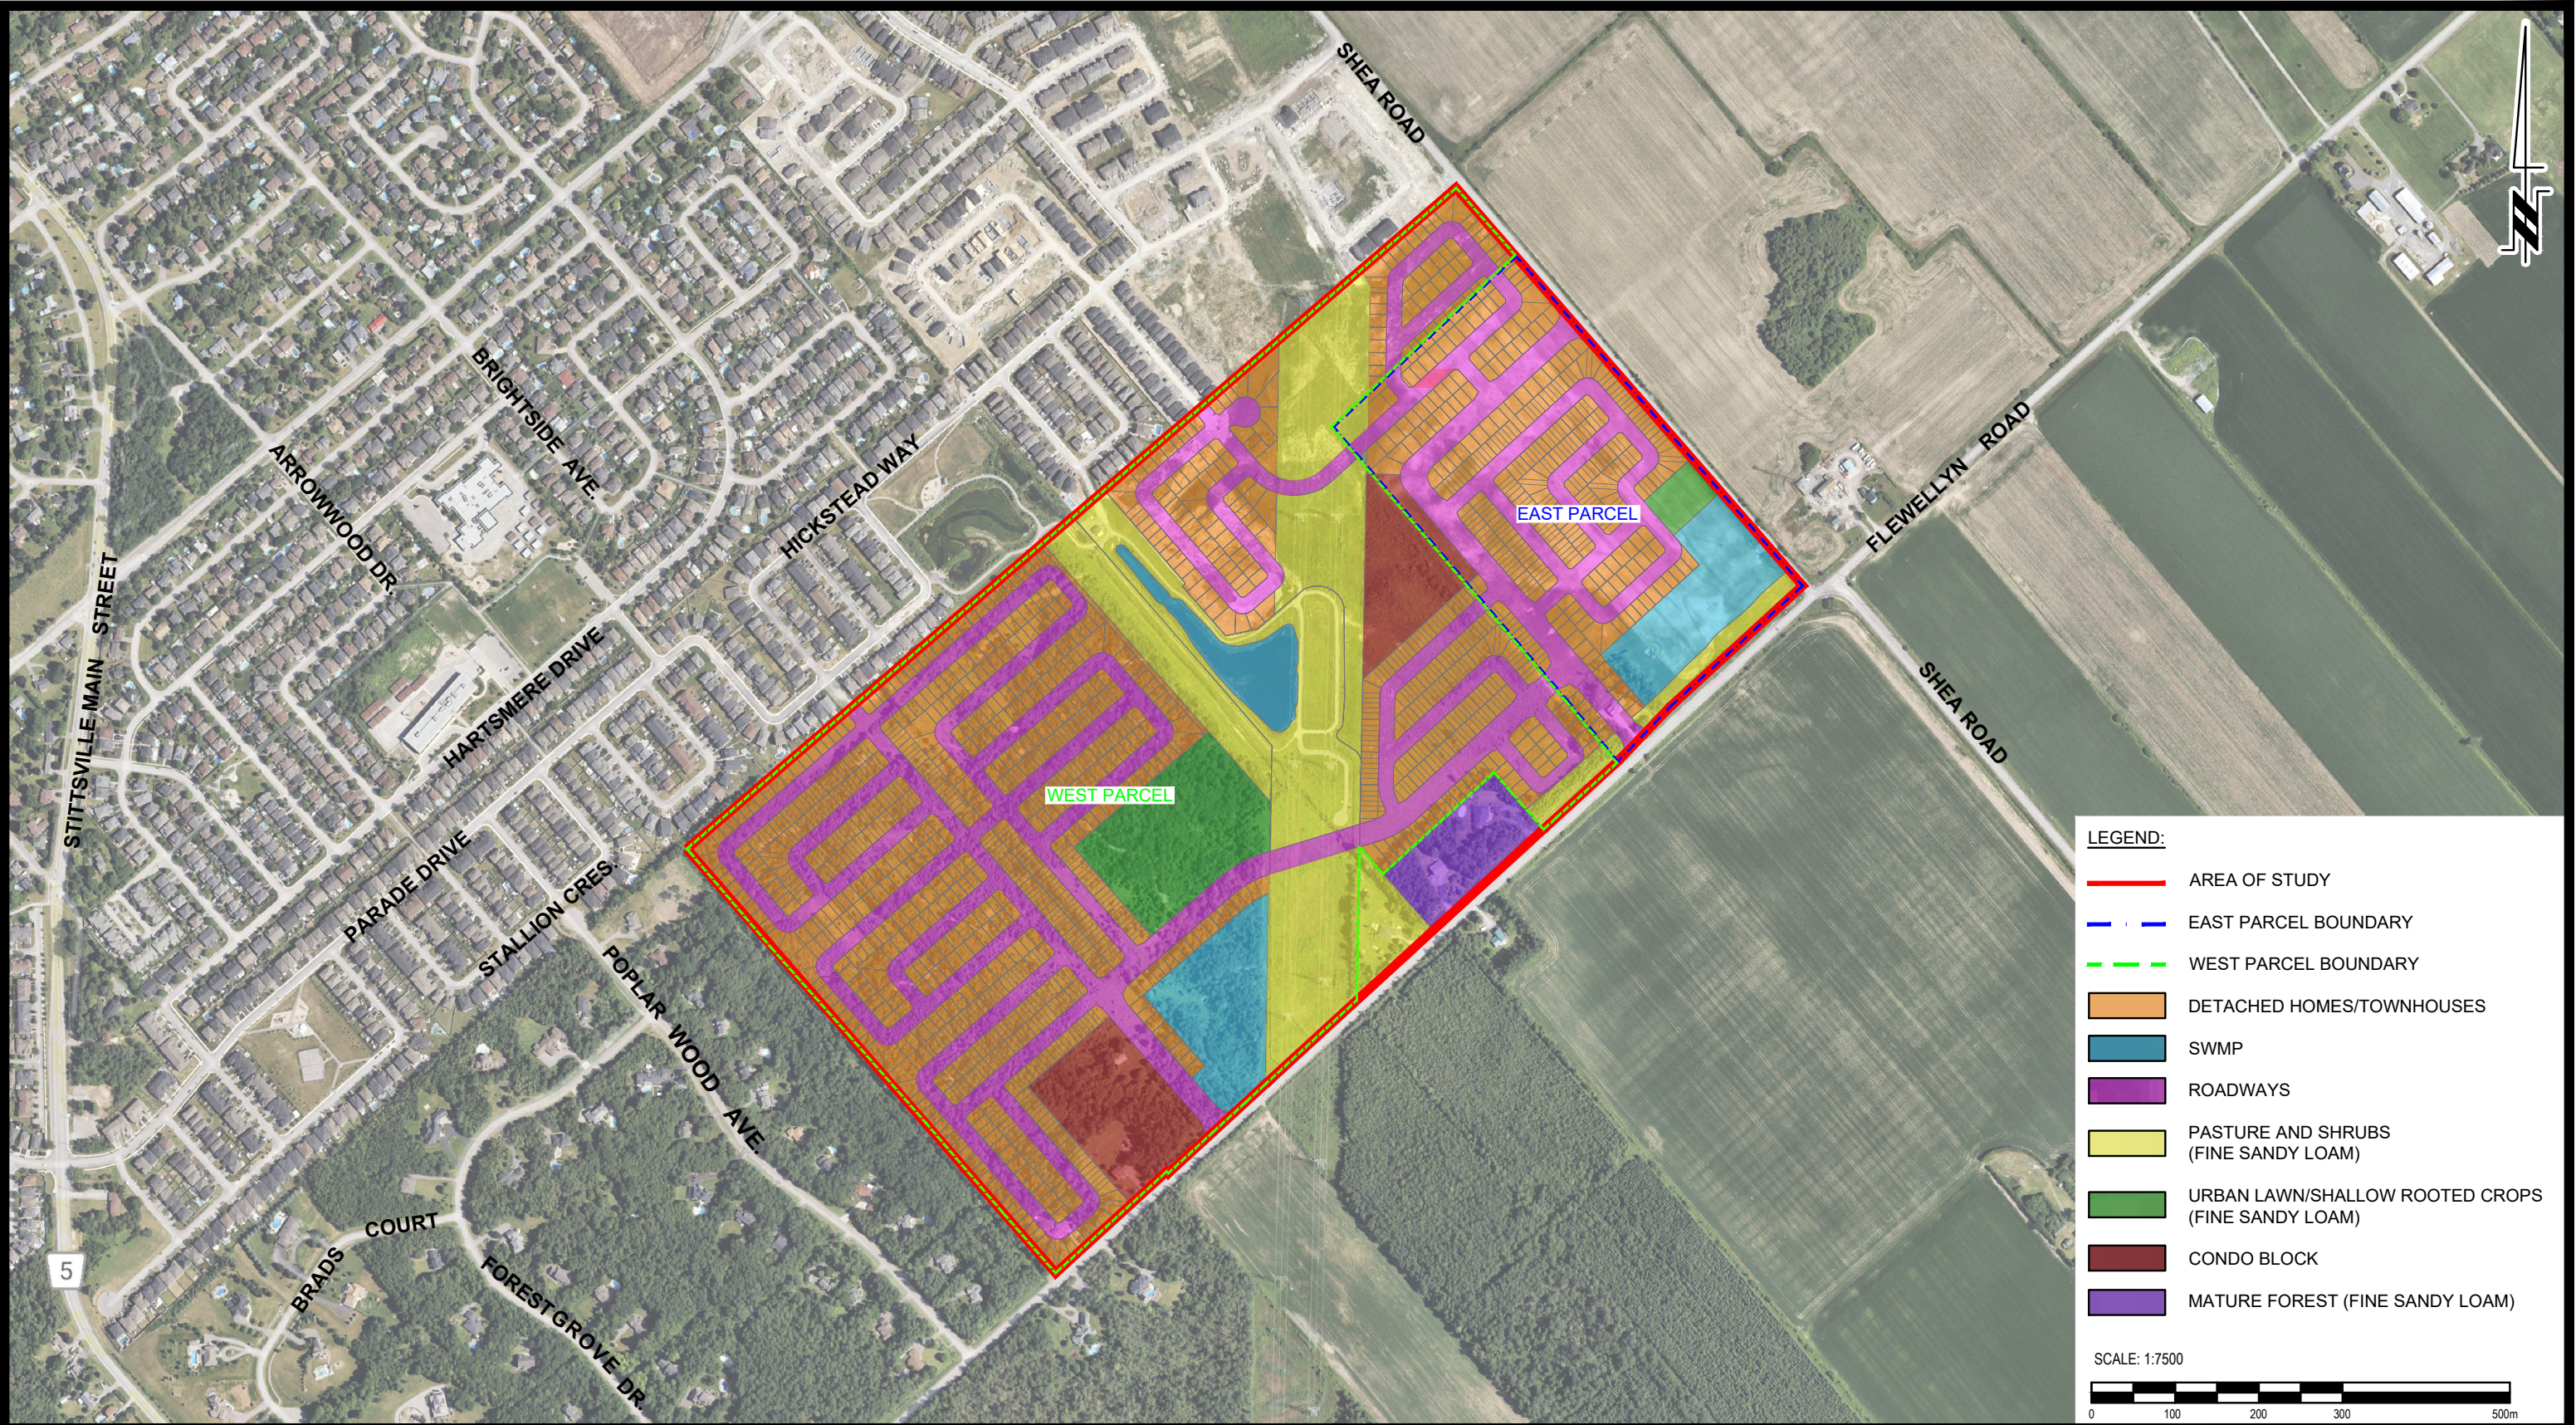
DRAWING PH4681-7 - POST-DEVELOPMENT TERRAIN COMPOSITION PLAN

The site-specific water budget assessment (SSWB) was conducted on a monthly and annual basis to determine the hydrologic/hydrogeological function of the subject site, to identify infiltration potential and to identify opportunities for Low Impact Development (LID) measures. The study area currently consists of a mixture of agricultural lands, meadows, and forested areas. The pre and post-development terrain compositions are illustrated on Drawings PH4681-6 - Pre-Development Terrain Composition Plan and Drawing PH4681-7 - Post-Development Terrain Composition Plan appended to this report.

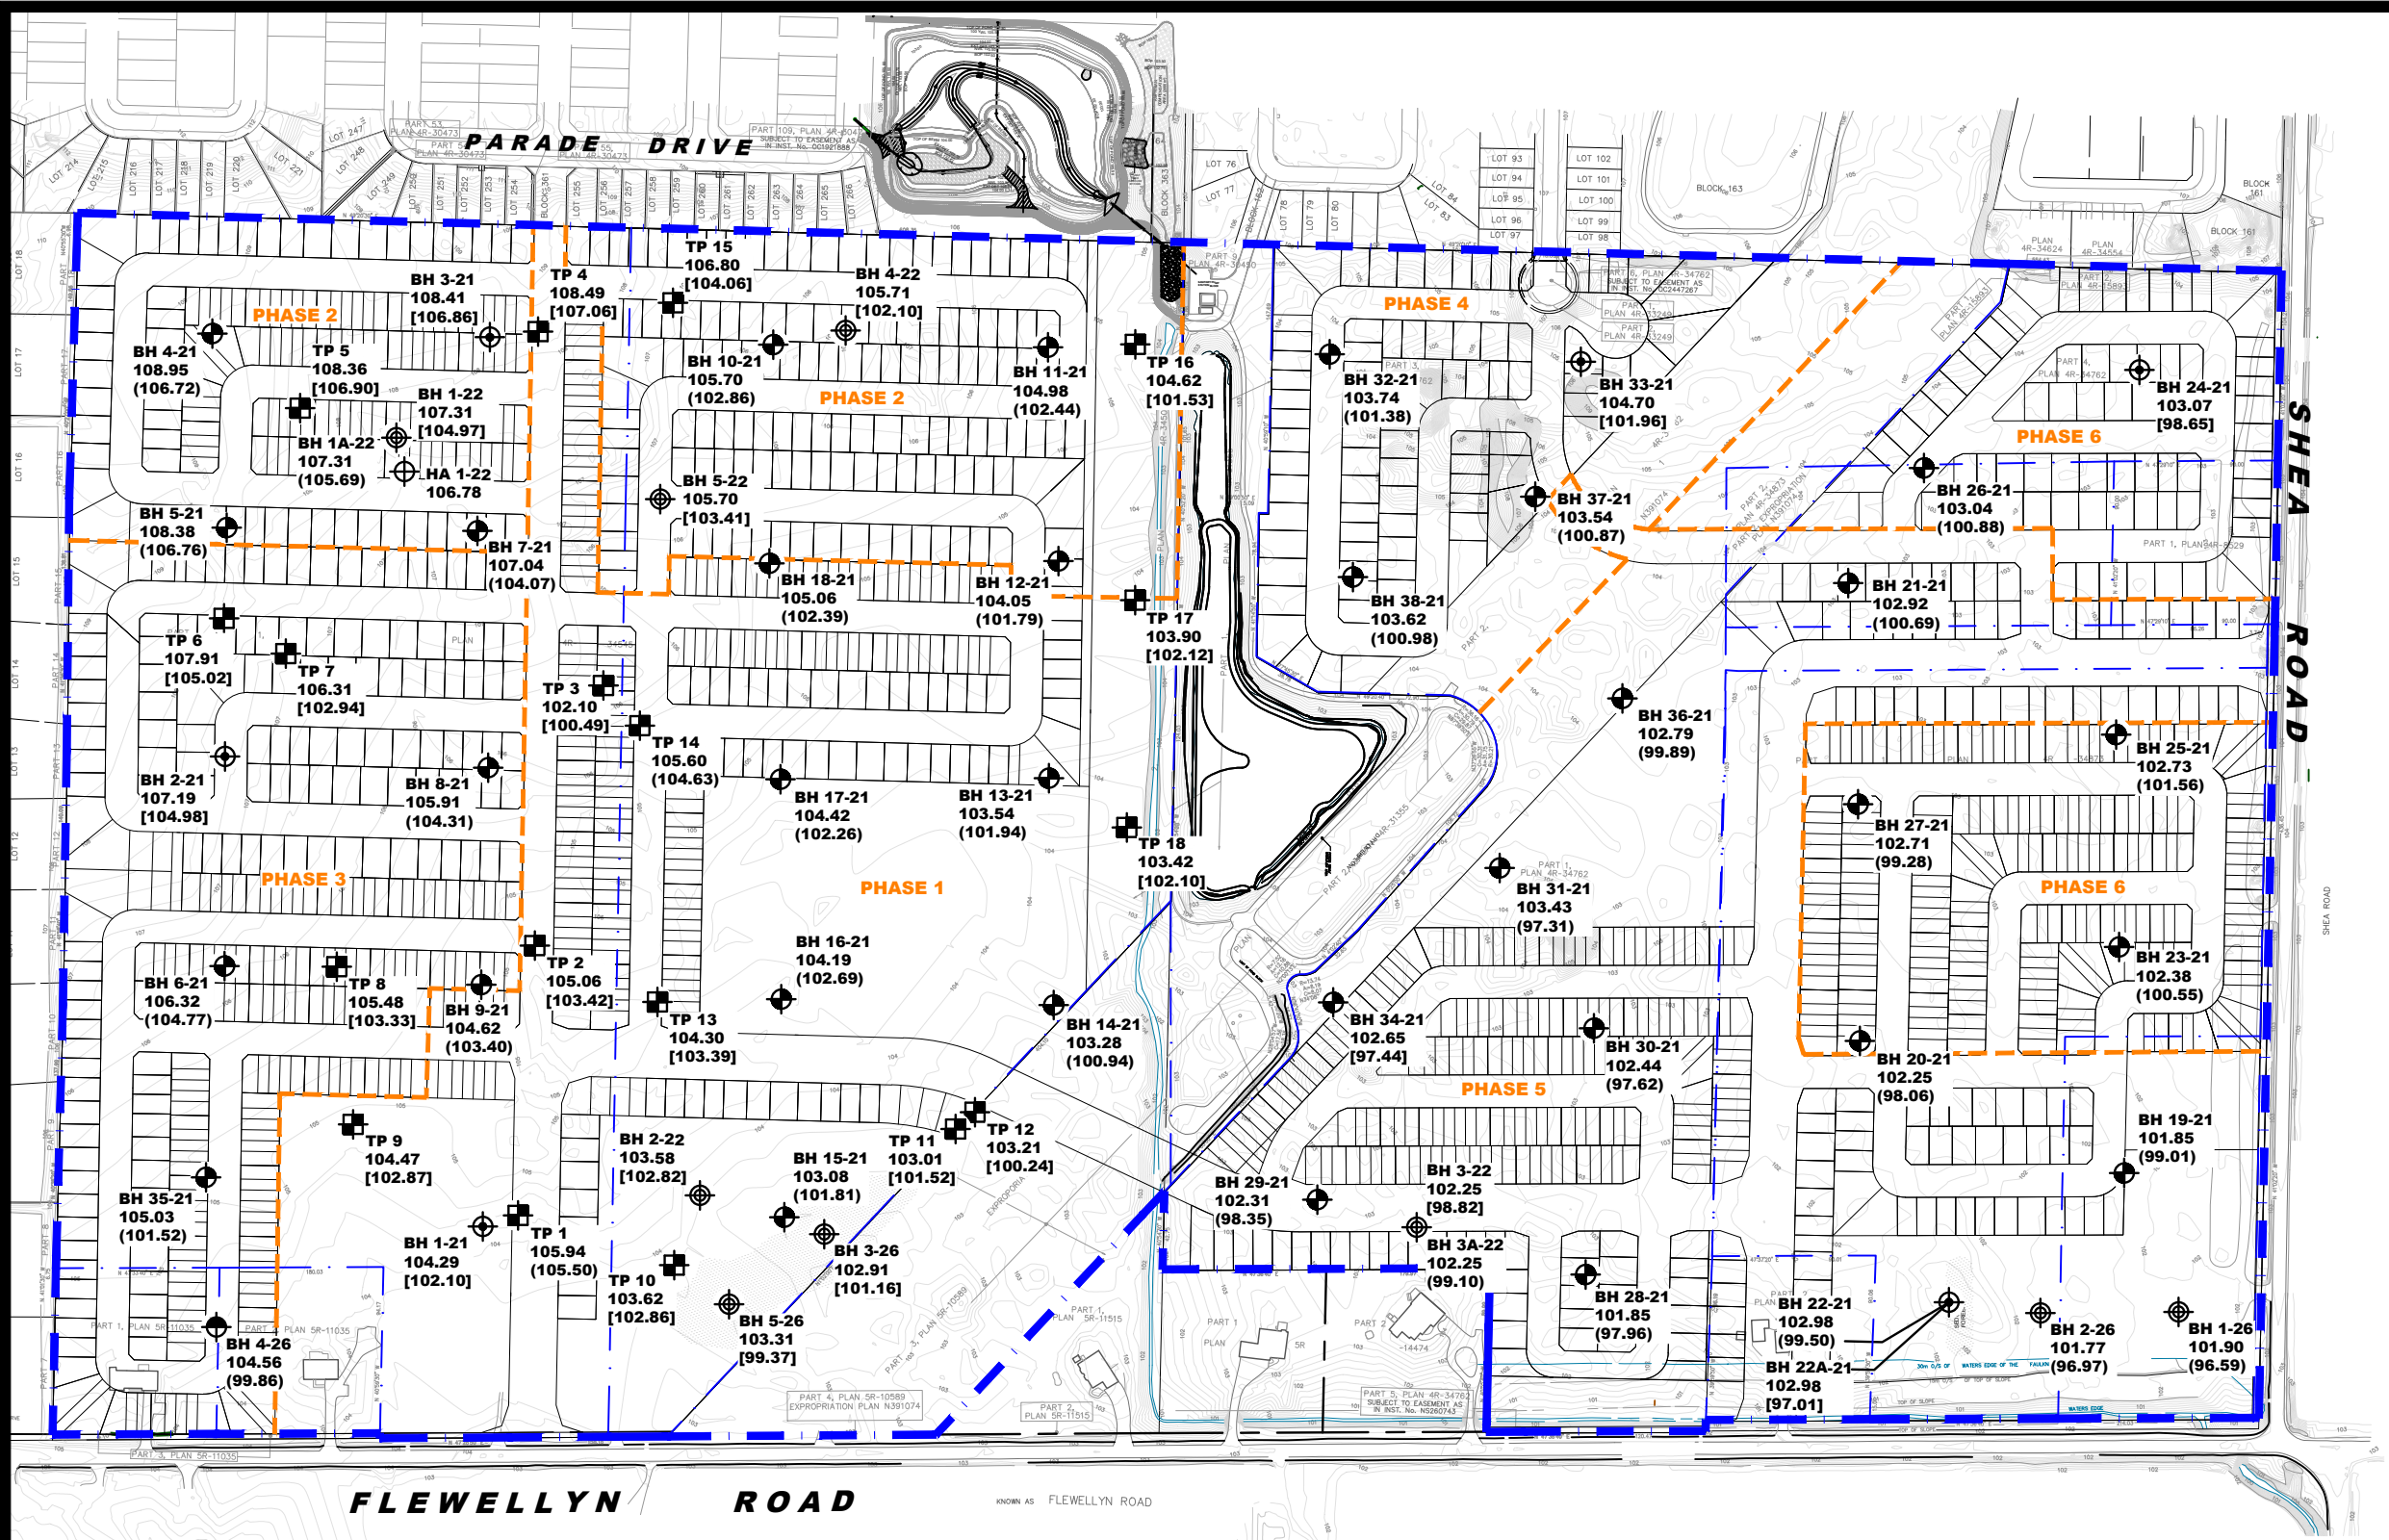
- LEGEND:**
- HAND AUGER LOCATION (CURRENT INVESTIGATION)
  - BOREHOLE WITH MONITORING WELL LOCATION (CURRENT INVESTIGATION)
  - BOREHOLE WITH PIEZOMETER LOCATION (CURRENT INVESTIGATION)
  - BOREHOLE WITH PIEZOMETER LOCATION (PATERSON GROUP REPORT; PG5570-2, JAN 20, 2022)
  - BOREHOLE WITH MONITORING WELL LOCATION (PATERSON GROUP REPORT; PG5570-2, JAN 20, 2022)
  - TEST PIT LOCATION (PATERSON GROUP REPORT; PG5570-1, JAN 3, 2021)
  - 104.29 GROUND SURFACE ELEVATION (m)
  - [102.10] BEDROCK SURFACE ELEVATION (m)
  - (102.39) PRACTICAL REFUSAL TO AUGERING / EXCAVATION ELEVATION (m)
