November 3, 2025  
File: PE7221-LET.01

Subject: **Phase I - Environmental Site Assessment Update  
1101 Baxter Road  
Ottawa, Ontario**

Further to your request, Paterson Group (Paterson) carried out a Phase I - Environmental Site Assessment (Phase I ESA) Update for the property located at 1101 Baxter Road, in the City of Ottawa (Phase I Property). The Phase I Property boundaries are defined as PIN 09356-0003 being Part of Blocks G and H, Registered Plan 383389, City of Ottawa, as shown on the attached Survey Plan by Annis, O'Sullivan Vollebekk Ltd. dated March 30, 2017.

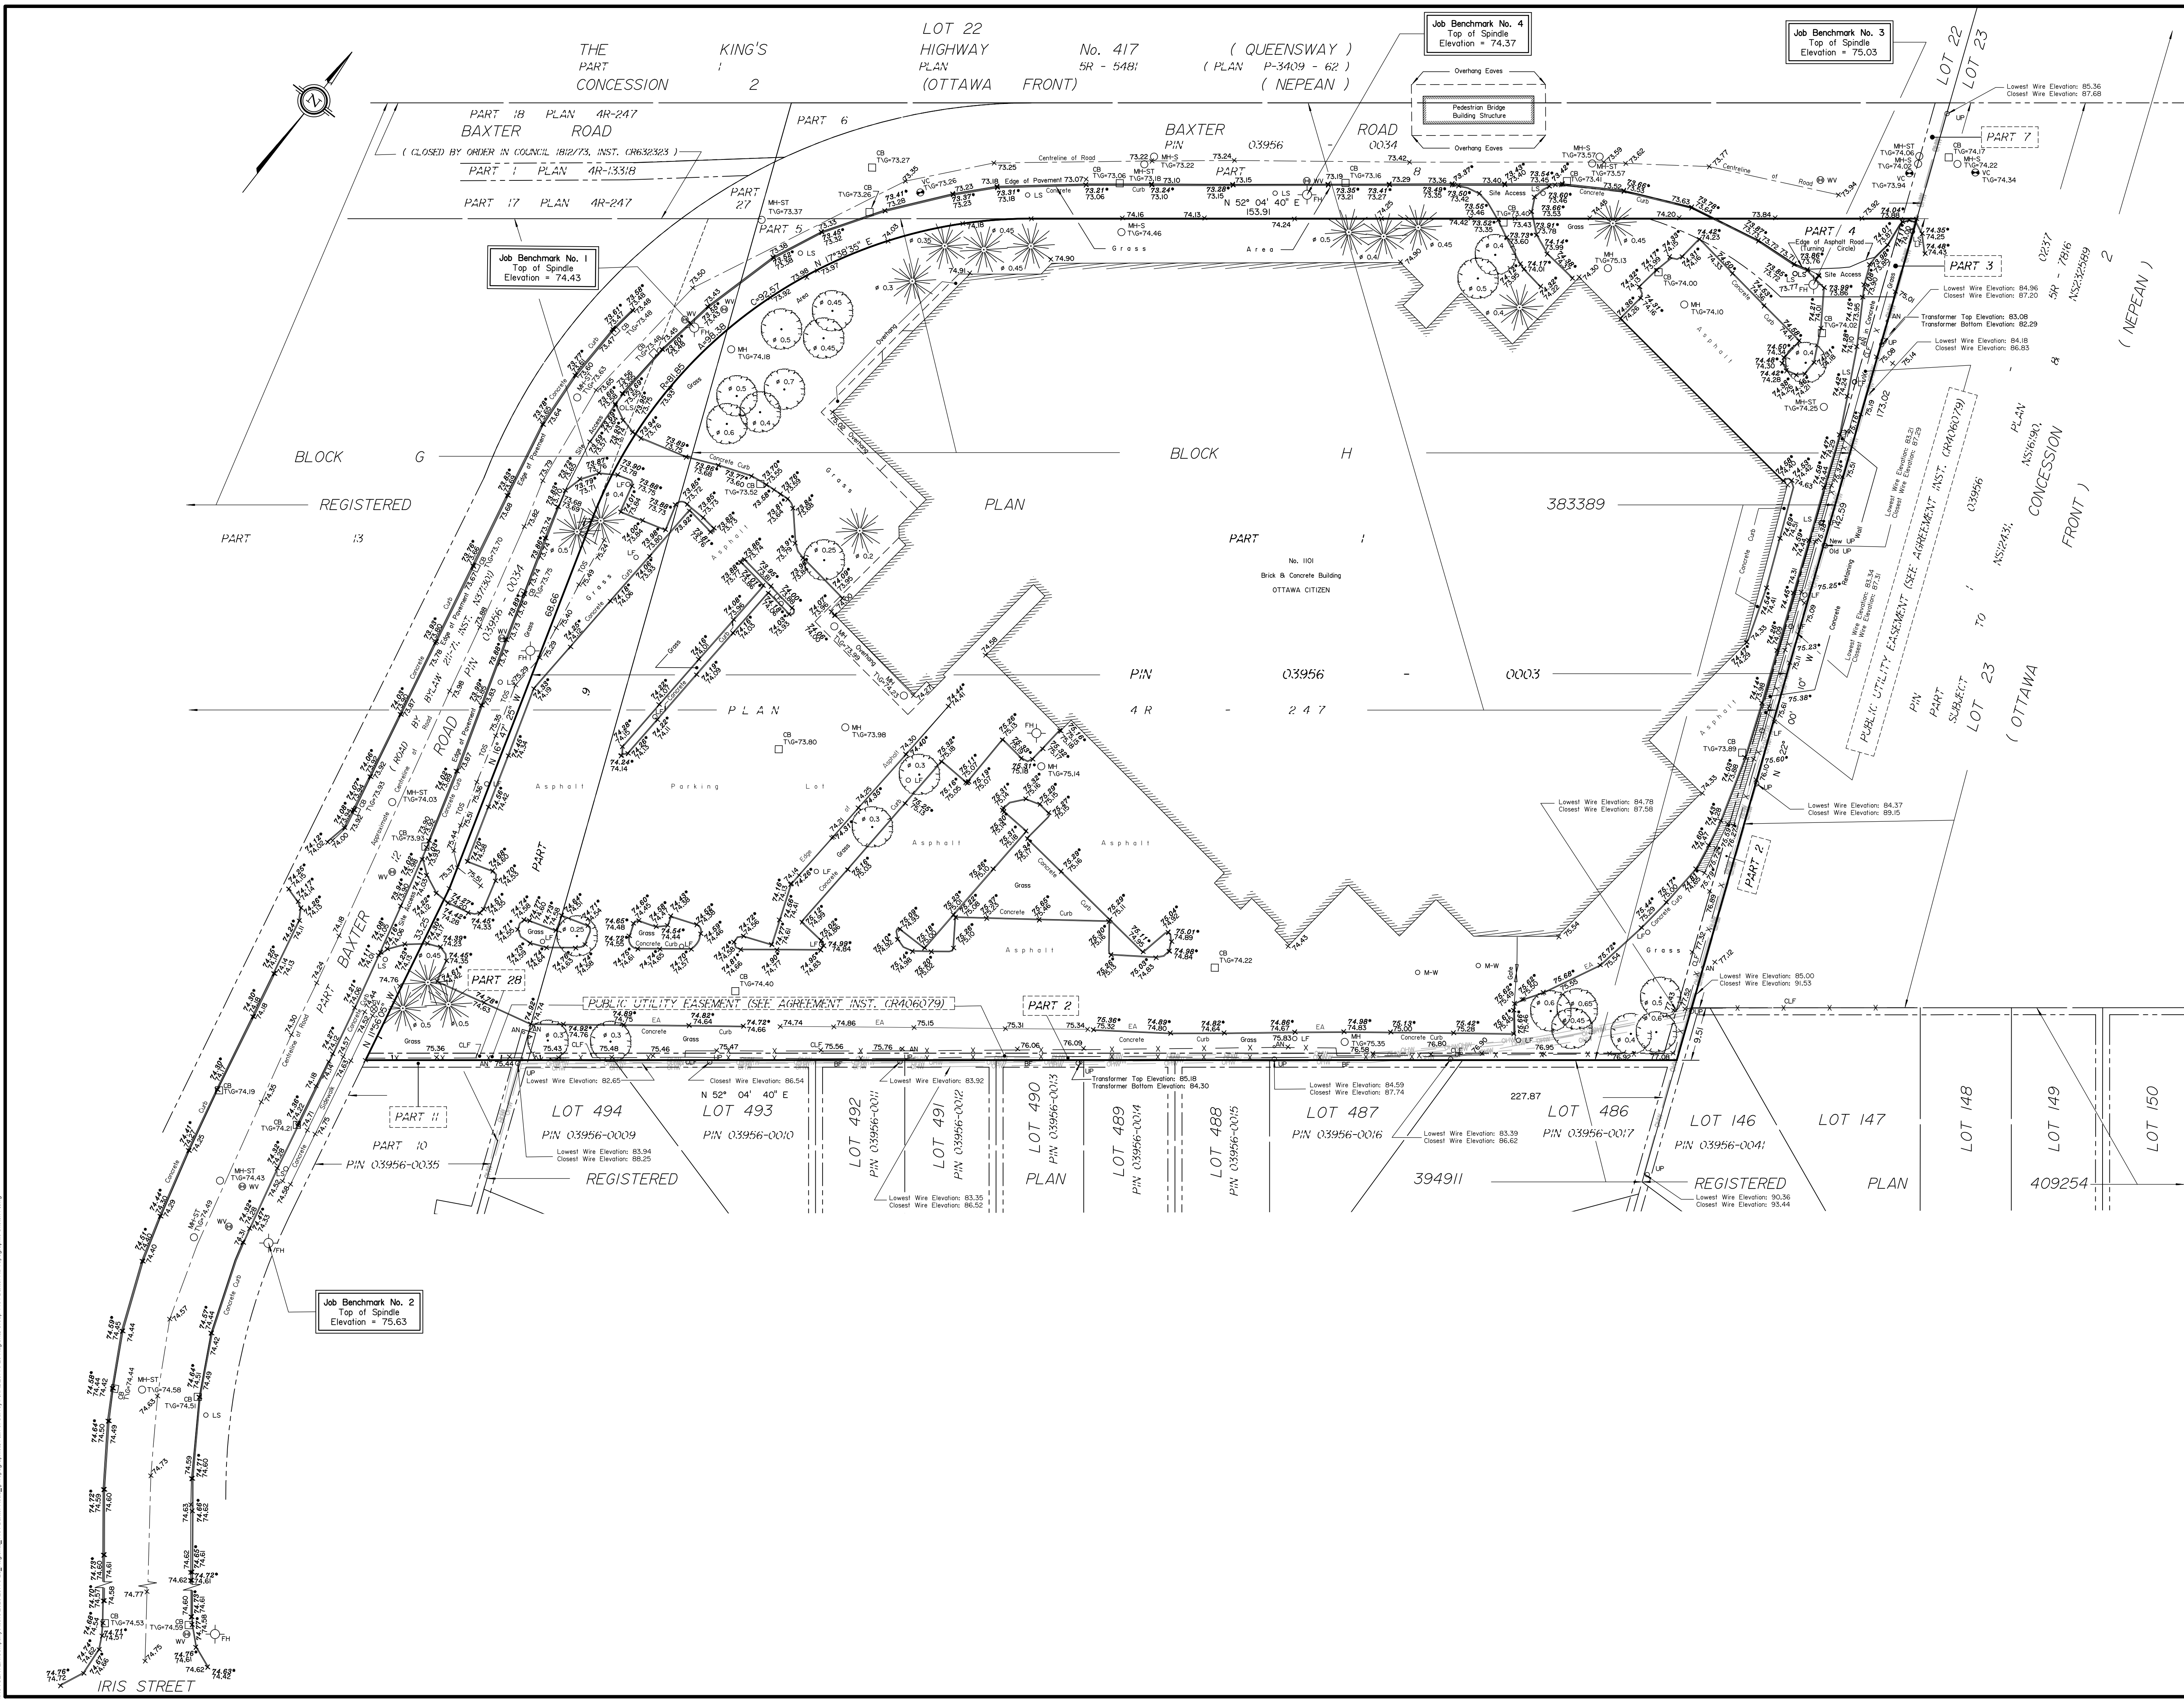
TOPOGRAPHIC SKETCH SHOWING

1101 Baxter Road, Ottawa Citizen  
CITY OF OTTAWA  
Prepared by Annis, O'Sullivan, Vollebekk Ltd.
